CONTAMINATION OF GUN MOUNTING HYDRAULIC SYSTEMS

LIEUTENANT-COMMANDER B. D. MANHIRE, R.N., A.M.I.MECH.E.

Introduction

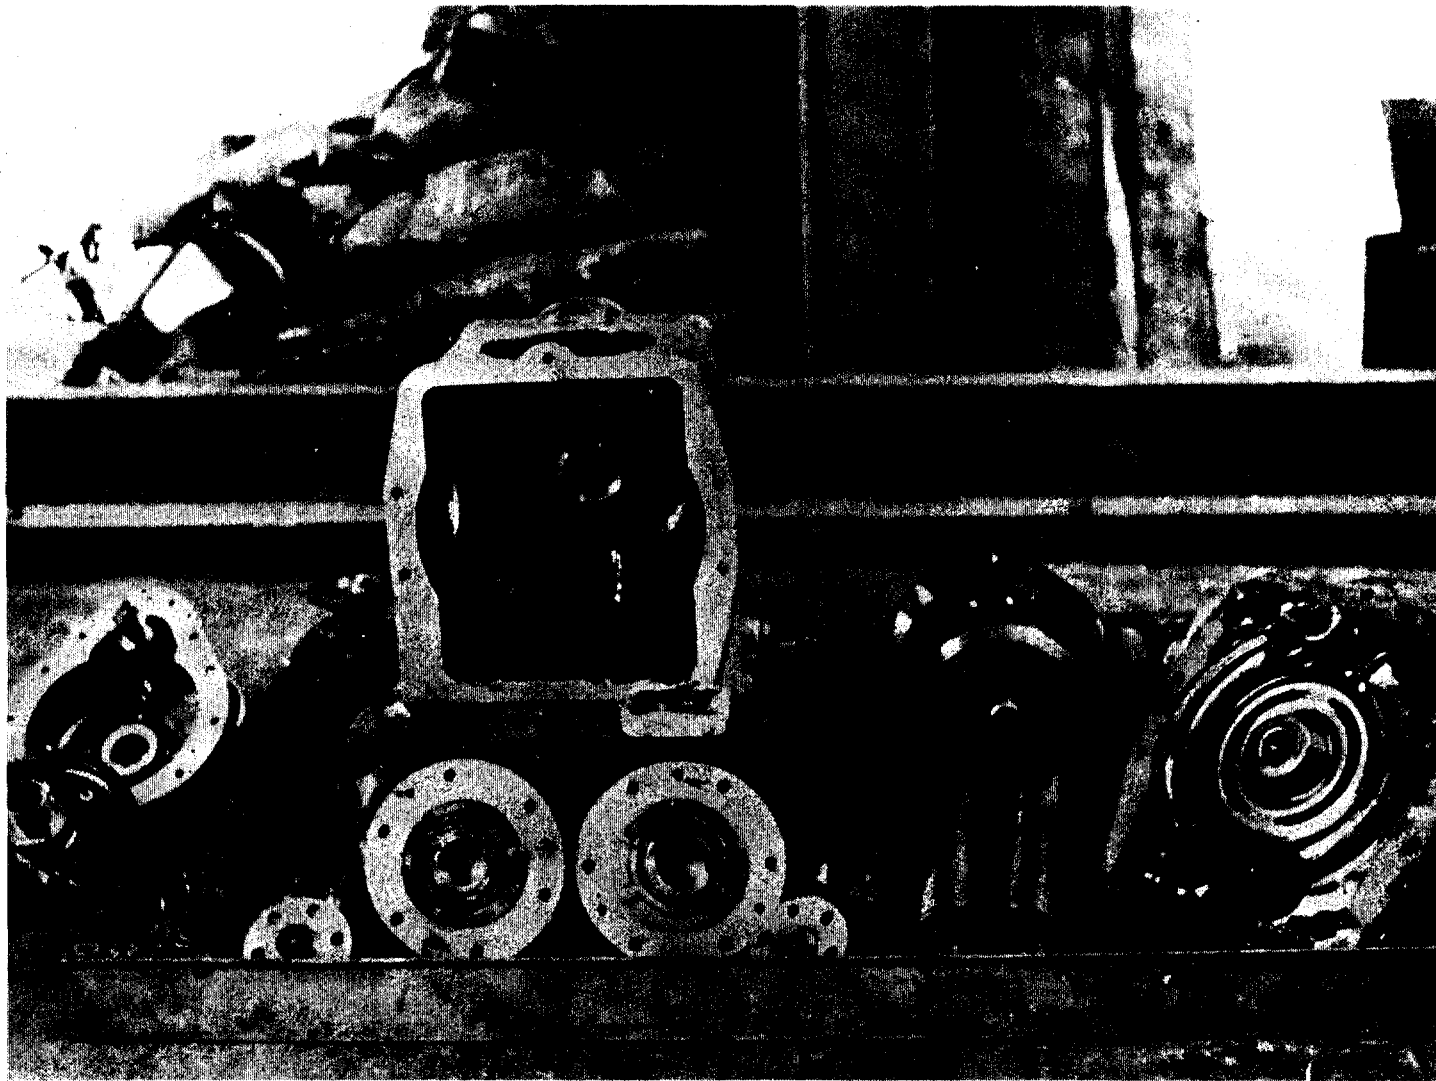
A routine examination was carried out on the general service V.S.G. pump ('A' end) of 'X' Turret (4.5 in Mk. 6 R.P. 41 mounting), and heavy deposits of a brownish-black rubbery substance were found on all the internal non-working surfaces of the pump. In the bottom of the pump body there was a sludge of the same substance. This sludge was $\frac{3}{8}$ in thick along the corners of the bottom of the pump body and gradually thinned towards the centre. The running temperature of the system had been reported to be rather high.

FIG. 1—'X' TURRET REVOLVING STRUCTURE GENERAL SERVICE PUMP, SHOWING EXTENT OF THE DEPOSIT ON COMPONENTS AFTER STRIPPING

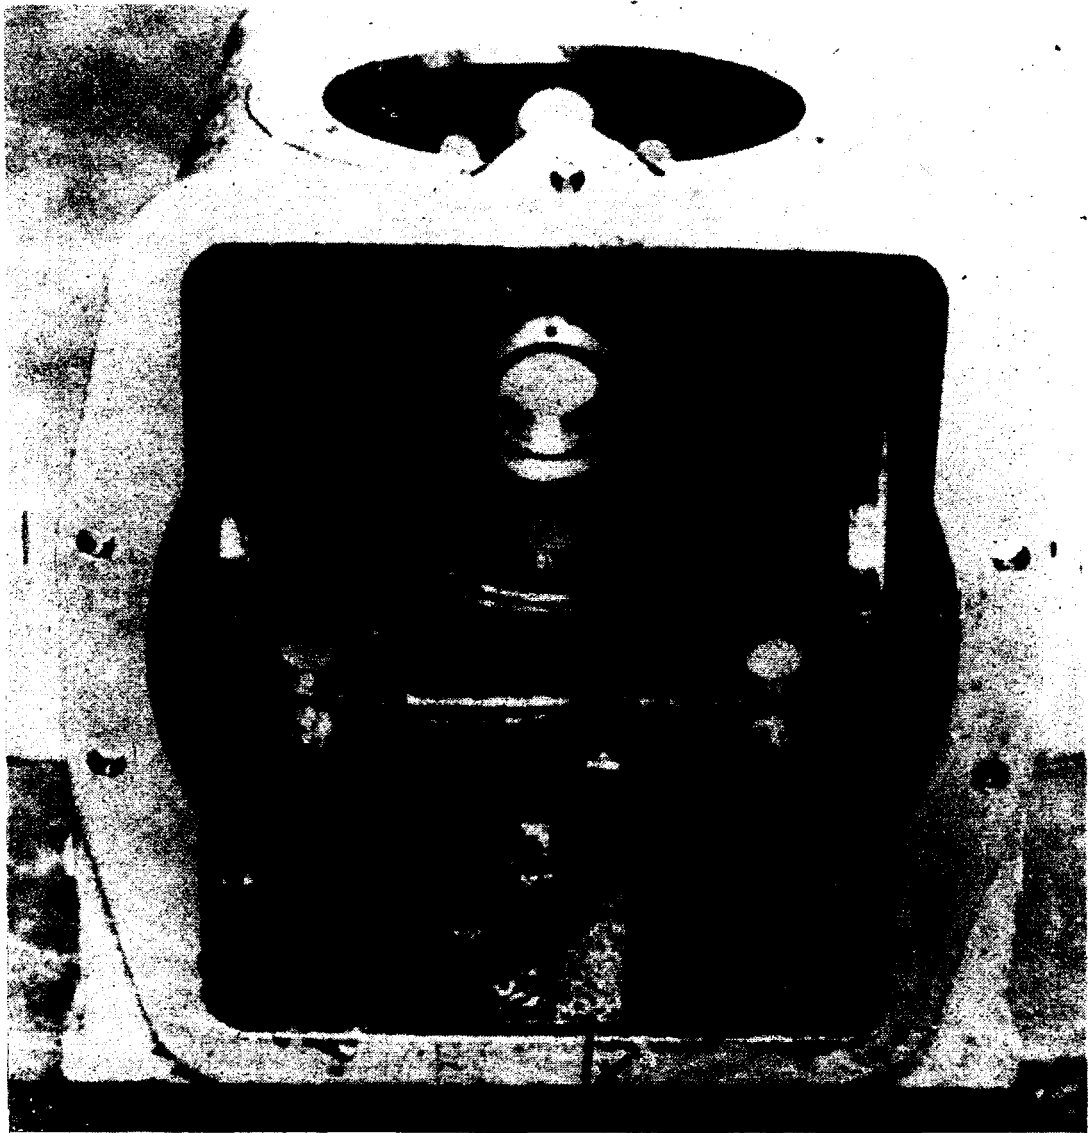
FIG. 2—' X ' TURRET REVOLVING STRUCTURE GENERAL SERVICE PUMP SHOWING DEPOSIT. THE LIGHTER 'LANE' AT BOTTOM OF PHOTOGRAPH COMPARES A REASONABLY CLEAN AREA WITH THE REMAINDER

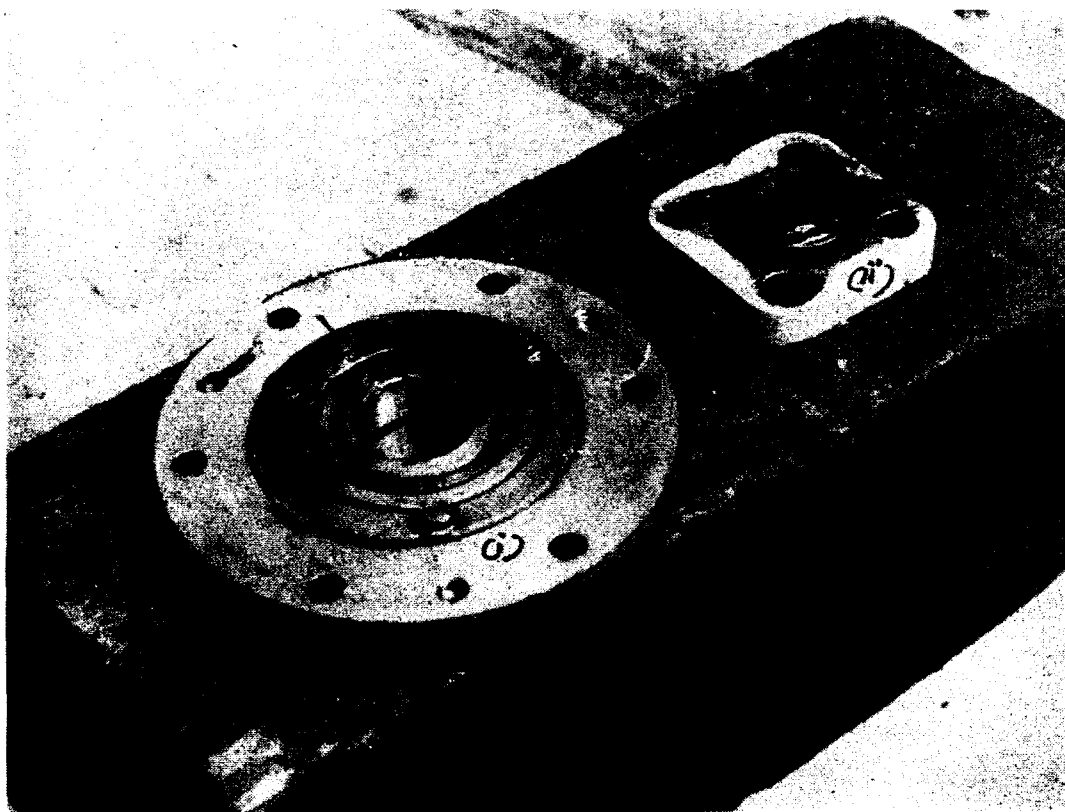
FIG. 4—END BEARING CAP AND BLANK FLANGE FROM PRESSURE PIPE SYSTEM. UPPER PORTION IN PHOTOGRAPH OF THE BLANK FLANGE HAS BEEN CLEANED, THE REMAINDER IS STILL HEAVILY COATED

been in use. The sludge was found to be soluble in benzine but not in acetone, thus indicating that it originated from natural rubber rather than petroleum. A section of the inner lining of one of the flexible rubber hoses was heated in oil for 10 hours at 175°F. At the end of this period, the woven reinforcement layers were coming apart slightly at the ends of the section and the inner rubber lining had softened to such an extent that it could be rubbed from the hose quite easily.

It was considered, from all this, that the inner lining of the hose was of natural rubber, and vulnerable to attack by the oil, thus causing the deposits. The oil probably took small particles of rubber or bonding material into suspension and passed it round the system while the machinery was running. When the machinery was stopped, the oil drained to the lower half of the systems, cooled off, and deposited the particles. This would account for the deposit not being in evidence in the upper parts of the systems.

Cleaning the systems was a major task because it involved removing all the contaminated machinery and pipes, hand cleaning and replacing them. D.N.O. 'Q' Section sent a complete set of replacement hoses to Hong Kong within ten days of the demand being placed—a creditable achievement.

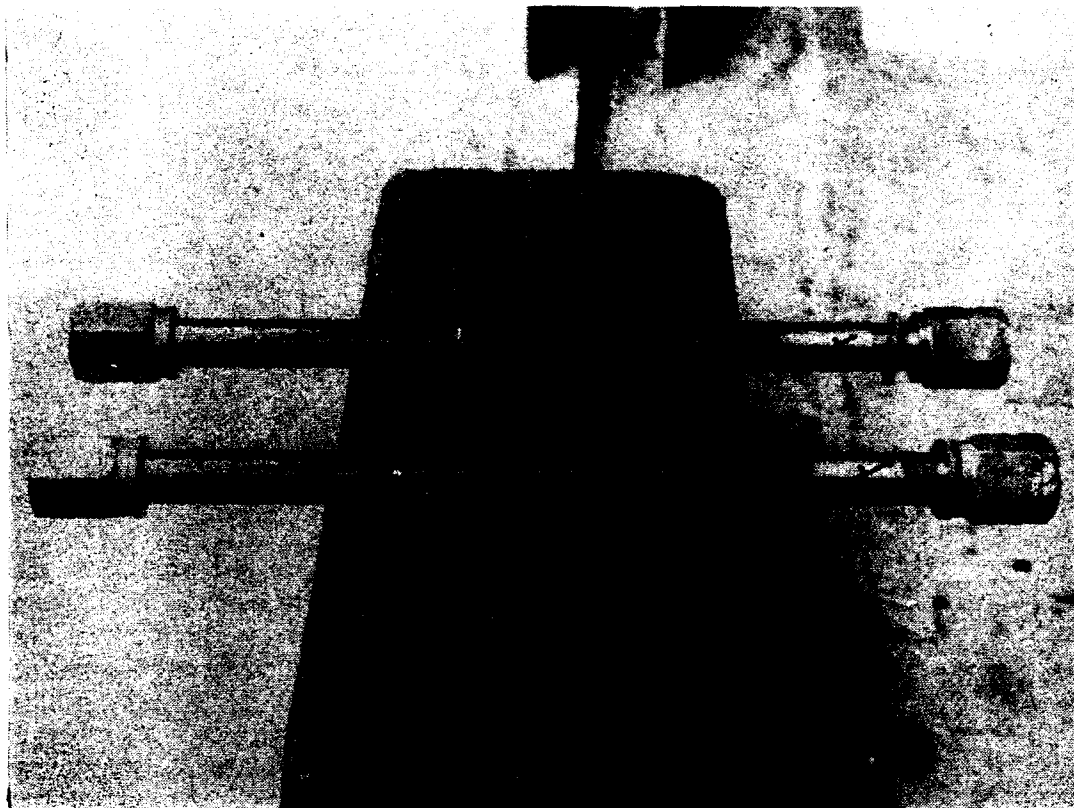
FIG. 5—TWO HEAVILY COATED TIE BOLTS FROM THE PUMP. RIGHT HAND ENDS HAVE BEEN CLEANED
