H.M.S. LION AT THE DOGGER BANK.

The following is an account of the damage which particularly affected the engine room department which was caused by German shell fire, together with the steps taken to clear the ship of water after the action and subsequent alterations and additions carried out as the result of experience in this action.

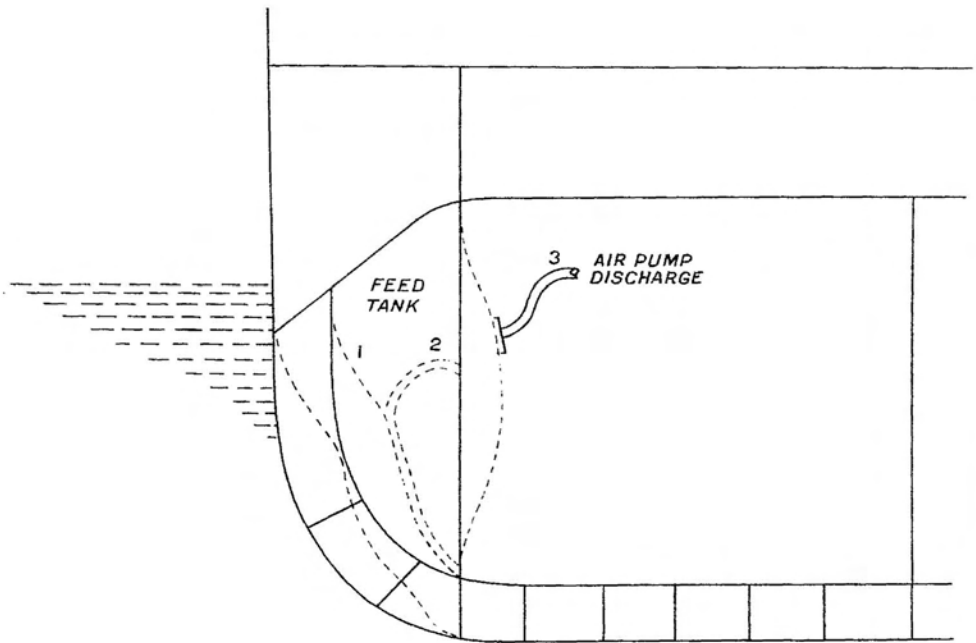
The hit which resulted in the ship being reduced to half-power occurred soon after and was effected by shells bursting under water against the ship's side in the vicinity of the forward bulkhead of the port engine room.

The result was to blow in the inner and outer bottoms outside the feed tank and to cause the side armour to be driven into the slope of the armour deck.

The ship section at this station was somewhat as shown in the figure and the drawing indicates diagrammatically (1) the displaced inner bottom, (2) an angle from the inner bottom which curled over and swept away a few rivets in the inner wall of the feed tank, and (3) the buckled main air pump discharge pipe.

It was extremely fortunate that the damage in the case of (2) and (3) was not more extensive since if many rivets in the vertical joint of the wall of the feed tank had been sheared the wall might have given way and if the air pump discharge pipe had been fractured it would have presented a difficult problem to have prevented the ingress of sea-water.

As a result of the impact such fittings as gauge boards, clocks, telegraph, etc., were thrown from the wall of the feed tank, but the steam exhaust and hydraulic pipes, which were situated high up in the angle formed by the wall and the deck overhead and also the ring main were undisturbed. *See* footnote (a).

(a) Sluice valves were subsequently fitted at the junction of the air pump discharge pipe with the wall of the feed tank.

(b) The air pump discharge pipes were subsequently cross-connected and the feed suctions modified so that all boiler rooms could obtain a suction from either feed tank.
