FIG. 1.—PART OF STARBOARD CRANKSHAFT OF H.M. PADDLE TUG "FIRM" SHOWING POSITION OF FRACTURE IN L.P. CRANK PIN

AN INTERESTING CRANKSHAFT REPAIR

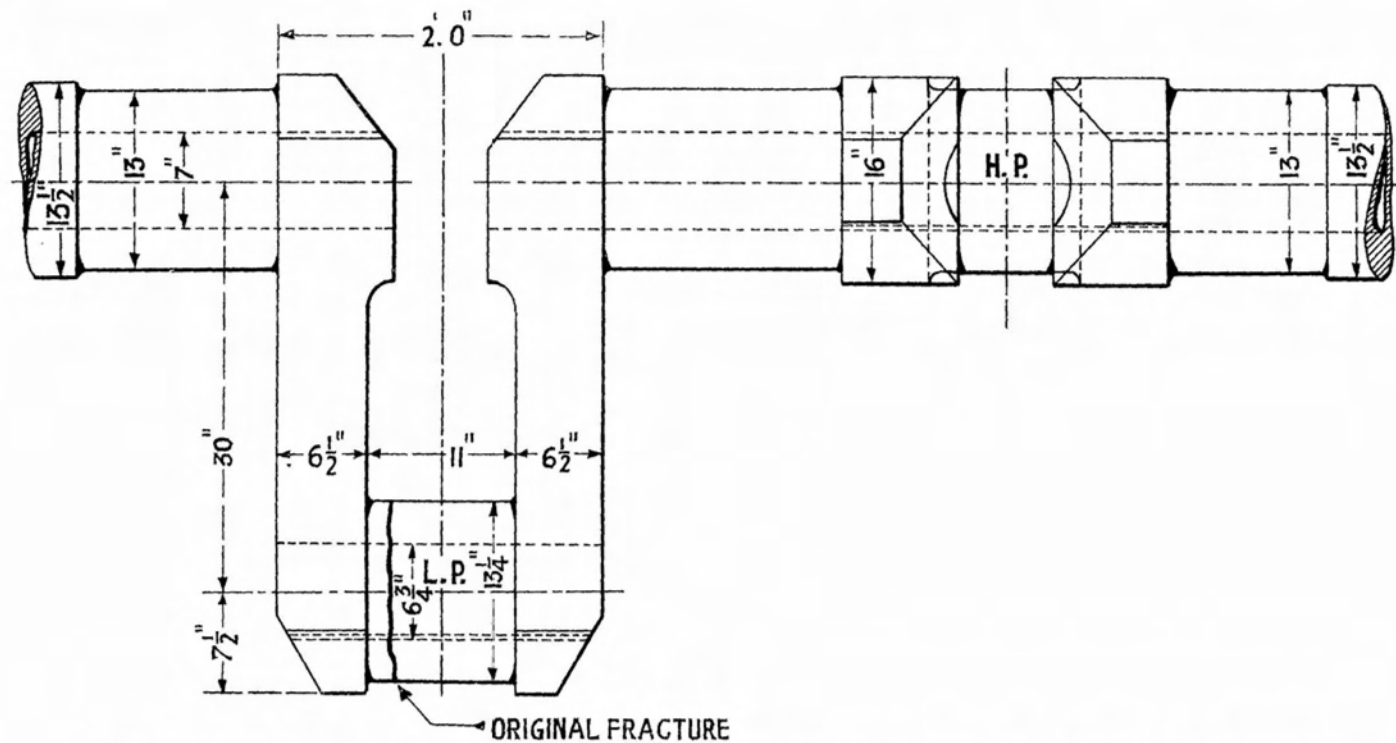
The starboard crankshaft of H.M. tug *Firm* was found to be fractured at the junction of the L.P. crank pin and L.P. web (Fig. 1) and was removed from the vessel by H.M. Dockyard, Sheerness. The shaft was sent to Chatham where the fractured crank pin was burnt through close to the webs and machined flush. This revealed hitherto unsuspected cracks in the outboard web (Fig. 2). The web was therefore cut back about 18 in. and prepared for welding. A forging was prepared from which a new portion of the web could

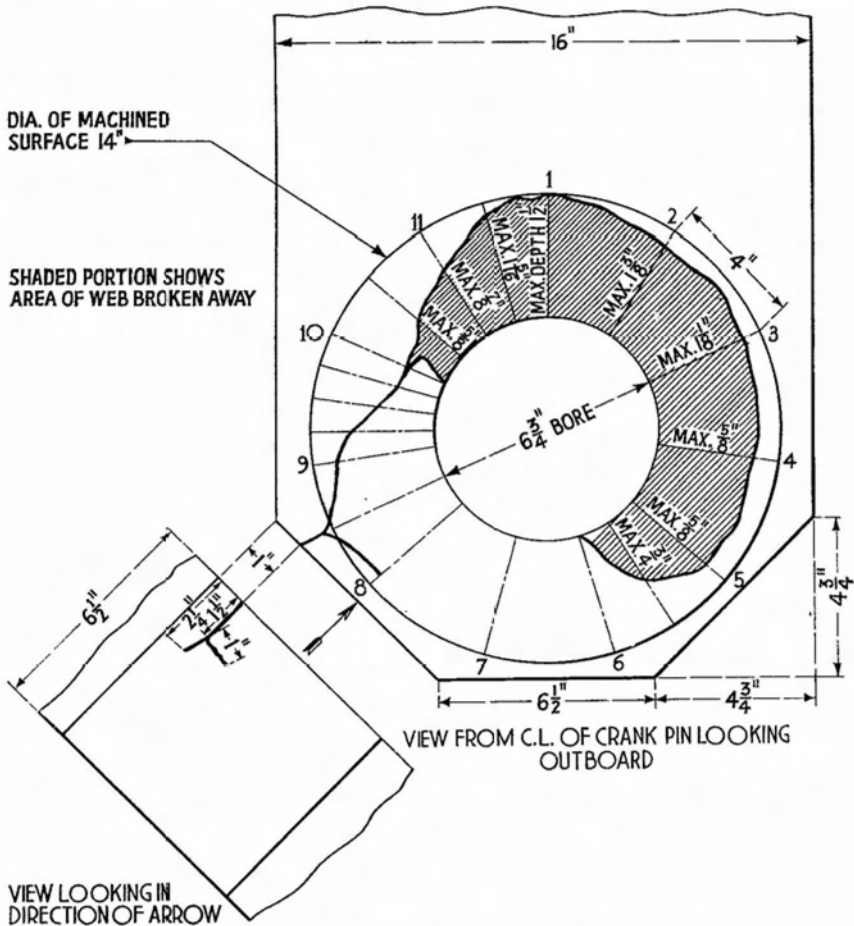
FIG. 2.—CRACKING DISCOVERED IN OUTBOARD WEB

be made. This was rough machined and bored and prepared for welding with a similar profile to the original portion of the web.

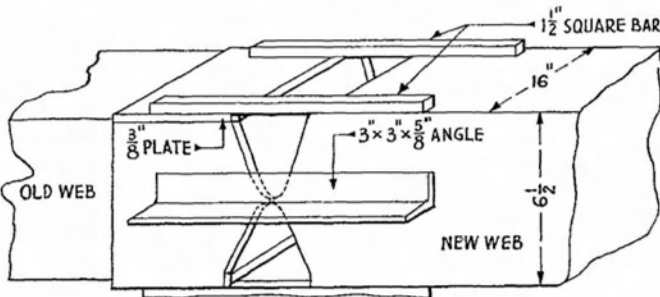
FIG. 3. ISOMETRIC SKETCH OF SET UP FOR WELDING.

The new portion of the web was rough machined $\frac{3}{8}$ in. larger on all dimensions to form a finishing face and $\frac{3}{8}$ in. plates were tacked on the face of the old web to conform to the section of the welding groove as shown in Fig. 3. The webs were then aligned to allow a $\frac{1}{16}$ in. gap between the throat faces (Fig. 4) and angle iron stiffeners were tacked in position. The joint was then tack welded, the gap being maintained by fox wedges and four stay bars of $1\frac{1}{2}$ in. square section were tack welded in position as shown in Fig. 3. These operations were carried out while the two components were fixed to the aligning slab, the whole unit was then lifted so that the shaft was in the vertical position to enable gravity welding to be carried out. This is shown in the upper illustration on page 76.

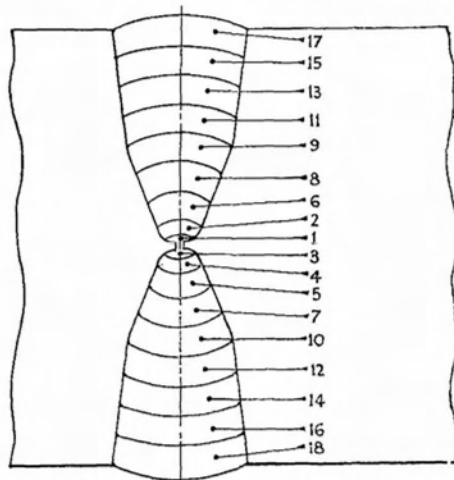
FIG. 5. ORDER OF WELDING STAGES.

The actual welding sequence with Ironex No. 1 electrodes is shown diagrammatically in Fig. 5 and was as follows :—

- (a) Two runs of 8 gauge were deposited on one side and the two stay bars were then temporarily removed.
- (b) Two runs of $\frac{5}{16}$ in. gauge were deposited at an amperage of 410 on the same side.

- (c) As a result of (a) and (b), the new portion of the web had lifted $\frac{3}{16}$ in. relative to the old portion. The two stay bars were replaced and the whole shaft turned upside down, thus placing the opposite welding groove in position for gravity welding. The other two stay bars were then removed and although good penetration was observed at the gap in the throat the joint was thoroughly chipped out to ensure that a good groove was obtained. The web was pre-heated to a low temperature to remove the chill and was allowed to warm through for approximately $1\frac{1}{2}$ hours.

- (d) Two runs of 8 gauge and two runs of $\frac{5}{16}$ in. gauge were then deposited on this side.
- (e) the angle support at the side was cut to facilitate movement and two more runs of $\frac{5}{16}$ in. gauge were deposited. This resulted in the new portion of the web distorting $\frac{5}{16}$ in. in the opposite direction.

- (f) The stays were replaced and the whole shaft reversed again.
- (g) Three runs of $\frac{5}{16}$ in. gauge at 410 amps were deposited after the stays on the upper face had been removed. This caused the web to lift $\frac{3}{16}$ in.

- (h) The shaft was again reversed and one run of $\frac{5}{16}$ in. gauge at 410 amps. and five runs of $\frac{5}{16}$ in. gauge at 460 amps. were deposited. This caused the web to lift $\frac{7}{16}$ in.

- (i) The shaft was reversed and nineteen runs of $\frac{5}{16}$ in. gauge at 460 amps. were deposited. This brought the new portion of the web level with the old.

- (j) The shaft was reversed and five runs of $\frac{5}{16}$ in. gauge at 460 amps. were deposited. Slight distortion occurred.
- (k) The web was then placed in a furnace at approximately 150° C. the shaft, being accommodated outside. The furnace temperature was gradually increased to 650° C. over approximately $6\frac{1}{2}$ hours and then allowed to cool for approximately $4\frac{1}{2}$ hours, after which the furnace was opened and allowed to cool for a further three hours. The shaft was then removed and allowed to cool until capable of being handled and transported to the welding site.

- (l) Seven runs of $\frac{5}{16}$ in. gauge at 460 amps. were deposited and the web lifted $\frac{1}{8}$ in.
- (m) Shaft was reversed and twenty runs of $\frac{5}{16}$ in. gauge at 460 amps. were deposited which brought the web level.

- (n) Shaft was reversed and twenty runs of $\frac{5}{16}$ in. gauge at 460 amps. were deposited. The web remained level. The welding grooves were then completely filled with weld metal which involved a further deposition of approxi-

mately 83 runs of 5/16 in. gauge at 460 amps. No further distortion of the web was noted.

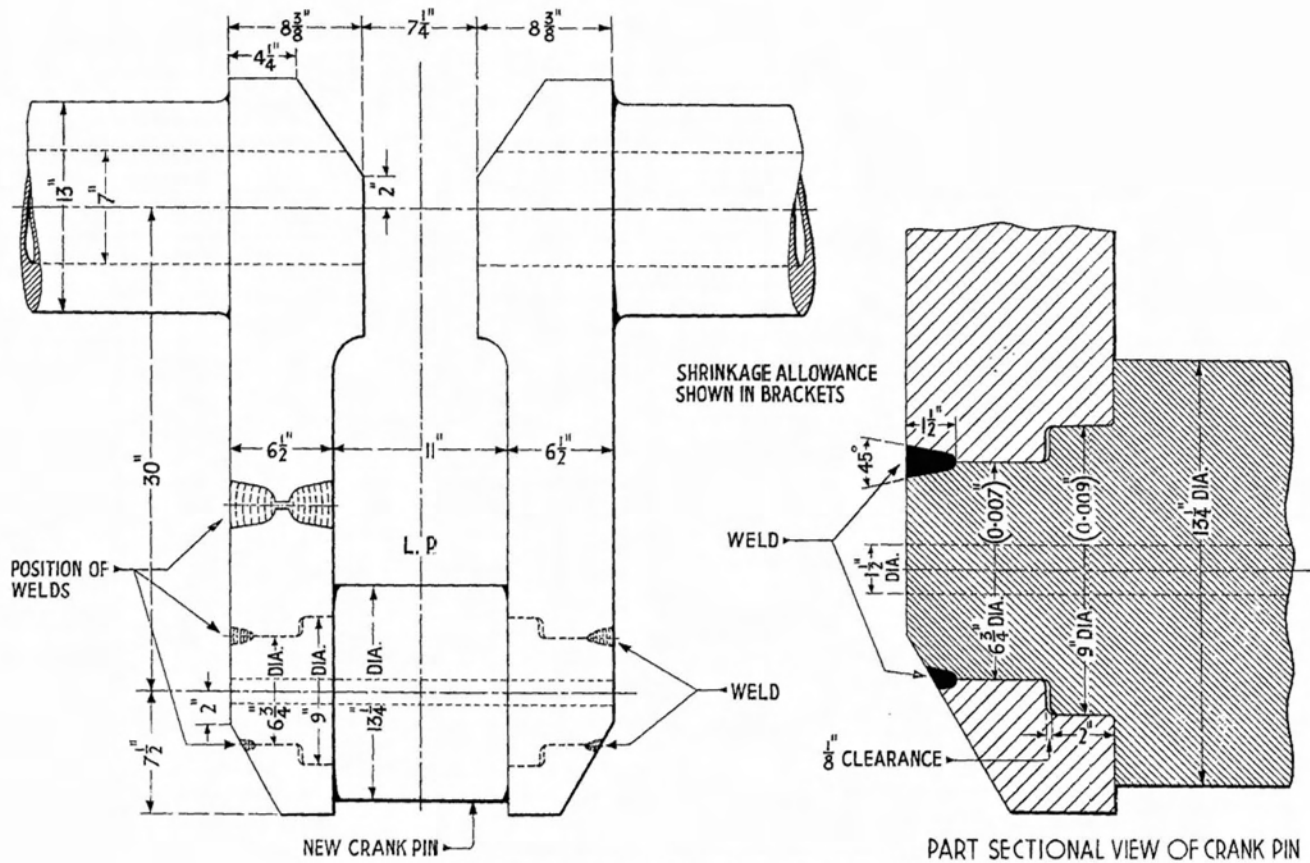
FIG. 6.—DETAILS OF NEW CRANK PIN FOR SHAFT OF "FIRM"

The sides and inner face of the web were machined and a pilot hole drilled to mandrel size. The inboard web was bored out to finished size and a new crank pin made with particulars shown in Fig. 6. Two cast iron bushes to fit the finished bore of the holes in the webs and a mandrel were made to assist

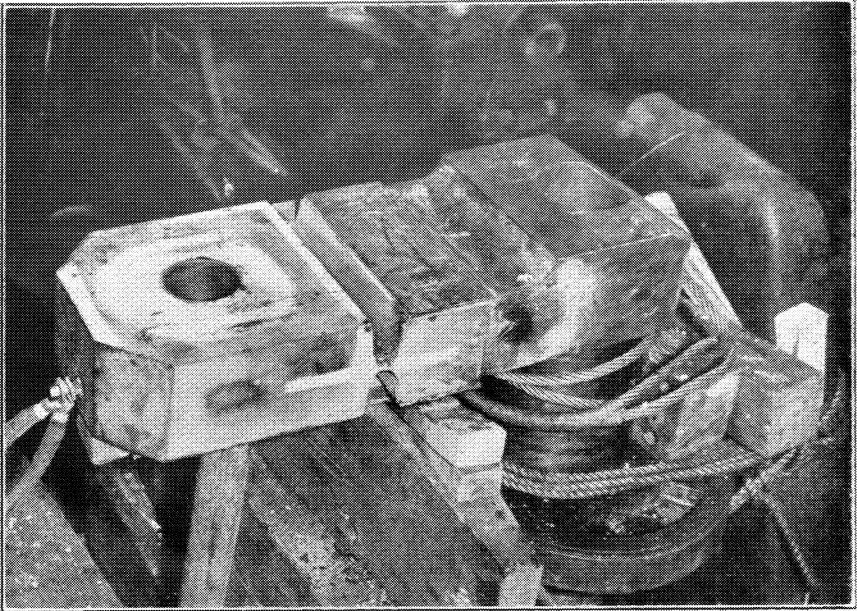
SHAFT IN POSITION FOR WELDING

In order to weld the crank pin to the webs the shaft was slung vertically from an overhead traveller to enable gravity welding to be carried out.

- (a) Six runs of 8 gauge, Ironex No. 1 electrode, were deposited in web 'A.'
- (b) The shaft was reversed and six runs 8 gauge were deposited in web 'B,' followed by seven runs of 6 gauge to complete the weld.
- (c) Shaft was reversed and fifteen runs of 6 gauge were deposited in web 'A' to complete the weld.

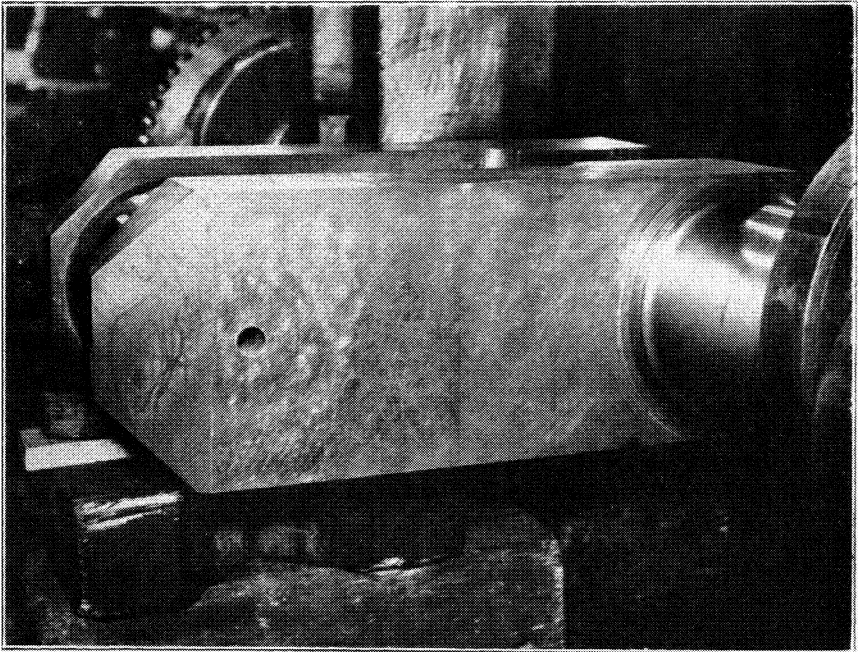
THE COMPLETED JOB, READY FOR DESPATCH

with the inboard end in the chuck and steady bearings placed under each main bearing and the journal in turn. The shaft was finally set up so that the sponson bearing and the journals between the H.P. and L.P. crank and inboard of the H.P. crank were running true. This resulted in the journal outboard of the L.P. crank running .025 in. out of truth. This journal was then machined true, approximately .050 in. on diameter being removed. (See lower illustration on page 76.) The paddle hub and keys were then fitted and the shaft was despatched for installation.

The work of repair was taken in hand during the second week of February, 1944, and completed during the third week in April. Satisfactory sea trials were carried out on May 26th, 1944.
