# **A Collaborative Approach to the Removal, Overhaul and Replacement of the Port and Starboard Electric Propulsion Motors on a T23 Duke Class Frigate**

*Babcock International Group*

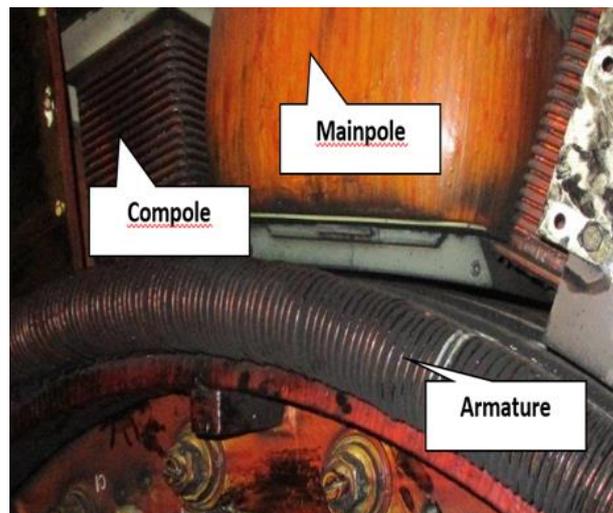
Figure 1 - Mainpole and Compole

The mainpoles and compoles, at Figure 1, are located around the armature and have set gaps which are crucial to correct motor operation. The motor has no inbuilt bearings and is reliant on the alignment of the gearbox quill bearings and the forward plummer block to maintain the required airgap. Variations in this airgap will influence the motor in terms of noise, commutation and thermal performance.

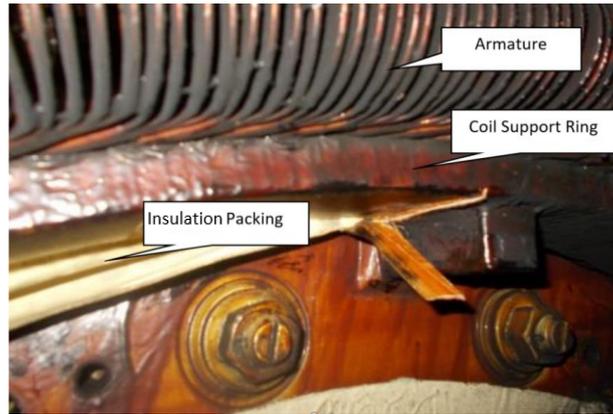
Figure 2 - Insulation Packing Detail

The inspection report noted that there was serious degradation with the insulation on the forward coil support ring. The insulation had split in a number of areas around the ring and the insulation packing was also migrating in several places. One of the damaged insulation sections was removed from the starboard motor and found to have migrated to such an extent that it was completely off the coil support ring. It was also noted that there was only a small amount of carbon dust contaminating the insulation, indicating that this movement was recent.

The report concluded that there was very little of the insulation still on the coil support rings, significantly reducing the insulation thickness between the coils and the support ring. This would heighten the risk of a major failure occurring with potentially extensive damage to the motor. The released packing can be seen in Figure 2.

- No damage was found on the rear support ring. This indicated that banding release on the front ring was caused by high temperature; a slight blockage in the air cooling duct could have worsened this effect.

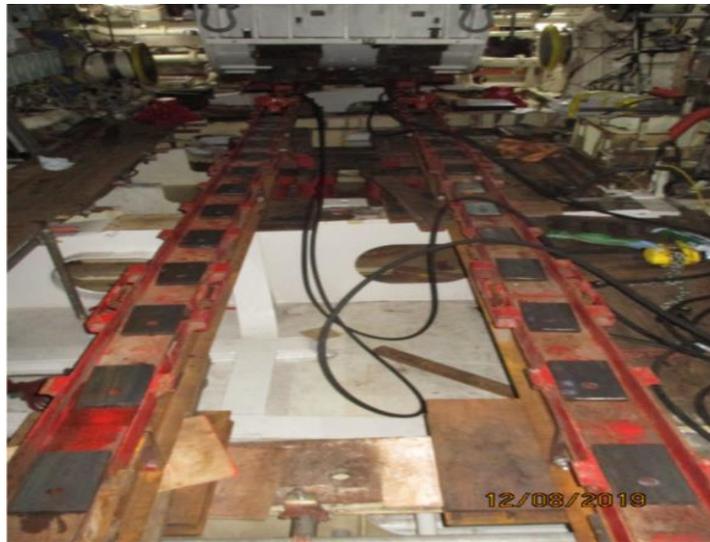
Figure 8 - Motor Prepared for Removal

Figure 8 shows the starboard motor already removed and the port motor prepared for removal.

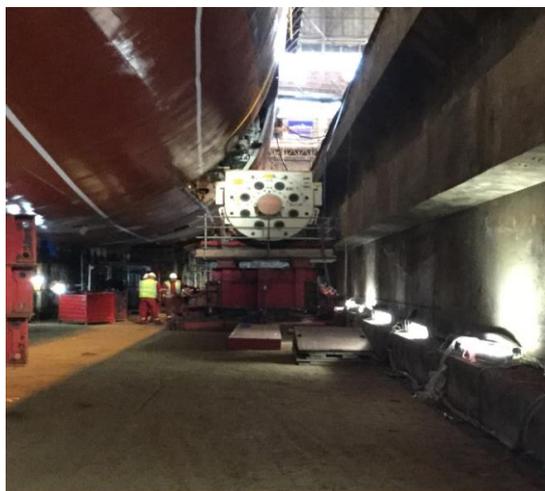
Figure 9 - Motor Removal

Figure 9 highlights the limited clearance between the ship and dock side.

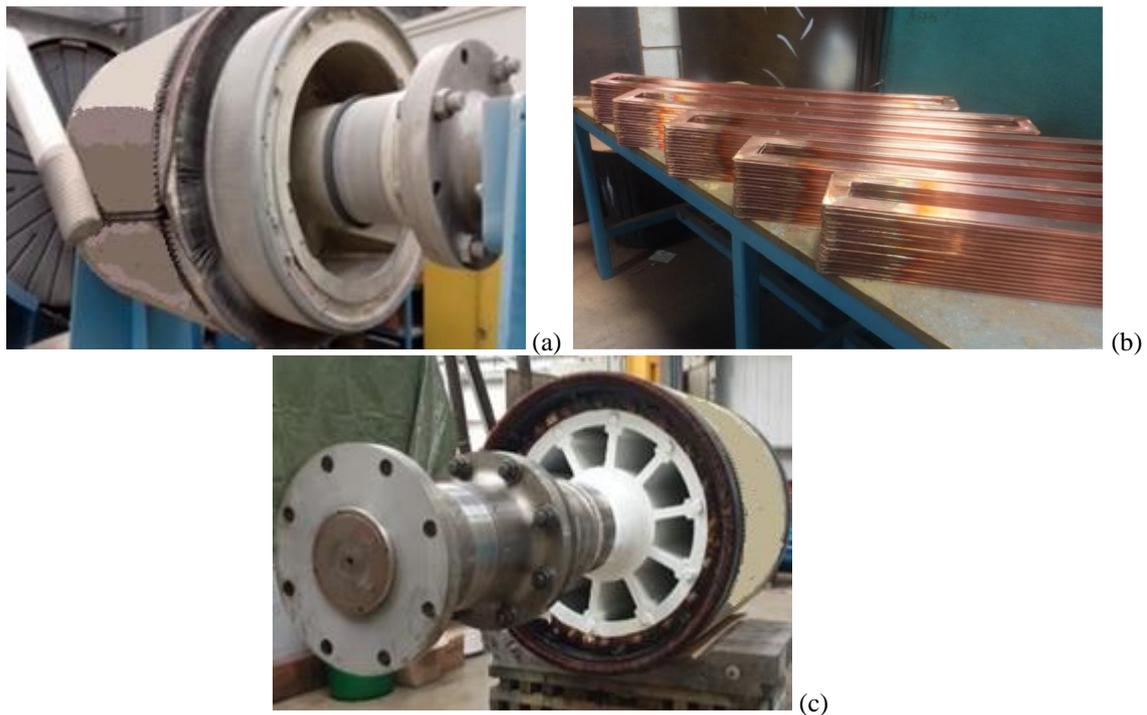
Figure 10 - (a) Armature Cleaning, (b) Compole Manufacture and (c) Armature Varnishing

One of the key requirements was assurance that the motors would be restored to their Design Intent. The motors were heavily contaminated with oil and carbon dust, which is a known in service challenge and remedied with a regular cleaning regime. However, when the motors were delivered to the OEM's facilities the motor casings, which had not been removed for over 17 years, revealed further issues. These motors were the very first to be opened within the Class and revealed a distinctive debris pattern, that suggested that there was a loss of cooling air flow along the motor armature.

Post strip down, the re-assembly progressed with all line testing completed and reported. Some stages are shown in Figure 10 (a, b and c)

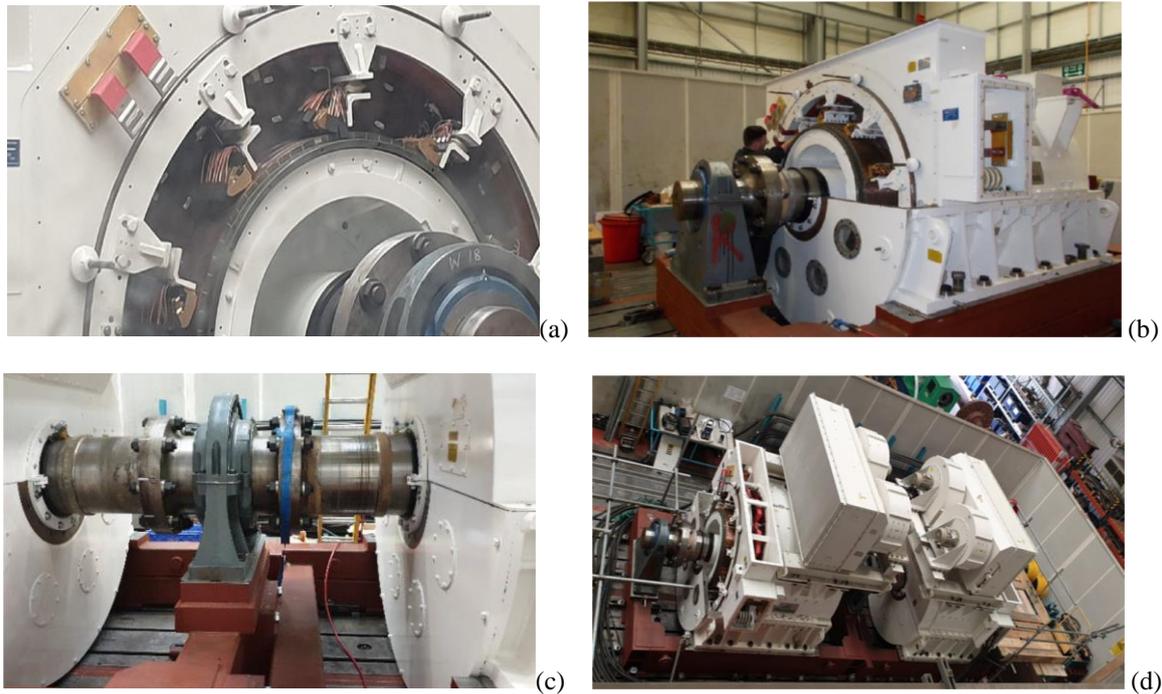
Figure 11 – (a) Brush Bedding, (b) Motor on Bedplate, (c and d) Motors Connected for Back to Back Testing

Figure 11 (a, b, c and d) shows the preparations for testing. Testing took approximately 3 weeks at the repair facility, which was attended by the WTA and the EAA.

Testing passed all criteria and the motors demonstrated design intent performance at the factory.

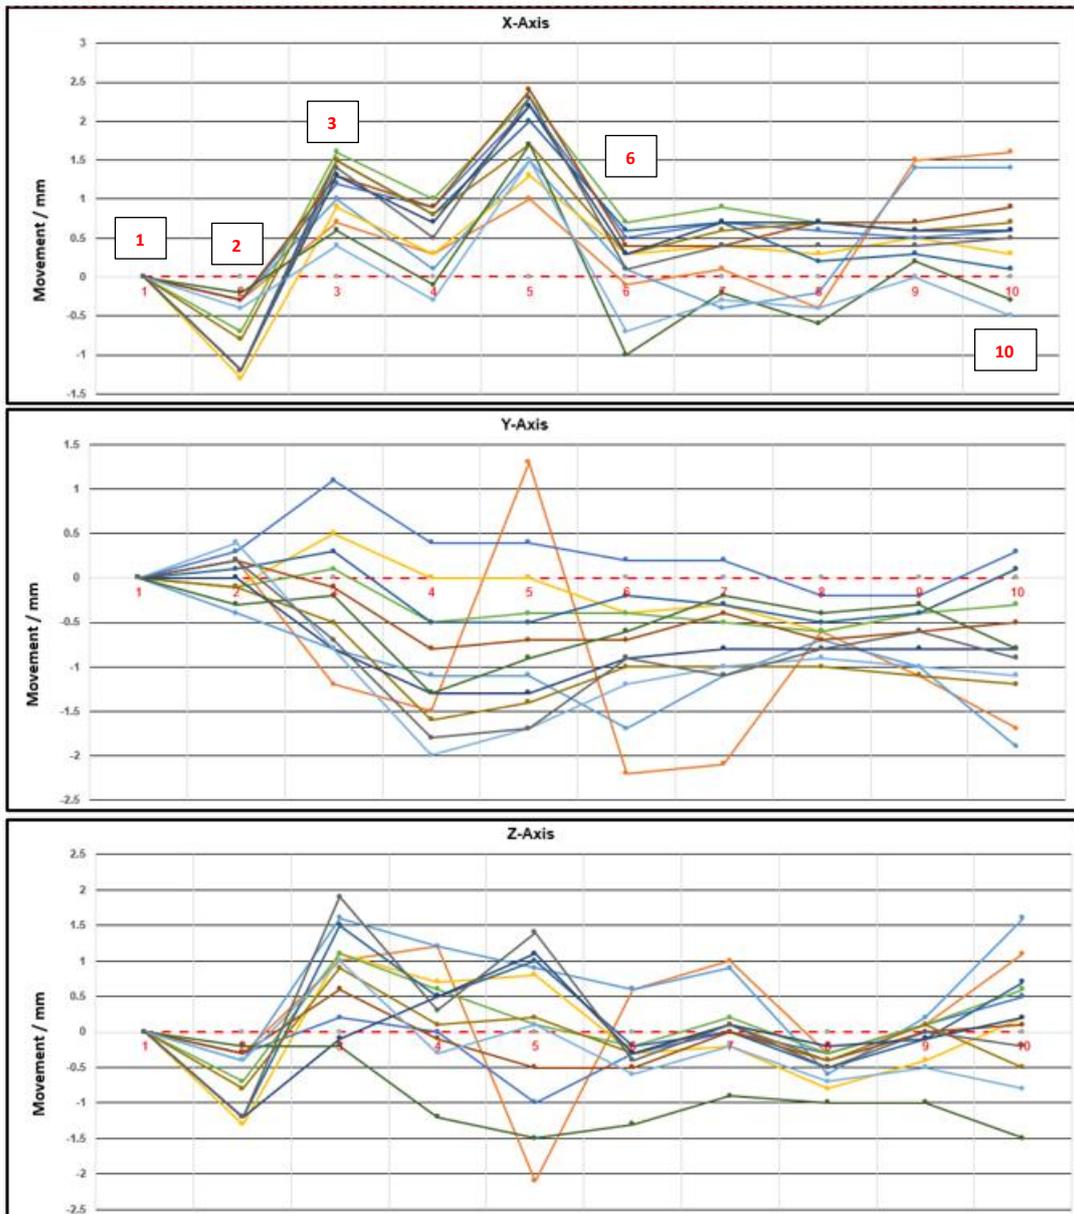
Figure 15 – X, Y, Z Readings for Port and Starboard Bedplates

Position	Event
1	Datum readings - the shaft line fully connected and in tension
2	Motor disconnected from shaft line, still on bedplate. The motor bedplate is experiencing the full weight of the motors (40 tonnes each motor). With the motors released from the shaft line but still in place, both bedplates moved slightly in the Z axis due to the bedplates being in greater compression with the weight of the motors.
3	Motors removed. With no beam tension from the shaft line or weight from the motor, both bedplates have moved forward towards the gearbox. The range of movement from motors in the Y axis was approximately 2 mm and although this is witnessed in both Port and Starboard direction, there is clearly more movement of both bedplates to Starboard. The insert cut into the Starboard side of the MGR hull may have influenced the movement of the motor bedplates.
6	Ongoing monitoring with associated deflections witnessed, motor replaced

10	Shaft line aligned and reconnected. The readings for the starboard motor show higher when compared to Port. This may explain why the starboard motor was more of a challenge to re-align and required greater adjustment.
