# Northern Star: Evolution and Operation

G. S. JACKSON (Member)\* and C. WINYARD (Member)†

This paper is complementary and supplementary to the paper "Passenger Liner With Engines Aft".<sup>(1)</sup> The first section covers the policy and evolution of *Northern Star*, based upon the experience gained from the *Southern Cross*. The second covers the operation of the propulsion machinery of the vessel during her first eighteen months in service. The British shipbuilding industry has remained quiescent since the advent of *Northern Star* in July 1962 due to lack of orders, but it is hoped that this will soon improve.

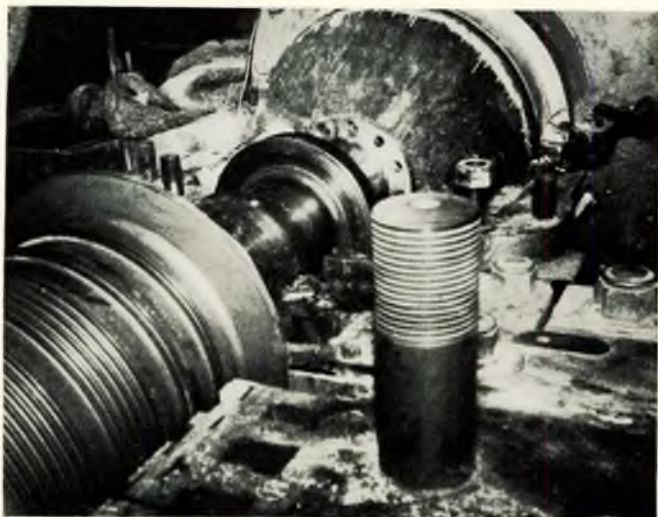
Within six days of leaving Southampton, having called at Las Palmas and bunkered to capacity en route to Cape Town, the starboard engine had to be stopped when the H.P. thrust bearing overheated and sparks were seen to emanate from the vapour hood between the ahead and astern turbines. Examination showed that the rotor had moved forward approximately  $\frac{1}{4}$  in. against the expansion indicator. On opening up the thrust not only was it found that the ahead thrust pads had worn down far into the gunmetal, but the ahead face of the thrust collar was serrated and severely scarred. The H.P. turbine was isolated and running conditions were established once more with the L.P. only on the starboard engine. Some three days later the port engine H.P. thrust failed and upon examination disclosed an identical failure to that which had occurred to the

FIG. 14—H.P. thrust collar after first failure

The H.P. rotors were removed, thrust collar faces restored by machining and phosphated. New thrust carriages supplied wherein the thrust pad carriers were supported on hydraulic pistons and provided with a means of self-alignment. The area of the pads was increased in order to reduce the load pressure from 151lb./sq. in. to 117lb./sq. in. Recording apparatus was installed to measure the thrust load indicated by the hydraulic pressure to support the pads. The oil system was cleaned and the E.P. oil replaced by a straight mineral turbine oil. Both turbines were assembled, but only the port H.P. was coupled with its L.P., the intention being to treat each side separately, and provided the port engine ran successfully to Sydney on the hydraulic support thrust, the starboard engine could be coupled to this flexible thrust, thence allowing the port engine thrust to become solid by removing the hydraulic pressure. This programme was fulfilled and on the homeward run the starboard engine thrust, after a period of running, was allowed to become solid. The ship arrived in Southampton without further incident.

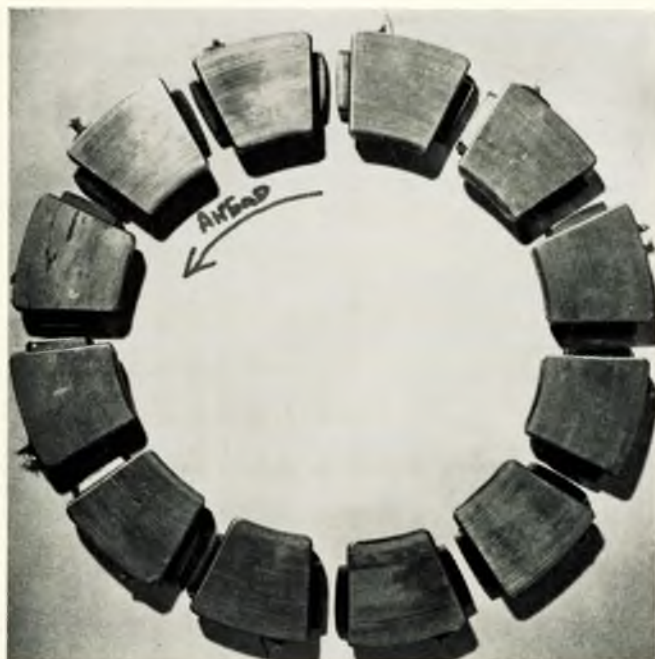
FIG. 16—Ring of port ahead pads  
(end of second voyage)

Both H.P. thrusts were opened for examination after this voyage, the collars being found in excellent condition with just a small amount of the phosphating having disappeared. The pads on the port side were in perfect condition and were replaced, but two pads on the starboard side showed signs of the black depressions that had been evidenced on the first voyage. Analysis indicated that the surface of the blackened marks contained iron-manganese-phosphate and below the surface sulphur and chlorine were detected; as there was still a suspicion of chlorine in the system, the oil was again replaced and tanks cleaned together with as many pipes as possible during the available time. Since the thrusts had not been opened up at all during the voyage, there was little evidence to prove when these marks had started to develop. The starboard engine had been in operation only from Sydney homewards. These

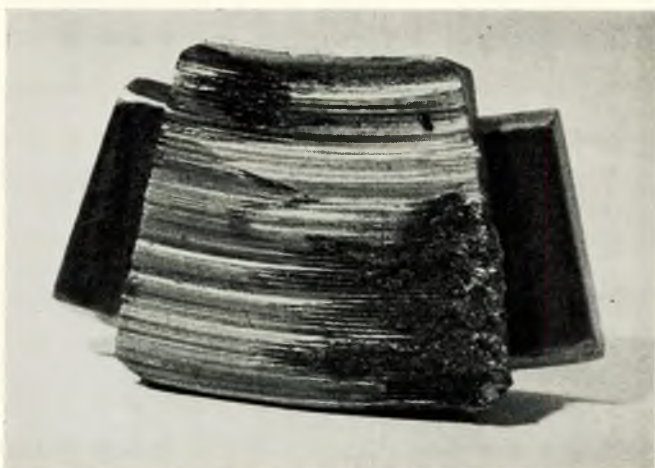
FIG. 15(a)—Enlarged view of one ahead pad  
(after second failure)

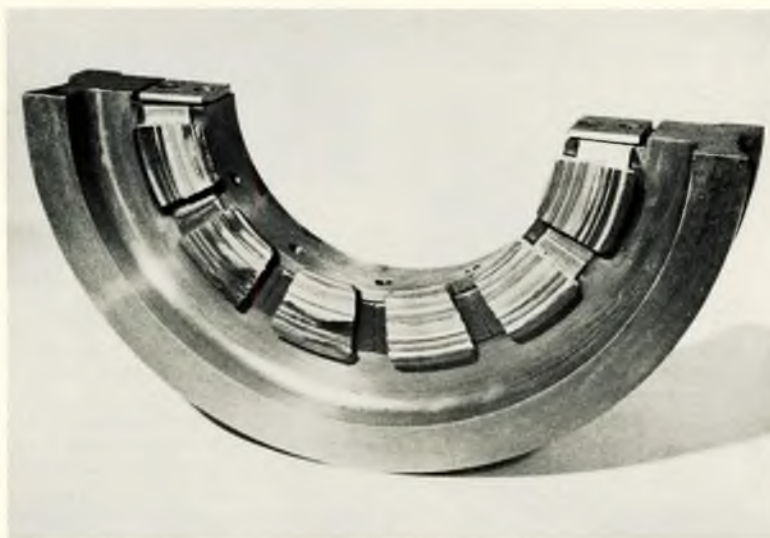
starboard thrust with the exception that the movement forward of the rotor had not been so great. Changing over to the L.P. running condition on the port side was effected, and the vessel proceeded to Cape Town under these conditions. Both H.P. turbines were opened up and whilst damage to blading on both rotor and stator was evident, more so on the starboard than the port, it was repairable. Exhaustive examinations did not reveal the cause, and representatives of the designers and builders met the vessel on arrival at Cape Town. With their assistance it was decided that the basic cause of the breakdowns was the rigidity of the steel lubricating oil drain pipe causing misalignment by preventing the bearing block following the movement of the turbine casing during expansion. The rotors were removed from the turbines and crated ready to land at Fremantle and the vessel proceeded to that port on her L.P. turbines only. Transported by air to Sydney, the rotors were reconditioned and ready for assembling in the vessel on her arrival at that port. Oil from the systems was filtered and cleansed, system and drain tanks thoroughly cleaned, the rigid drain pipes replaced by flexible ones and the vessel left on her homeward run, a few days late fully restored with all turbines operating. In the restoration of the thrust collars some metal had to be machined off before a satisfactory working surface could be obtained, owing to thermal surface cracking.

FIG. 15—Half ring of ahead pads (second failure)

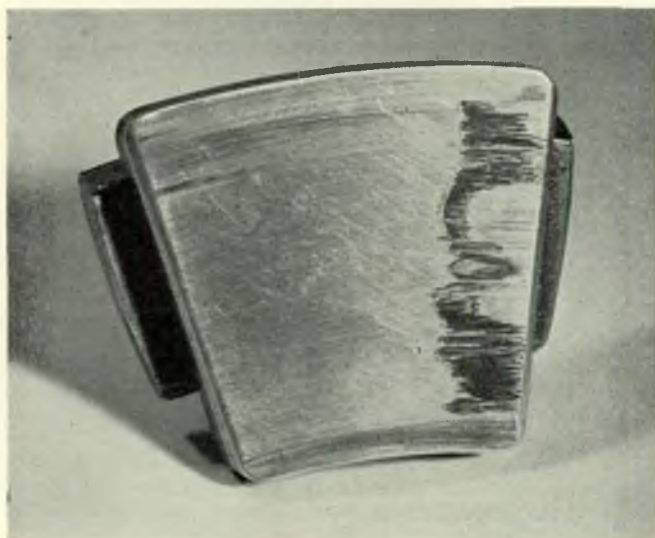
FIG. 17(a)—Enlarged view of astern pad  
(end of second voyage)

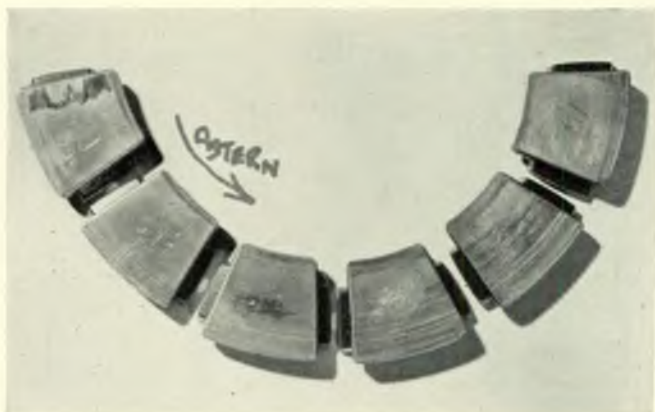
FIG. 17—Half ring of astern pads  
(end of second voyage)

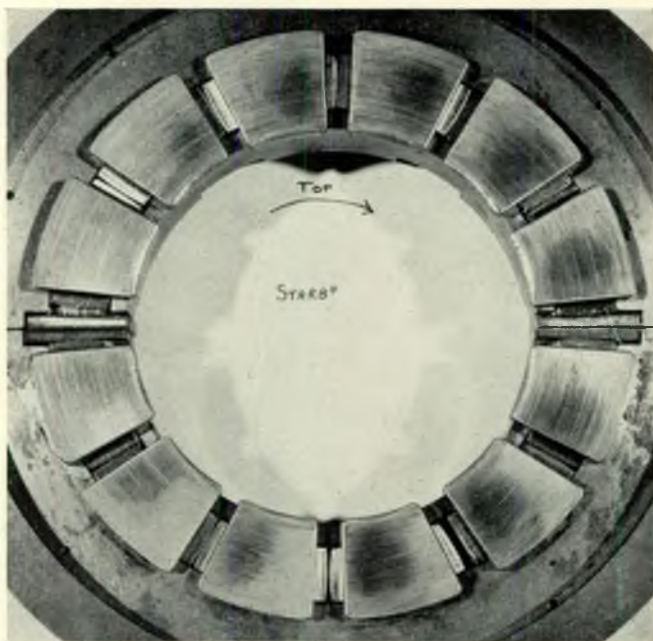
It was decided to run the port side solid and the starboard side hydraulically supported on the ensuing voyage down to Las Palmas. There the excessive clearance of 0.025in., which was necessary to allow for operation of the hydraulic support was reduced by the insertion of liners, to the original running clearance of 0.010in. Leaving Las Palmas the starboard thrust was allowed to become solid and at Sydney liners were inserted restoring to the original clearance of 0.010in. The thrusts were opened for examination at four stages on the voyage and found to be in perfect condition and again at Southampton prior to her next voyage this was the case. After the fourth voyage, without examination, the rotors were removed to repair the blading damage at the end of twelve months and the thrusts and collars were in the same good condition. During subsequent voyages when the vessel has been running for long periods at full power the defects that occurred on the first voyage have not been repeated. Photographs showing the first failure thrust collar and pads from the second failure and those removed with black marks embedded, thrust rings with pads, together with micro section through the damaged pad, are shown in Figs. 14, 15, 16, 17, 18 and 19.

FIG. 18—Ring of ahead pads  
(after completion of fourth voyage)

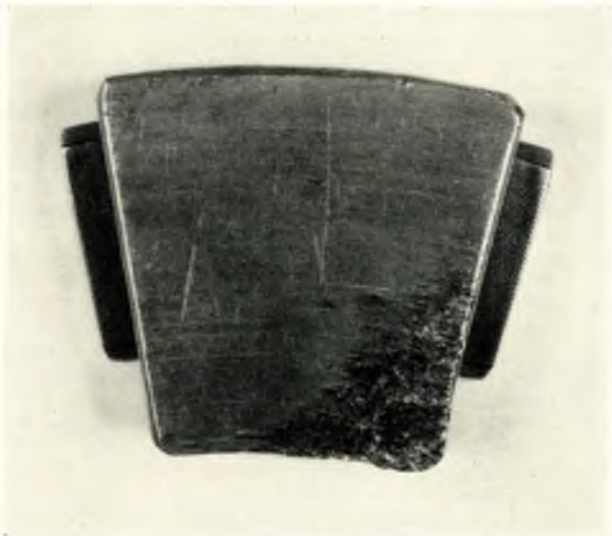
MR. R. COATS said that at the time the *Southern Cross* went into service thrust failures were extremely rare, and those that did occur were of a very mild variety, involving scoring or loss of white metal, but no appreciable damage to the shaft collar face. When *Northern Star* was being built the picture had changed rather disturbingly. There was a considerable increase in the number of minor thrust failures, and an occasional severe failure involving heavy scoring of thrust faces. Foreign matter was always found after such incidents, and if failure could not be attributed to oil failure or boiler priming it would usually be attributed to dirt in the system. Examination of design figures for the intervening period did not reveal any significant difference in loading or peripheral speeds, but there was a general tendency for rotational speeds to be higher: for instance, in the H.P. turbine of the *Southern Cross* the speed was 4,520 r.p.m. and in the *Northern Star* it was 5,386. There was also an upward trend in operating temperature, with

FIG. 20—H.P. thrust pad from another vessel showing area of cavitation

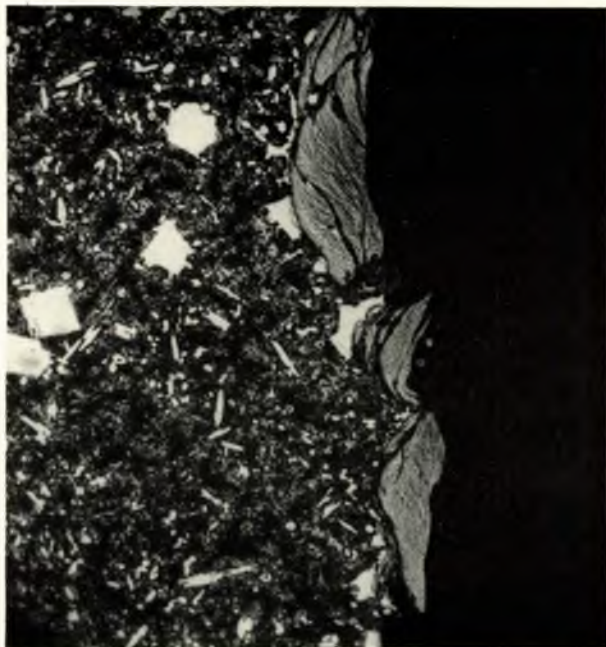
FIG. 21—Micro section through cavitated area, showing iron carbide layers

these thrusts, at the time of the accident in the second part of the maiden voyage, enabled a set of pads to be salvaged before the white metal had completely disappeared, thus providing the evidence of the mode of failure, if not the cause. Comparison of these pads with two from another vessel (Figs. 20 and 21) showed the damage to be of the same type, namely, areas of irregular pitting on which were superimposed layers of iron carbide having a hardness of the order of 400-600 V.P.N. The iron carbide provided the cutting edges which machined away the surface of the collars. This operation, known as "machining" type failure, or "wire woolling" type failure, was a very low temperature one, in that there was no indication from oil bulk temperature measurement that any failure was occurring, and even with thermocouples embedded in the white metal, as on the test rig, there was no indication of failure.

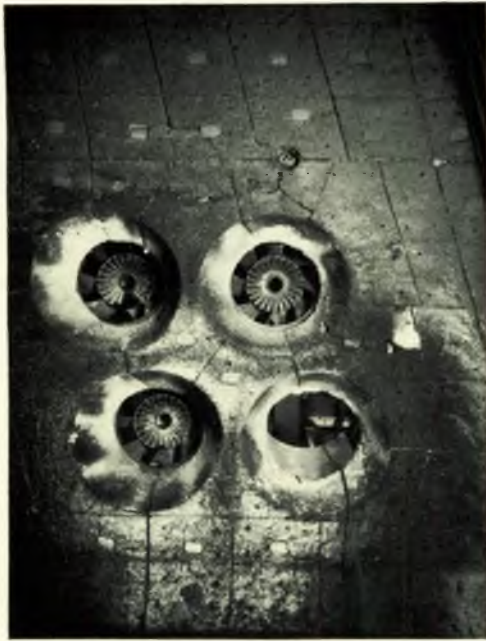
FIG. 26

almost identical to those installed in *Northern Star*. Fig. 26 showed the front wall of the furnace with the quarls and air registers clearly visible. As could be seen, the condition of the monolithic refractory was excellent. Fig. 27 showed the view taken diagonally through the screen wall looking at the external bank of the superheater next to the combustion chamber. There was no bridging and the superheater tubes themselves were in very good condition.

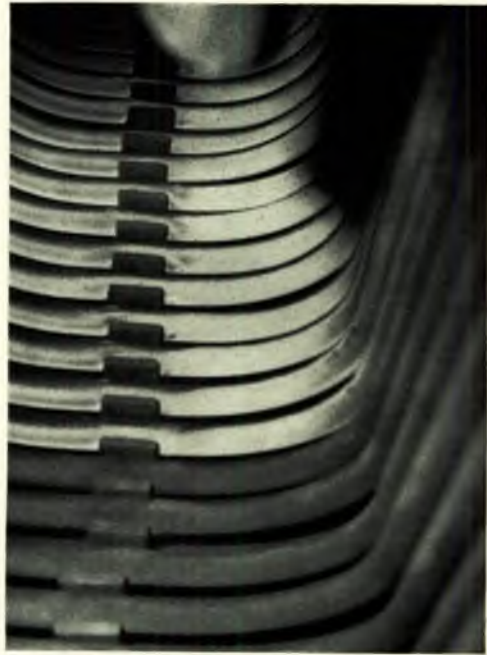
FIG. 28

Fig. 28 showed the superheater tubes from inside the walk-in space of the superheater bank looking towards the boiler front. The superheater tubes were in excellent condition, and there was no sign whatsoever of slagging.

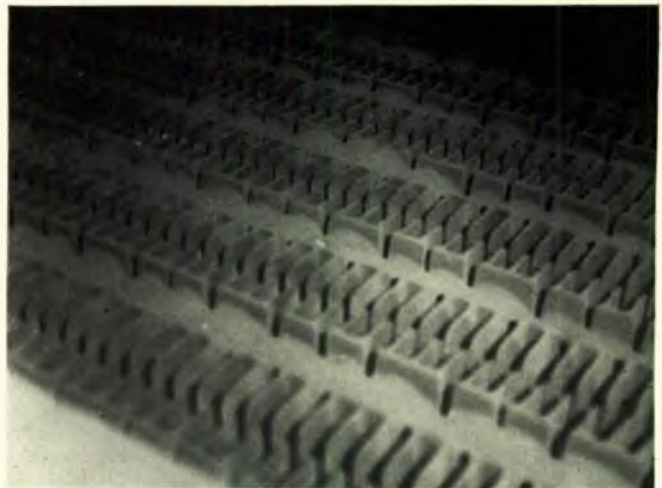
FIG. 29

Fig. 29 showed a photograph taken in between the two

cast iron economizer sections, looking down on the top of the first bank.
