INVESTIGATIONS AND SOLUTIONS FOR SUPERSTRUCTURE FATIGUE CRACKING IN UK ROYAL NAVAL VESSELS

CATRIONA SAVAGE BEng MSc CEng MRINA
JEREMY ATKINS MEng
BMT DEFENCE SERVICES LTD, UK

This paper seeks to review and consolidate the work undertaken to date, including reporting on the survey of the forgings fitted to HMS ST ALBANS.

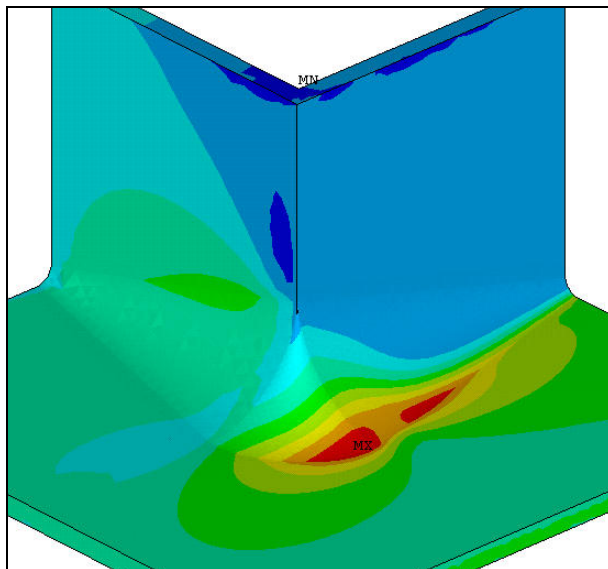
FIG.2 - VON MISES STRESS PLOT ABOVE DECK FORGED INSERT

The study found that the forged insert piece would virtually eliminate fatigue cracking in this area. The use of a deck insert or doubler plate was not found to be sufficiently effective to consider progressing further.

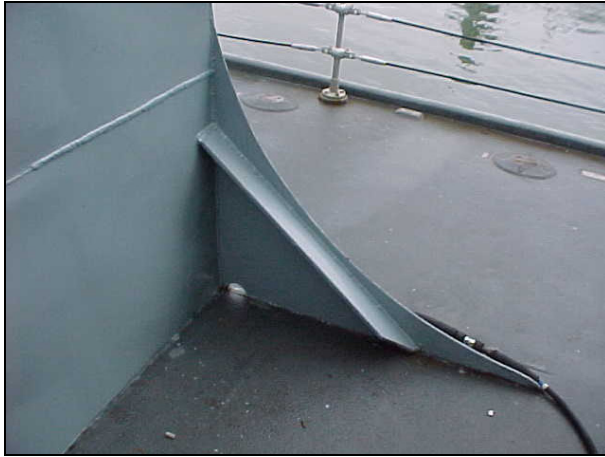
FIG.3 - T23 HANGAR BLOCK GUSSET PLATE

The results demonstrated that the fatigue life of the gusset plate is severely limited and as such it may be preferable to adopt a design without a gusset plate rather than frequent replacement of the cracked gusset plate.

It has already been mentioned that since the launch of HMS NORFOLK a number of different alterations have been made to the arrangement. One of these changes was a flat bar stiffener fitted to the gusset plate on T23 02, HMS ARGYLL, to assist in preventing cracking of the gusset plates. The flat bar extended diagonally across the gusset plate from the hangar to the deck plate (FIG.3). Following time at sea, survey identified that although no cracking had occurred in the gusset, fracture was evident along the gusset/deck plate weld seam.

These structural changes were later endorsed in addition to continuing with work to refine the design of the gusset plate at the forward end of the hangar block.

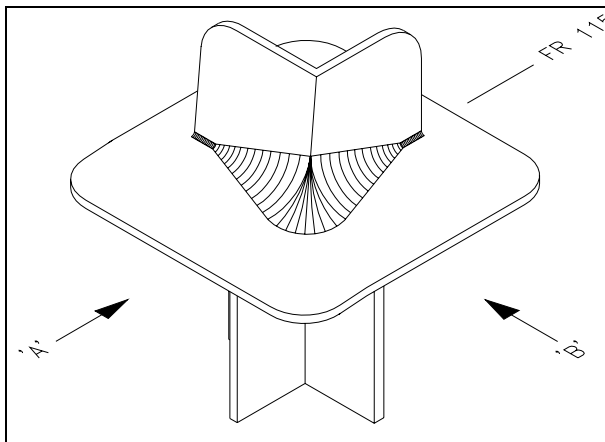
FIG.5 - FORGED INSERT

The second and third forgings were installed in HMS ST ALBANS at build (launched in May 2000). Visual survey of the upper surfaces of the forgings was undertaken in 2007 which concluded that there were no signs of cracking or fatigue. Unfortunately no access to the underside of the forgings could be achieved.

The forgings fitted to HMS ST ALBANS are still relatively young. Continuing to monitor the forgings throughout the life of the ship would allow a better understanding of just how effective they have been. Likewise monitoring of the forgings on T45 would add depth to the knowledge.
