RECENT RN GEARING EXPERIENCES

Peter HOPKINS

(Defence Logistics Organization, Marine Propulsion Systems IPT)

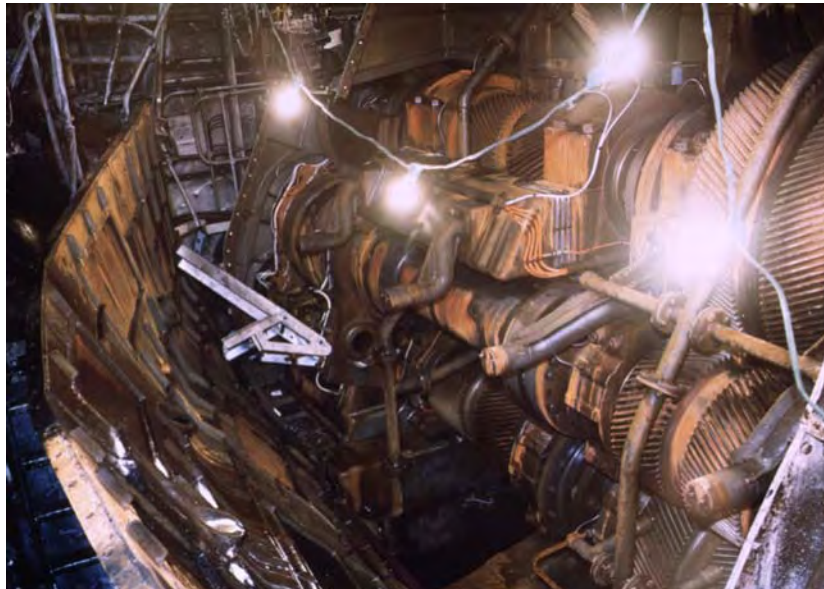
FIG.1 – HMS *ILLUSTRIOUS* GEARBOX EXPLOSION

The gearbox explosion in HMS *Illustrious* (FIG.1) was caused by insufficient clearance between an SSS clutch controller shoe and the clutch following maintenance. This produced the frictional heat necessary to generate a flammable oil mist, which then ignited producing a small primary explosion. The primary explosion fractured the gearcase, allowing fresh air to ingress and feed the much larger secondary explosion. Although there were no casualties *Illustrious* was unavailable for three months and repair costs totalled £4M. As a result of this incident the running clearances of all in-service SSS clutch actuators were checked and procedures introduced to ensure that acceptable minimum clearances were achieved and recorded during maintenance and new build. A review of all potential steel/steel contacting components was also undertaken across the fleet that resulted in the modification of some seals. The board of enquiry also recommended a review of the Gearbox Explosion Working Party findings.

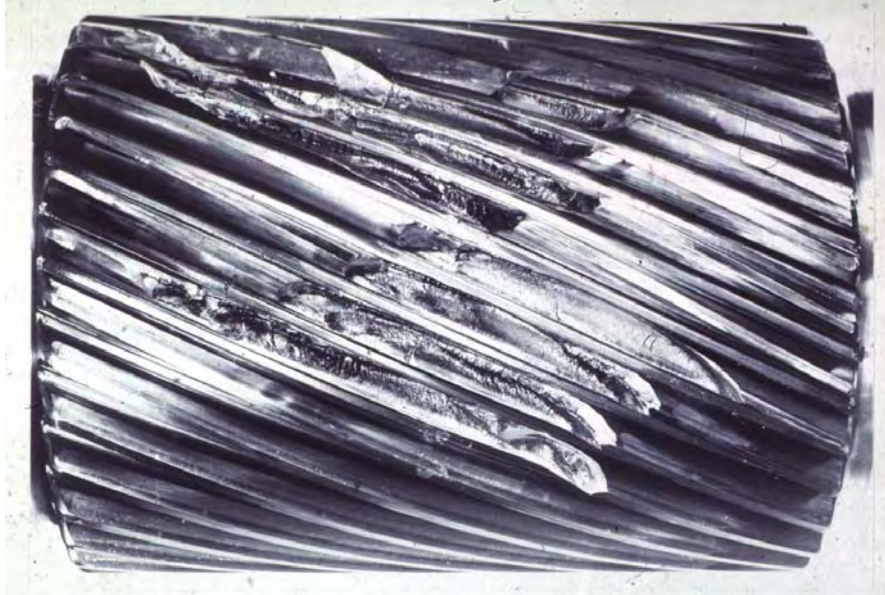
FIG.3 – SSN PRIMARY PINION FAILURE

Detailed investigations into the S&T primary pinion failures (FIG.3), making use of strain gauging, identified the cause to be a combination of dynamic misalignment and excessive tooth profile reliefs. The solution was replacement pinions with improved tooth profiles and strain gauging to enable dynamic load distribution to be measured and improved where necessary by re-alignment.

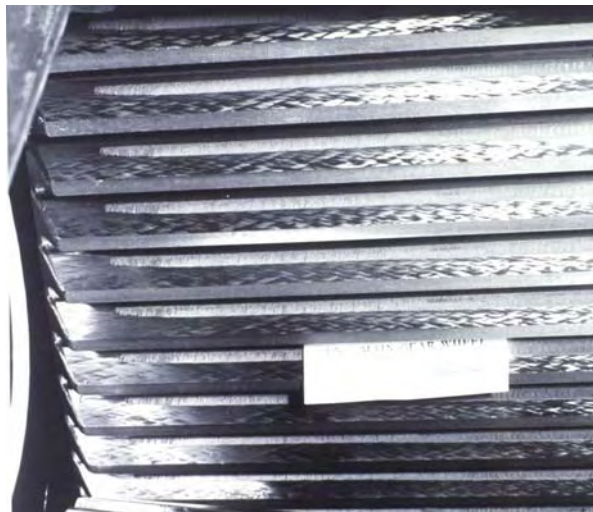
FIG.4 – HMS VANGUARD SECONDARY GEAR SCUFFING

HMS *Vanguard*'s mainwheel and secondary pinions scuffed during trials in SMITE (FIG.4). The failure was not investigated in detail at the time but the cause was believed to have been misalignment and poor tooth profiles. These issues were addressed in SSBN 06-08, which all operated successfully in SMITE and in-service. *Vanguard* completed her first commission with a power restriction in place and the gears were replaced in LOP(R). The geometry of the replacement pinions was optimized for low noise at critical speeds and the pinions were crowned to reduce end loading and to reduce the sensitivity to misalignment. Strain gauging was fitted to enable load distribution to be assessed. These gears were successfully tested during the post LOP(R) sea trials, when gearbox vibration analysis showed the gearbox to be significantly quieter than any other of the class.

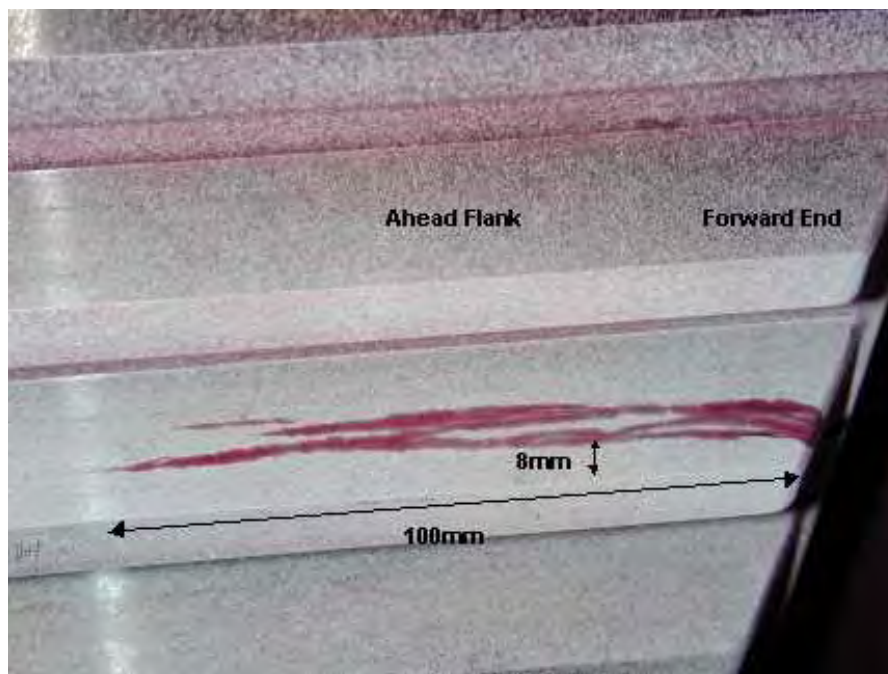
FIG.6 – HMS LANCASTER MAINWHEEL TOOTH CRACKING

The subsequent failure in *Lancaster* (FIG.6) cast doubt that misalignment was the sole cause of a potential class deficiency. As a result a wide examination of design, material, manufacturing and operational issues was implemented and a class wide visual inspection regime introduced for every 50 cumulative running hours. Following palliative repairs *Lancaster* continued to operate, with a power restriction in place to reduce the risk of further degradation.

The cause of these failures has now been confirmed as a combination of:

- Low main wheel strength due to insufficient case depth, especially at tooth ends.
- High contact stresses due to less than ideal pinion geometry leading to high end loading.

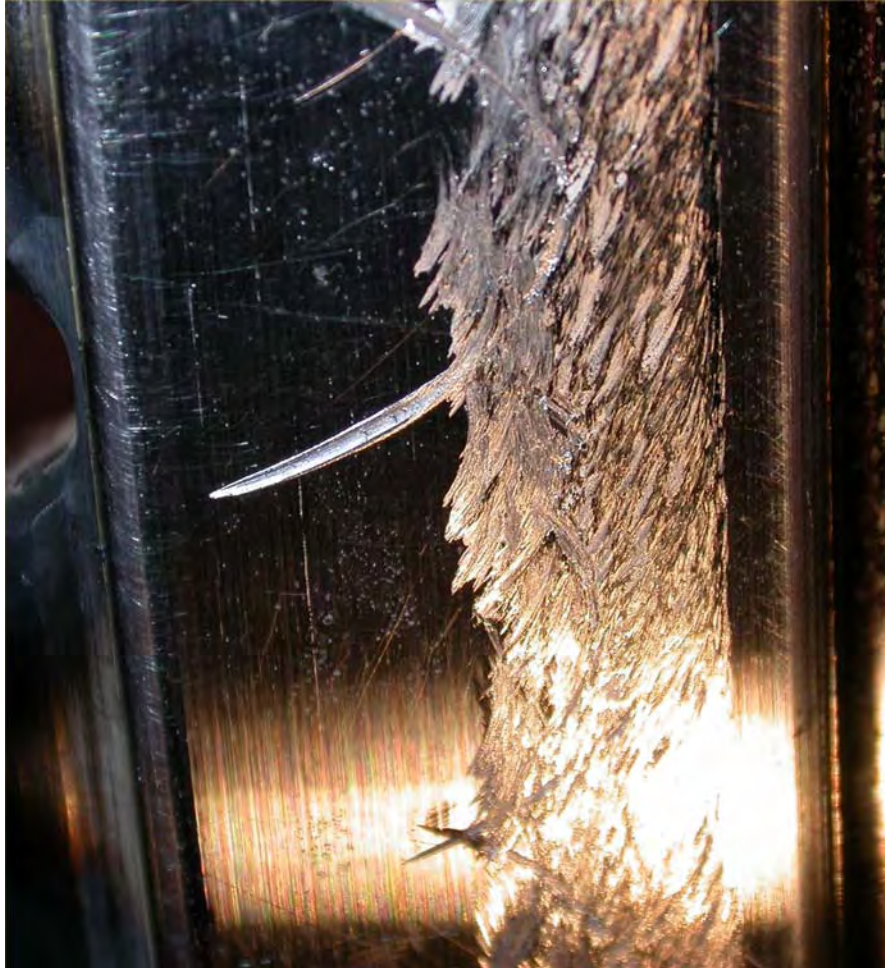
FIG.8 – HMS LANCASTER THRUST CONE DAMAGE

Following the replacement of *Lancaster*'s secondary pinions in 2004 the starboard thrust cones failed during a basin trial (FIG.8). The subsequent investigation identified that the angle of the replacement pinion cone track had not been well matched to that of the replacement starboard wheel, which resulted in poor contact and breaking up of the nitrided surface of the pinion cone track. The repair required replacement thrust cones to be fitted to the pinion and in-situ honing of the mainwheel. The correct angle for the replacement pinion thrust cone track was accurately established by checking the contact between a selection of mandrels with the wheel. As a result of the failure comprehensive measurements and installation checks have been introduced for the thrust cones on future replacement pinions and wheels. Replacement pinions were subsequently fitted in *Kent* in 2005 and no problems were encountered.

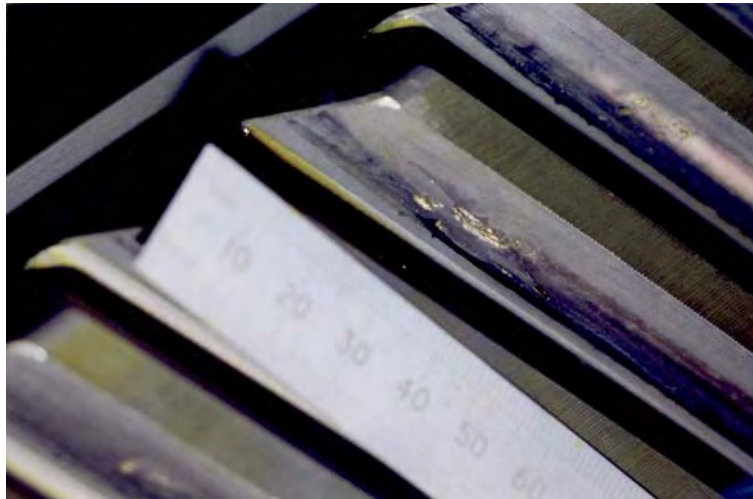
FIG.9 – HMS *INVINCIBLE* MAINWHEEL PITTING

During a routine inspection in 1999 ship's staff discovered apparently minor cracking originating from pitting on HMS *Invincible*'s starboard mainwheel (FIG.9). During the subsequent specialist inspection and palliative repair the true extent of the problem became apparent, with some cracks extending the length of the tooth. This resulted in the removal of 9 whole teeth and the ends of 2 teeth (FIG.10).

The investigation into the *Invincible* failure confirmed the most probable sequence of events leading to failure to be:

- Loosening of the mainwheel aft side plate fasteners in 1983 led to a lack of radial support, transferring the load to the forward end of the forward helix.

- This overload resulted in localized pitting.
- Replacement of the side plate nuts and tightening of bolts in 1984 arrested the pitting.
- Changing deployment patterns in the 1990's (operating with high ambient temperatures and lower winds) necessitated higher ship speed to achieve safe aircraft launch.

- Fuel restrictions led to more high power single engine running and with each engine driving onto the mainwheel through a separate drive train the maximum tooth loading is the same in single engine operation as twin engine operation. It is worth noting that the design codes would only have assumed maximum tooth loading for a small percentage of the time.

- This increased usage at high power, exacerbated by transient over-torques, resulted in cracks developing from the pitting.

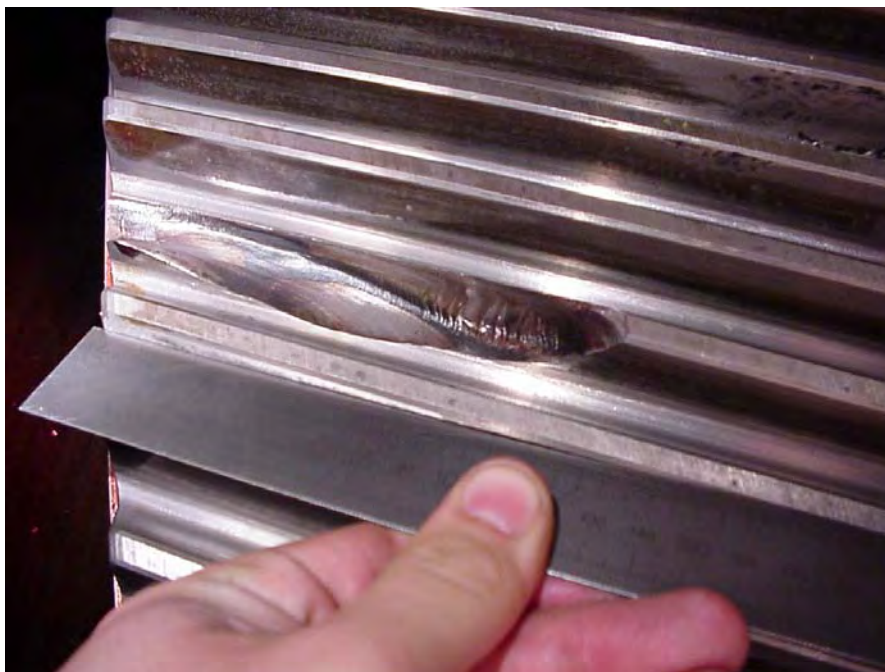
FIG.11 – HMS *ILLUSTRIOUS*' MAINWHEEL FAILURE

Subsequent inspections of the other CVS gearboxes identified that the ends were missing from 2 teeth on HMS *Illustrious*' port mainwheel (FIG.11).

The investigation into the *Illustrious* failure confirmed the most probable sequence of events leading to failure to be similar to *Invincible*, except that the initiating damage had been caused by part of a failed primary gear wheel tooth going through mesh. The main wheel had been dressed in-situ but stress raisers had

remained. The two failed wheels were effectively more fragile than others of the class due to existing damage.

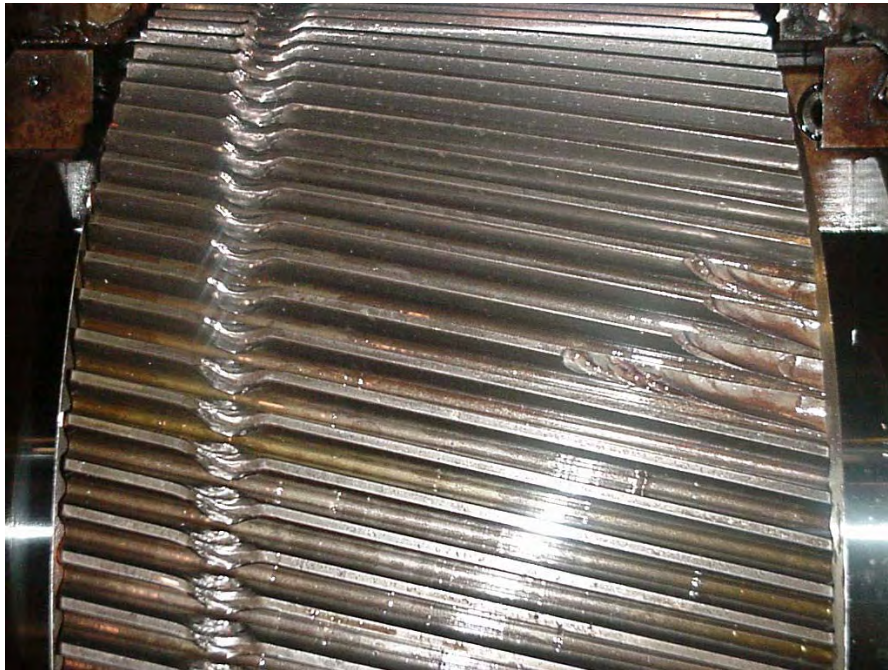
FIG.13 – HMS *ANGLESEY* PINION FAILURE

Gear tooth failures are not isolated to larger platforms. In July 2003, during her final RN passage, several teeth fractured on HMS *Anglesey*'s port input pinion, with consequential damage to the mainwheel and starboard pinion (FIG.13). The fractures were classic bending fatigue initiated close to the end face, caused by misalignment. A replacement set of gears were fitted prior to the sale of *Anglesey*.

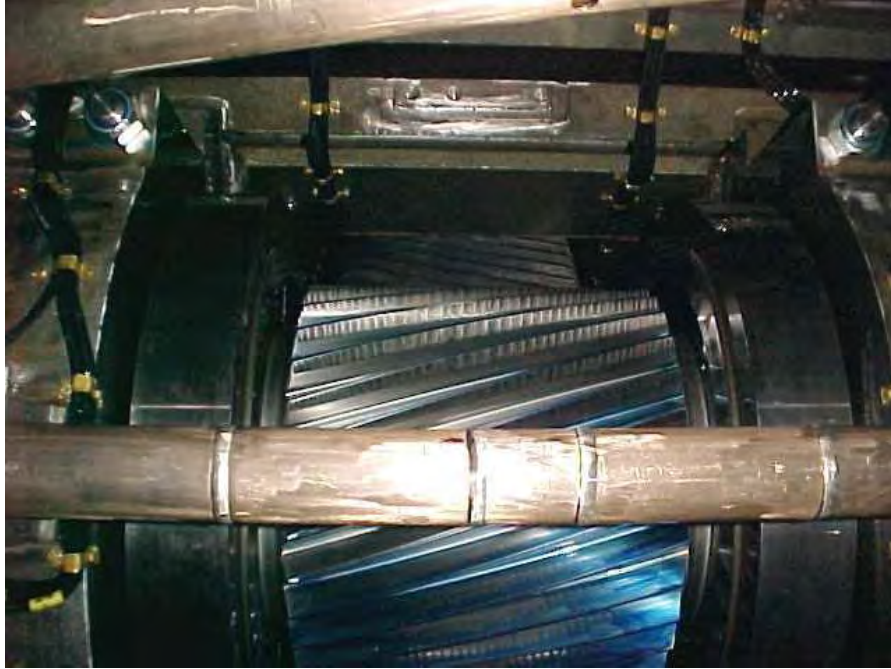
FIG.15 – HMS *ASTUTE* SECONDARY GEAR SCUFFING

These achievements were partly overshadowed by a scuffing incident that occurred on the secondary gear elements part way through the full power trial (FIG.15). The damage was remarkably similar to that experienced in *Vanguard* (1989). In addition during the dismantling of the gearbox damage was discovered on the secondary gear thrust cones.

Investigations by members of the gearing peer group identified that the most probable cause of the *Astute* scuffing failure (and with hindsight the *Vanguard* failure) was poor oil supply to the gear mesh. The secondary gears were replaced with those destined for boat 3, which embodied very subtle tooth profile modifications. The most significant change was an improvement to the oil spray arrangements for the gear teeth and thrust cones.

A programme of work undertaken by Design Unit has demonstrated a significant improvement in the scuffing performance of test gears with these modifications incorporated. In March 2005 trials in SMITE re-commenced and the gearbox was successfully tested without further incident.
