# HMS NOTTINGHAM

## FROM WOLF ROCK TO PORTSMOUTH

*This is an edited version of the paper that was presented at The Royal Institution of Naval Architects on 6 November 2004*

The article considers the recovery of HMS *Nottingham* following her grounding in July 2002 off Lord Howe Island, from the design authority and salvage team points of view. The article commences with a brief overview of the initial incident and considers the stabilization and tow to Newcastle, Australia. De-ammunitioning, de-fuelling and heavy lift in Australia are detailed, followed by the offload in Portsmouth, the dry-docking and subsequent repair.

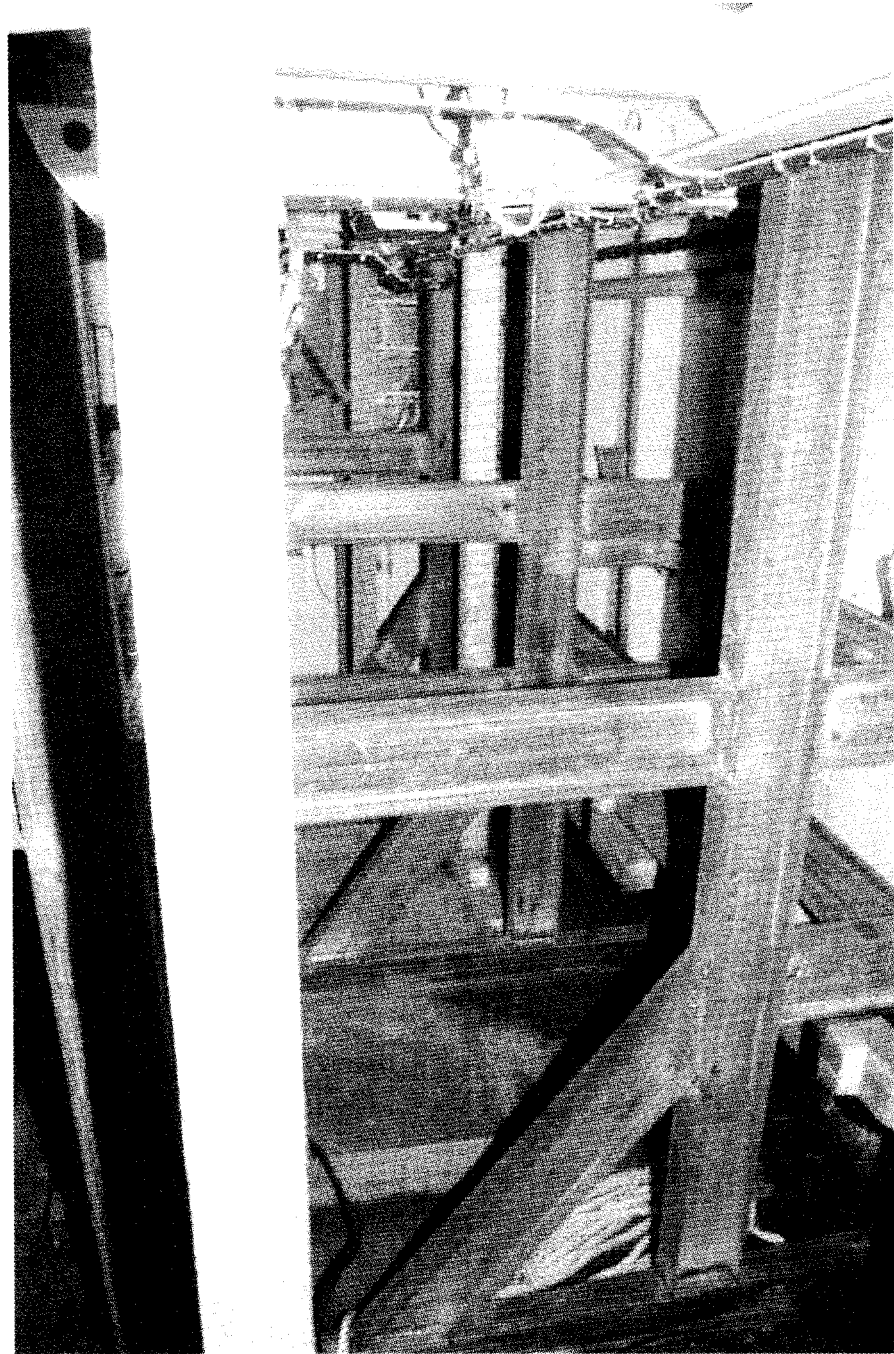
FIG.4 3F STEEL SHORES

3F's shoring was designed to fix the deck and bulkhead stiffeners in place using welded steel I beam shores. The design that evolved also had to consider the difficulties of fabricating a structure in a seaway such as the risk of flooding a dry compartment by accidentally burning through plating. The final design only allowed welding onto stiffeners or plating that did not form part of the flood-boundary

Seven Steel shores (FIG.4) were later introduced consisting of I beams laid longitudinally onto the deck, over a potentially damaged under-deck stiffener. Each beam was stiffened by two vertical steel pillars welded to the deckhead stiffening and angle connecting beams. Four pillars were connected to the forward bulkhead stiffening. Additional transverse beams linked the four shores and the forward bulkhead stiffeners to allow the shoring of bulkhead plate by wooden wedges.
