# NAVSEA 00C5 CONDUCTS FIRST OF TYPE WATERBORNE FIN STABILIZER REPAIRS

LIEUTENANT COMMANDER A.L.BLAKEY, RN  
(COMNAVSEASYSCOM Arlington Virginia)

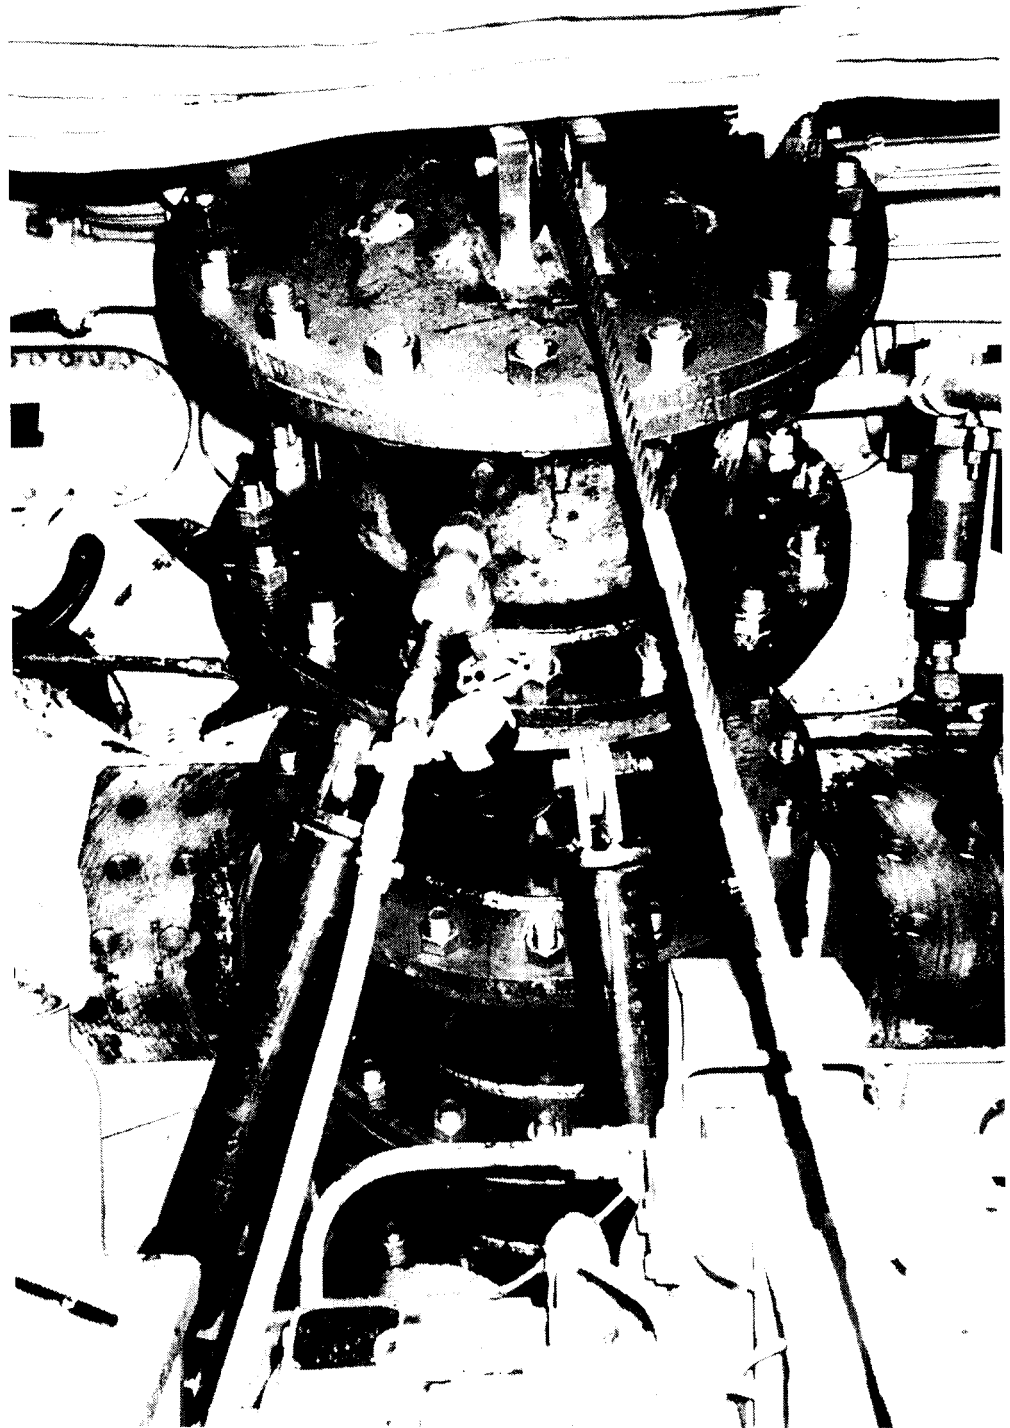
FIG. 1—THE COFFERDAM FULLY BUILT

NOTE THE SUPPORT BRACE, AIR BLOW-DOWN LINE AND GAUGE, AND MARKINGS ON INTERNAL WIRE

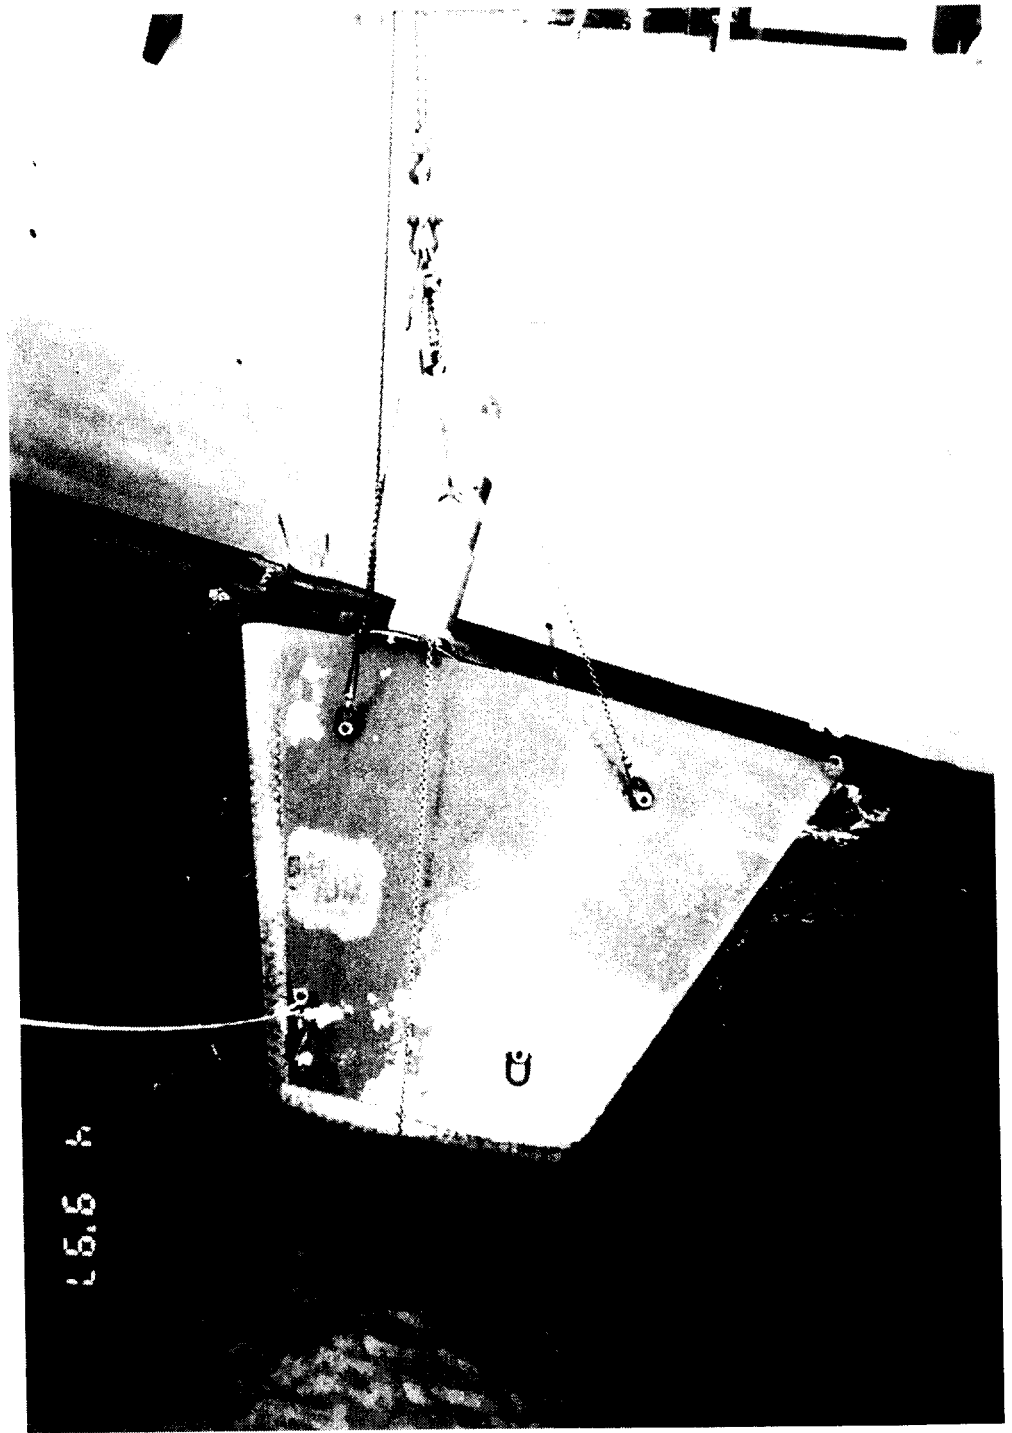
FIG. 2—OLD FIN SHAFT SHOWING EXTERNAL RIGGING

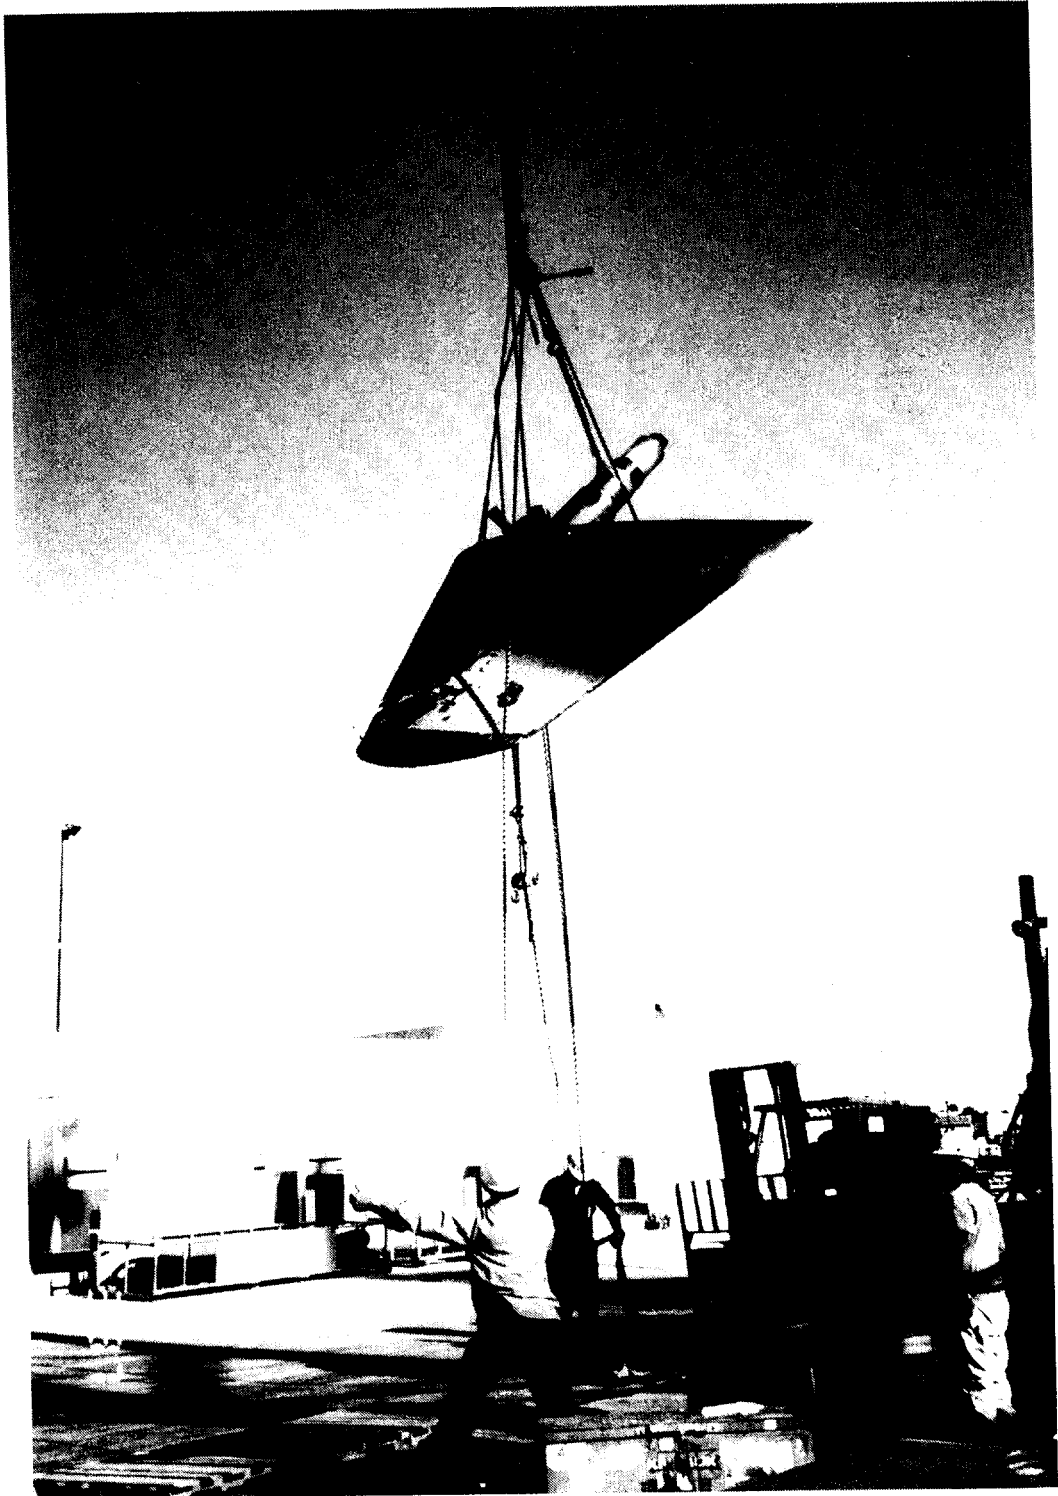
FIG. 3—OLD FIN SHAFT IS TRANSPORTED TO THE JETTY AFTER REPAIRS ARE MADE TO THE USS 'DE WERT'

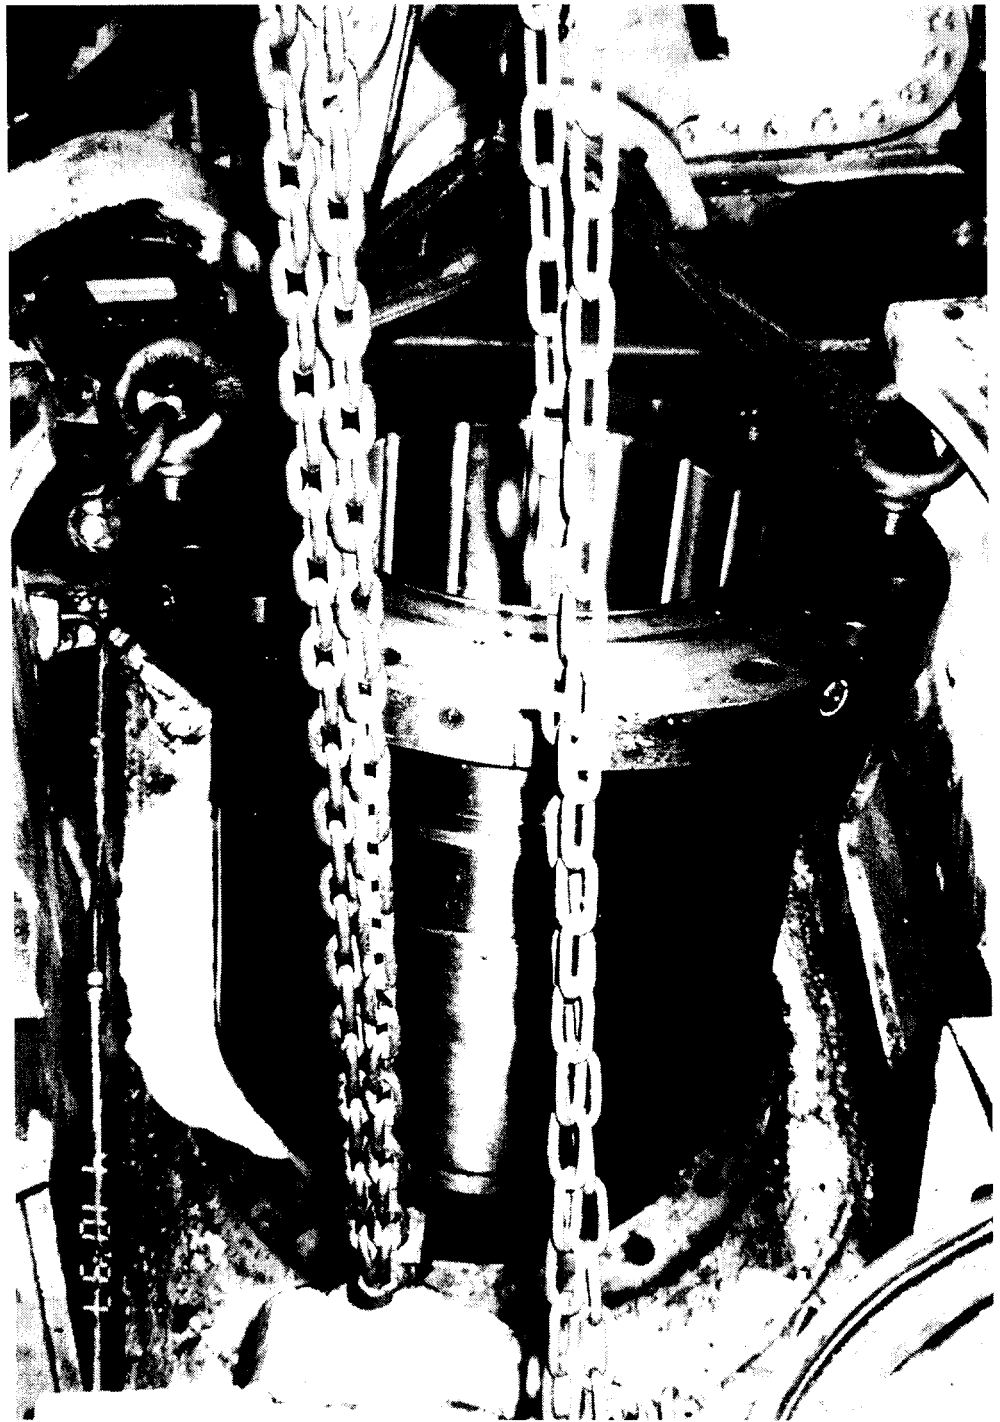
FIG. 4—THE NEW OUTBOARD BEARING IS POSITIONED FOR INSTALLATION

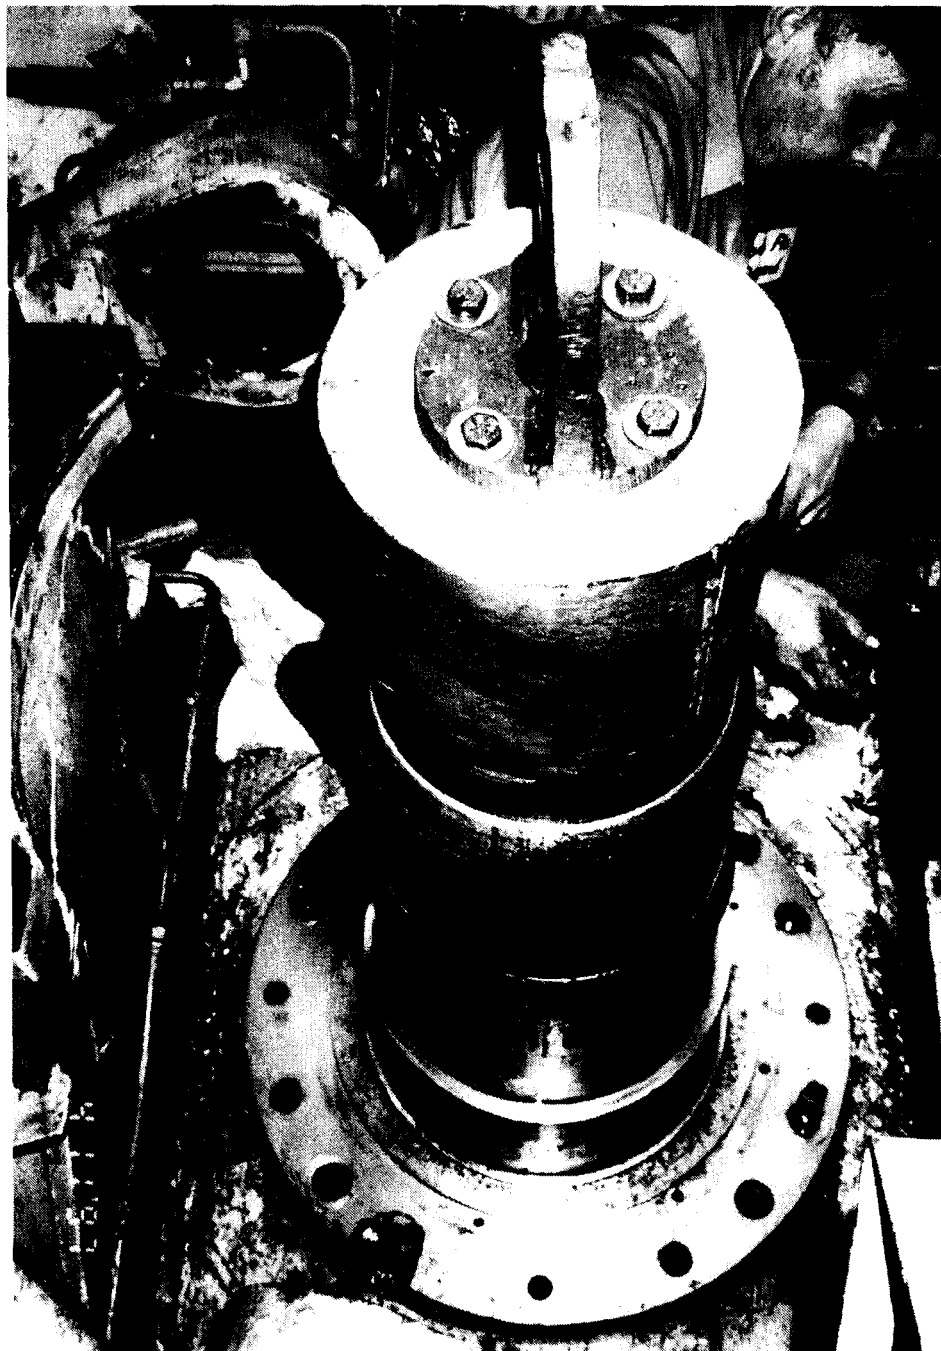
FIG. 5—NEW FINSHAFT IN POSITION INSIDE SHIP, WITH COFFERDAM REMOVED AND SHAFT HELD IN PLACE BY EXTERNAL SUPPORT RIGGING  
NOTE THE GREASE SMEARS ON THE SHAFT

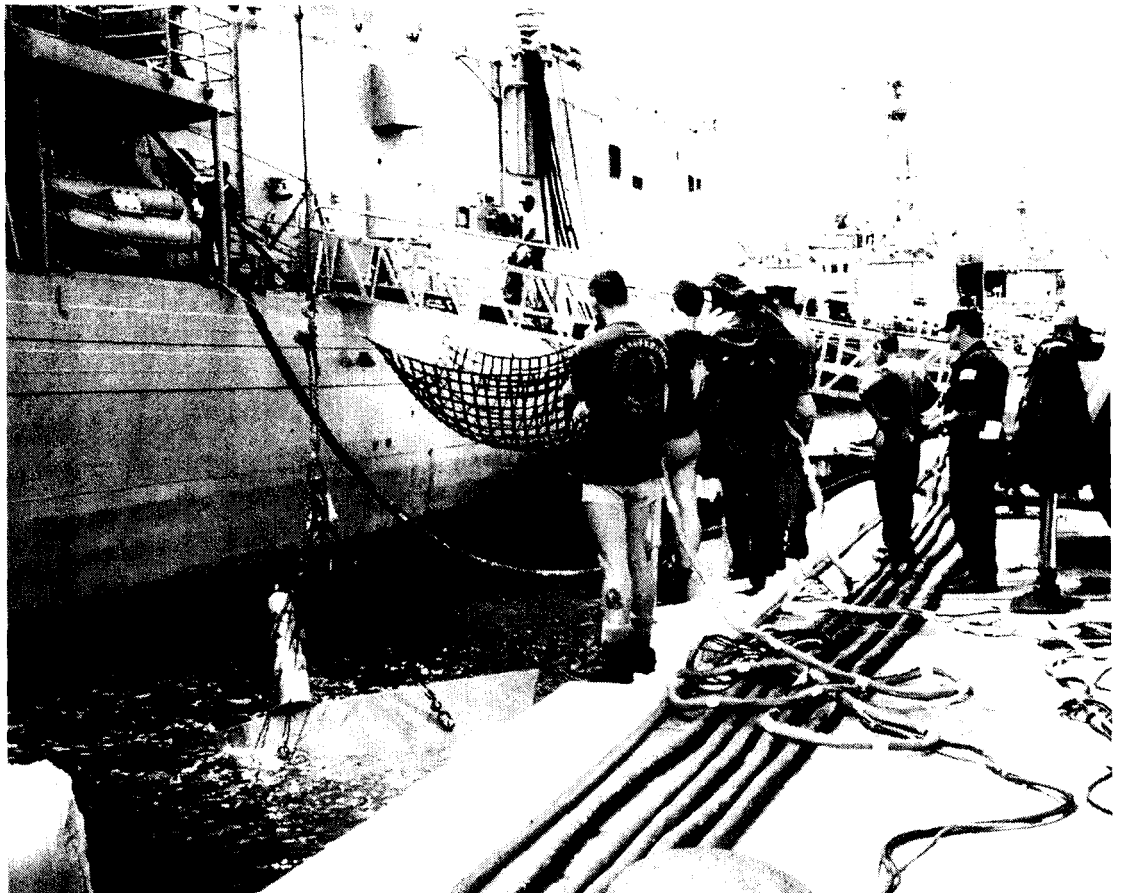
FIG. 6—RED TEAM SUPERVISE THE REMOVAL OF USS 'DOYLE'S' PORT FIN STABILIZER
