SM1A MARINE GAS TURBINE EVALUATION AT PYESTOCK

LIEUTENANT-COMMANDER R. A. CARTWRIGHT, BSc, C.ENG.,
M.I.MAR.E., RN.

LIEUTENANT P. B. LAMBERT, I.ENG., A.M.I.MAR.E., R.N.
(*Royal Aerospace Establishment, Pyestock*)

ABSTRACT

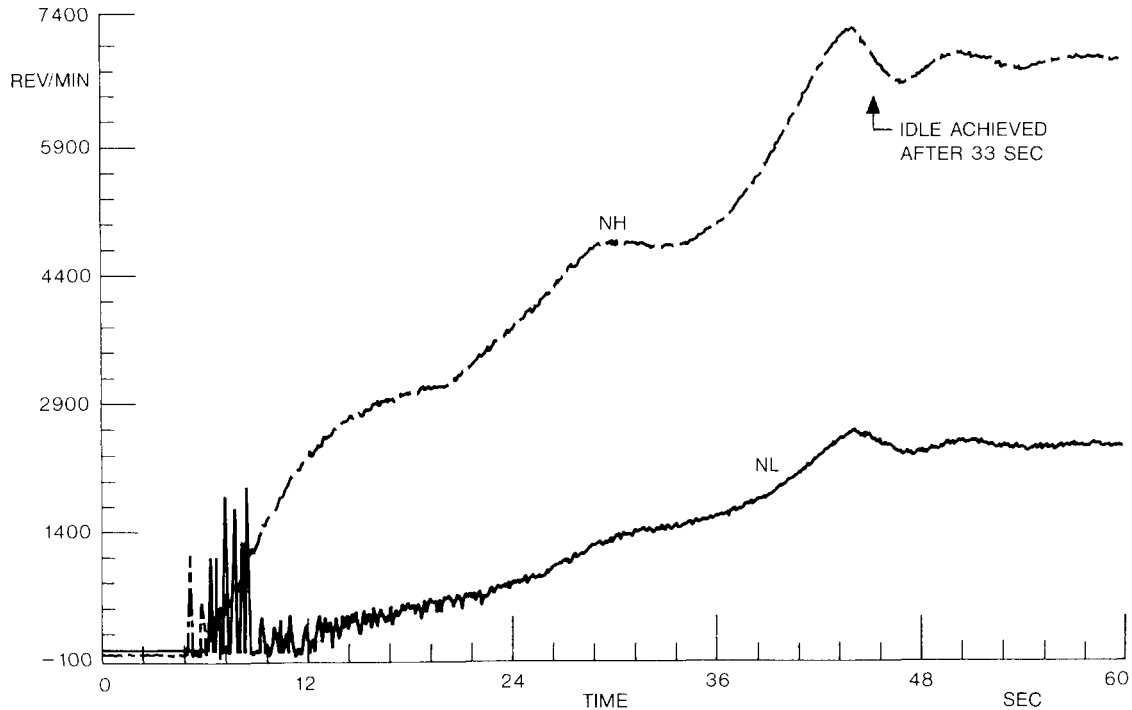
It should be noted that up until this point in the trial, the running performance of the GTCU had not been affected by the degradation and holing of the combustor heads. The transient response of spool speeds and T6s to a normal start cycle is shown in Figs. 8 and 9. However, at approximately 1600 hours the starting characteristics began to be affected by the significant through-holing in the primary zone of No. 3 combustor head. The effect was that the flame in combustor No. 3 was blown out during the start, and did not relight for about 5 seconds. This is shown in Figs. 10 and 11. This not only extended the time to achieve idle but, more significantly, increased the average value of T6 steadily. The GTCU control system has a T6 trip which terminates the start if the average T6 temperature exceeds 500°C. By this point in the trial the average T6 had risen by some 40°C and was within 1° of the trip level. Hence it can be seen that the limiting factor on combustor life may be its effect on GTCU starting temperature rather than structural integrity.

FIG. 10—HP AND LP SPOOL SPEEDS DURING START SEQUENCE AFTER 1625 COMBUSTOR HOURS—A POOR START

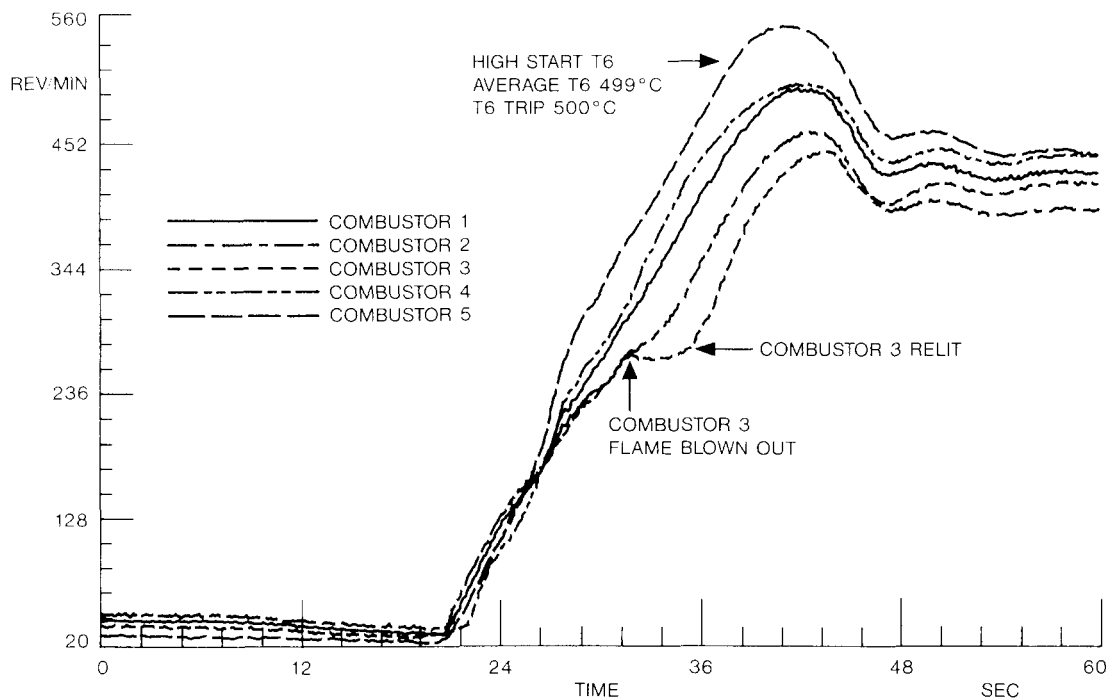
FIG. 11—POWER TURBINE ENTRY TEMPERATURE DURING START SEQUENCE AFTER 1625 COMBUSTOR HOURS—A POOR START

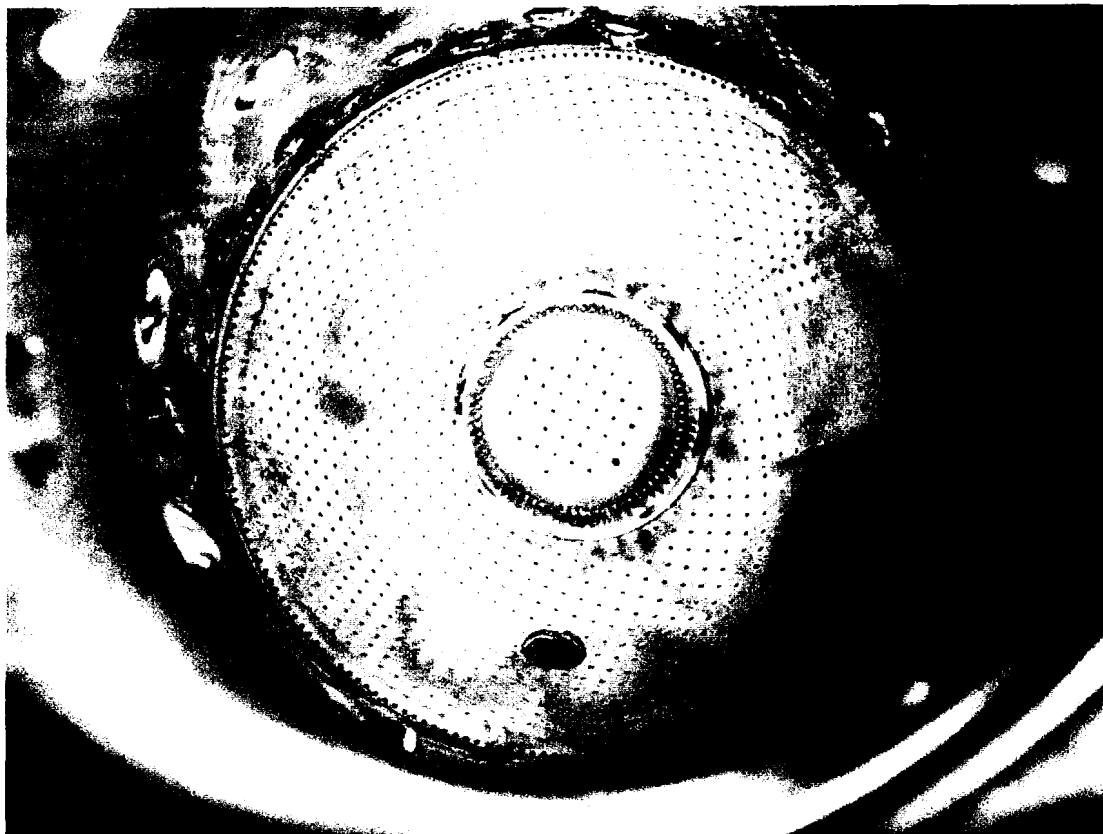
The degradation of the enhanced combustor No. 1 with engine use over 800 hours may be contrasted to that of the original IRAB version of the same combustor by comparing the conditions in Figs. 12 and 13 with those in Figs. 14 and 15. It can be seen that corrosion at the Y ring has become firmly established at the 1000 hours point in each case. The steady progress of this sulphidation corrosion to eventual penetration of both hot and cold

FIG. 12—COMBUSTOR No.1 AT 1200 HOURS (1000 HOURS AS IRAB, 200 HOURS AS ERAB)

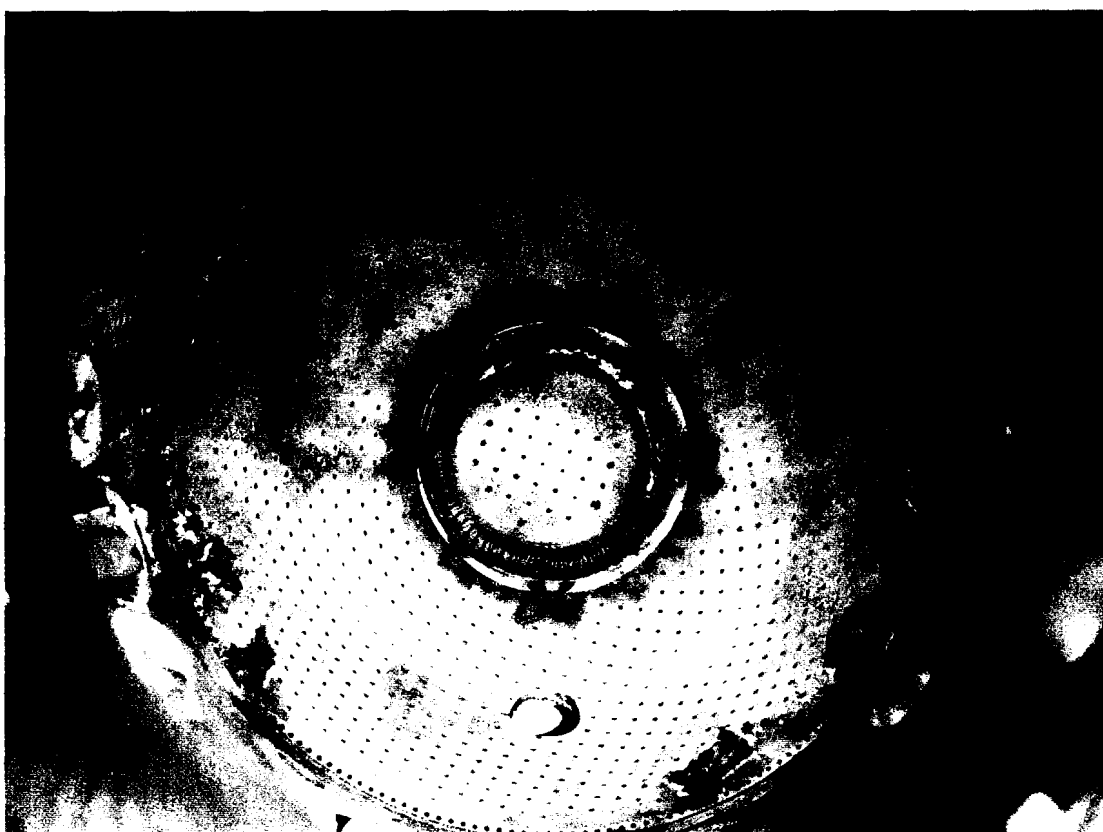
FIG. 13—COMBUSTOR No.1 AT 2000 HOURS (1000 HOURS AS IRAB, 1000 HOURS AS ERAB)

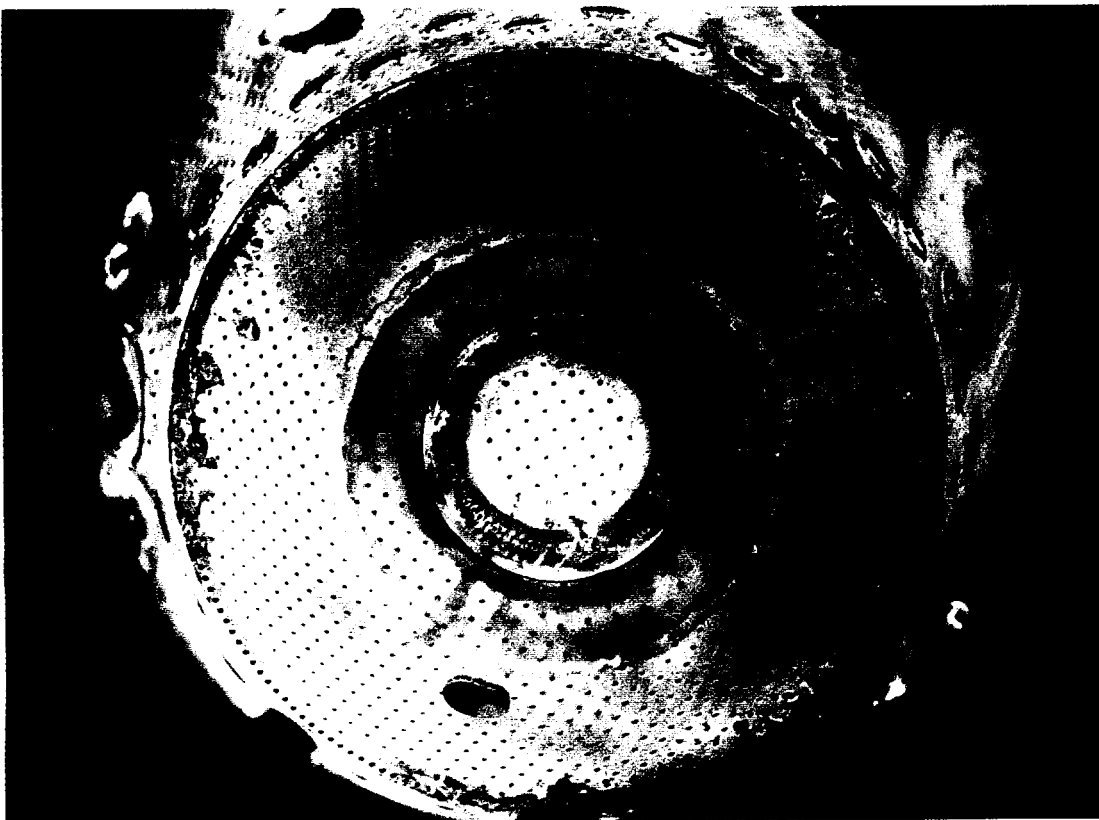
FIG. 15—COMBUSTOR No.1 AT 1000 HOURS (IRAB)
