FIRE IN THE FORWARD GEAR ROOM

THE 'ILLUSTRIOUS' GEARBOX EXPLOSION

COMMANDER R. A. ROWLEY, O.B.E., B.Sc., R.N.
(*Marine Engineer Officer, H.M.S. Illustrious*)

LIEUTENANT T. M. GAUGHT, M.Sc., C.ENG., M.I.MAR.E., R.N.
(*lately Propulsion Engineer Officer, H.M.S. Illustrious,
now in Sea Systems Controllerate*)

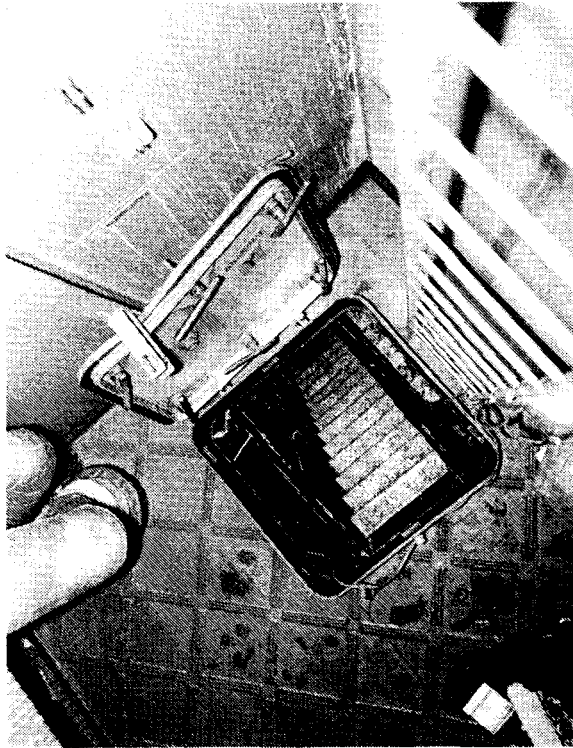
FIG. 2—PORT SIDE ACCESS HATCH BLOWN OPEN AND DISTORTED BY THE EXPLOSION. THE STARBOARD HATCH WAS SIMILARLY AFFECTED

The closing of the gear room vents ready for drenching was achieved in about 10 minutes and the first shot of BTM was then fired immediately. By this time emergency stations had been ordered and NBCD State 1 was being assumed. The Standing Sea Fire Party had commenced an attack on the fire by the port access. They were withdrawn in order to allow BTM drenching, but they had meantime discovered the port access hatch to be open. This hatch had been blown open by the explosion and was severely distorted (Fig. 2), although this was not realized at the time.

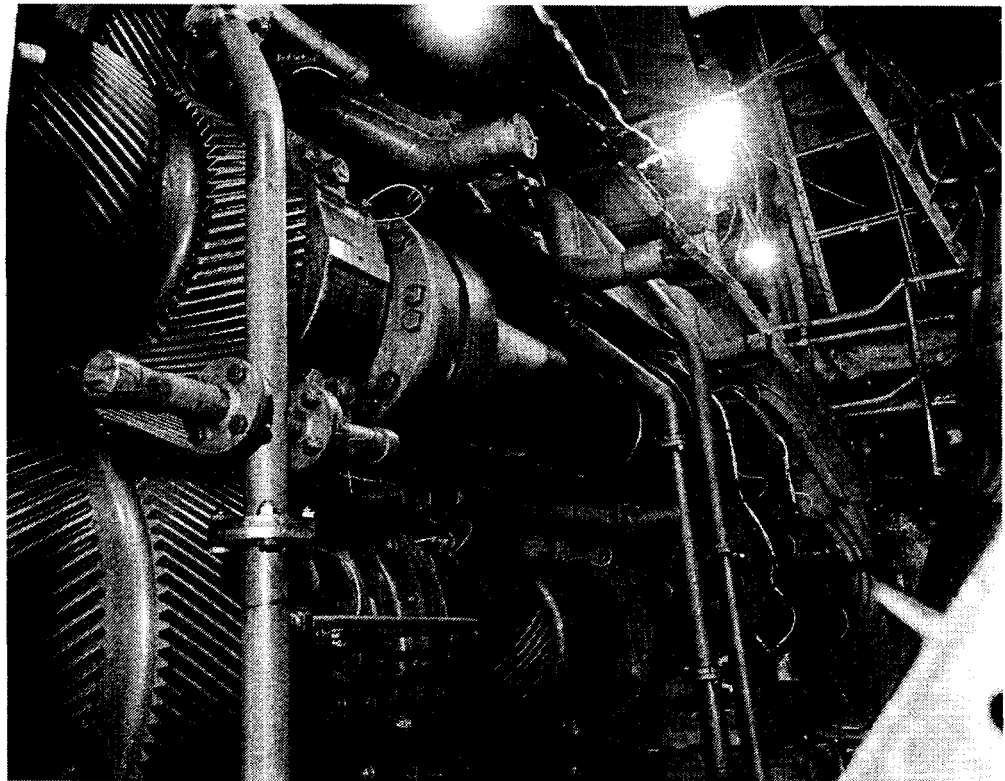
Initial examinations of the gearbox showed remarkably little sign of damage to its internals. The gears themselves appeared unscathed except for the obvious and very rapid reddening as a rust film formed. Ship's staff immediately washed down with fresh water and the TCV repeated the process when it arrived. (The looks of amazement from the TCV crew when invited to spray water over the internals of a gearbox was one of the lighter moments of the saga.) The gears were sprayed with PX24 as a water repellent and subsequently with PX4 as a preservative. Instrumentation cabling within the box was undamaged and, in striking contrast to almost every other cable in the space, not even smoke blackened. The gearbox itself was the 'eye of the storm' and everything had exploded outwards from it (FIG. 6).

FIG. 6—OUTBOARD SIDE OF THE GEARBOX SHOWING THE VIRTUALLY UNDAMAGED GEARS.
NOTE THAT INSTRUMENTATION WIRING WITHIN THE BOX IS NOT EVEN SMOKE-BLACKENED

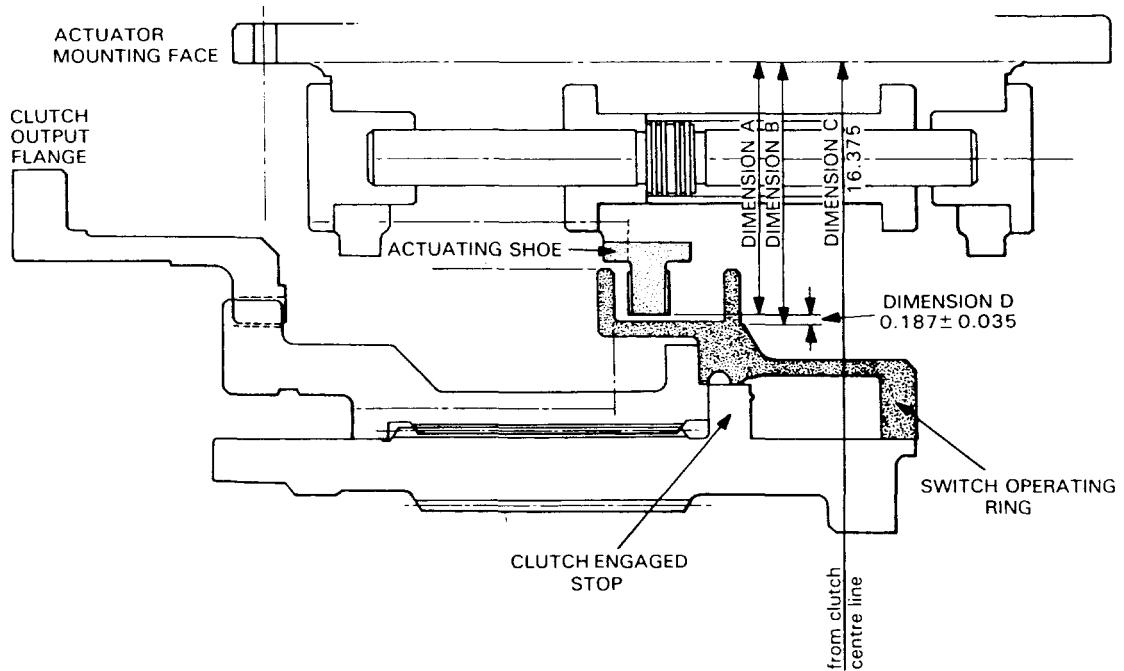
FIG. 8—SSS CLUTCH AND ACTUATOR, IN ENGAGED POSITION
dimensions in inches

The clearance between the actuating shoe and the switch operating ring (FIG. 8, dimension D) is the critical dimension and this could be checked in three independent ways:

- (b) Measuring the distance from the clutch actuator mounting face to the circumferential surface of the shoe (FIG. 8, dimension A) and from the actuator mounting face on the gearcase to the closest point on the switch operating ring face (FIG. 8 dimension B). The clearance was then calculated as the difference between these two dimensions (B-A).
- (c) Examination of the vertical surfaces of the switch operating ring showed an oil stain where the bearing face of the shoe had not contacted. By measuring the unstained area and the width of white-metal on the associated shoe the clearance was calculated.

<i>Feeler gauges</i> inches	<i>Dimension difference</i> inches	<i>Staining</i> inches	<i>Design clearance</i> inches
Port outer	0.152	0.154	0.153	0.187
Port inner	0.029	0.030	0.028	0.187
Starboard outer	0.167	0.182	0.070	0.187
Starboard inner	0.100	0.088	?	0.187

All the clearances were less than their design value and all were different.
