FIRE IN THE FORWARD GEAR ROOM

THE 'ILLUSTRIOUS' GEARBOX EXPLOSION

COMMANDER R. A. ROWLEY, O.B.E., B.Sc., R.N.
(*Marine Engineer Officer, H.M.S. Illustrious*)

LIEUTENANT T. M. GAUGHT, M.Sc., C.ENG., M.I.MAR.E., R.N.
(*lately Propulsion Engineer Officer, H.M.S. Illustrious,
now in Sea Systems Controllerate*)

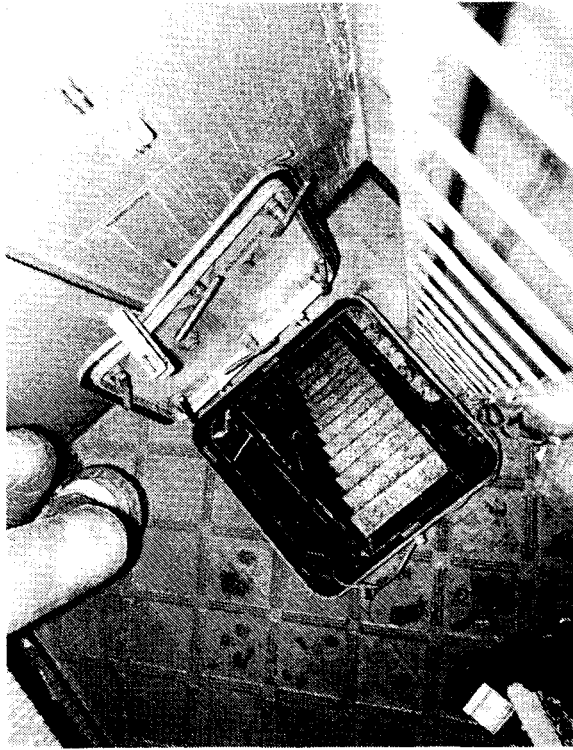
FIG. 2—PORT SIDE ACCESS HATCH BLOWN OPEN AND DISTORTED BY THE EXPLOSION. THE STARBOARD HATCH WAS SIMILARLY AFFECTED

The closing of the gear room vents ready for drenching was achieved in about 10 minutes and the first shot of BTM was then fired immediately. By this time emergency stations had been ordered and NBCD State 1 was being assumed. The Standing Sea Fire Party had commenced an attack on the fire by the port access. They were withdrawn in order to allow BTM drenching, but they had meantime discovered the port access hatch to be open. This hatch had been blown open by the explosion and was severely distorted (Fig. 2), although this was not realized at the time.

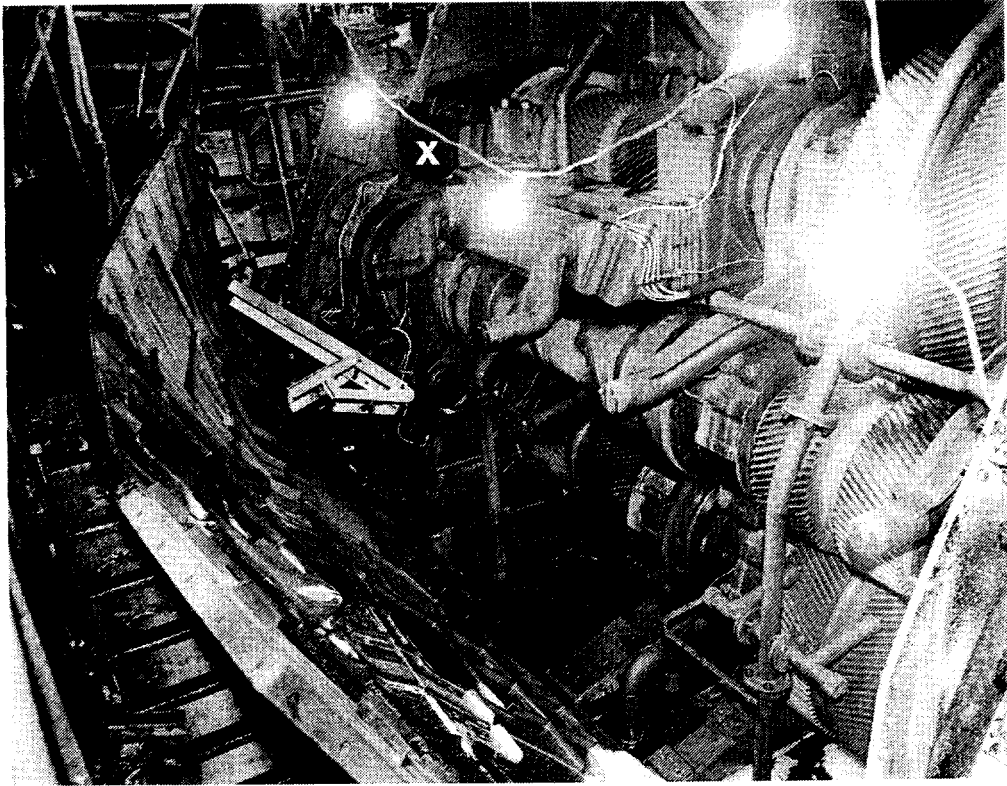
An immediate inspection of the compartment commencing at the port side revealed a scene of considerable devastation. The whole space was smoke blackened, significant amounts of cable had been burned, and both structural and pipework lagging were damaged. As the investigating team progressed across the gear room, however, the true horror of the gearbox itself overshadowed all else. It now had its side covers blown outwards from the base to the upper plate level and arched upwards above that (Figs. 4 and 5).

FIG. 4—THE DAMAGED GEARBOX SHOWING THE LOWER INBOARD COVERS BLOWN OUTWARDS. THE SSS CLUTCH IS BEHIND THE CYLINDRICAL BAFFLE MARKED X. THE EFFECT ON THE STARBOARD SIDE WAS ALMOST IDENTICAL

Immediately evident was the symmetry of the explosion. The effects upon the inboard and outboard sides of the box were almost identical. Clearly months of work were going to be involved in repairing this and there was no question but that the ship should return to Portsmouth. Turning gear was engaged on the starboard shaft, the ship got under way on the port shaft and, having disembarked her aircraft, arrived alongside North West Wall at 0900. Those in Portsmouth Naval Base, who the previous evening had breathed a sigh of relief that one of the CVSs was out of their hair for the next nine months, were on the jetty to meet us and to view the devastation. Support in several forms, including a TCV, was quickly provided. The TCV helped to pump out bilges and the gearbox sump and carried out an initial clean down of the worst areas of the compartment.

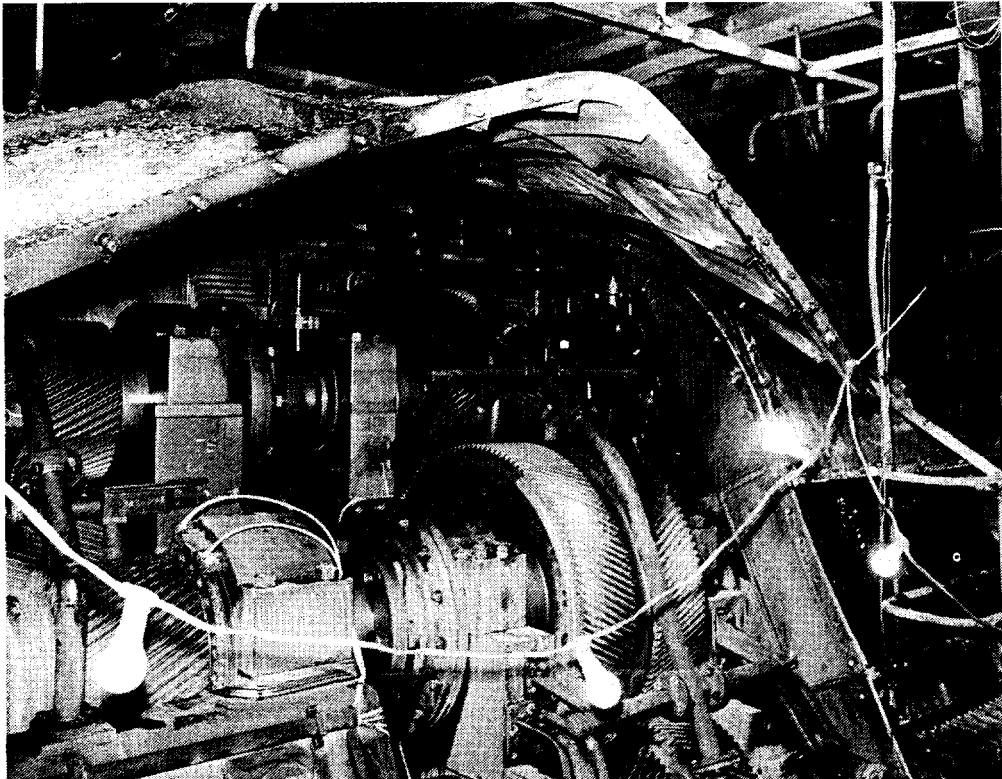
FIG. 5—THE TOP COVERS ARCHED UPWARDS. AGAIN THIS WAS MIRRORED ON THE OTHER SIDE OF THE GEARBOX

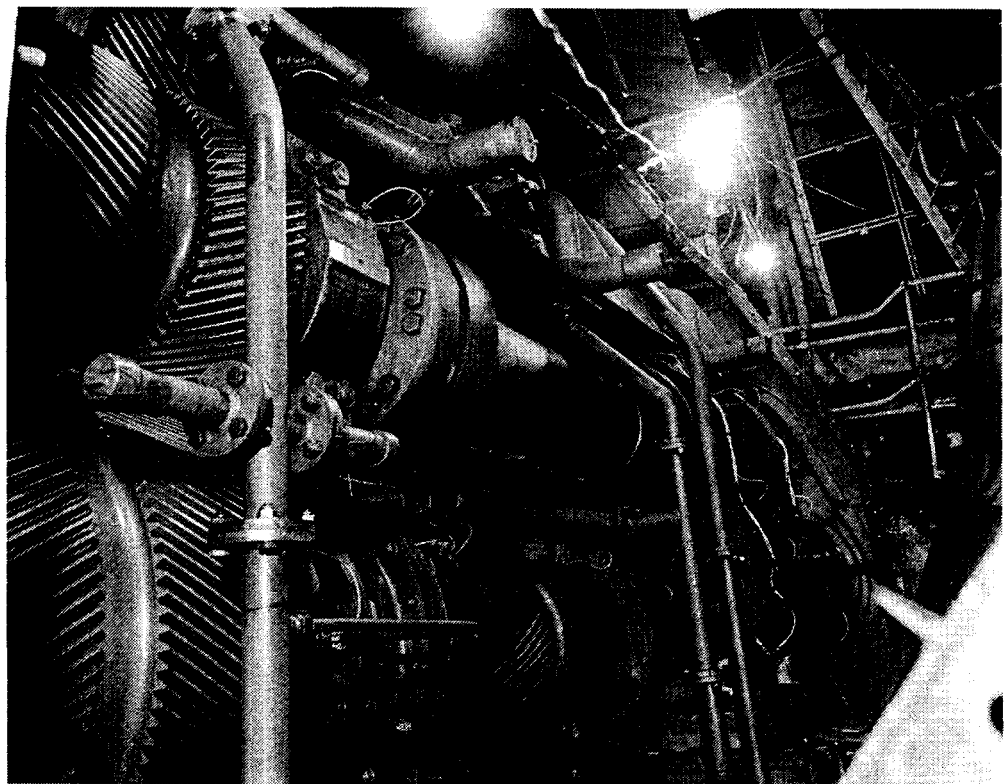
Initial examinations of the gearbox showed remarkably little sign of damage to its internals. The gears themselves appeared unscathed except for the obvious and very rapid reddening as a rust film formed. Ship's staff immediately washed down with fresh water and the TCV repeated the process when it arrived. (The looks of amazement from the TCV crew when invited to spray water over the internals of a gearbox was one of the lighter moments of the saga.). The gears were sprayed with PX24 as a water repellent and subsequently with PX4 as a preservative. Instrumentation cabling within the box was undamaged and, in striking contrast to almost every other cable in the space, not even smoke blackened. The gearbox itself was the 'eye of the storm' and everything had exploded outwards from it (FIG. 6).

FIG. 6—OUTBOARD SIDE OF THE GEARBOX SHOWING THE VIRTUALLY UNDAMAGED GEARS.
NOTE THAT INSTRUMENTATION WIRING WITHIN THE BOX IS NOT EVEN SMOKE-BLACKENED

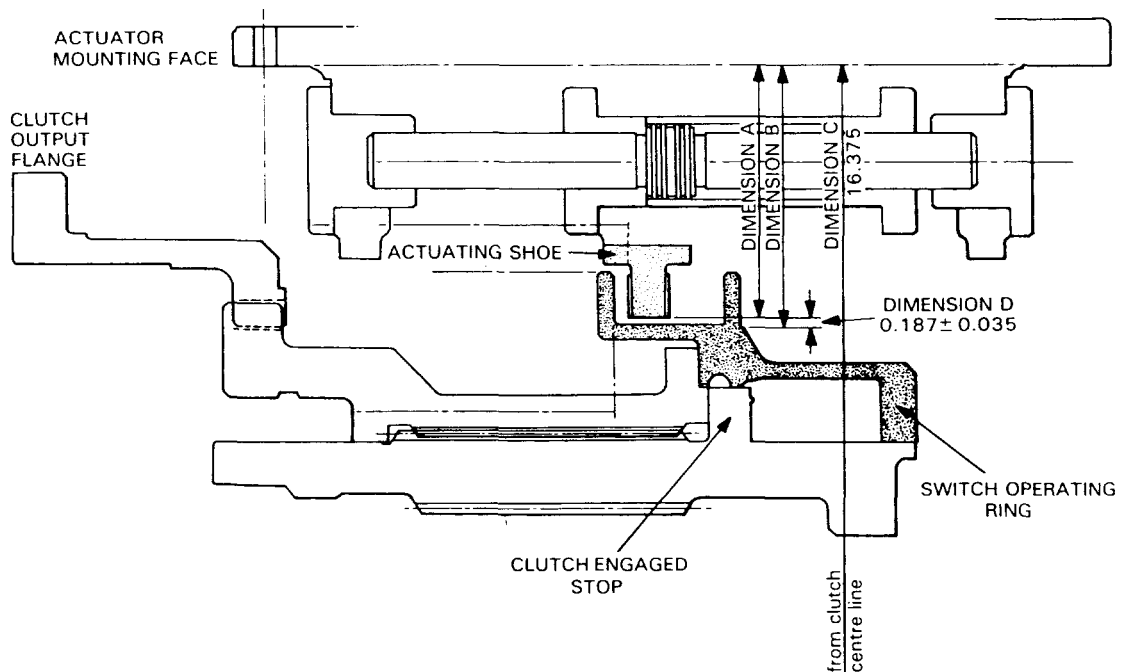
The clearance between the actuating shoe and the switch operating ring (FIG. 8, dimension D) is the critical dimension and this could be checked in three independent ways:

FIG. 8—SSS CLUTCH AND ACTUATOR, IN ENGAGED POSITION
dimensions in inches

- (b) Measuring the distance from the clutch actuator mounting face to the circumferential surface of the shoe (FIG. 8, dimension A) and from the actuator mounting face on the gearcase to the closest point on the switch operating ring face (FIG. 8 dimension B). The clearance was then calculated as the difference between these two dimensions (B-A).
- (c) Examination of the vertical surfaces of the switch operating ring showed an oil stain where the bearing face of the shoe had not contacted. By measuring the unstained area and the width of white-metal on the associated shoe the clearance was calculated.

The stain marks on the starboard inner clutch indicate a previously existing clearance of approximately 0.070 inches. This compares with measured and calculated clearances after the explosion of between 0.167 inches and 0.182 inches: in round figures an increase of 0.100 inches. This is a similar figure to the measured clearance under the starboard outer clutch shoe and yet it was clear that contact had occurred at this shoe from the blueing of the ring and deformation of the shoe itself; i.e. there had been zero clearance.

Referring again to FIG. 8, the clearance is determined by the relative position of the surfaces of the ring and the shoe. This in turn depends upon the dimensions of the components and upon the positioning of the actuator mounting face with respect to the clutch centre line (FIG. 8, dimension C). The component dimensions were found to be within tolerance and it was the latter dimension of 16.375 inches, specified by the clutch manufacturer to the gearbox manufacturer, and toleranced to ± 0.002 inches by the latter, which was found to be less than nominal in every case. The discrepancies were also consistent with the clearances which had been measured and calculated.

The answer lies in the loading on the third reduction direct drive pinion and hence the position of the load line in its bearings at the full power condition. In the case of the outer drives the effect of gear loading is to raise the pinion and hence the SSS clutch in its bearings whereas in the case of the inner drives the pinion is forced down in its bearings. The effect is to reduce the static shoe-to-ring clearance by the amount of the clearance in the outer pinion bearings as the gears approach full power. This bearing clearance is of the order of 0.018 inches. Conversely, the inner clutches are forced into the bottom of the bearings and hence the 0.030 inches clearance at the port inner clutch is not reduced further at full power.

There was now a complete explanation. The evidence provided by the measurements on the port inner clutch showed that a much smaller radial clearance than the design figure could exist between the clutch shoe and the clutch ring. Indeed in H.M.S. *Illustrious* all four clearances were less than the design figure. If the estimates of gearcase distortion above the starboard outer clutch were correct, it follows that a smaller clearance still was present at this clutch. Add to this the fact the outer clutches rise in their bearings under power and it follows that a near-critical situation had always existed. The exchange of shoe reduced the critical clearance by a few thousandths of an inch further although regrettably not sufficiently to foul in the static condition otherwise the problem would have been detected. It is deduced that a static clearance existed after the exchange but that it was less than the 0.018 inches bearing clearance.

As the gearbox approached full power the clutch rose within that bearing clearance and contact occurred. Frictional heat was generated and the temperature rose sufficiently to convert the normally safe atmosphere in the clutch housing 'enclosure' into a flammable mist. This eventually ignited and released sufficient energy to cause the main part of the gearcase to explode. That high surface temperatures were reached is confirmed by the metallurgical examination of the shoe and that these are sufficient to create the necessary conditions is well documented¹.

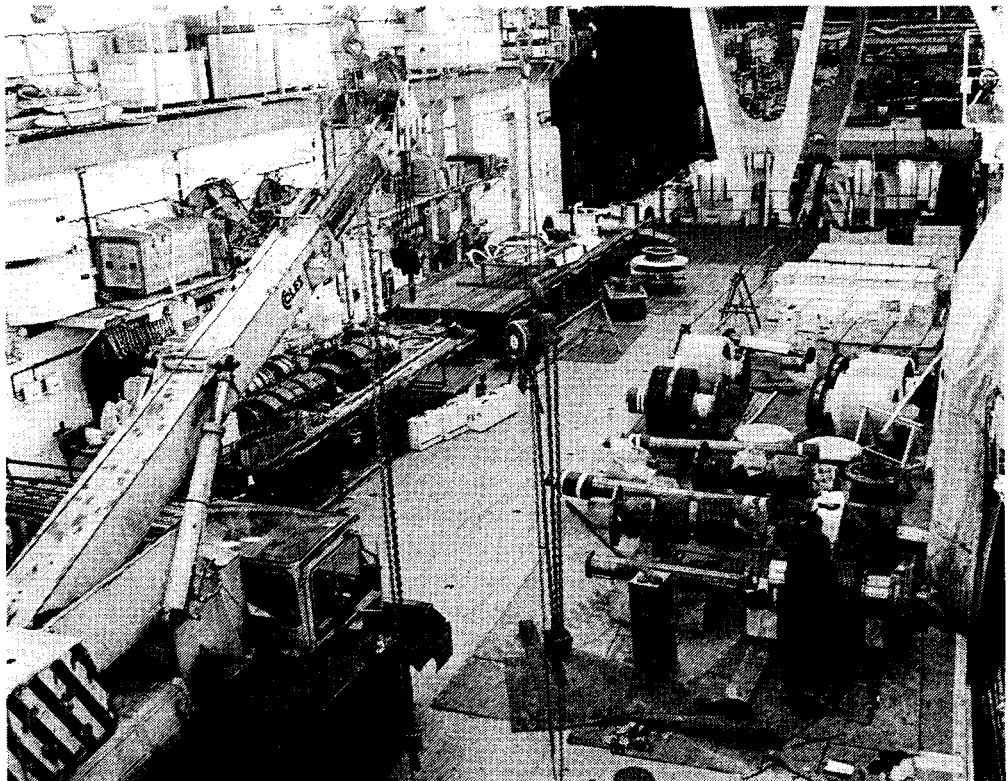
FIG. 10—THE FORWARD END OF THE AIRCRAFT HANGAR WITH MOST OF THE GEARS REMOVED FOR CLEANING, CONCENTRICITY CHECKS AND HARDNESS TESTING. THE LARGE WOODEN CRATES CONTAIN THE ANCILLARY SUPPORT EQUIPMENT

workmen. Stagers, ladders, shipwrights, electricians and, even at this early stage, painters were working alongside each other to prepare the scene for those who would tackle the critical path activities. The hangar became the scene of a village industry, with temporary workshops erected and such items as ventilation trunks being cleaned, relagged, painted and marked up for replacement without them even leaving the ship (FIG. 10).

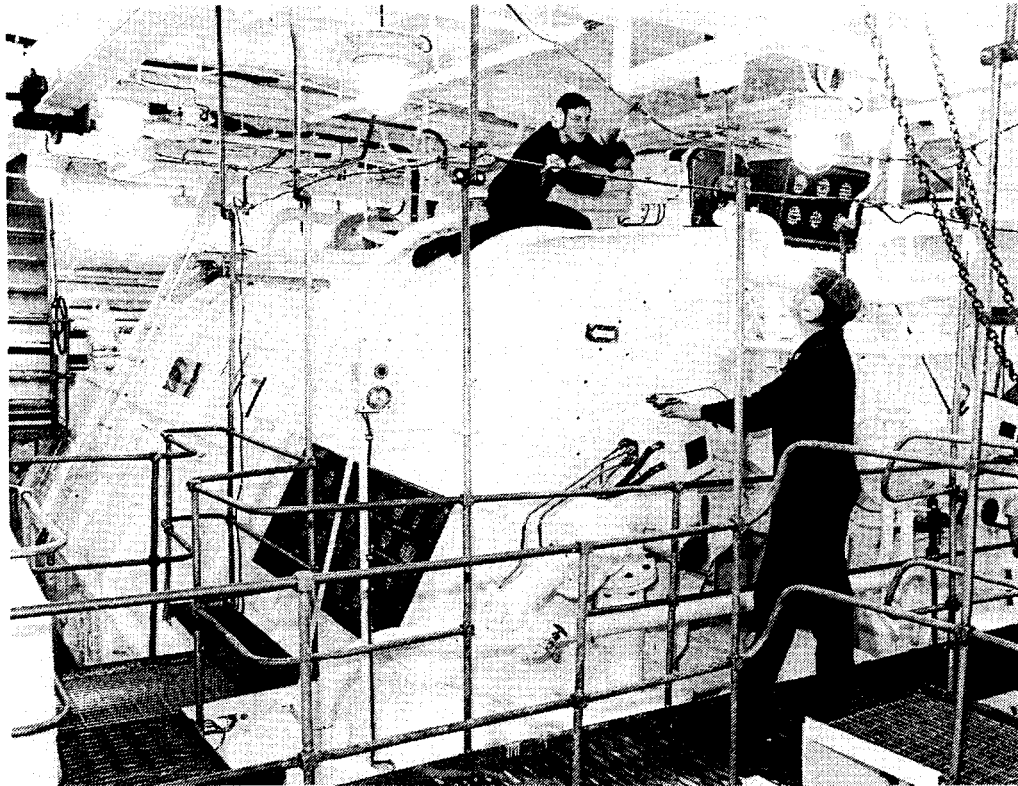
FIG. 11—THE FINISHED ARTICLE. THE REBUILT STARBOARD GEARBOX DURING PRE-SEA CHECKS

All the planned work was achieved with round-the-clock working, seven days a week, by Portsmouth Naval Base for a total of thirteen weeks. At the outset, many had thought that six months was a more appropriate timescale. The successful completion was a tribute to the Naval Base, the support organization, numerous sub-contractors (particularly the on-site guidance provided by David Browns) and indeed to the design of the ship. Without the built-in removal routes, good documentation, and the facility to terminate cable runs in cable passages outside the machinery space, the repair would have taken much longer (FIG. 11).
