U.S.S. 'STARK' BATTLE DAMAGE AND FIRE PROTECTION LESSONS LEARNED

R. L. DARWIN, M.S., P.ENG.
(*Naval Sea Systems Command, Washington, D.C.*)

ABSTRACT

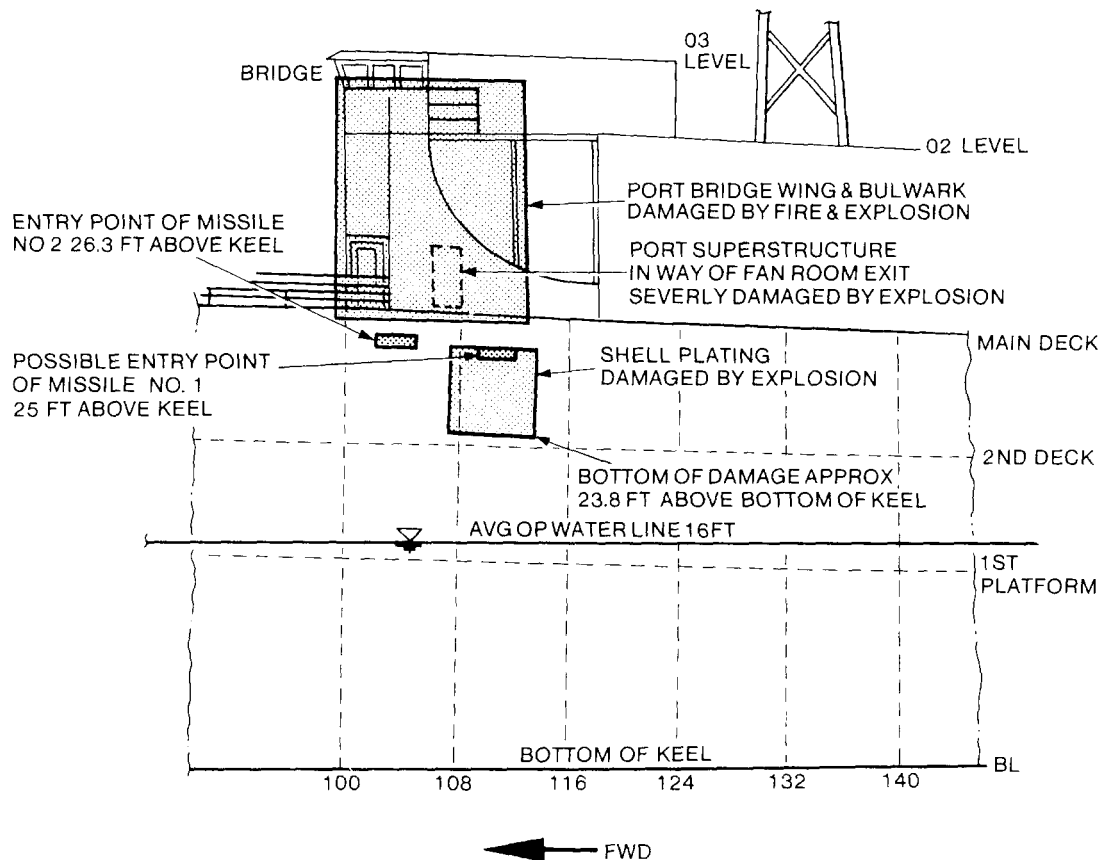
FIG. 1—SIDE VIEW OF U.S.S. STARK FROM PORT SIDE, SHOWING ENTRY POINTS FOR MISSILES 1 AND 2 AND THE EXTERNAL DAMAGE

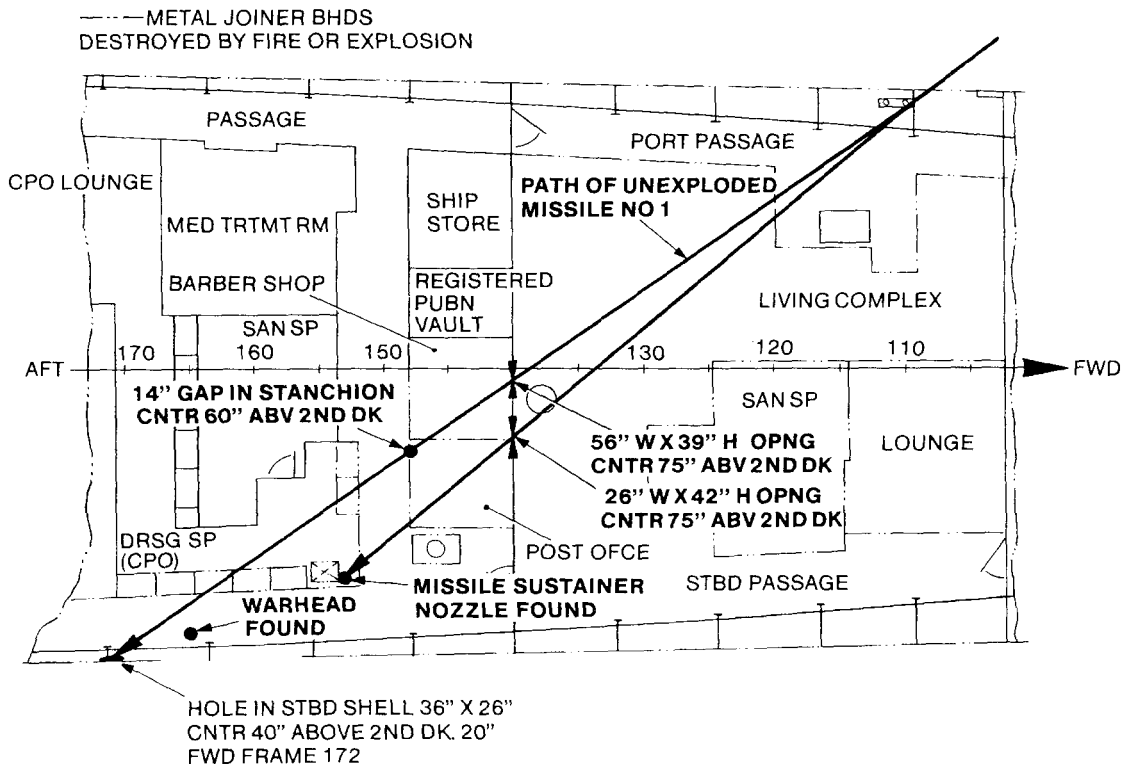
The warhead of the first missile hit the ship 10 feet above the waterline, at about Frame 110. It ruptured the port firemain upon entry and separated into two large pieces, but failed to detonate. The two pieces passed (FIG. 3) through the crew's sleeping quarters (Living Complex compartment), then through a bulkhead at Frame 140 (near the post office and barber shop FIG. 4) and continued diagonally across the deck, spreading nearly 120

FIG. 3—2ND DECK LAYOUT, SHOWING THE PATHS OF THE TWO PIECES OF MISSILE NO. 1

pounds of solid burning residual propellant in their wakes from Frame 150 to Frame 171 on the starboard side. Dense and acrid black smoke immediately began to fill the surrounding area in the vicinity of the athwartship passageway at Frame 150 and in the port and starboard passageways in the same compartment, impeding personnel from escaping the affected compartments.

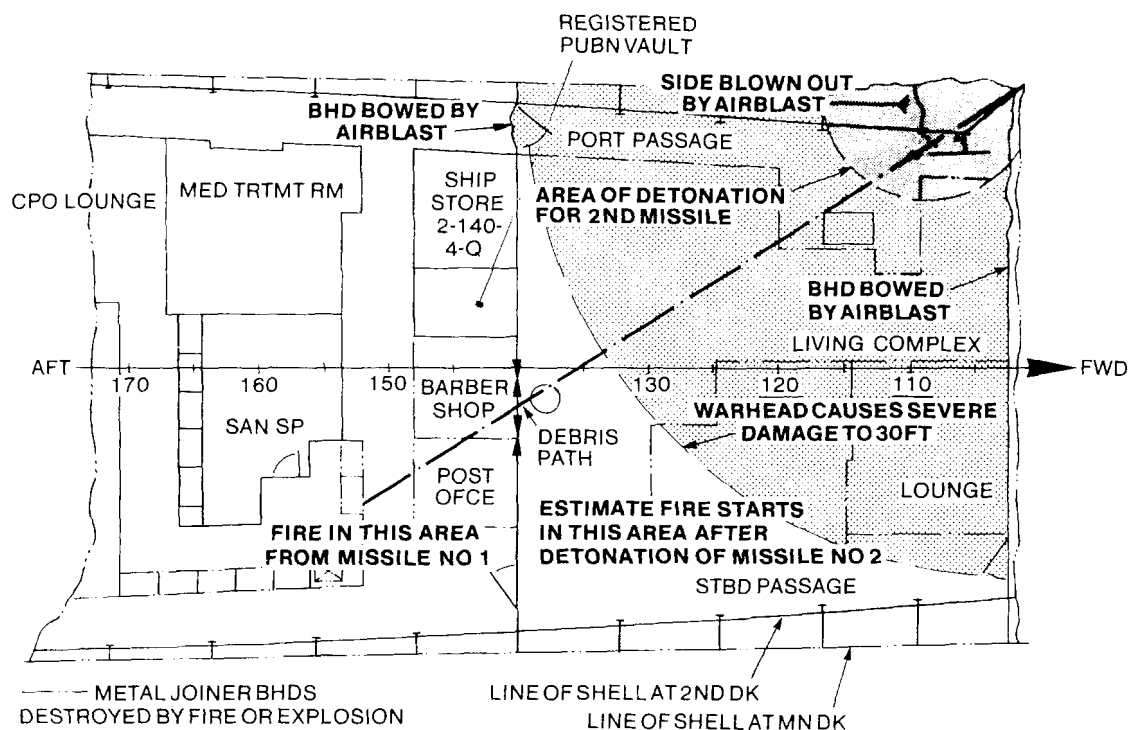
The second missile entered the ship at about Frame 102, 10 to 12 feet above the waterline, and is thought to have detonated about 5 feet inside the hull on the second deck and several feet below the main deck (see FIG. 5). The close proximity of the detonation point to the point of entry through the shell plating is believed to have resulted from a faster warhead fuse action than previously reported with Exocet missile experiences. Because most blast energy was vented to the ship exterior, internal blast damage was less than would be expected from a typical Exocet detonation.

FIG. 5—2ND DECK LAYOUT IN WAY OF MISSILE NO. 2

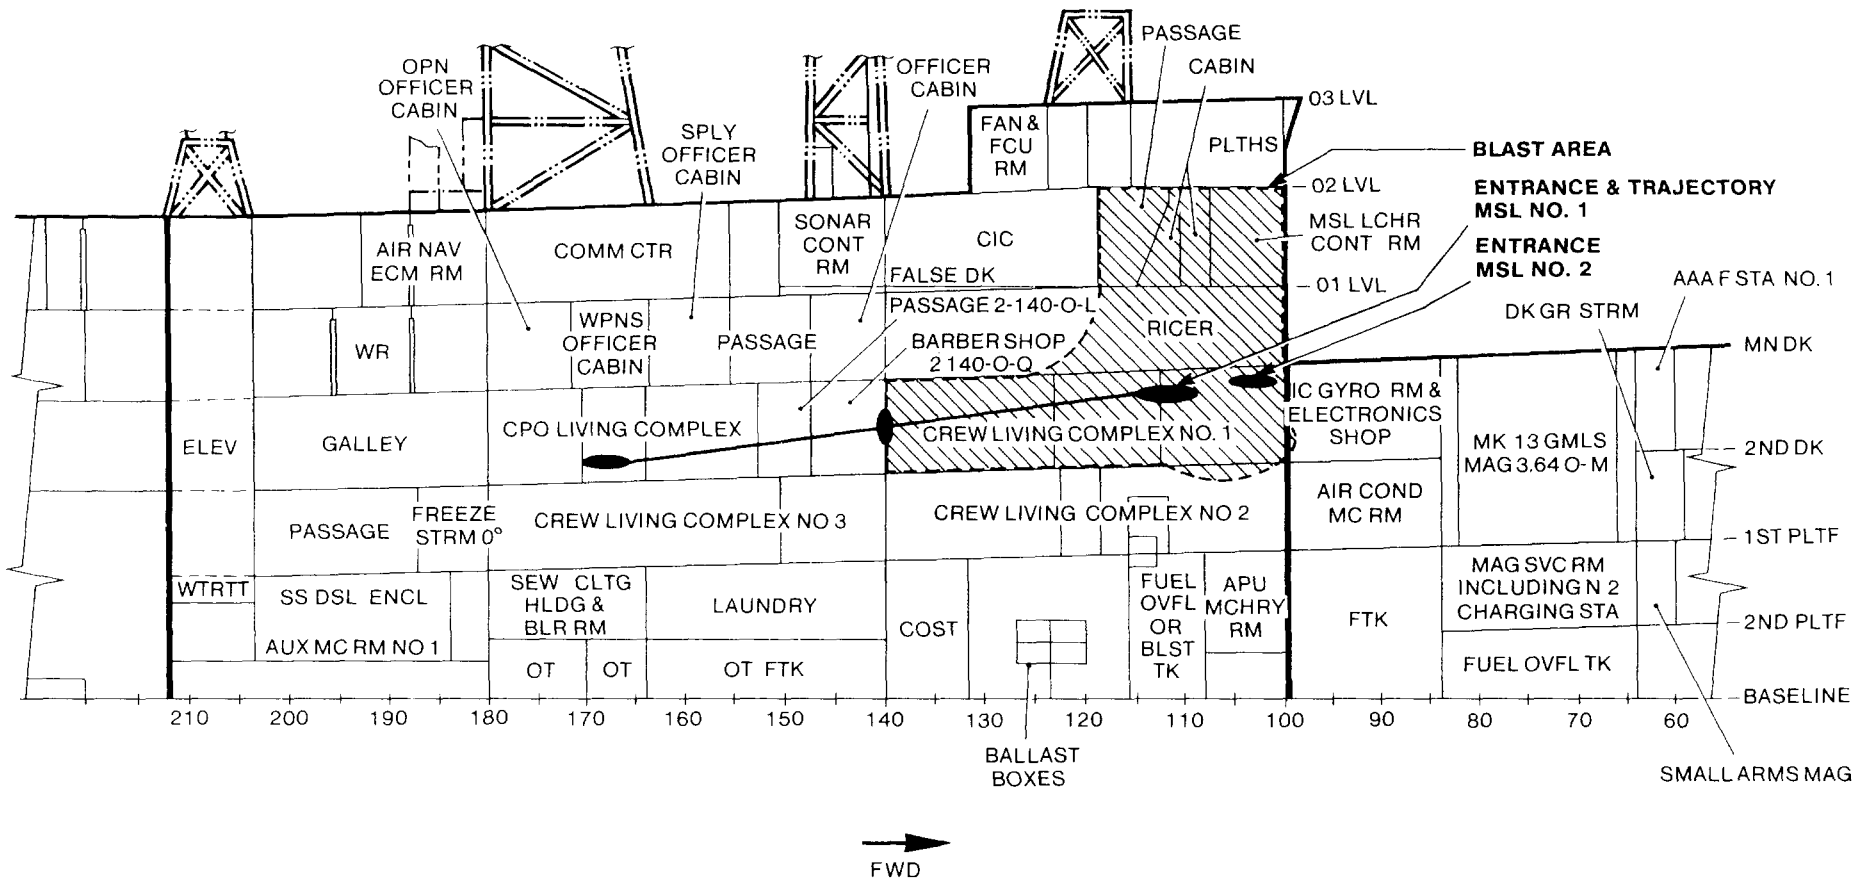
- (a) Externally, the blast from the second missile created a gaping hole in the hull and damaged the bridge wing, bulwark and main deck superstructure areas on the port side, allowing free air ventilation for combustion and restricting firefighting team passage on the entire port side of the ship in the vicinity of Frame 100 (FIG. 8).

FIG. 6—CENTRELINE PROFILE SHOWING BLAST AREA ON PORT SIDE FROM MISSILE NO. 2 AND TRAJECTORY FOR MISSILE NO. 1

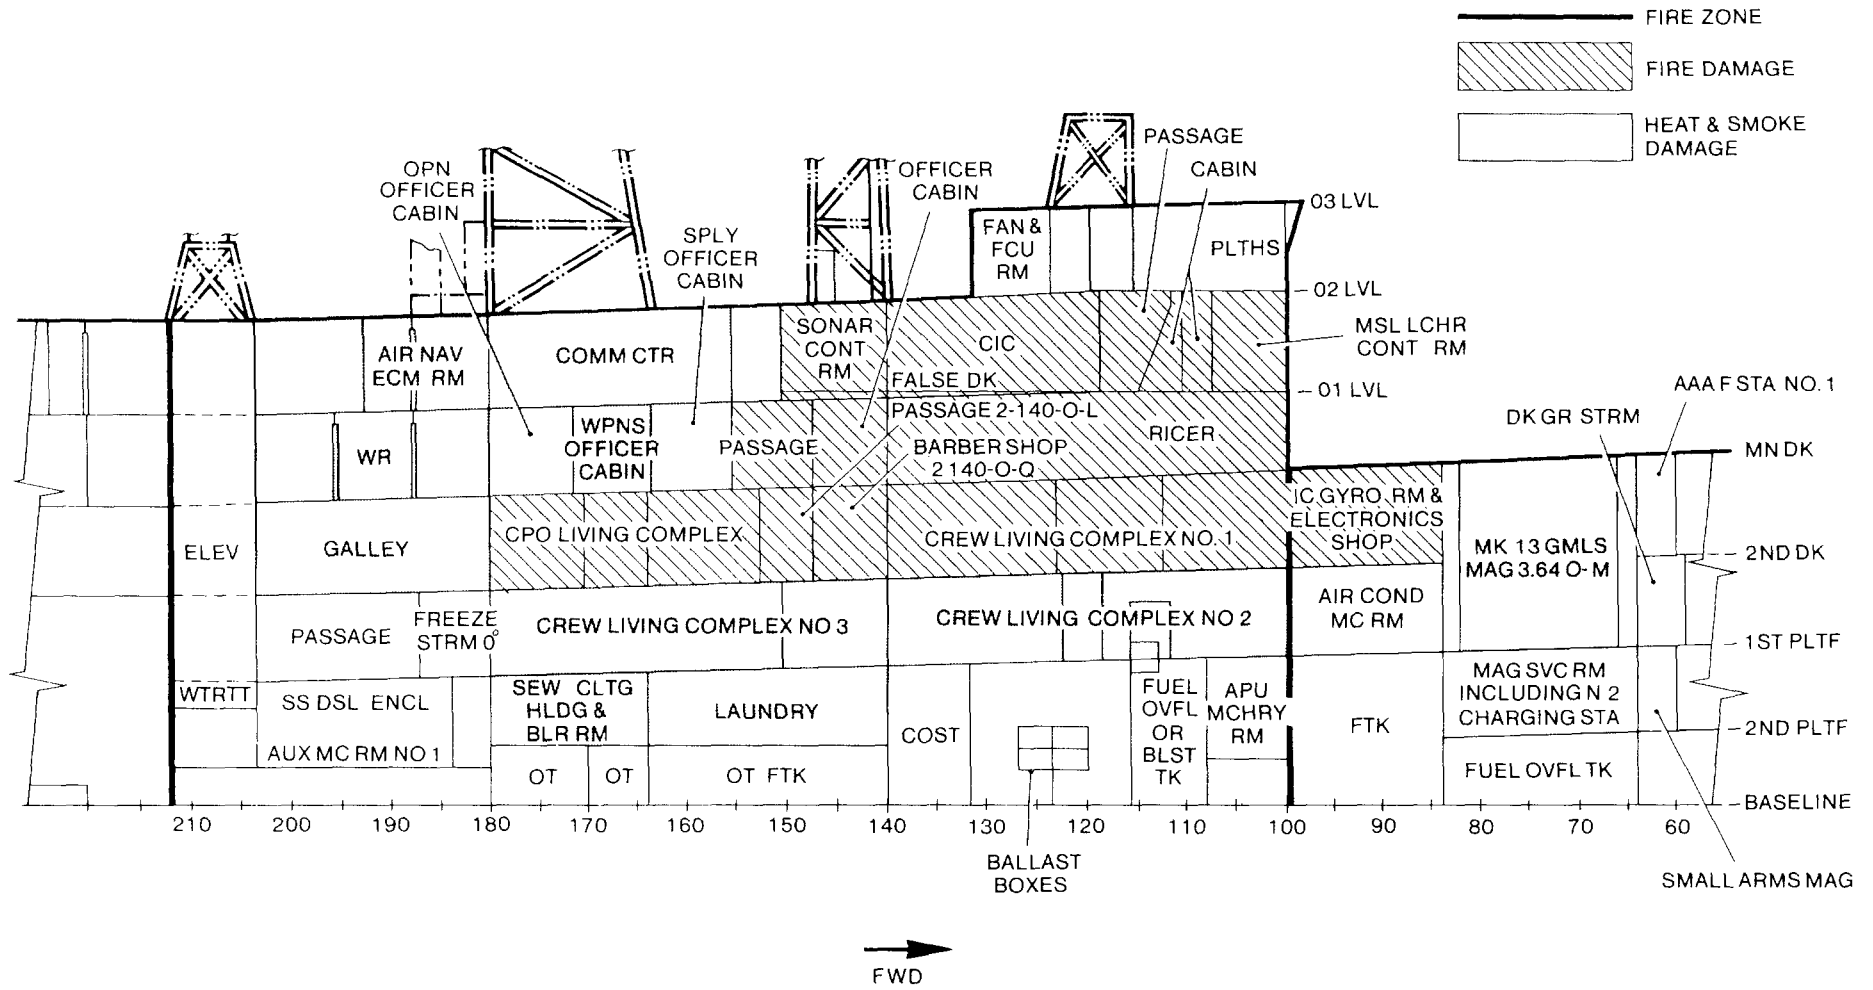
The propellant used in the Exocet missile burns at temperatures estimated at 3,000° to 3,500°F and contains an oxidizer, which causes efficient and complete combustion. The combination of the burning unspent propellant from the two missiles and the heat of detonation from the second missile subjected the Living Complex to a rapid, intense thermal pulse (or inferno) seldom seen in normal peace-time, accidental fires. FIG. 6 is an inboard profile showing the compartments affected, with the blast damage superimposed, and FIG. 7 shows the area ultimately damaged due to fire, heat, and smoke.

FIG. 7—CENTRELINE PROFILE SHOWING AREA OF FIRE, HEAT AND SMOKE DAMAGE

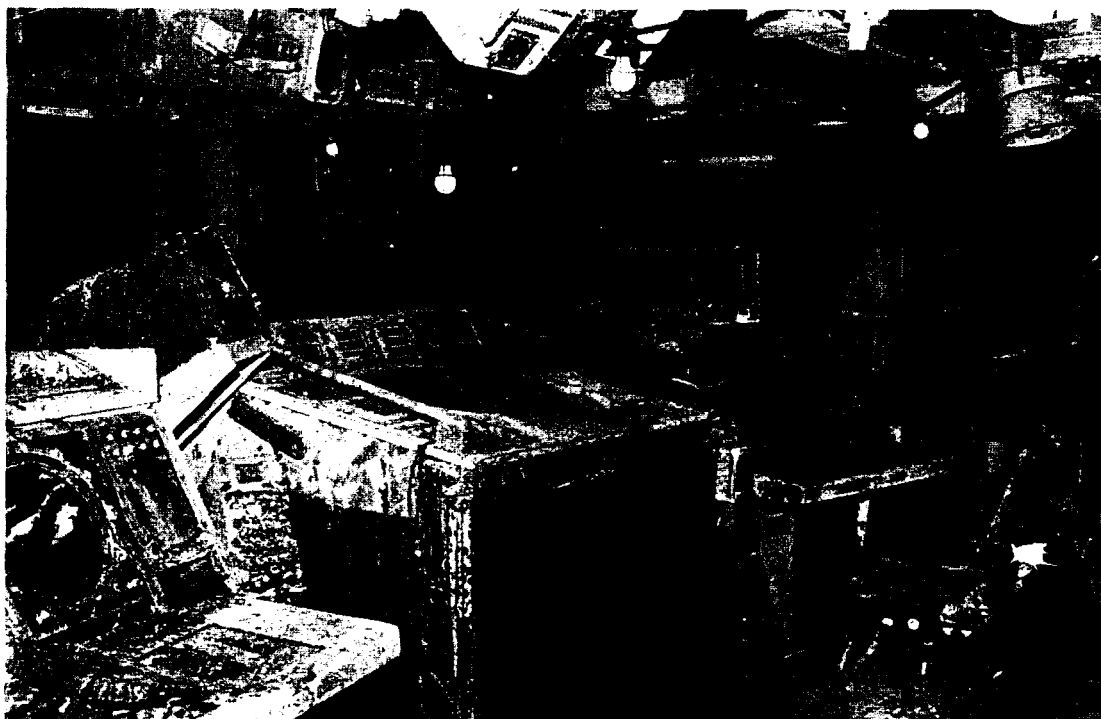
- (a) The fire in RICER was considerably less intense than that of the berthing complex, thus taking longer to overheat CIC to auto-ignition temperature.
- (b) Unlike the deck beneath RICER, which was steel, the deck between RICER and CIC was aluminium. There was a false deck with extensive nesting of electrical cabling feeding CIC equipments. When temperatures reach 400°F aluminium loses about half of its yield strength; at 600° it begins to sag under its own weight; and at 1,100° it finally melts. Steel, however, does not melt until at least 2,800°. While the steel deck in RICER buckled under the intense heat, only several small holes melted in the aluminium overhead and in segments of

Fig. 9—COMBAT INFORMATION CENTRE (CIC); THE PORT AFTER CORNER SEEN FROM THE CENTRE LINE

compartment stanchions and framing, attesting both to the thermal intensity of the fire and the structural integrity of the aluminium superstructure design.

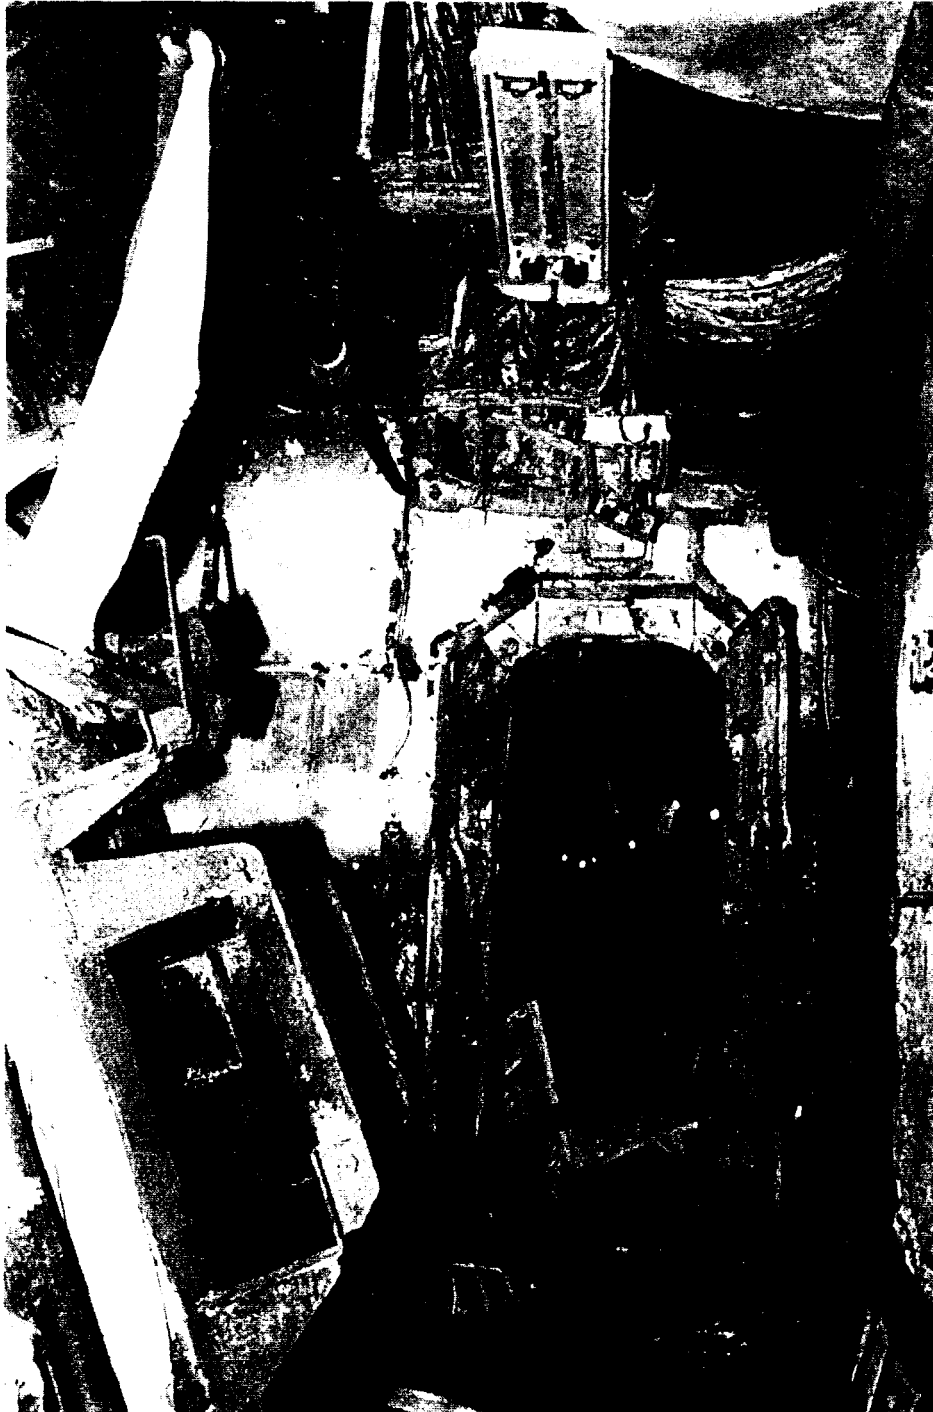
FIG. 10—2ND DECK STARBOARD PASSAGE, LOOKING AFT FROM NEAR FRAME 89

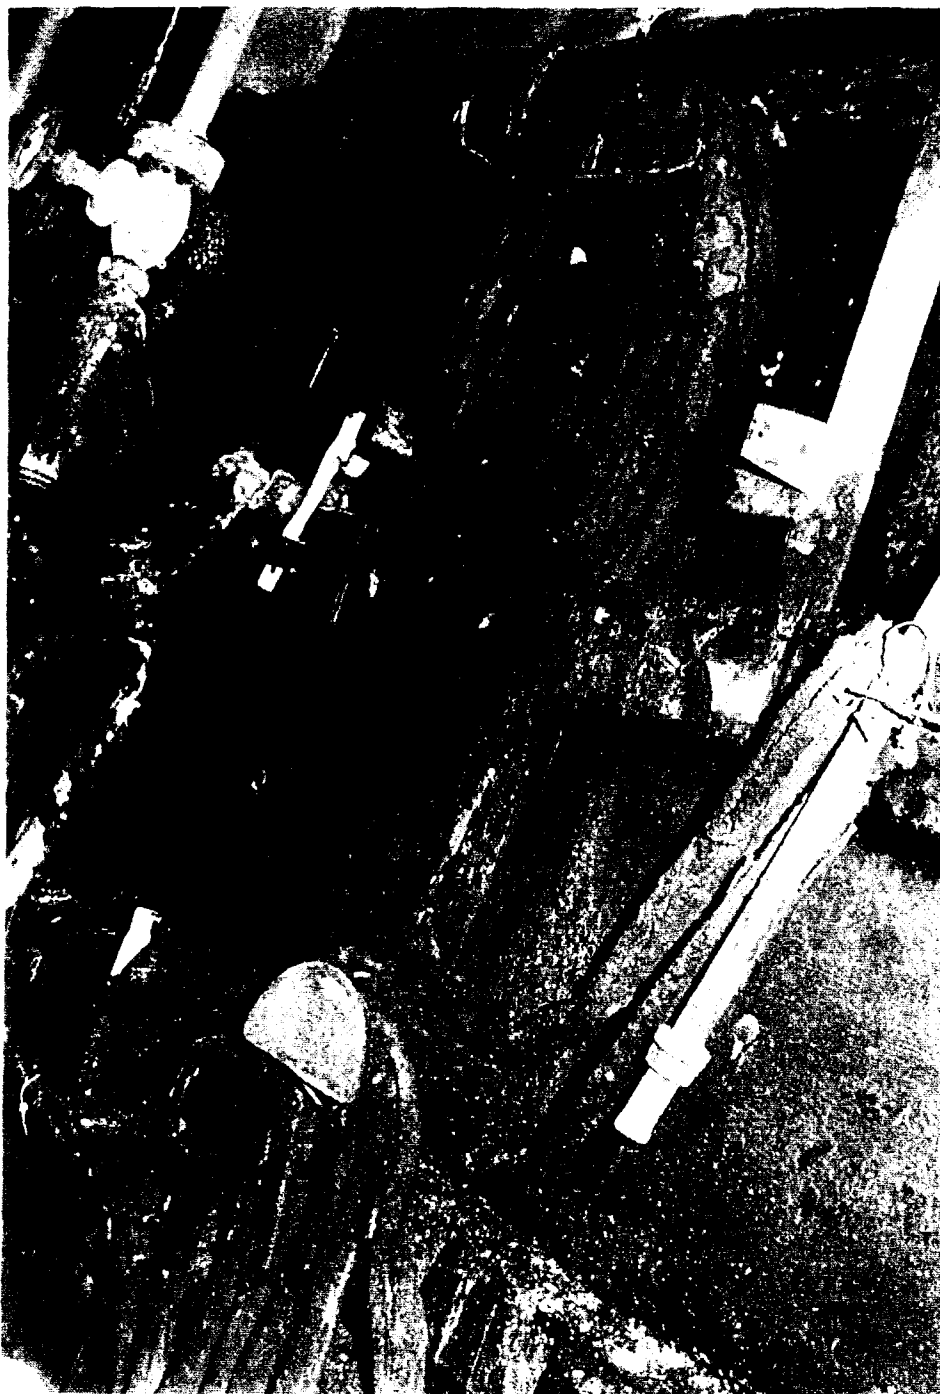
Despite the extremely intense heat in the Living Complex, *Stark's* damage control effort was able to limit horizontal fire spread to between Frames 100 and 180. Primary fire boundaries were set immediately at Frames 64 and 180, with secondary boundaries at Frames 32 and 212. Other than the original fire area immediately after the hit (which extended from Frames 100 to 171), the only actual fire spread on the second deck was forward on the starboard side through an open water-tight door (Frame 100), through the IC/Gyro Room, and along the passageway (FIG. 10) to Frame 64 and across the port side to Frame 64. The fire consumed overhead cables and shoring lumber stowed in the passageway (FIG. 11) and threatened the Mk. 13 missile magazine.

FIG. 11—DAMAGE CONTROL HOSES IN 2ND DECK STARBOARD PASSAGE NEAR FRAME 89

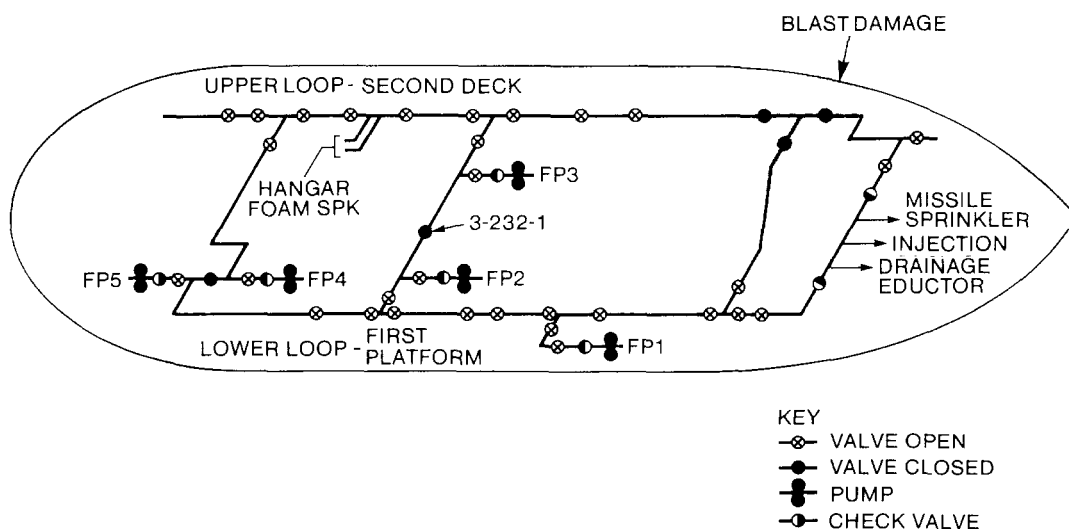
Five fire pumps discharge through risers to port and starboard longitude mains that are segregated into two independent systems in Material Condition 'Zebra,' and Readiness Condition I (General Quarters) (see FIG. 12). The

FIG. 12—U.S.S. STARK FIREMAIN ISOLATED FOR CONDITION ZEBRA

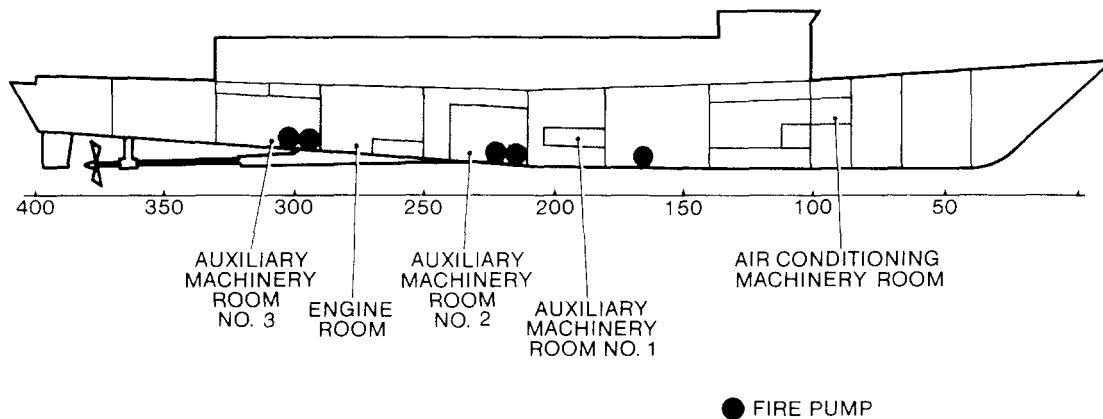
Five electric pumps produce a total pumping capacity of 5,000 gal/min (1,000 gal/min each). The five pumps are located in the following spaces (see FIG. 13): Fire Pump No. 1 in Fire Pump Room 1; Fire Pumps No. 2 and 3 in Auxiliary Machinery Room 2; Fire Pumps No. 4 and 5 in Auxiliary Machinery Room 3. No fire pumps are installed forward of Frame 172. Locating fire pumps well forward in a ship is difficult, because the sea suction for the fire pump causes turbulence, which may affect sonar performance.

FIG. 13—FIRE PUMP LOCATIONS IN U.S.S. STARK

Provide on future ship designs and, where practical, backfit on existing ships, not less than one installed fire pump in each fire zone. This will provide primary firefighting water supply in the area where damage has occurred and will ensure an alternative supply from immediately adjacent areas. Those firepumps in the forwardmost and aftermost fire zones should be independently powered and located as close to the ends of the ship as possible. Locating firepumps at the ends of the ship ensures that a firefighting water source will be available to those personnel who are stationed at these points. This configuration is the same as that now required by GENSPECS. Independent power ensures that power will be available to the fire pumps. Conduct the necessary R&D to solve sonar noise and pump suction problems associated with a forward fire pump, sea chest and associated turbulence. For the FFG 7 Class, the installation of a 500 gal/min fire pump forward of Frame 100 should be investigated.
