# MARINE GEARBOX EXPLOSIONS

## A REVIEW

COMMANDER M. D. COOPER, C.ENG., F.I.MAR.E., R.N.  
(*Ship Department*)

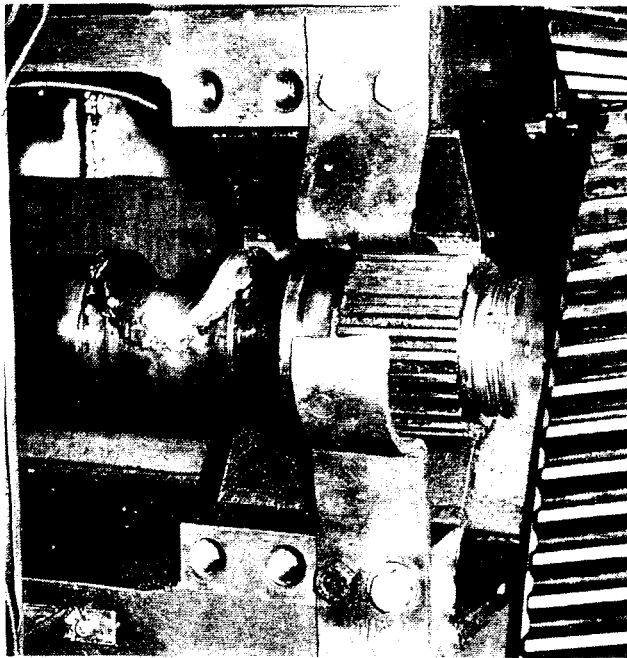
FIG. 3a—H.M.S. 'ZULU' JACKSHAFT BEARING JOURNAL

A better documented example of oil ignition contained within the gearcase is that in H.M.S. *Zulu* (FIG. 3) when a lightly-loaded steam-turbine jackshaft bearing failed. Popping noises and discharge of smoke through joints were reported, followed several minutes later by a heavy grinding noise. 'Flashing' or 'sparkling' at some distance away from the bearing in distress, visible through clutch inspection sight ports, was also reported.

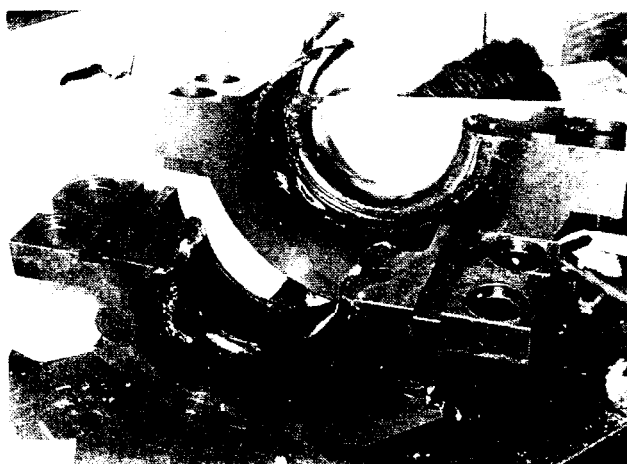
FIG. 3b—H.M.S. 'ZULU' JACKSHAFT BEARING HOUSING
