MAIN PROPULSION PRIMARY GEAR WHEEL FAILURES IN TYPE 42 AND TYPE 21 SHIPS

LIEUTENANT D. I. BOGGUST, M.Sc., C.ENG., M.I.MECH.E., R.N.
(Formerly R.N.E.C., Manadon)

AND LIEUTENANT-COMMANDER R. A. BOTTEN, B.Sc., Ph.D.,
C.ENG., M.I.M., R.N.
(R.N.E.C., Manadon)

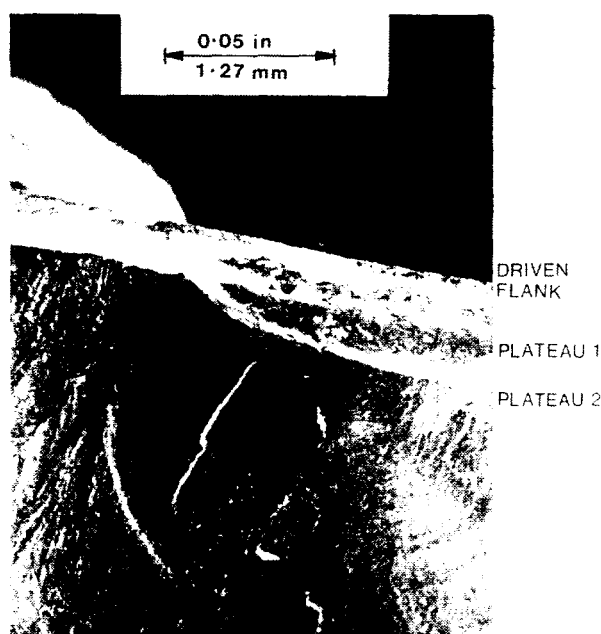
FIG. 2—VIEW OF TOOTH FRACTURE FACE SHOWING ORIGIN OF FATIGUE FRACTURE

The scanning electron microscope was employed to assess the salient features of the fracture of a failed tooth from H.M.S. *Sheffield's* No. 1 starboard gear-box. The fracture surface of this specimen was viewed looking parallel to the surface of the driven flank of the tooth. The area shown in FIG. 2 illustrates the origin of the bending fatigue failure which appears to emanate from the lower of the two planes or plateaux designated plateau No. 1 and plateau No. 2 as shown, these plateaux being parallel to the driven flank of the tooth. The lower plateau was seen to contain probable sites of inclusions, and the upper plateau ran into a crack on the fracture surface (FIG. 3) which appeared on the surface of the driven flank of the tooth in an area of shallow pits and spalls (FIG. 4).

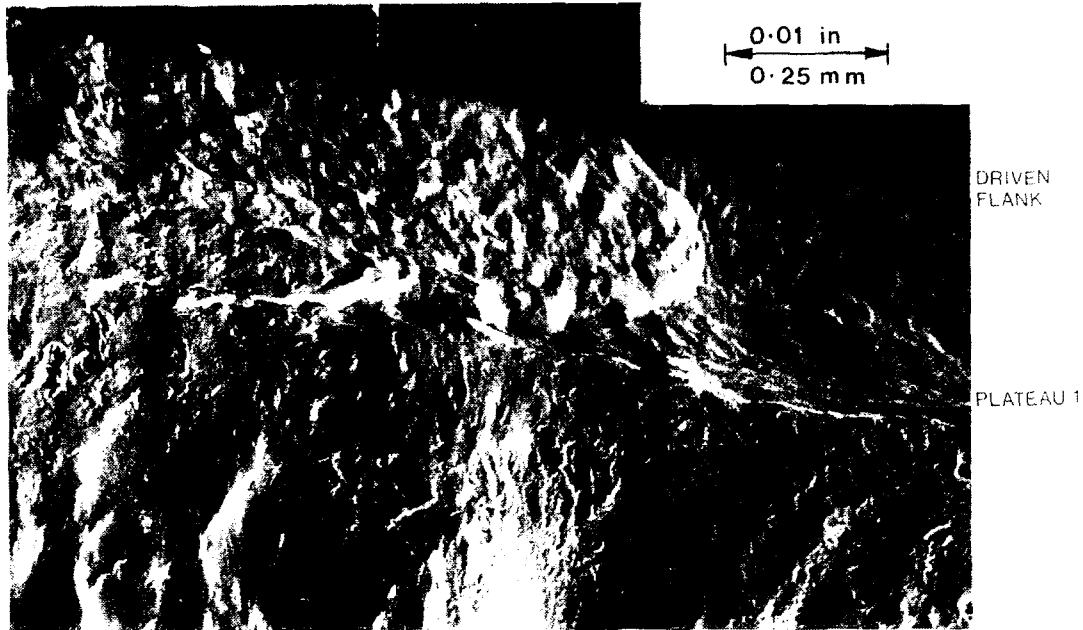
FIG. 3—VIEW OF PLATEAU NO. 1 SHOWING CRACK ON FRACTURE FACE

The evidence from the microscopical observations of the failed tooth was that subsurface cracking had occurred parallel to the surface of the driven flank of the tooth at depths of plateau 1 (0.015 in; 0.38 mm) and plateau 2 (0.026 in; 0.66 mm) and that their initiation was possibly due to inclusions. A surface crack on the driven flank of the tooth had also been observed although no indication of its initiation could be ascertained.

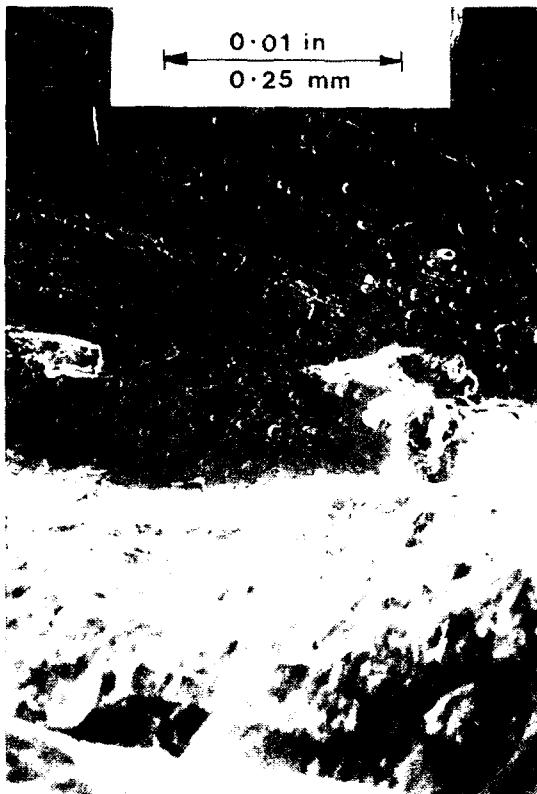
FIG. 4—CRACKING, SPALLING, AND PITTING ON SURFACE OF DRIVEN FLANK OF TOOTH

The associated spalling or pitting of the disc track surface bore a marked similarity to the flank of the failed gear tooth (FIG. 4). The test also showed that it was possible to initiate surface cracking on the driven flank of the tooth under a simulated service condition.

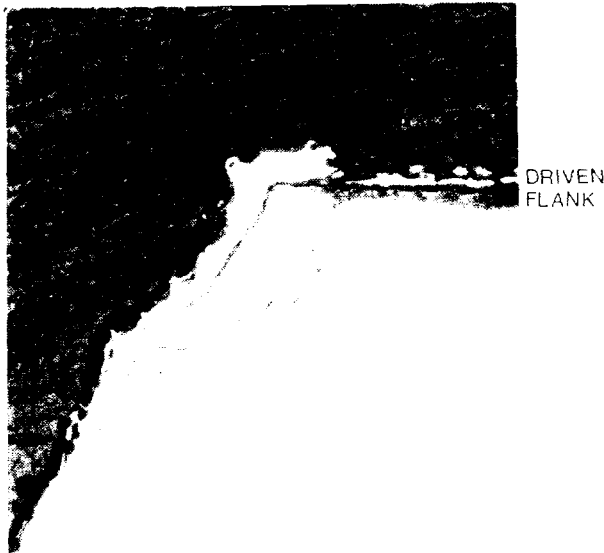
FIG. 5—SECTION OF TOOTH SHOWING CRACKING BETWEEN DRIVEN FLANK AND FRACTURE FACE

This failed tooth was sectioned, and under the optical microscope it was seen that two cracks existed: one originating from the driven flank and one from plateau No. 1 (FIG. 5). Also, a group of three inclusions was found at or adjacent to the fracture surface at a depth of 0.04 in (1.02 mm) from the driven flank, the largest of which was 0.01 in (0.25 mm) in length.

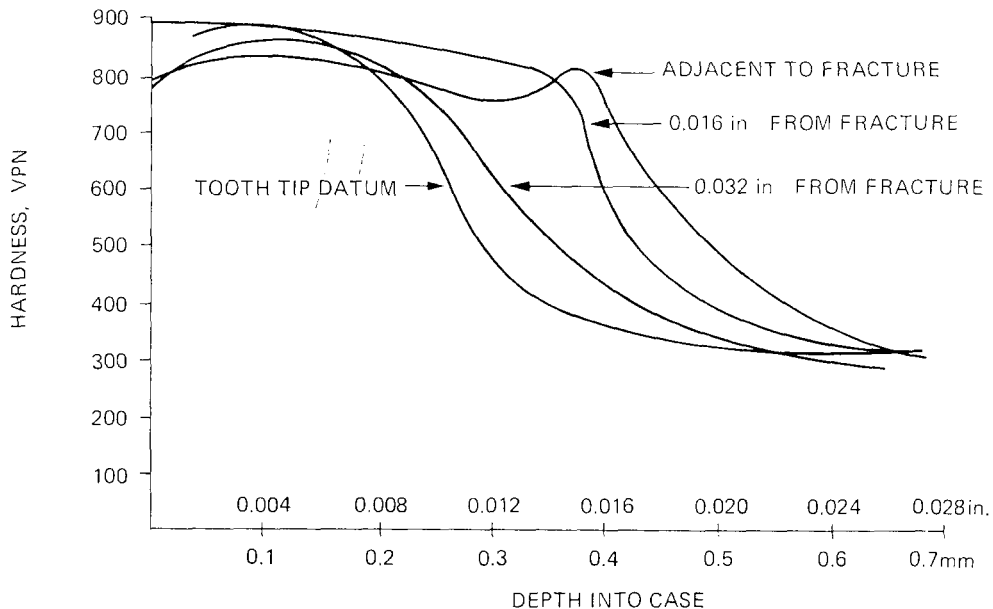
Microhardness traverses were undertaken through the nitrided case in the area of the bending fatigue initiation and it was found that there was a sharp rise in hardness to over 800VPN at a depth of plateau No. 1. This rise in micro-

FIG. 6—MICROHARDNESS TRAVERSES (100 g) OF NITRIDED CASE ADJACENT TO FRACTURE SURFACE

hardness was very localized and at about 0.032 in (0.81 mm) back from the fracture face its value had fallen back almost to the tooth tip value which had been taken as a datum. FIG. 6 gives the results of these traverses. The rise in microhardness was caused by the presence of a stress raiser which in this case could have been an inclusion.

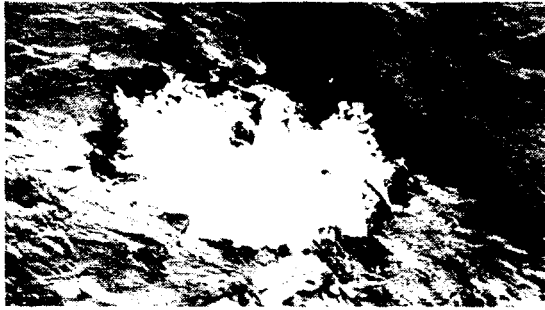
Initiation of the fatigue failures was at the case/core interface of the specimens and was generally caused by an inclusion, typically 0.01 to 0.014 in (0.25 to 0.36 mm) in size.

FIG. 8—INCLUSION AT INITIATION OF FATIGUE FAILURE

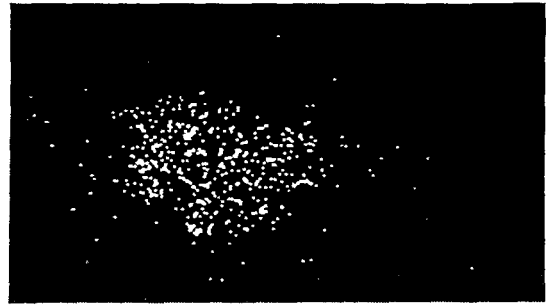
FIG. 9—ALUMINIUM SPOT MAP OF INCLUSION IN FIG. 8

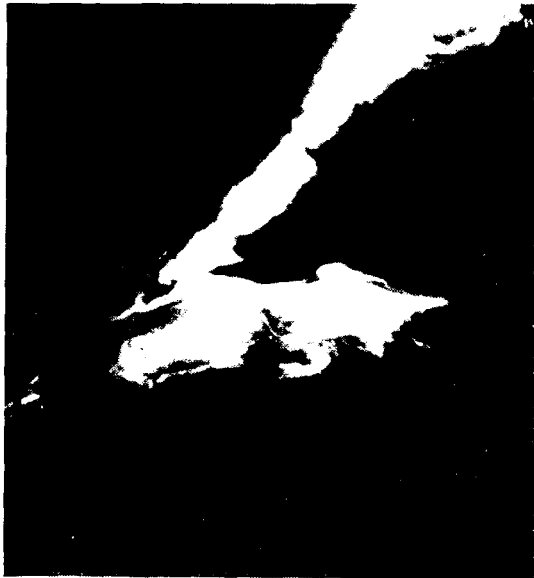
FIG. 10—LARGE INCLUSION IN FRACTURE SURFACE

This association was also detected when specimens, prepared for optical microscopy, were analysed (FIGS. 10, 11, 12, and 13). The aluminium bearing inclusions are indicative of slag inclusions from the original cast and they could act as stress raisers.

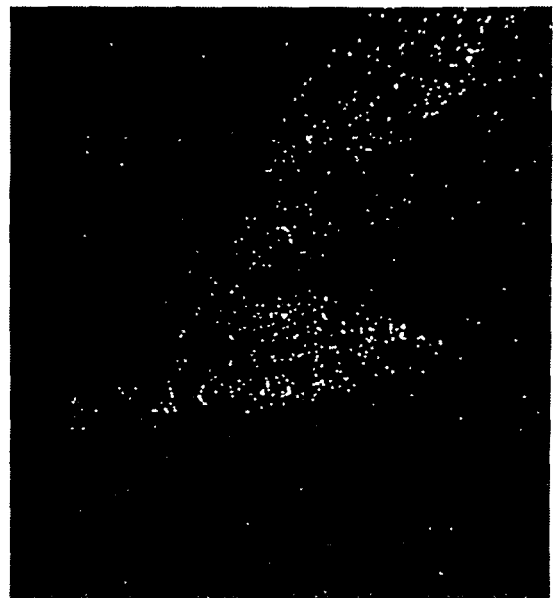
FIG. 11—ALUMINIUM SPOT MAP OF INCLUSION IN FIG. 10

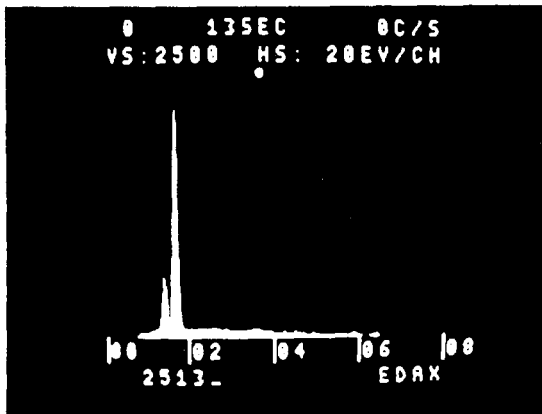
FIG. 12—'EDAX' QUALITATIVE ANALYSIS OF THE CORE REGION OF INCLUSION IN FIG. 10 SHOWING ALUMINIUM AND SILICON PEAKS

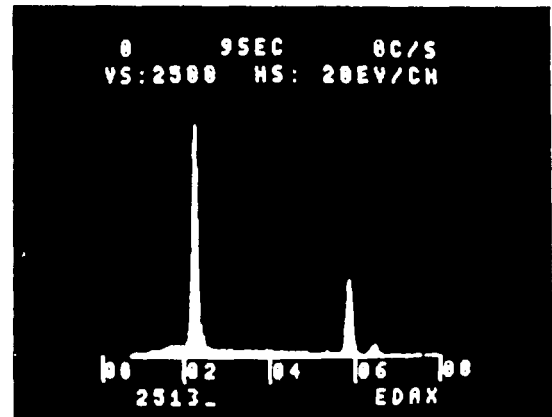
FIG. 13—'EDAX' QUALITATIVE ANALYSIS OF THE PERIPHERY OF INCLUSION IN FIG. 10 SHOWING SULPHUR AND MANGANESE PEAKS

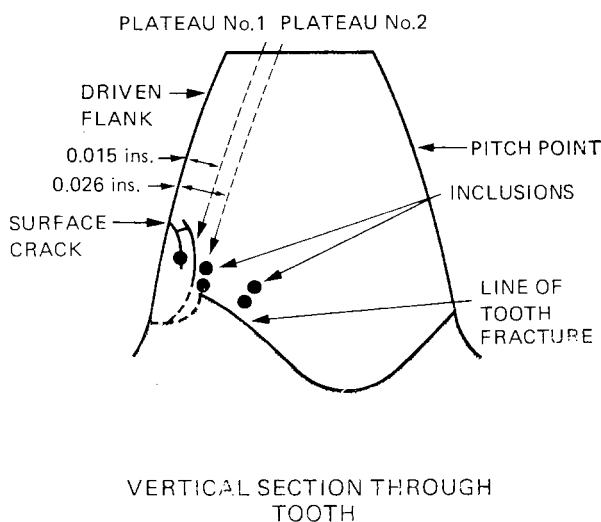
The following failure model of the tooth specimen from No. 1 starboard primary wheel of H.M.S. *Sheffield* was deduced. (see FIG. 15).

A surface fatigue crack initiated by the asperity interaction between the contacting primary teeth propagated into the driven flank away from the pitch point and curved towards the plane of maximum shear stress in the nitrided case. At the same time, inclusion-initiated fatigue cracking developed parallel to the tooth flank at depths of 0.015 in (0.38 mm) and 0.026 in (0.66 mm) by the shear stress induced at tooth contact. These cracks are indicative of rolling contact fatigue mechanisms. The surface crack and the crack at a depth of maximum shear stress propagated until a crack formed between them. The hydraulic action of tooth contact caused the cracks to propagate rapidly and a large pit was formed. Bending fatigue failure then followed caused by the stress-raising influence of the pit.

FIG. 15—MODEL OF TOOTH FRACTURE OF H.M.S. 'SHEFFIELD' NO. 1 STARBOARD PRIMARY WHEEL TOOTH (NOT TO SCALE)

Failure of the No. 1 starboard primary wheel of H.M.S. *Sheffield* was due to bending fatigue, initiated by rolling-contact fatigue mechanisms and exacerbated by the stress-raising effect of slag inclusions within the steel of the primary wheel.
