NEEDLE(S) IN A HAYSTACK

DISTRIBUTION OF FEED PUMP TURBINE BLADES IN AN EXHAUST STEAM RANGE

LIEUTENANT J. PRIOR, C.ENG., M.I.MAR.E., R.N. AND
LIEUTENANT K. F. WARD, B.SC., R.N.

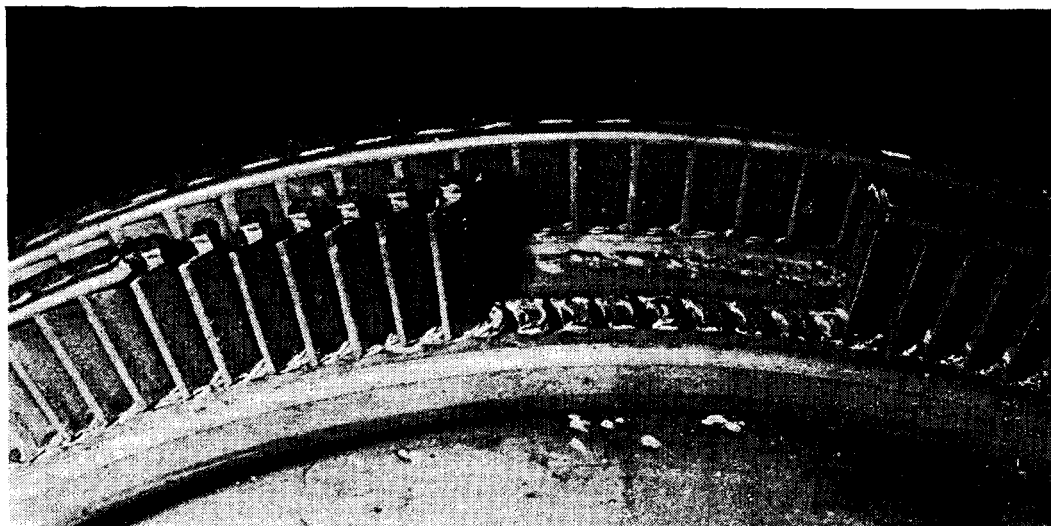
During trials of her GWS 25 equipment, H.M.S. *Penelope* at anchor off Mevagissey was preparing for sea and another day of trials which included steaming up and down a range at 20 shaft r.p.m. The TMFP 35 feed pump was out of action because of an unusual distortion of its turbine casing attributed to an originally faulty casting. The TWL 35 feed pump, which was in use and had been running satisfactorily for the preceding 55 hours, tripped on overspeed and, as was subsequently discovered, shed eight turbine blades and a 5·2-inch length of shrouding.

FIG. 1—TWL 35 FEED PUMP TURBINE ROTOR SHOWING MISSING BLADES

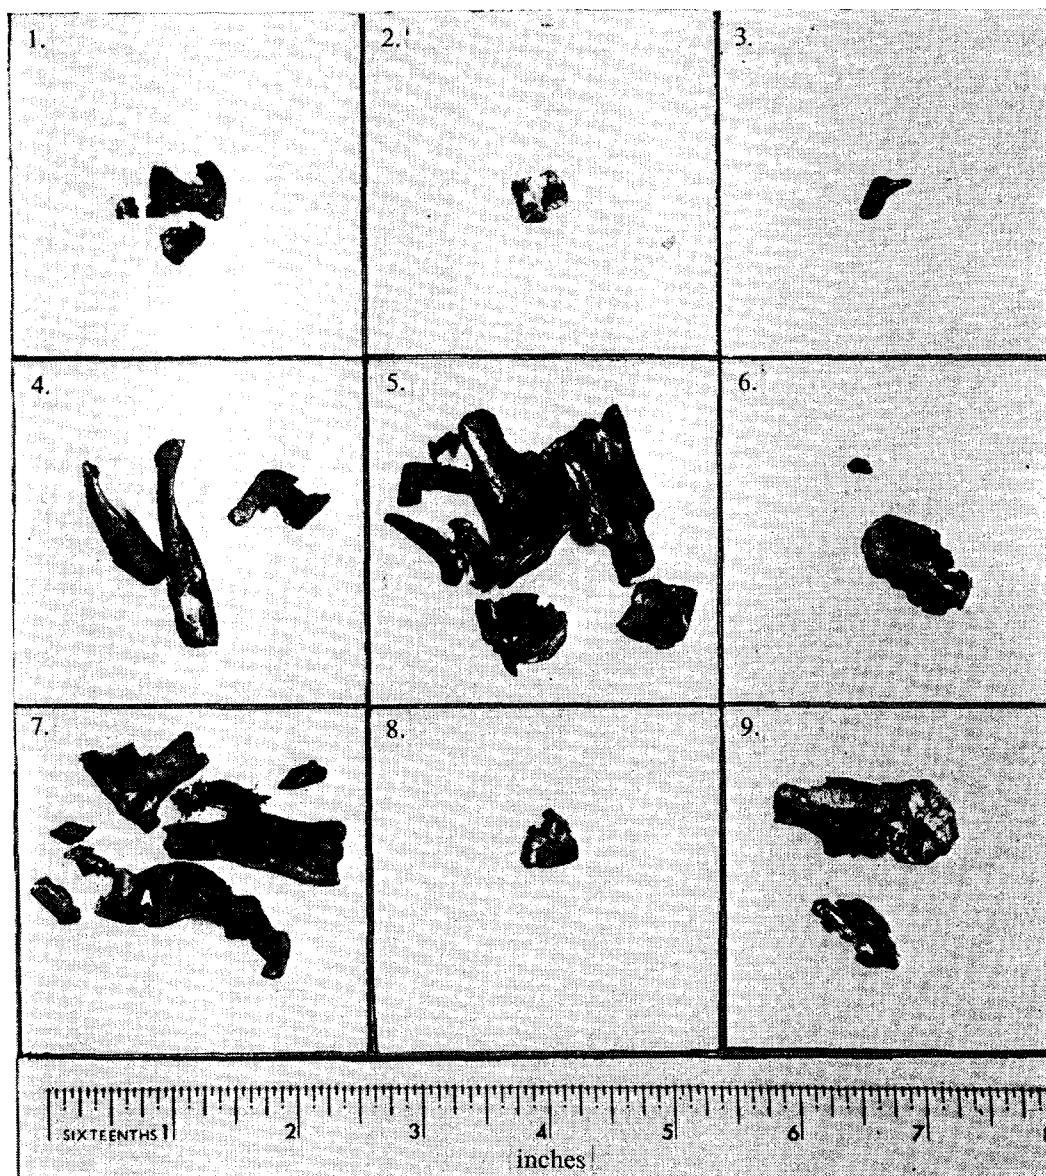
<i>Item examined</i>	<i>Date removed</i>	<i>Date replaced</i>	<i>Result</i>	<i>Piece No.</i>
Pipe from star'd blower to exhaust valve	18.12.73	7.1.74	Pieces of blade and shrouding in pipe 1 ft. from blower (11.6 g)	(4)
Star'd blower exhaust valve	18.12.73	20.12.73	Pieces of blade and shrouding (27.4 g)	(5)
Pipe from outb'd fuel pump to exhaust valve	18.12.73	20.12.73	Clear	—
Inb'd fuel pump Glissard valve	3.1.74	3.1.74	Clear	—
Exhaust to atmosphere valve	18.12.73	20.12.73	Small piece of blading or shrouding	(2)
Pipe to port main engine Arca valve	9.1.74	11.1.74	Clear	—
Exhaust valve in E.R. to evaporators	20.12.73	10.1.74	Piece of blading (2.1 g)	(8)
TWL feed pump exhaust valve	12.12.73	20.12.73	Small pieces of shrouding (2.6 g)	(1)
B.R. T/G extraction pp suction pipe and condenser sump	7.1.74	11.1.74	Small piece of metal (0.55 g)	(3)
E.R./B.R. exhaust isolating valve in E.R.	19.12.73	10.1.74	1½ blades including roots. Shrouding from 4 blades complete (24.7 g)	(7)

Inside D.A. on trays	20.12.73	21.12.73	1 blade and part blade (12.3 g)	(9)
For'd evap. element	27.12.73	3.1.74	Part of blade (5.25 g)	(6)

piece found was recorded on a tabular chart. The TABLE (which includes all the pieces found) shows about 15 per cent. of this chart. The numbers in brackets in column 5 of the TABLE refer to FIGS. 2 and 3.

FIG. 2—RETRIEVED MATERIAL (NUMBERS REFER TO THE TABLE)

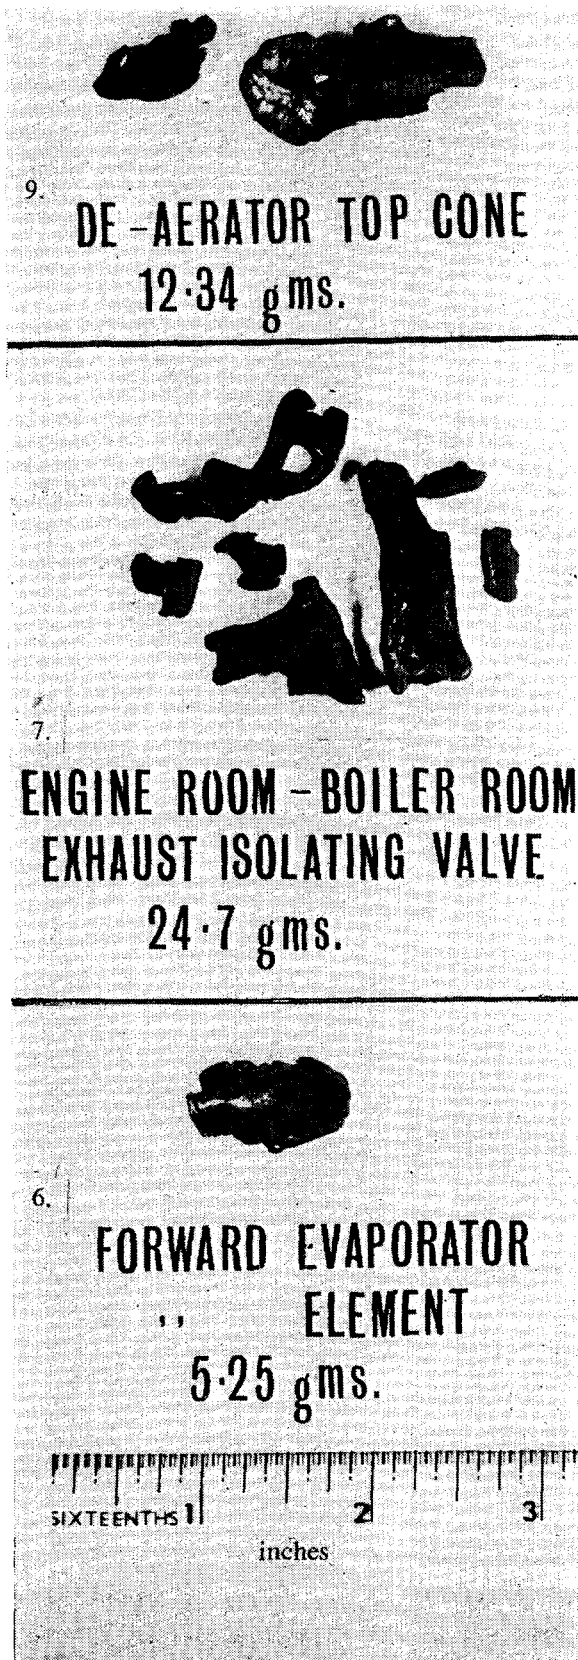
FIG. A—THREE OF THE PIECES SHOWING LOCATION AND WEIGHT

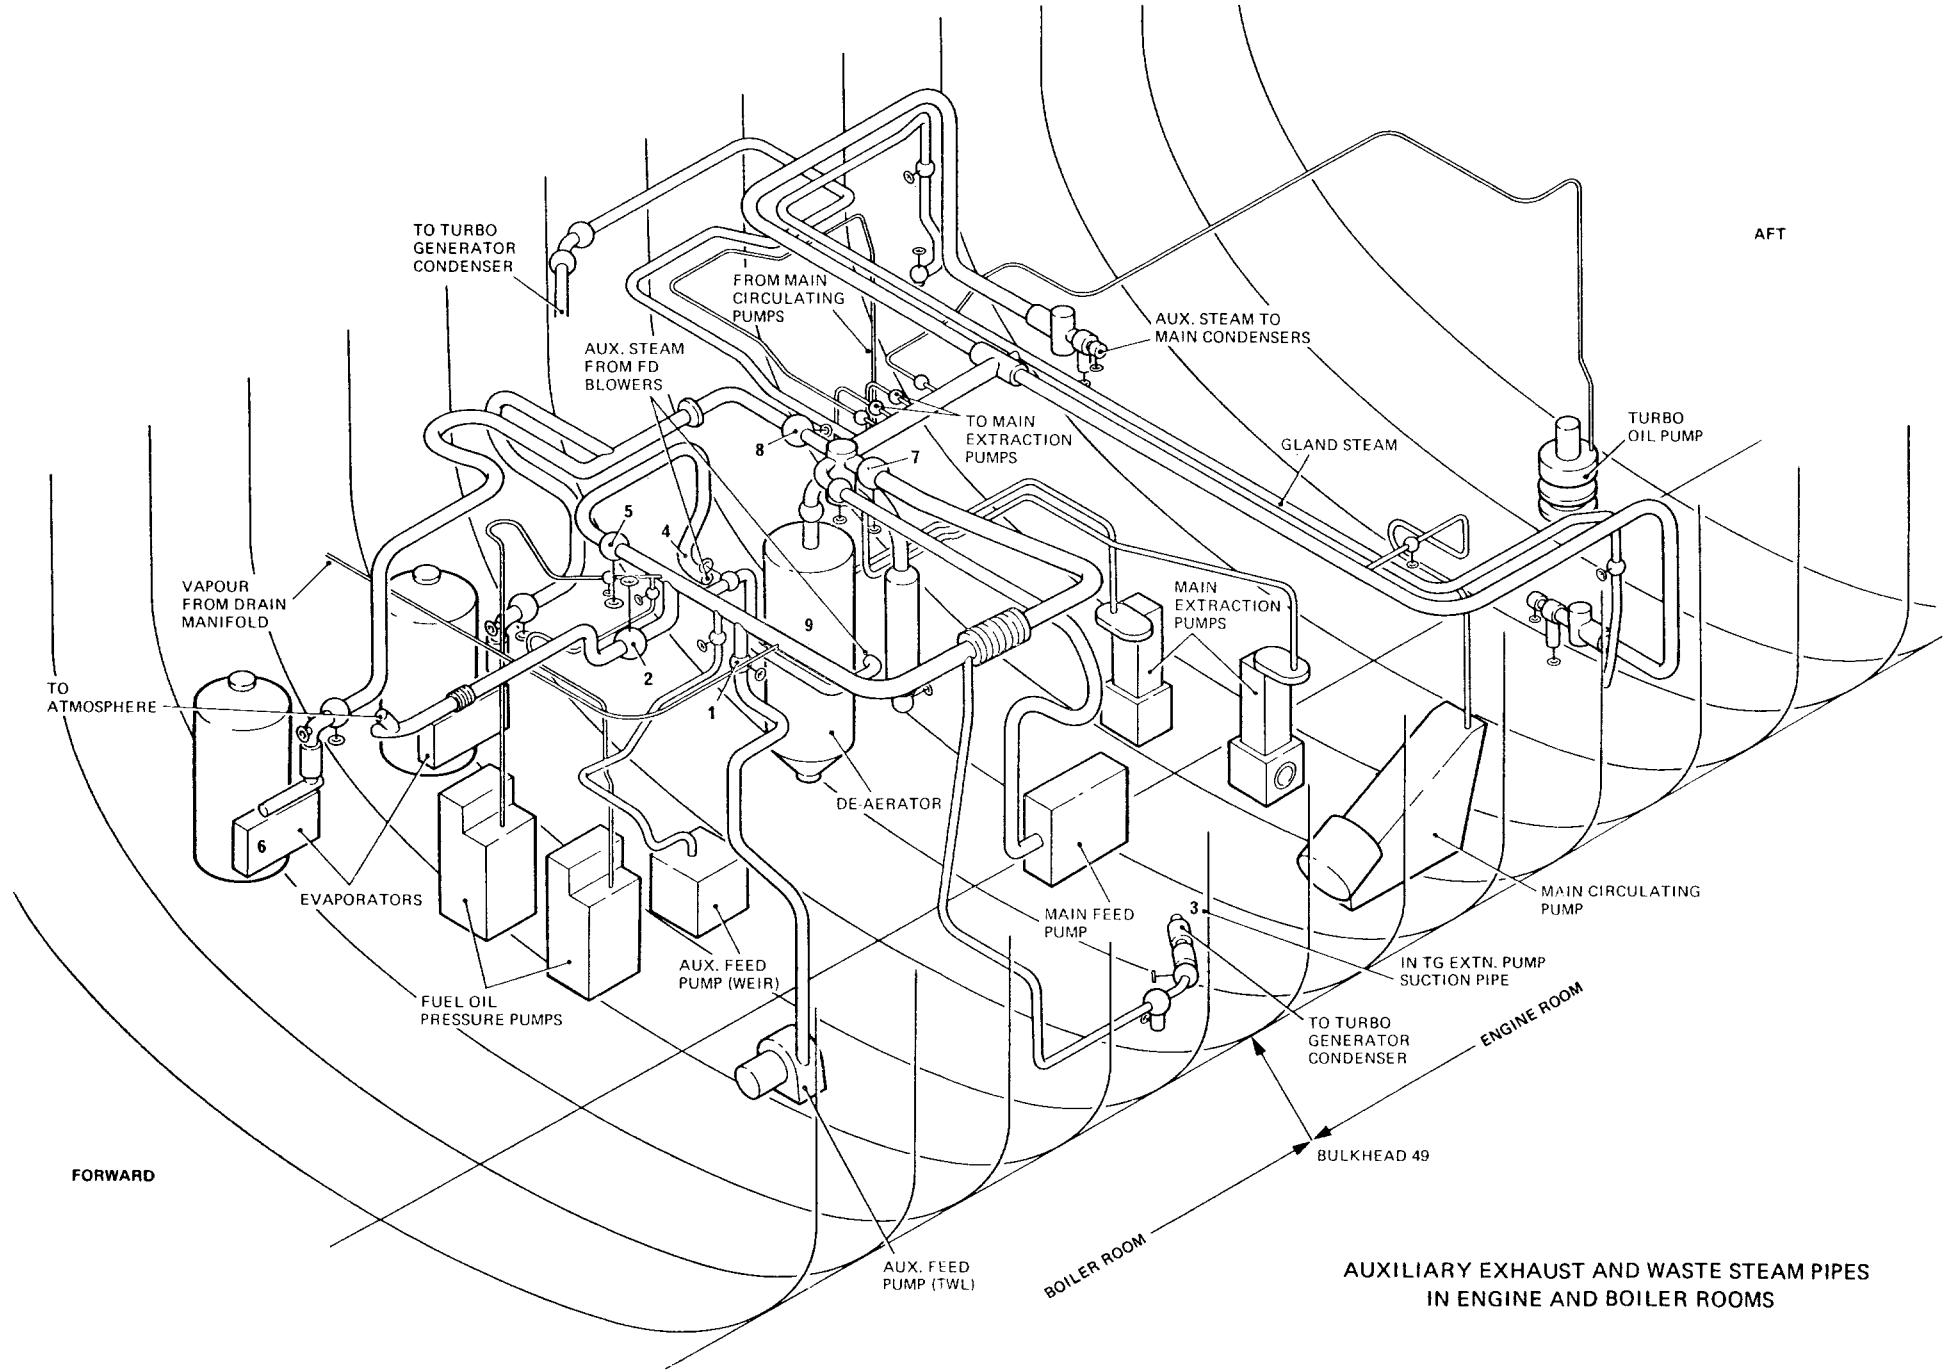
**AUXILIARY EXHAUST AND WASTE STEAM PIPES
IN ENGINE AND BOILER ROOMS**

The answer to the initial questions 'Where does one begin to look?' and 'Where can one expect to find?' appears to be 'anywhere and everywhere'. Valve boxes and any nooks and crannies out of the main exhaust steam flow were, of course, prime targets. The surprising fact was that the missing pieces had travelled so far from the TWL feed pump, e.g. to the evaporator element and to the turbo-generator extraction pump suction. Some pieces

had been blown upwards through long vertical lengths of pipe and, even more surprisingly, had even travelled against the exhaust flow, e.g. into the exhaust from the starboard forced-draught blower (The blower had been running until arrival alongside when all machinery was shut down).

A real touch of irony was added when, having searched for 105 grammes of potential trouble, at least 2 lb. of 'ironmongery' in the form of what is presumed to be half a dozen de-aerator-baffle spacers were found lodged inside the exhaust pipe adjacent to the exhaust steam inlet valve to the de-aerator. The latter may well have been resting 'safely' there since the ship was built.

FIG. 4—EXHAUST STEAM SYSTEM SHOWING LOCATIONS OF MATERIALS RETRIEVED
