# SEA-WATER VALVES IN THE ROYAL AUSTRALIAN NAVY

B. W. TURNBULL

*(Dockyard Laboratory, H.M.A. Naval Dockyard, Garden Island, Sydney)*

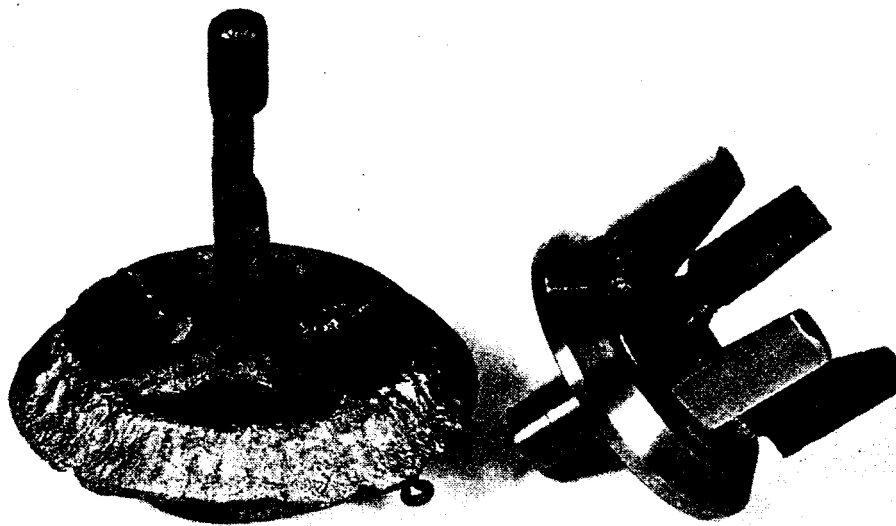
FIG. 1—CORRODED ADMIRALTY TYPE 3 IN. DIAMETER VALVE DISC IN GUNMETAL TOGETHER WITH AN R.A.N. TYPE 2 IN. VALVE DISC IN MONEL

The principal cause of failure in globe (screw-down) type was corrosion of the seats and discs together with mechanical damage to guides or legs of the discs. Drip-tight operation was possible if the valves were kept closed, but after some throttling use, continuous leakage occurred. Many valve bodies including the standard Admiralty design, could not be refaced very often before replacement became necessary. The design also prevented the valves from being bored to take a screwed insert and large numbers were therefore scrapped at each refit. (see FIGS. 1 and 2).

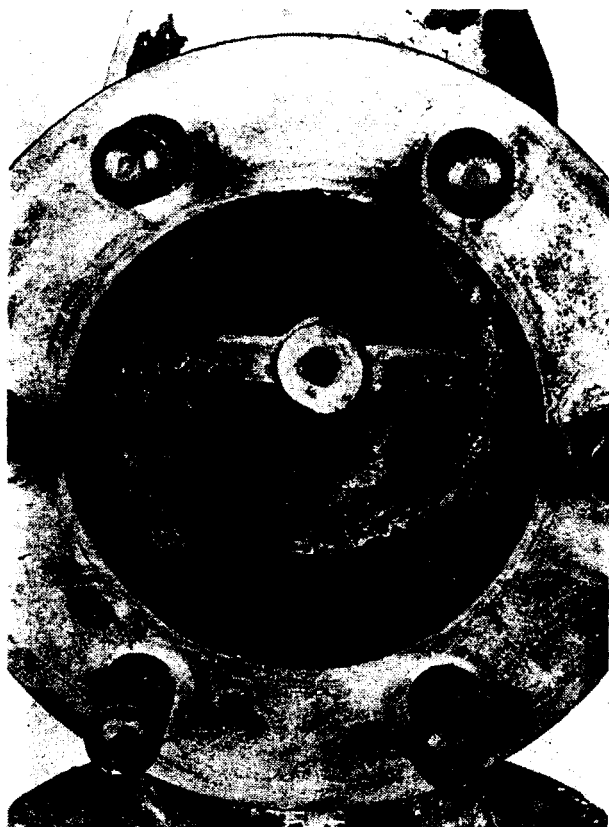
FIG. 2—THE CORRODED SEAT OF A 3 IN. ADMIRALTY TYPE VALVE

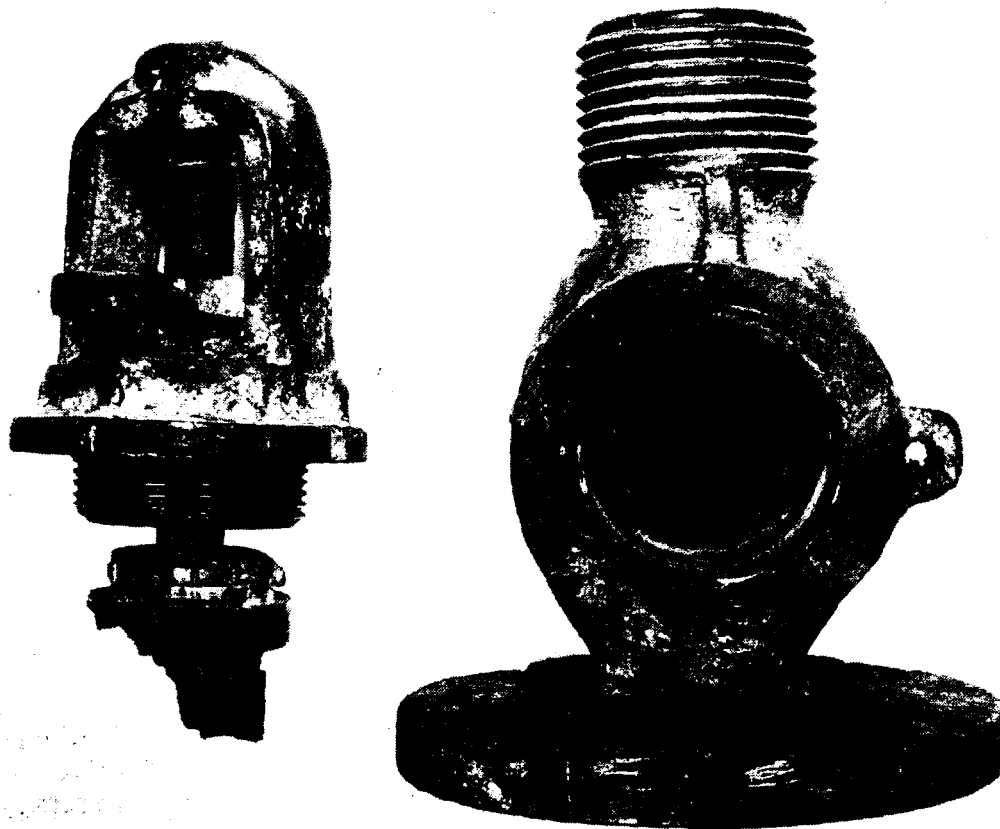
Seizing and fracture of spindles, due to painting of exposed screw threads and other moving parts, marine fouling and corrosion of internal threads or overtightening of glands to prevent leakage was common. In commercial valves, dezincification of brass spindles, erosion of bodies and breakage of handwheels contributed to the list of defects (see FIG. 3).

FIG. 3—TYPICAL 1 IN. VALVE WITH CORRODED SEAT AND DISC AND BROKEN SPINDLE
