PLAIN BEARING FAILURES

GEORGE R. FURMAN

The following article is reproduced by courtesy of Texaco Incorporated of New York. It was first published in July, 1964, in the Company's magazine Lubrication, a technical publication devoted to the selection and use of lubricants.

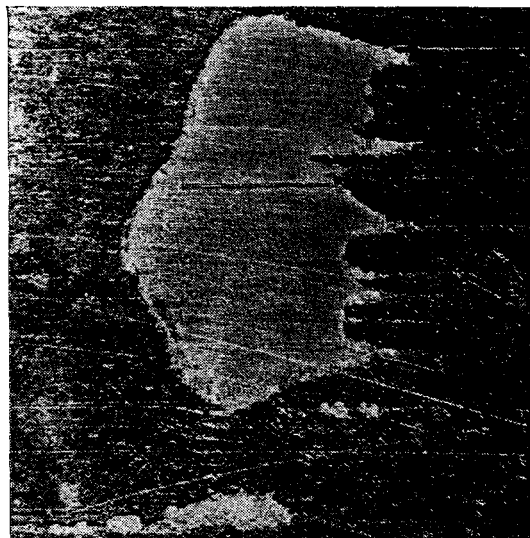
FIG. 5—PATCHY REMOVAL OF LEAD FLASHING ON A SILVER BEARING BY OIL-BORNE ABRASIVE. ALSO NOTE SCRATCHING OF BOTH LEAD AND SILVER BY HARD PARTICLES ($\times 4$)

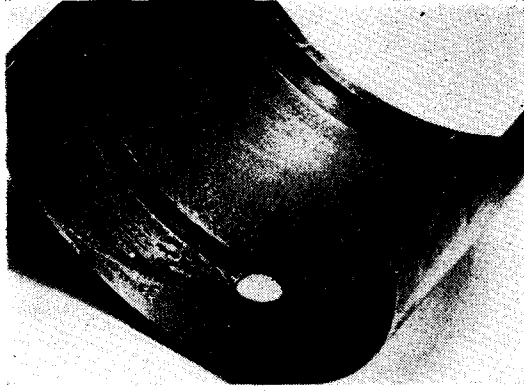
FIG. 6—SURFACE EROSION BY OIL-BORNE PARTICULATE MATTER FLOWING FROM BEARING'S OIL SUPPLY HOLE

A high velocity oil flow with very fine hard particulate matter can locally wash out a gully in the bearing surface as illustrated in FIG. 6; this is sometimes called 'erosion'.

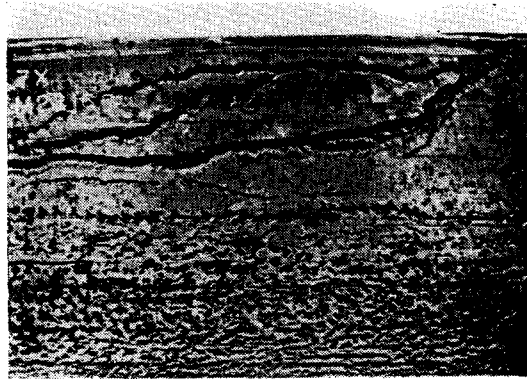
FIG. 7—GROOVING OR TRACKS MADE BY RELATIVELY LARGE HARD PARTICLES MIGRATING SLOWLY THROUGH THE BEARING CLEARANCE

For example, large particles may migrate through the clearance space as conditions of load and speed permit; such action can be recognized on the bearing surface by a path of indentations of similar shape wandering more or less in the direction of journal motion. Several such tracks are shown on the bearing surface in FIG. 7.

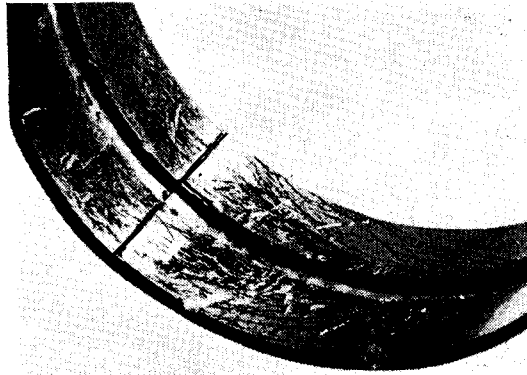
FIG. 8—PLOUGHING OR SURFACE SCORING OF BABBITT BEARING CAUSED BY OIL-BORNE HARD PARTICLES FLOWING OUTWARD DIAGONALLY FROM CENTRAL OIL SUPPLY GROOVE

Large hard particles can be dragged along by shaft motion and oil flow, plowing grooves in the softer bearing alloy. FIG. 8 shows a babbitt bearing in which the lubricant delivered hard particles to a central oil groove; as the oil spread outward across the bearing surface, the particles moved with it, cutting diagonal, branched paths in both halves of the babbitt.

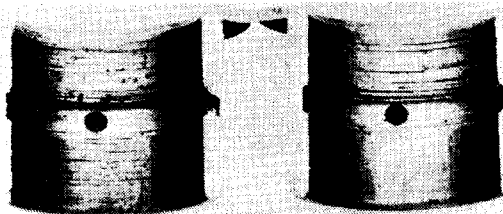
FIG. 9—SHALLOW EMBEDMENT AND GROOVING OF HARD METALLIC PARTICLES IN LEAD FLASHING OF SILVER BEARING

FIGS. 9 and 10 show a lead-flashed silver bearing in which hard metallic particles plowed grooves for short distances and then became embedded in the thin lead overlay: the causative particles can be found at the ends of the score paths. The harder silver base, having poor 'embedability', prevented these particles from being depressed any further. Embedments such as these are especially

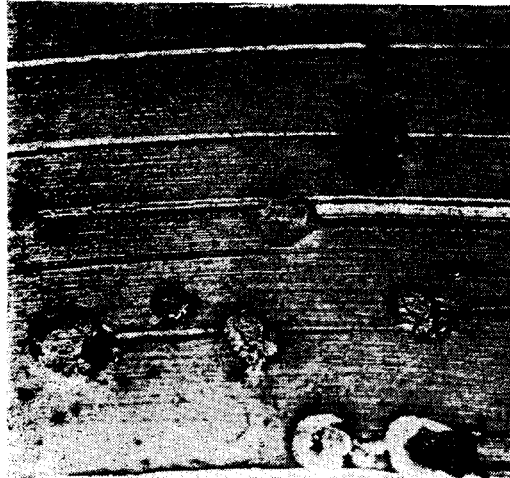
FIG. 10—ENLARGEMENT OF A PORTION OF FIG. 9 SHOWING THE CAUSATIVE PARTICLES AT THE RIGHT END OF THEIR GROOVES AND PROJECTING ABOVE THE BEARING SURFACE

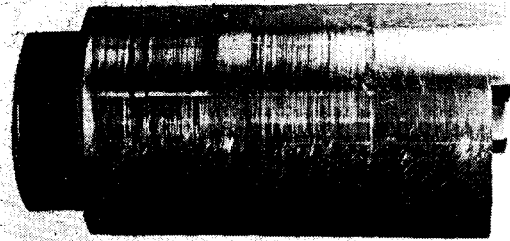
FIG. 11—A HARDENED STEEL JOURNAL SCRATCHED BY ABRASIVE PARTICLES

bad as they project slightly above the surface and are in perfect position to heavily score the shaft. FIG. 11 shows a hardened steel journal scratched by abrasive particles.

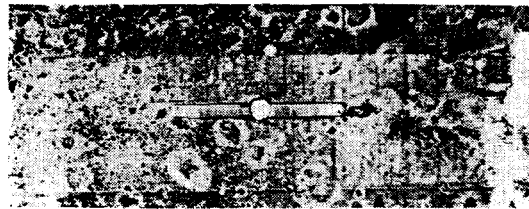
FIG. 12—A SEMI-CIRCULAR BEARING SHELL WHICH HAS BEEN 'OPTICALLY UNWRAPPED' TO SHOW INDENTATIONS MADE IN ITS BABBIT BY CARBONACEOUS AGGLOMERATES IN ENGINE SLUDGE

On the other hand, soft-bearing metals can be damaged by relatively *soft* particulate matter; for example, carbonaceous agglomerates can indent a bearing surface as illustrated in FIG. 12. These markings show how compressed lumps of common sludge produced shallow cavities with raised edges. Cavities appear as circular dark spots and the raised edges are bright and shiny from direct contact with the journal. Sometimes the surface is only indented as in FIG. 13.

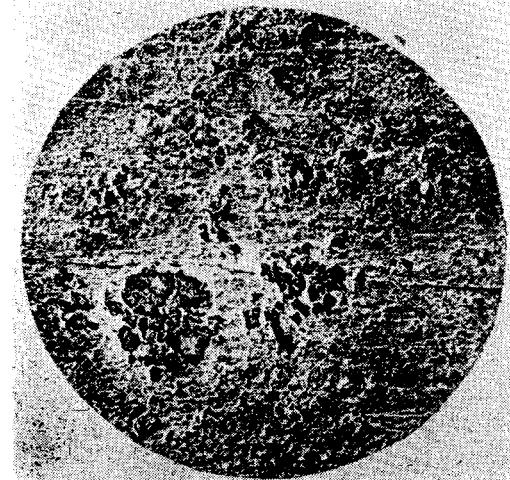
FIG. 13—THE SURFACE OF ANOTHER BEARING WHICH HAS BEEN INDENTED BY CLUMPS OF SLUDGE PARTICLES (X 40)

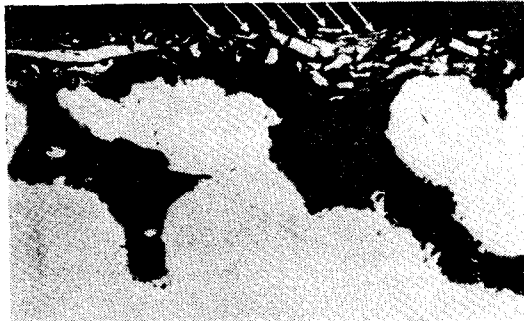
Hard particulate matter can become completely embedded in the bearing alloy and, in effect, be taken out of circulation. This requires a comparatively soft-bearing metal such as lead or babbitt. FIG. 14 shows a cross-section through a babbitt-impregnated, sintered bearing with many hard metallic chips embedded in the babbitt. When thus buried in the alloy their tendency to damage the shaft is less than if they protrude as in FIG. 10.

FIG. 14—PHOTOMICROGRAPH OF CROSS-SECTION OF A BABBIT-IMPREGNATED SINTERED BEARING WHICH HAS EMBEDDED AND LARGELY NEUTRALIZED THE HARD STEEL CHIPS INDICATED BY THE ARROWS (X 100)

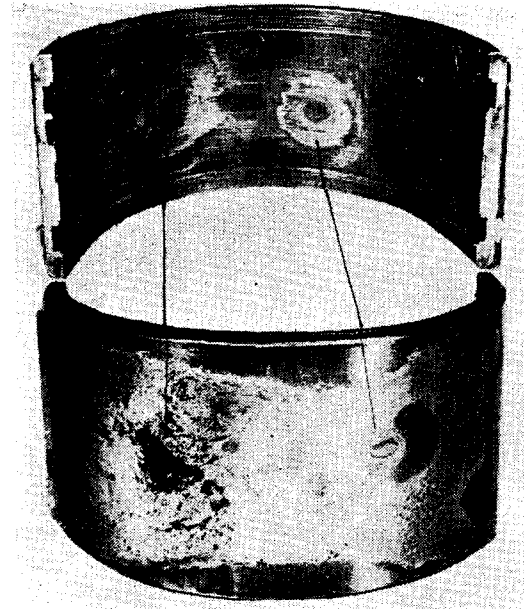
FIG. 15—THE BEARING SURFACE (TOP) AND CORRESPONDING BACKING SURFACE (BOTTOM) OF A RAILWAY DIESEL CONNECTING ROD BEARING SHOWING DISTORTION, EXCESSIVE WEAR AND INCIPENT FAILURES ON THE BEARING SURFACE CAUSED BY TWO HARD FOREIGN PARTICLES BETWEEN THE BEARING BACKING AND ITS CONNECTING ROD

overhaul of automotive engines is carried out in dirty surroundings. A metallic chip or grain on the back of the bearing shell or on its housing can easily escape notice during installation; however, even normal bearing loads are sufficiently great to deform the steel shell around that particle, dent the back, and create a high spot on the bearing face. The high spot will run excessively hot in wearing down and may lead to seizure or fatigue breakouts. Dents or nicks on either the back of the bearing insert or its housing will cause similar failures. The lower part of FIG. 15 shows the back of a Diesel connecting rod bearing shell which was installed on two hard particles; even though the steel back was a quarter of an inch thick, it was deformed and created matching wear spots on the bearing face as shown in the upper part of the figure. Relatively thin steel backings common to automotive service are even more sensitive to this type of damage. Therefore, when inspecting any damaged bearing shell, one should always look for marks on the steel back to determine if dirty seating is associated with disfigurements on the bearing surface.

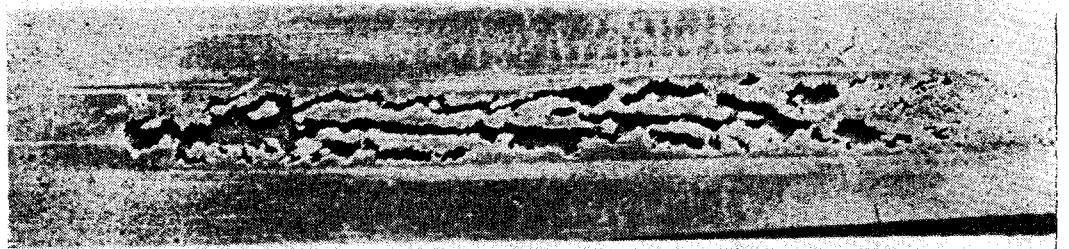
FIG. 17—FATIGUE BREAKOUT IN LOWER LOADED HALF OF A REPLACEMENT BEARING LIKE FIG. 16 CAUSED BY FAILURE TO REMOVE RAISED RIDGE WORN ON JOURNAL BY THE OIL GROOVE IN THE UPPER HALF

However, if the worn bearing shells should now be replaced *without refinishing the journal*, a high stress area will be set up where the non-grooved bearing makes contact with the journal ridge, and rapid failure can be expected. FIG. 17 shows such a bearing shell where a band of fatigue breakouts defines the overload zone. In FIG. 18 this kind of fatigue breakout is even more pronounced.

A journal surface worn to any other non-cylindrical shape would also produce abnormal local stresses corresponding to the areas of highest load. In such instances it is essential to regrind the shaft before installing a new bearing set.

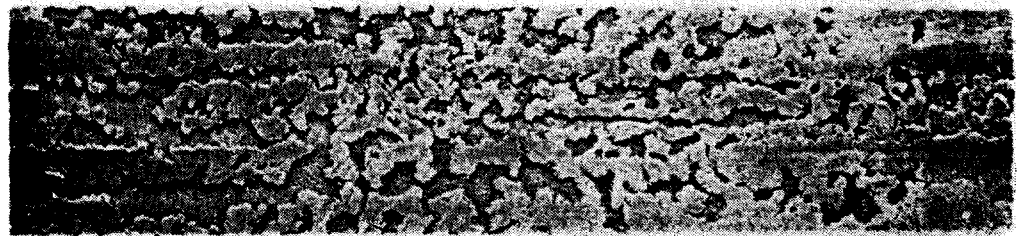
FIG. 18—IN CONTINUATION OF FIG. 17, THE REDUCTION IN AREA OF THE LOWER BEARING BY FATIGUE BREAKOUT RAISES UNIT LOADING ON THE REMAINING AREA AND ACCELERATES FATIGUE FAILURE OVER THE ENTIRE BEARING SURFACE

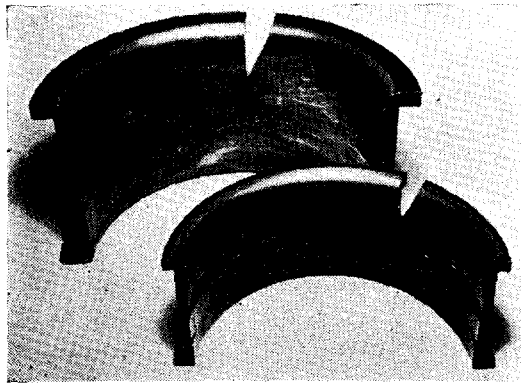
FIG. 19—CRESCENT-SHAPED WEAR SPOTS CAUSED BY MISALIGNMENT

Misalignment between a journal and its bearing is readily apparent from a distorted wear pattern on the bearing surfaces. In sleeve bearing lubrication, misalignment generally can be regarded as any instance where the axes of the journal and bearing are not parallel. Normal wear produces a more-or-less rectangular visible band of contact across the bearing face; whereas misalignment forms a wear zone—depending on clearance ratio, degree of skew between the bearing and journal, etc.—which may be roughly trapezoidal, triangular or half-moon in shape as in FIGS. 19 and 20.
