PLAIN BEARING FAILURES

GEORGE R. FURMAN

The following article is reproduced by courtesy of Texaco Incorporated of New York. It was first published in July, 1964, in the Company's magazine Lubrication, a technical publication devoted to the selection and use of lubricants.

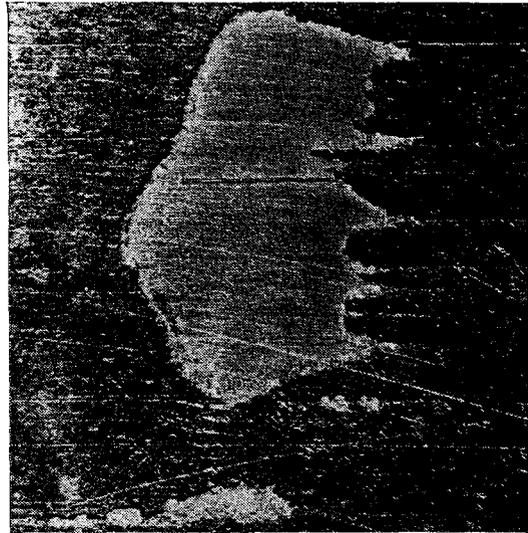
FIG. 5—PATCHY REMOVAL OF LEAD FLASHING ON A SILVER BEARING BY OIL-BORNE ABRASIVE. ALSO NOTE SCRATCHING OF BOTH LEAD AND SILVER BY HARD PARTICLES ($\times 4$)

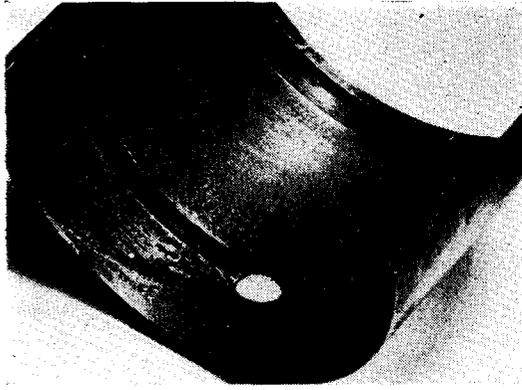
FIG. 6—SURFACE EROSION BY OIL-BORNE PARTICULATE MATTER FLOWING FROM BEARING'S OIL SUPPLY HOLE

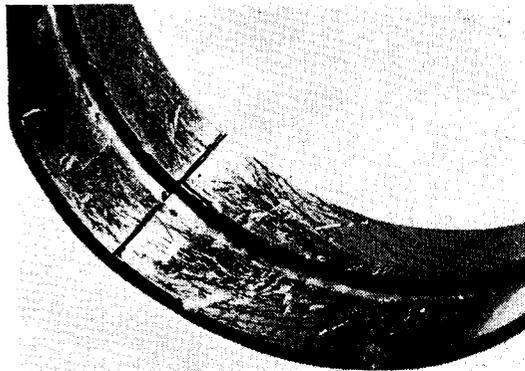
FIG. 8—PLOUGHING OR SURFACE SCORING OF BABBITT BEARING CAUSED BY OIL-BORNE HARD PARTICLES FLOWING OUTWARD DIAGONALLY FROM CENTRAL OIL SUPPLY GROOVE

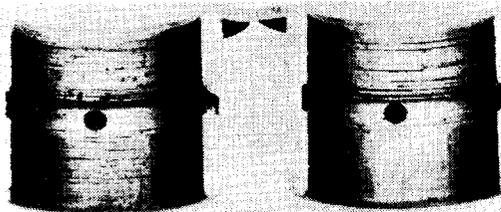
FIG. 9—SHALLOW EMBEDMENT AND GROOVING OF HARD METALLIC PARTICLES IN LEAD FLASHING OF SILVER BEARING

FIGS. 9 and 10 show a lead-flashed silver bearing in which hard metallic particles plowed grooves for short distances and then became embedded in the thin lead overlay: the causative particles can be found at the ends of the score paths. The harder silver base, having poor 'embedability', prevented these particles from being depressed any further. Embedments such as these are especially

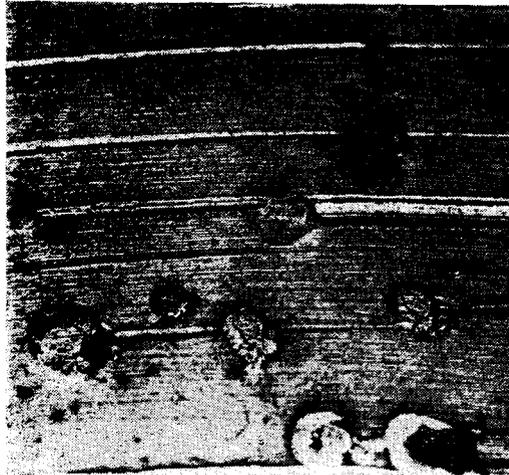
FIG. 10—ENLARGEMENT OF A PORTION OF FIG. 9 SHOWING THE CAUSATIVE PARTICLES AT THE RIGHT END OF THEIR GROOVES AND PROJECTING ABOVE THE BEARING SURFACE

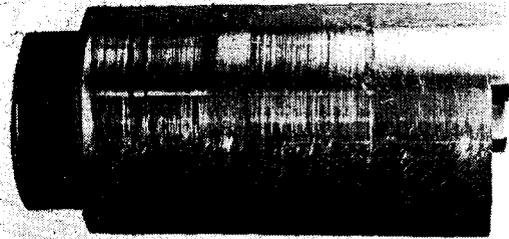
FIG. 11—A HARDENED STEEL JOURNAL SCRATCHED BY ABRASIVE PARTICLES

bad as they project slightly above the surface and are in perfect position to heavily score the shaft. FIG. 11 shows a hardened steel journal scratched by abrasive particles.

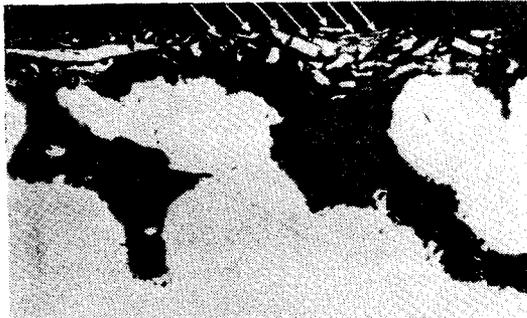
Hard particulate matter can become completely embedded in the bearing alloy and, in effect, be taken out of circulation. This requires a comparatively soft-bearing metal such as lead or babbitt. FIG. 14 shows a cross-section through a babbitt-impregnated, sintered bearing with many hard metallic chips embedded in the babbitt. When thus buried in the alloy their tendency to damage the shaft is less than if they protrude as in FIG. 10.

FIG. 14—PHOTOMICROGRAPH OF CROSS-SECTION OF A BABBIT-IMPREGNATED SINTERED BEARING WHICH HAS EMBEDDED AND LARGELY NEUTRALIZED THE HARD STEEL CHIPS INDICATED BY THE ARROWS (X 100)

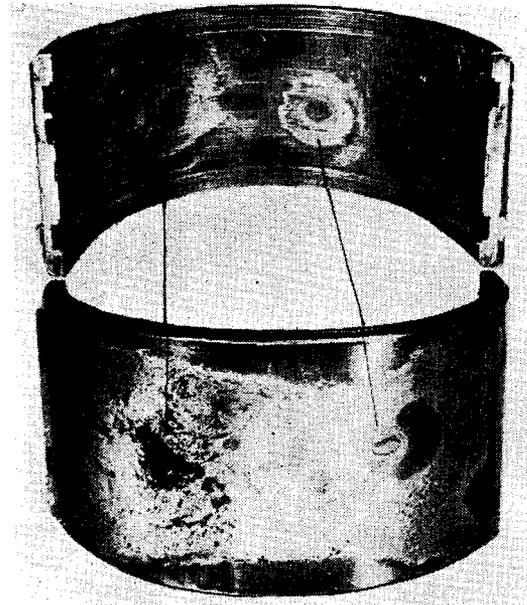
FIG. 15—THE BEARING SURFACE (TOP) AND CORRESPONDING BACKING SURFACE (BOTTOM) OF A RAILWAY DIESEL CONNECTING ROD BEARING SHOWING DISTORTION, EXCESSIVE WEAR AND INCIPENT FAILURES ON THE BEARING SURFACE CAUSED BY TWO HARD FOREIGN PARTICLES BETWEEN THE BEARING BACKING AND ITS CONNECTING ROD

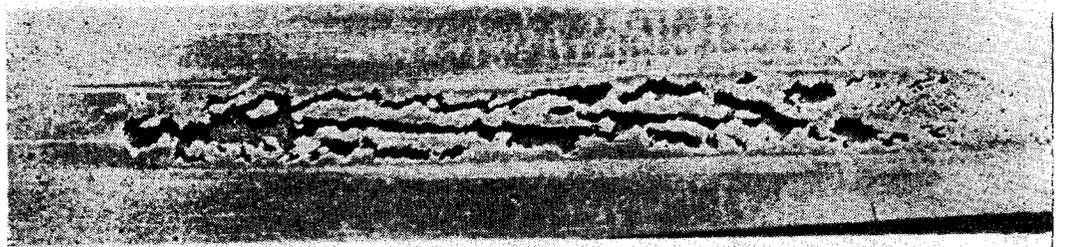
FIG. 17—FATIGUE BREAKOUT IN LOWER LOADED HALF OF A REPLACEMENT BEARING LIKE FIG. 16 CAUSED BY FAILURE TO REMOVE RAISED RIDGE WORN ON JOURNAL BY THE OIL GROOVE IN THE UPPER HALF

However, if the worn bearing shells should now be replaced *without refinishing the journal*, a high stress area will be set up where the non-grooved bearing makes contact with the journal ridge, and rapid failure can be expected. FIG. 17 shows such a bearing shell where a band of fatigue breakouts defines the overload zone. In FIG. 18 this kind of fatigue breakout is even more pronounced.

A journal surface worn to any other non-cylindrical shape would also produce abnormal local stresses corresponding to the areas of highest load. In such instances it is essential to regrind the shaft before installing a new bearing set.

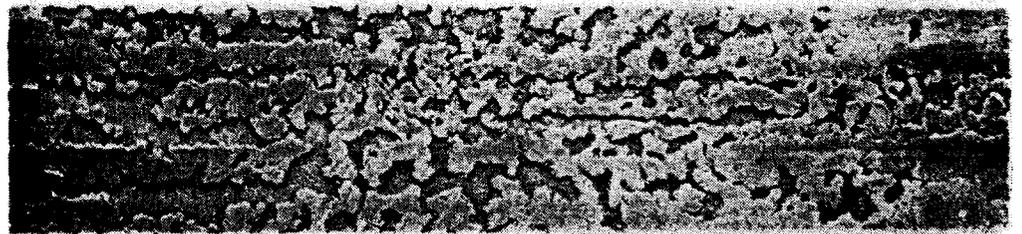
FIG. 18—IN CONTINUATION OF FIG. 17, THE REDUCTION IN AREA OF THE LOWER BEARING BY FATIGUE BREAKOUT RAISES UNIT LOADING ON THE REMAINING AREA AND ACCELERATES FATIGUE FAILURE OVER THE ENTIRE BEARING SURFACE

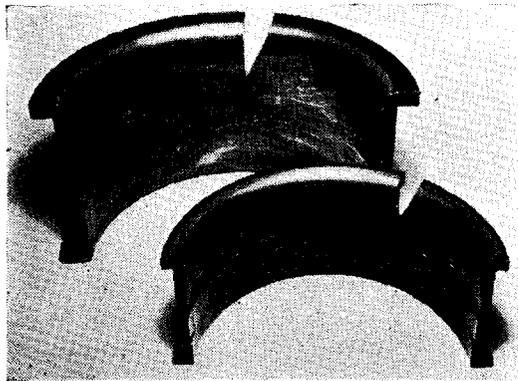
FIG. 19—CRESCENT-SHAPED WEAR SPOTS CAUSED BY MISALIGNMENT

Misalignment between a journal and its bearing is readily apparent from a distorted wear pattern on the bearing surfaces. In sleeve bearing lubrication, misalignment generally can be regarded as any instance where the axes of the journal and bearing are not parallel. Normal wear produces a more-or-less rectangular visible band of contact across the bearing face; whereas misalignment forms a wear zone—depending on clearance ratio, degree of skew between the bearing and journal, etc.—which may be roughly trapezoidal, triangular or half-moon in shape as in FIGS. 19 and 20.

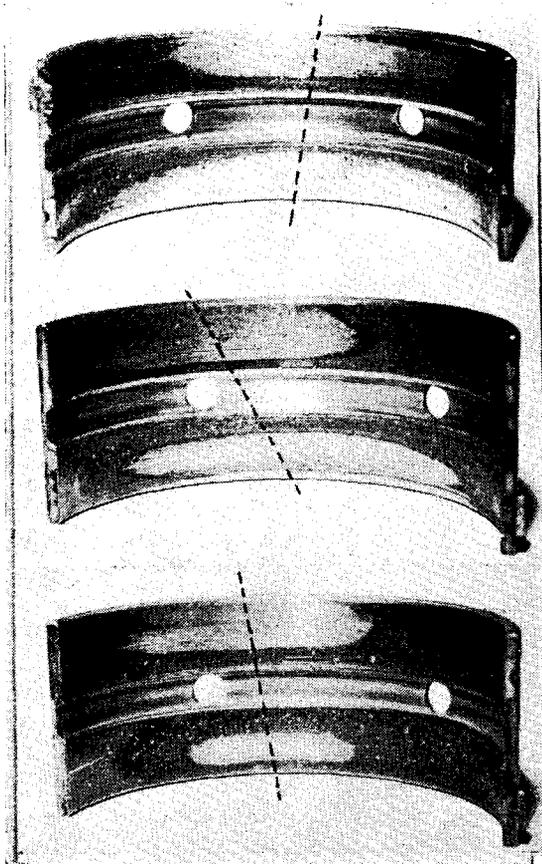
FIG. 20—DIAGONAL AXES OF WEAR PATTERNS INDICATE MISALIGNMENTS

In internal combustion engines, warped connecting rods and faulty bearing installation are common causes of misalignment. A bent rod often will create two wear spots at diagonally opposite regions on the bearing shell. In multi-bearing installations as, for example, in an automotive engine, warpage of the crankcase can cause severe wear on a centre main bearing, yet maintain an even wear pattern. Instead of the wear being centred in the lower half, however, crankcase warpage may cause maximum pressure zones (and, accordingly, the greatest rubbing) at one side or even on top. This clue to misalignment can then be followed by checking the wear zones of the end bearings; here wear probably will be found in different quadrants.

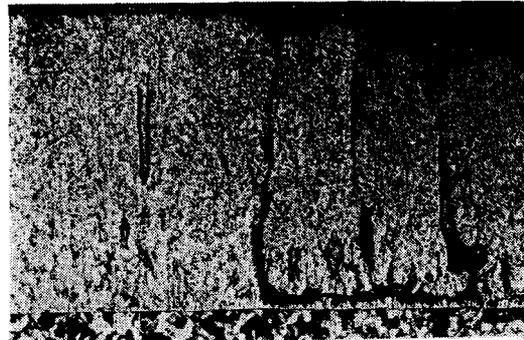
FIG. 23—PHOTOMICROGRAPH OF A CROSS-SECTION OF A FATIGUED COPPER-LEAD BEARING SHOWING HOW FATIGUE CRACKS FIRST PENETRATE VERTICALLY ALMOST TO THE BOND ON THE STEEL BACKING, THEN HORIZONTALLY TO SEPARATE FRAGMENTS OF COPPER-LEAD (X 80)

the cracks horizontally, undermining appreciable areas of bearing alloy until large segments are loosened, drop out, and radically reduce the area supporting the load. FIG. 23 shows a cross-section of a fatigued copper-lead bearing. Note that the cracks do not penetrate all the way to the steel backing. The loss of metal by fatigue breakout disrupts the lubricating film, causes excessive lubricant loss from pressure-fed bearings, and frequently leads to bearing seizure and shaft damage.

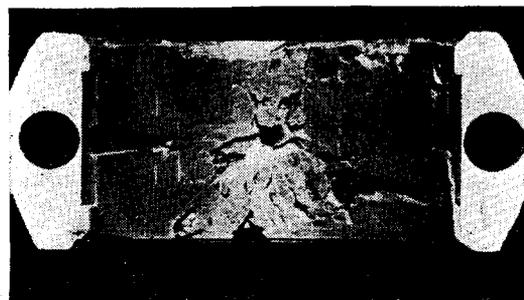
FIG. 24—HEAVILY FATIGUED CONNECTING ROD BEARING IN WHICH A RATHER THICK LAYER OF BABBIT HAS BEEN CAST ON TO THE STEEL BACKING

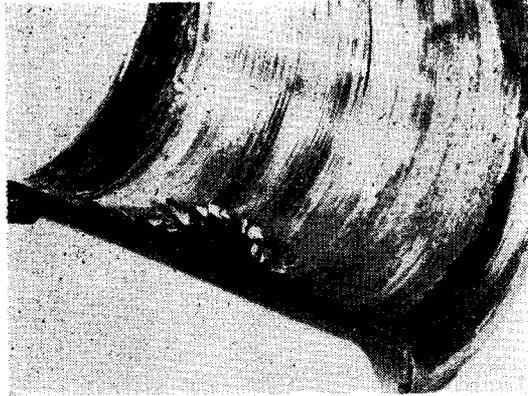
bearing alloy to the backing metal. FIG. 25 shows the silver surface of an aircraft bearing which peeled from the steel base. A defective bond can occur during manufacture of the bearing and might be due to (1) oxide films (inadequate fluxing) on the base metals; (2) contaminants such as dirt, soot or grease on the surface; (3) dross from the surface of molten alloy; (4) gas evolution from the metal; or (5) improper fabrication temperatures. A bond failure is visibly different

FIG. 25—POOR ADHERENCE AND PEELING OF SILVER FROM THE STEEL BACKING OF AN AIR-CRAFT ENGINE BEARING

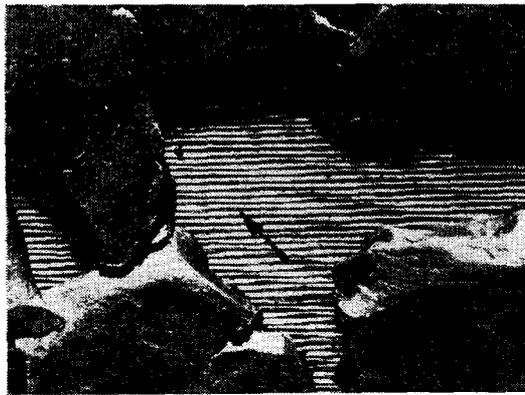
FIG. 26—POOR BONDING IS INDICATED BY CLEAN BREAKOUT OF BABBITT FROM THE 'PHONOGRAPH RECORD' MACHINING PATTERN (SEE ARROW) ON A STEEL BEARING BACKING (X 6)

from ordinary fatigue breakout in that there is a clean separation of bearing metal from the backing. Fatigue cracking usually leaves some bearing metal adhering to the shell. On a backing that has been lathe-bored, breakout from a bond failure will usually expose a raw 'phonograph finish' of clean horizontal grooves devoid of bearing alloy like that in FIG. 26: loosened fragments of babbitt surround the breakout.

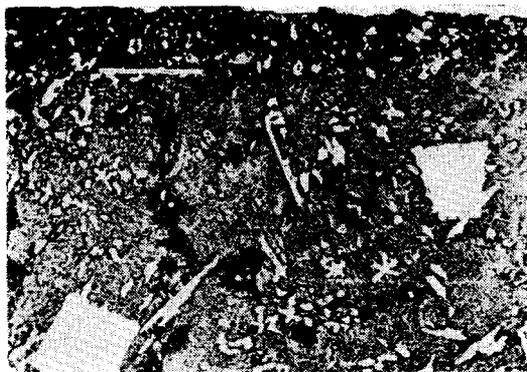
FIG. 28—PHOTOMICROGRAPH OF CROSS-SECTION OF A HIGH-TIN BABBIT BEARING SHOWING A DARK-COLOURED TIN OXIDE LAYER AT THE TOP WHICH FORMED THE BEARING RUBBING SURFACE. THE LARGE WHITE OBJECTS ARE CUBICAL CRYSTALS OF AN ANTIMONY COMPOUND IN THE BABBIT (X 120)

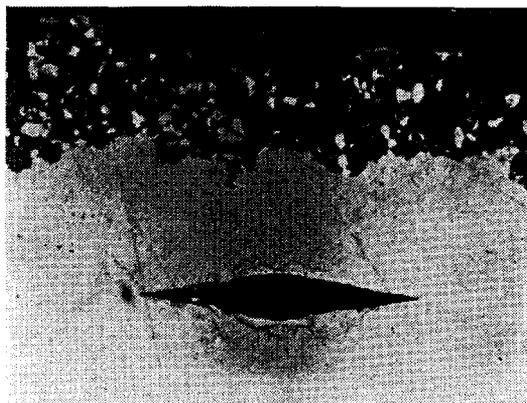
does not appear. The two elongated black diamonds are impressions made by a Tukon Hardness Tester at the same indenter load. The much smaller impression in the oxide layer (dark) shows it to be appreciably harder than the babbitt base (white). The oxide surface is also more brittle than the basic babbitt alloy and has poor frictional properties. Pieces of oxide can crack loose from the babbitt, become wedged in the bearing clearance and cause hot spots ultimately leading to complete failure.

FIG. 29—PHOTOMICROGRAPH OF ANOTHER BABBIT BEARING WITH A TIN OXIDE SURFACE. A COMPARISON OF THE TWO DIAMOND-SHAPED INDENTATIONS (MADE WITH A TUKON HARDNESS TESTER) INDICATES THE MUCH GREATER HARDNESS OF THE UPPER OXIDE LAYER THAN THE BABBIT (X 200)

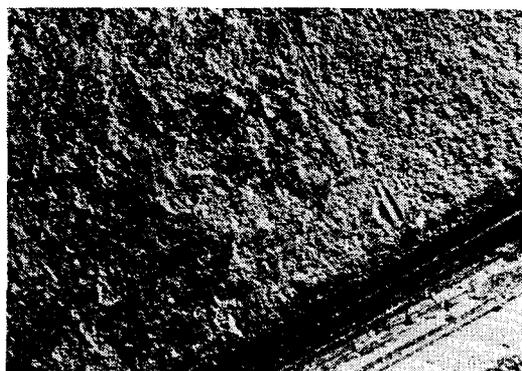
FIG. 30—CORROSION AND CONSEQUENT ROUGHENING OF THE SILVER SURFACE OF A DIESEL ENGINE WRIST PIN BUSHING NEAR ITS OIL GROOVE (LOWER RIGHT) (X 10)

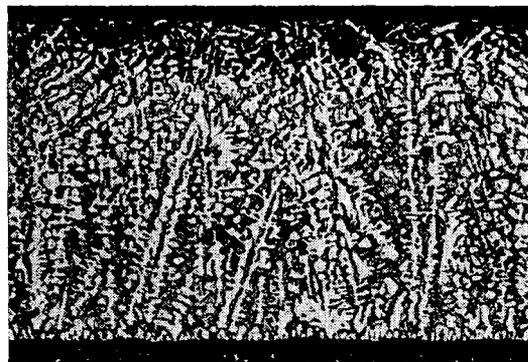
FIG. 32—PHOTOGRAPH OF CROSS-SECTION OF A CAST COPPER-LEAD BEARING SHOWING THE CORROSIVE REMOVAL OF GREY-COLOURED LEAD FROM THE BEARING SURFACE (AT TOP) TO FORM BLACK VOIDS IN THE WHITE COPPER MATRIX. SMALL PORTION OF STEEL BEARING BACKING SHOWS AT THE BOTTOM (x 80)

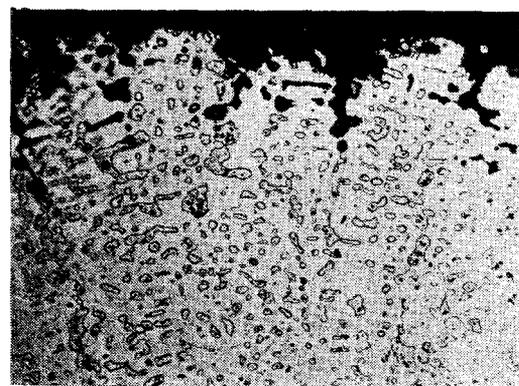
FIG. 33—ANOTHER EXAMPLE OF LEAD CORROSION IN ANOTHER CAST COPPER-LEAD STRUCTURE WHICH LEFT AN IRREGULAR BEARING SURFACE (AT TOP) (x 200)

FIG. 33 shows another copper-lead structure in which globules of lead have been removed from the upper portion, leaving an irregular surface which to the naked eye had a 'peppered' appearance. FIG. 34 shows a very coarse, sintered structure which experienced corrosion of copper (white), allowing the weaker lead (grey) to break away. The original surface is estimated to have been at the top edge of the photo. FIG. 35 illustrates a copper-lead bearing protected by a non-corrodible lead-tin overlay with only partial coverage. Corrosion of the underlying lead occurred only at the left side where the protective overlay had been worn or abraded away.

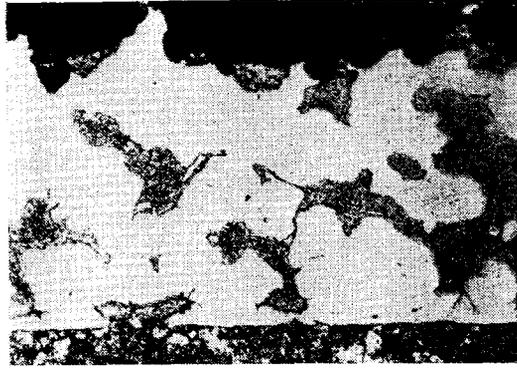
FIG. 34—PHOTOMICROGRAPH OF CROSS-SECTION OF A SINTERED (POWDER-METALLURGY) COPPER-LEAD STRUCTURE SHOWING CORROSIVE PITTING OF THE WHITE COPPER IN THE BEARING SURFACE (AT TOP). NOTE THAT GREY-COLOURED LEAD ON THE BEARING SURFACE HAS ALSO BEEN EXPOSED TO CORROSION, BUT IS STILL INTACT (X 120)

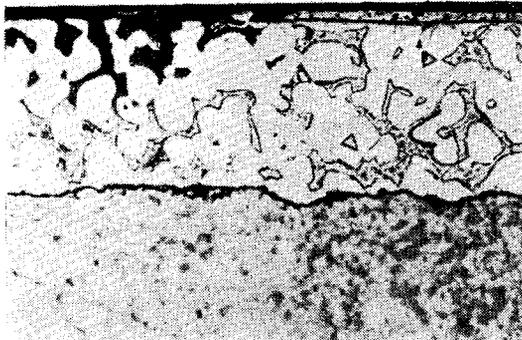
FIG. 35—PHOTOMICROGRAPH OF CROSS-SECTION HAVING A GREY-COLOURED LEAD ALLOY OVERLAY ON THE BEARING SURFACE (AT TOP). NOTE THAT CORROSIVE REMOVAL OF GREY-COLOURED LEAD IN THE BEARING STRUCTURE AND CONSEQUENT BLACK VOIDS HAVE OCCURRED ONLY WHERE THE OVERLAY WAS ABSENT (X 200)

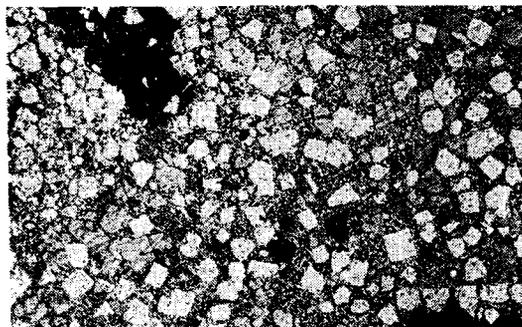
FIG. 36—PHOTOMICROGRAPH OF A CAST BABBIT ALLOY SHOWING INCLUSIONS OF A BLACK-COLOURED CONTAMINANT (X 40)

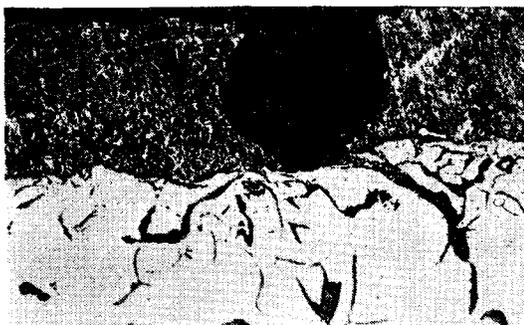
FIG. 38—PHOTOMICROGRAPH OF A CROSS-SECTION OF A PINHOLE FROM FIG. 37 SHOWING THAT THE PINHOLE EXTENDS INWARDS TO THE GRAPHITIC IRON BACKING (X 200)

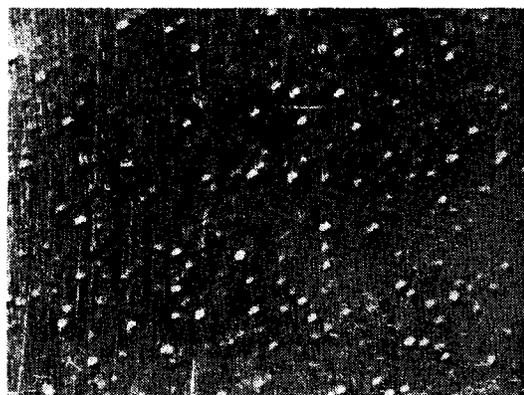
FIG. 39—WHEN HEATED, GAS TRAPPED IN AN ALUMINIUM BEARING SHELL CAN RAISE BLISTERS IN ITS LEAD-TIN OVERLAY SURFACE (X 8)

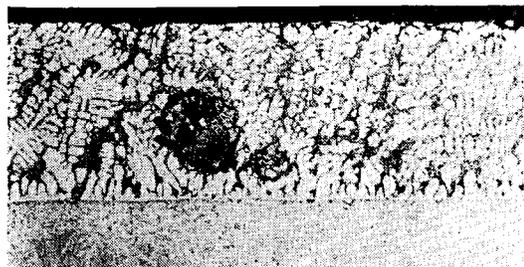
FIG. 40—BLACK AND GREY-COLOURED CONTAMINANTS OR TRASH TRAPPED IN A COPPER-LEAD BEARING STRUCTURE DURING MANUFACTURE (X 60)

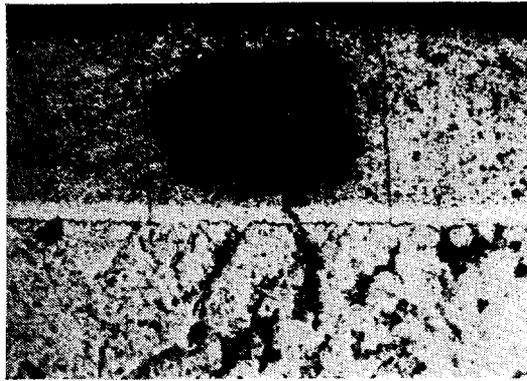
FIG. 41—PHOTOMICROGRAPH OF A CROSS-SECTION OF AN ALUMINIUM BEARING SHOWING A GAS POCKET IN ITS LEAD OVERLAY. NOTE CHANNEL THROUGH WHITE-COLOURED SILVER DAM CONNECTING GAS POCKET WITH A BLACK INTRUSION IN THE ALUMINIUM (X 160)

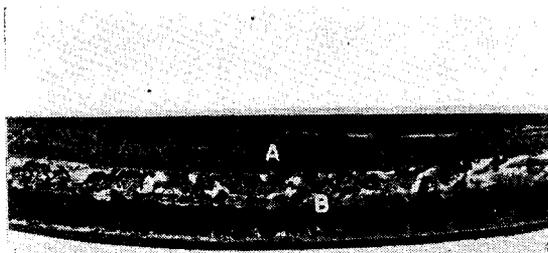
FIG. 42—EDGE OF A COPPER-LEAD BEARING SHELL (A) SHOWING GLOBULES OF METALLIC LEAD; METALLIC LEAD (B) SWEATING OR EXTRUDING FROM IT (X 8)

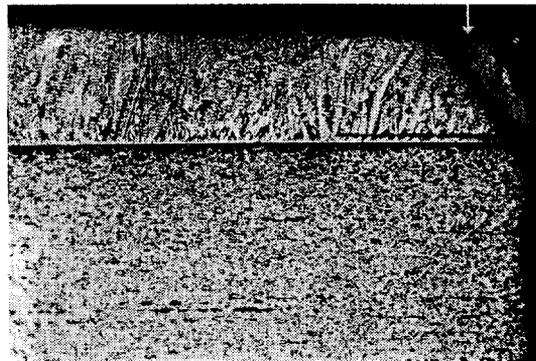
FIG. 43—PHOTOMICROGRAPH OF SAME BEARING SHOWN IN FIG. 42. ARROW POINTS TO BUILD-UP OF LEAD ON THE LEADING EDGE (X 40)

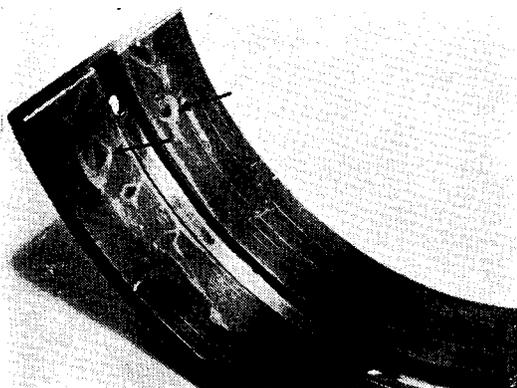
FIG. 45—SPOTTY REMOVAL OF OVERLAY BY CAVITATION

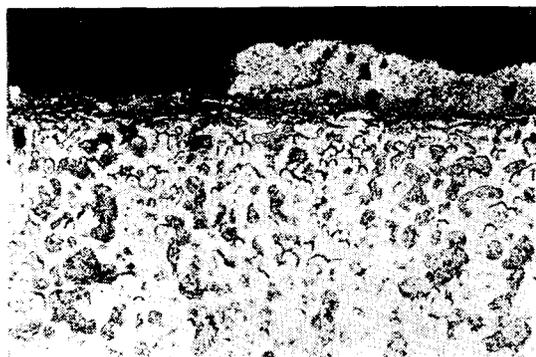
FIG. 46—PHOTOMICROGRAPH OF CROSS-SECTION OF A BEARING IN WHICH THE OVERLAY HAS BEEN REMOVED BY CAVITATION AT UPPER LEFT AND THE REMAINING OVERLAY AT UPPER RIGHT IS DEVELOPING A FATIGUE CRACK BENEATH IT (x 200)

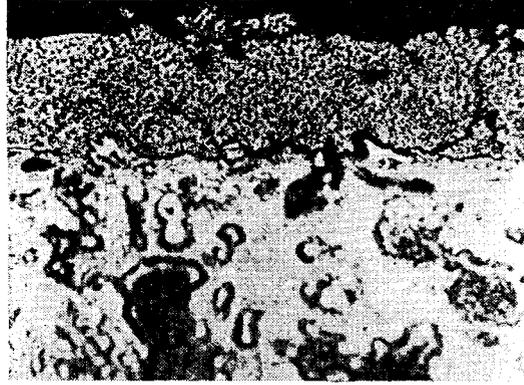
FIG. 47—PHOTOMICROGRAPH AT A HIGHER MAGNIFICATION (X 410) OF A CAVITATION FATIGUE CRACK IN A BEARING OVERLAY WHICH EXTENDS DOWNWARDS AT THE RIGHT ALMOST TO THE OVERLAY BOND, THEN CHANGES DIRECTION TO THE LEFT
