NOTES FROM SEA

MARINE ENGINEERING

Firemain H.M.S. 'Loch Ruthven'

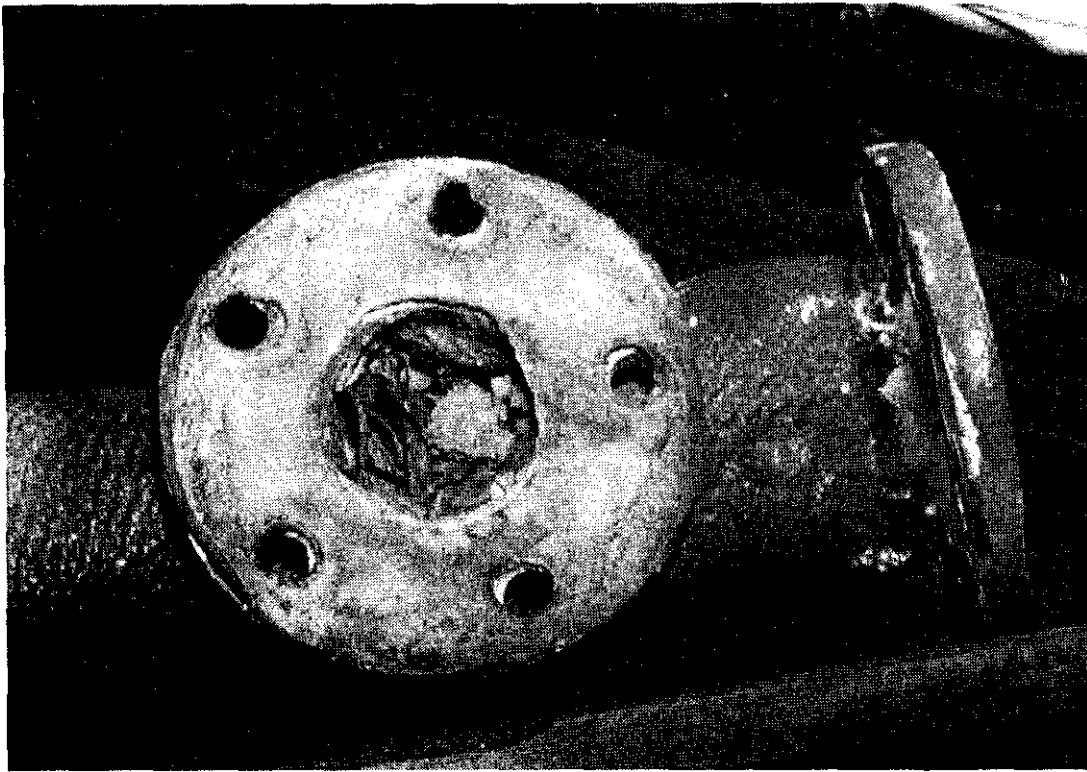
FIG. 1

At the beginning of the refit various hydrants and isolating valves were removed in the normal manner for refit by dockyard. Within a day of this commencing it was apparent that the ship's firemain system was completely choked with a shell fish or mussel type growth throughout the entire length of the main run of piping on No. 2 deck.

It was noticeable that the chokages did not occur everywhere. The living growth was confined to the main run where a continual flow of water existed. Chokages, nevertheless, did occur in dead ends and downcomer leads from hydrants due to extinct formations of the growth being flushed into them. One of the denser sections is shown in FIG. 1. Had the system not been com-

The extensive fouling reported above is another example of the experience of ships fitted with mild steel systems and which have served for long periods in the Arabian Sea and the Persian Gulf.

Resulting from this chokage the complete run had to be removed, burnt out, regalvanized, replaced, relagged and repainted, which added considerably to the work already in hand.

For ships operating in areas where they are subject to marine growth of this density, it would be of great assistance to the maintainer if all firemain leads supplying auxiliary machinery, e.g. air conditioners, secondary supplies to T.G.s, etc., were fitted with a small strainer box containing a small strainer plate which could be quickly and easily isolated and cleaned. Devonport Dockyard tried to assist on these lines knowing as we do that plumbers' piping and threaded unions are not the easiest of pipes to disconnect and sight.

New construction ships are fitted with copper-nickel iron sea-water systems which considerably reduces the incidence of marine fouling. (A.F.O.1218/60 refers).
