H.M.S. LION

MAIN ENGINE BEARING TROUBLES

COMMANDER J. R. BROADHURST, R.N.

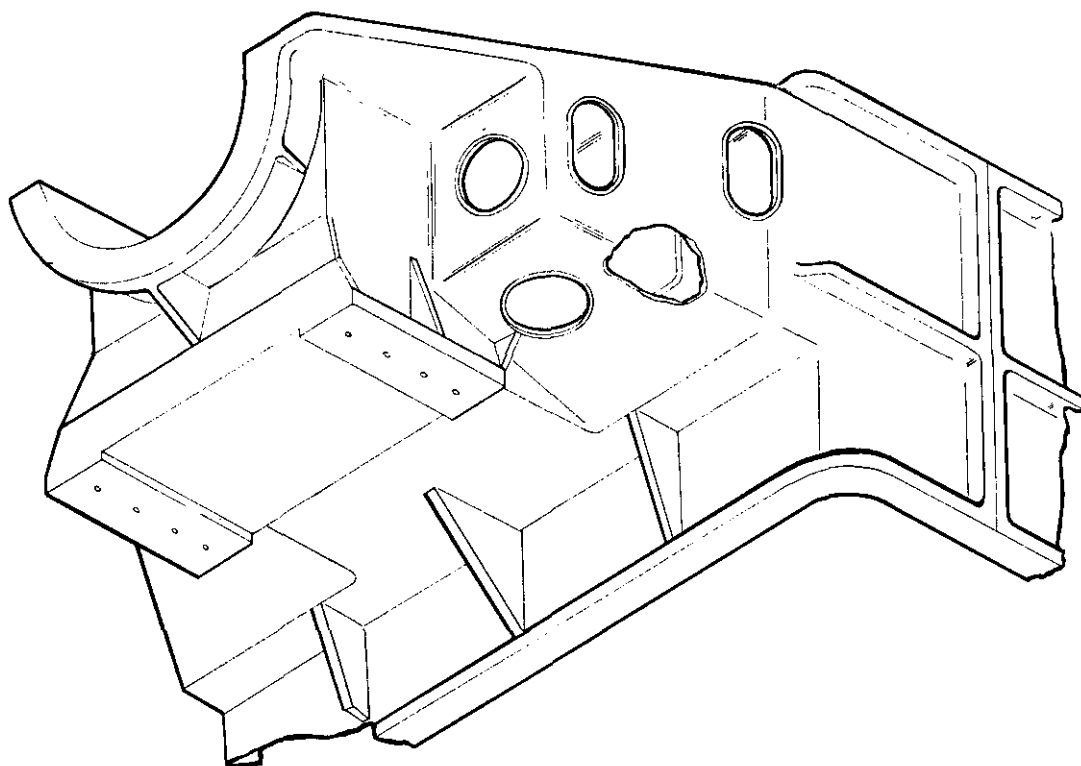
FIG. 1—L.P. TURBINE AFTER PEDESTAL—H.M.S. GAMBIA

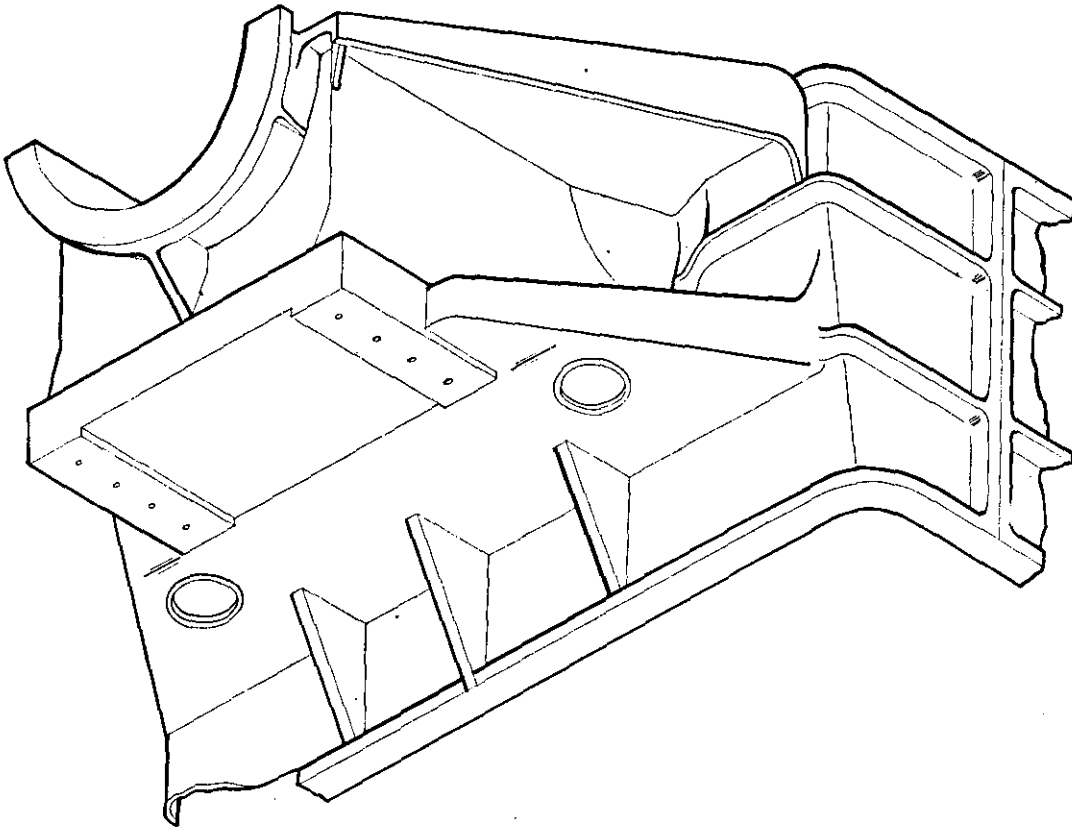
FIG. 2—L.P. TURBINE AFTER PEDESTAL—H.M.S. LION

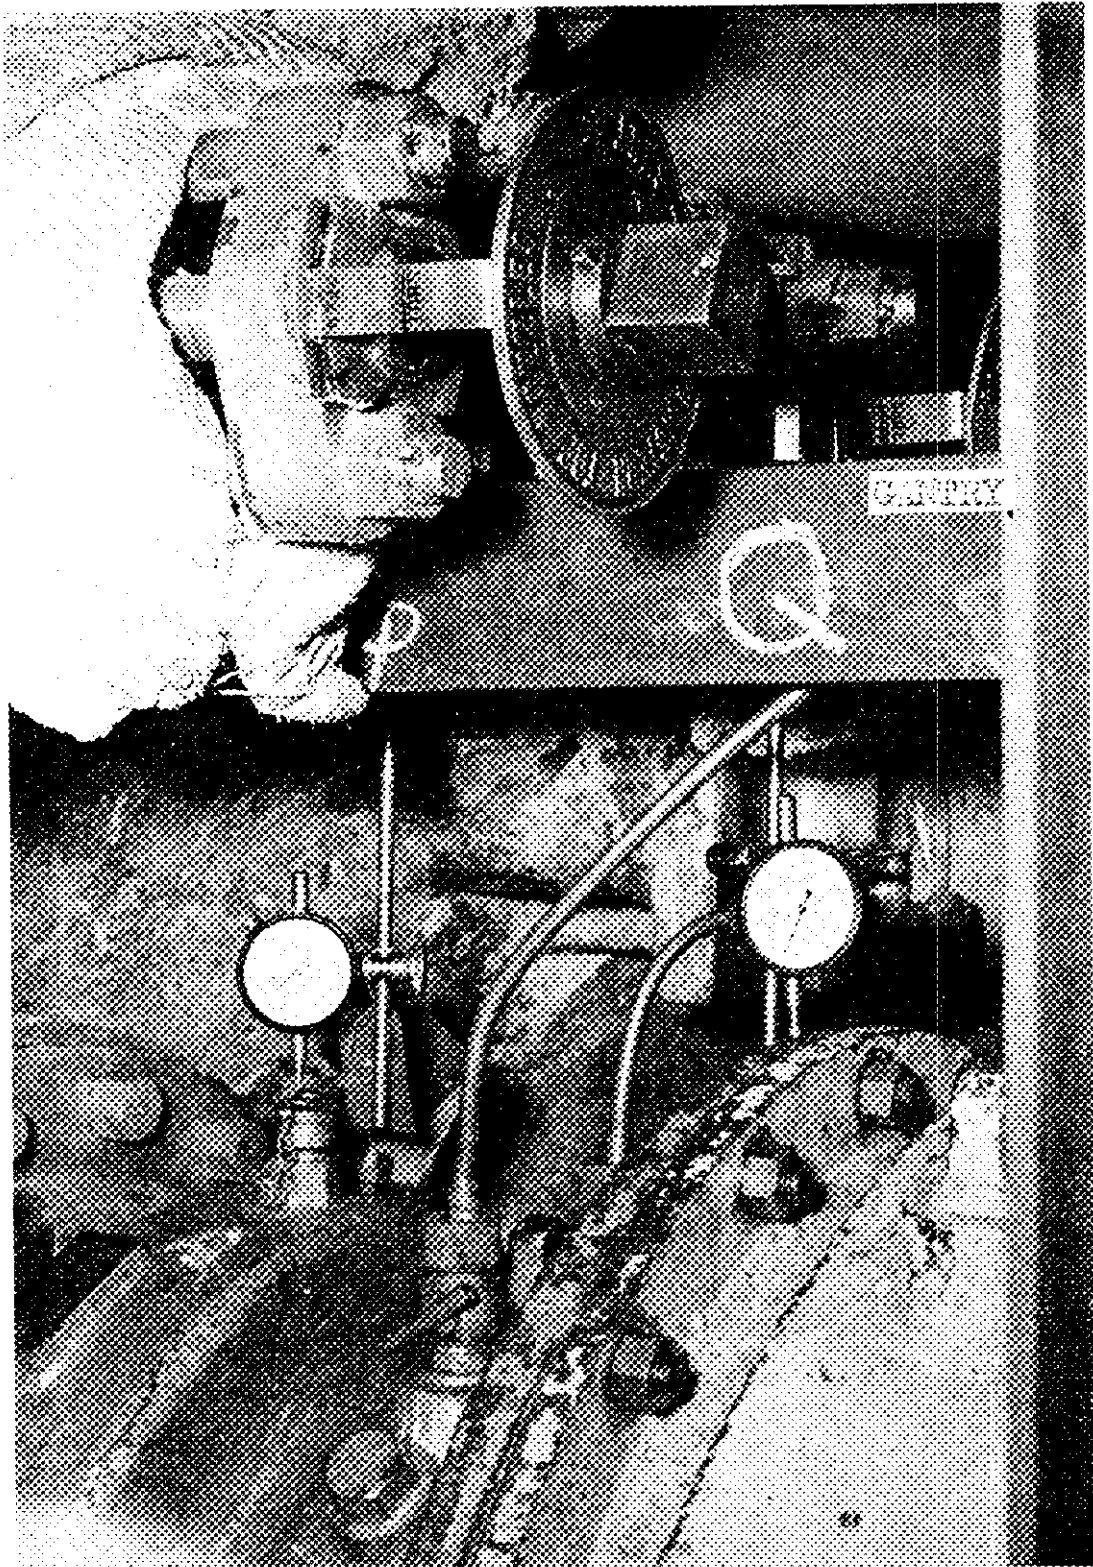
FIG. 3—L. P. AFTER BEARING SHOWING GANTRY AND MICROMETER CLOCKS

The examinations carried out had produced no satisfactory explanation for the failure, and as there was a pressing need to go to sea to advance the gunnery trials, the machinery was closed up and prepared for going to sea on the three remaining shafts. To study the behaviour of the after bearings of the L.P. turbines angle bar gantries were fixed to the armoured deckhead above these bearings, and from which micrometer clocks were set to touch the bearing housings and surrounding structure. It was appreciated that these gantries were not ideal datum fixtures, but they were the best that could be devised for the job. Micrometer clocks were also fitted to the sliding feet.

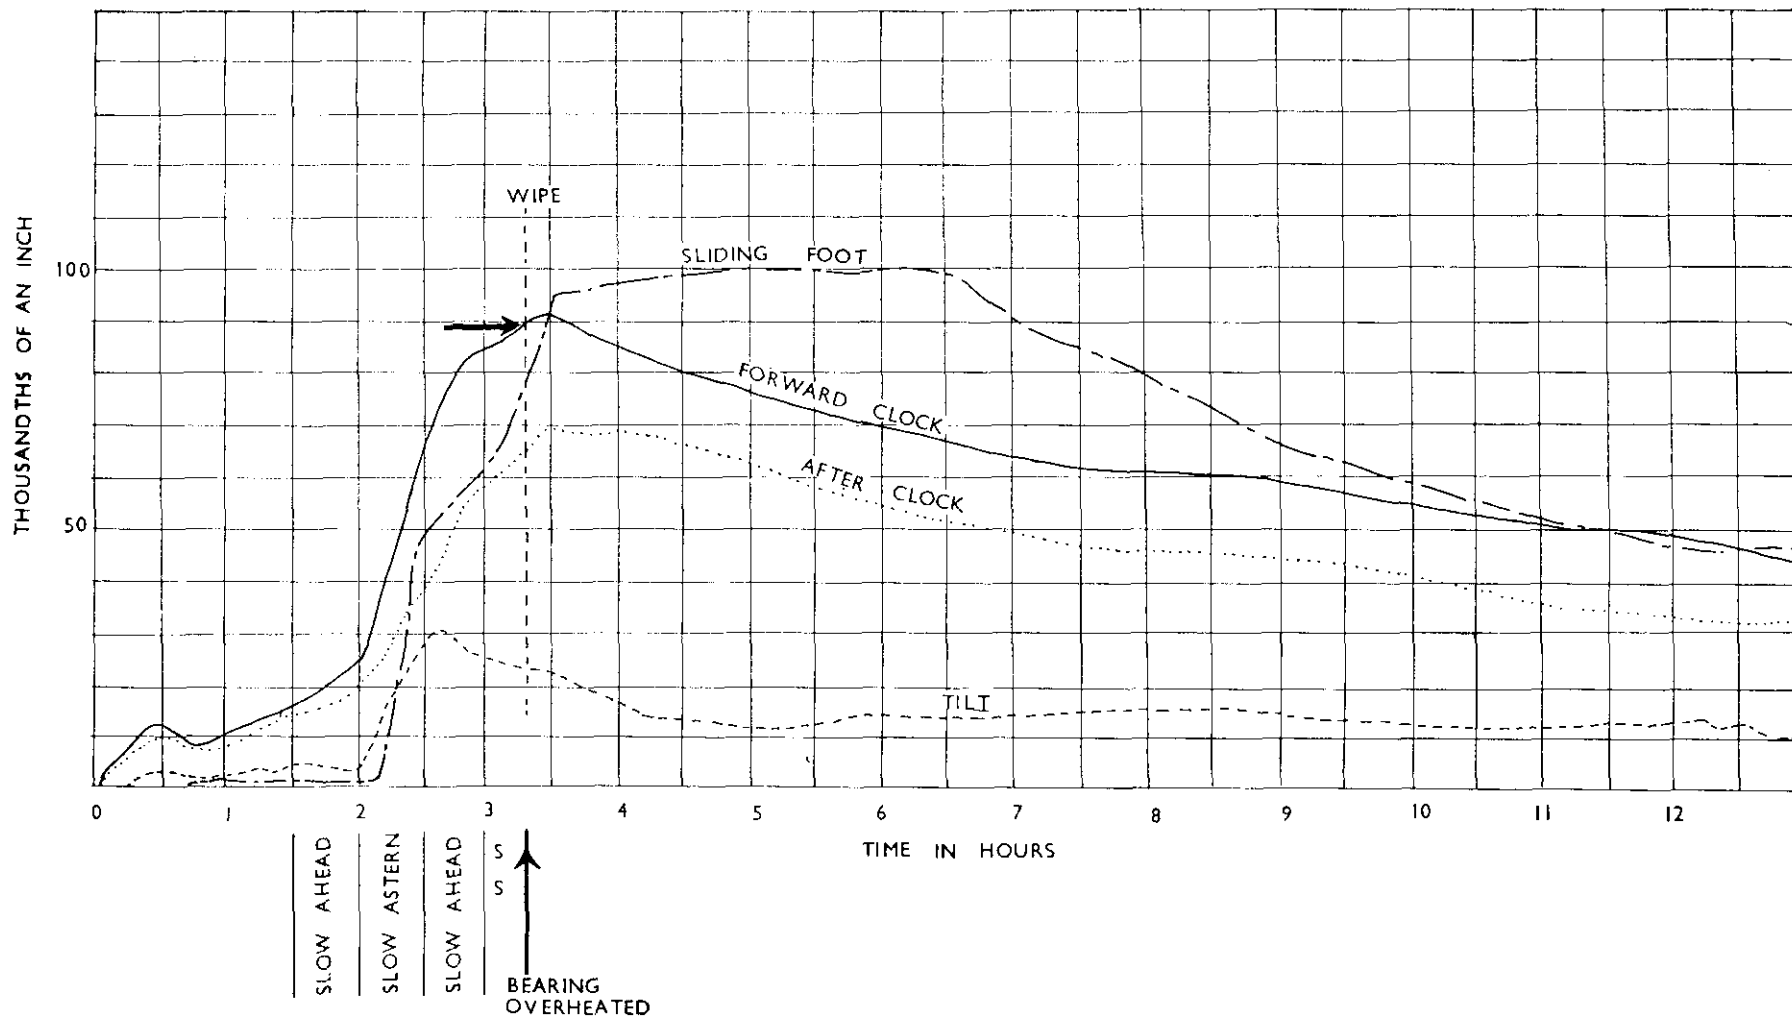
Before proceeding to sea a series of basin trials were carried out on the after unit, and these showed that in general the forward end of the bearing rose about 0.018 in. relative to the after end, this tilt varying according to the operation of the machinery—and in particular to the amount of astern running. Also these trials showed that this tilt once established persisted for a long time. This suggested casting distortion by heat soakage, which would be enhanced when running astern, the astern turbine being at the after end of the L.P. rotor.

FIG. 4—PLOTTED RESULTS OF TILT OF AFTER L.P. BEARING

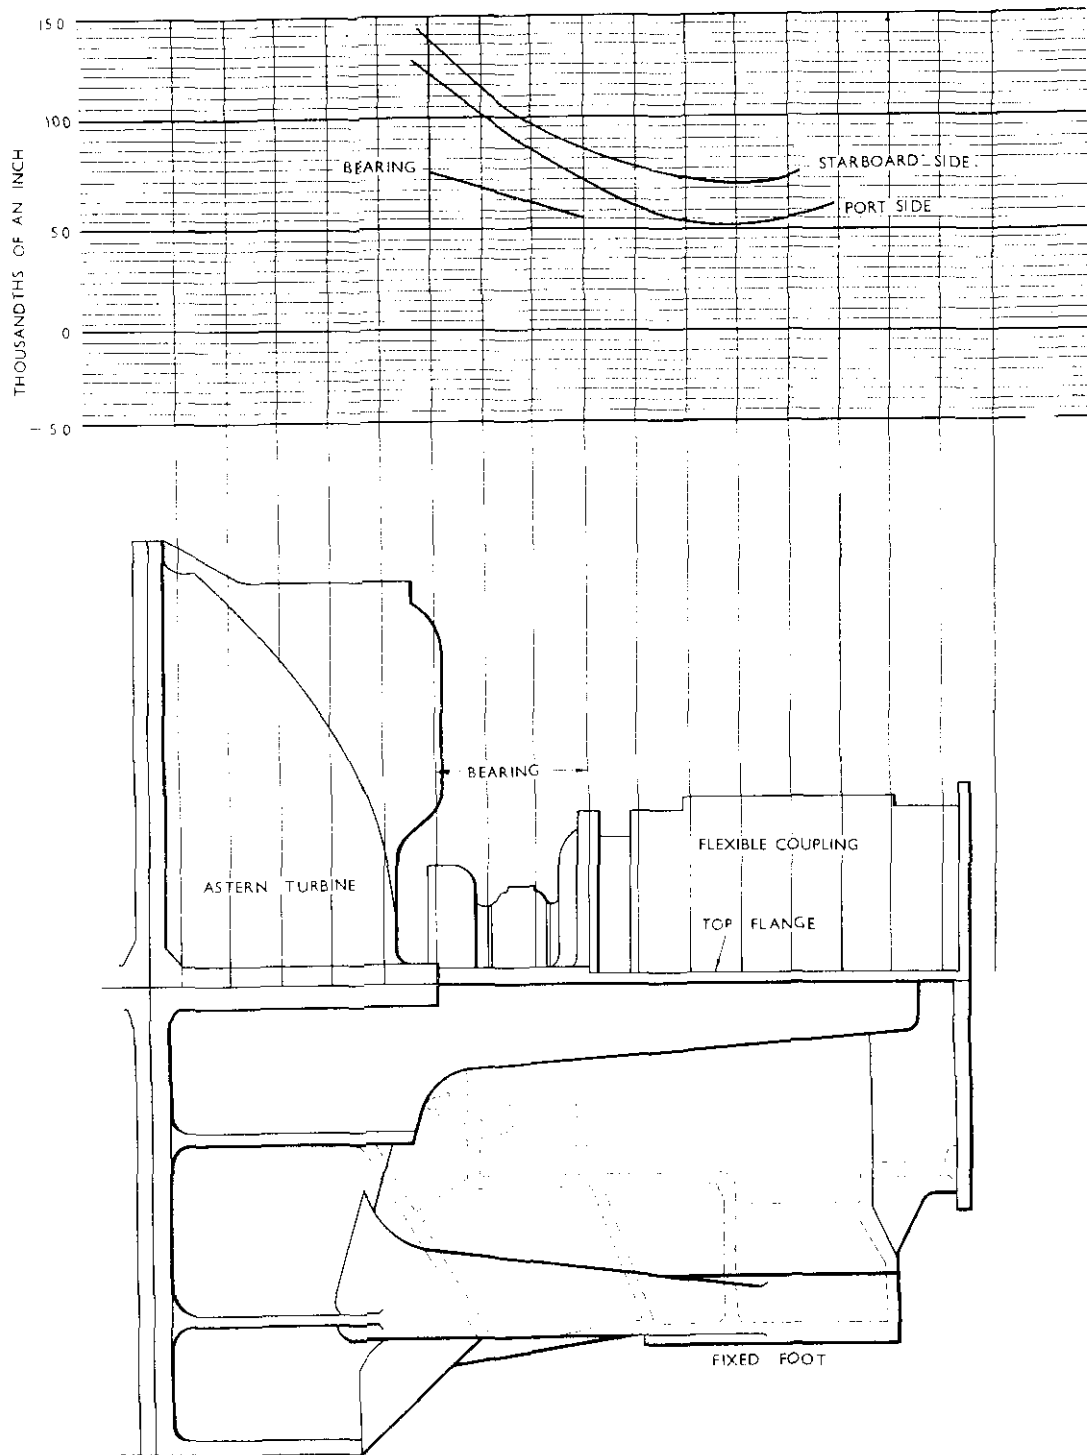
FIG. 6—DISTORTION DIAGRAM SHOWING HOT SHAPE OF TOP FLANGE OF CASTING

Study of the results shows that the distortion is initiated by the expansion of the forward end of the lower half of the astern turbine casting, for in this vicinity the vertical rises resulting could be related to the metal temperatures. At the bearing the prevailing metal temperatures could not explain the rise, and it is considered that the casting stretches under the jacking effect of the hot end. This theory explains both the rise and the tilting action. The hot shape of the casting top flange was measured, and was found to be dished, a shape encouraged by the admission of the astern steam to the lower group of nozzles through passages formed in the actual casting.

From all this work the important factor emerged that the source of the distortion lay in the temperature of the astern steam.

1. Fitting of a desuperheater in the astern steam pipe

2. Increasing the degree of freedom of all L.P. flexible couplings, by doubling the tooth flank clearance and lowering the L.P. turbines by 0.04 in. at the fixed foot
3. Fitting of a convection cooled habitability shield over the unlagged portion of the L.P. and astern turbine casings
4. Fitting of temperature sensitive electrical switches to the lower halves of the after bearings of the L.P. turbines.
