# MARINE BOILER TUBE FAILURES

R. D. BARER, B.A.Sc. S.M.

*Pacific Naval Laboratory, Defence Research Board of Canada*

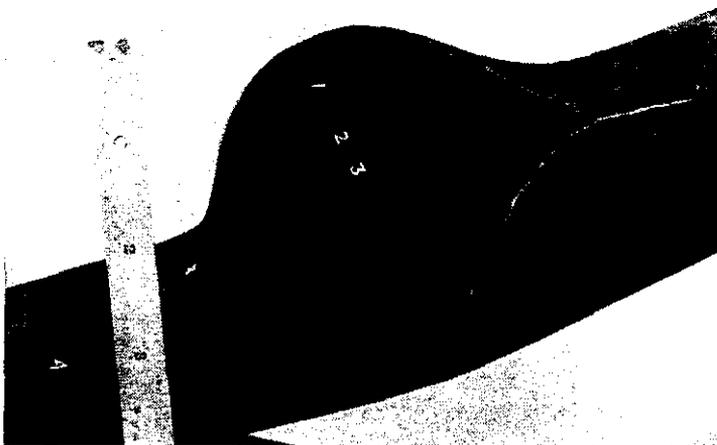
- (a) The split was at the centre line of the tube—facing the fire and was consequently at a high heat input zone
- (b) The thin edges of the split, practically a knife edge, and the 'stretcher' marks on the inner surface at the break, as shown in FIG. 2, are indicative of plastic flow of the metal

FIG. 2—THE BURST ON THE DESTROYER ESCORT VESSEL

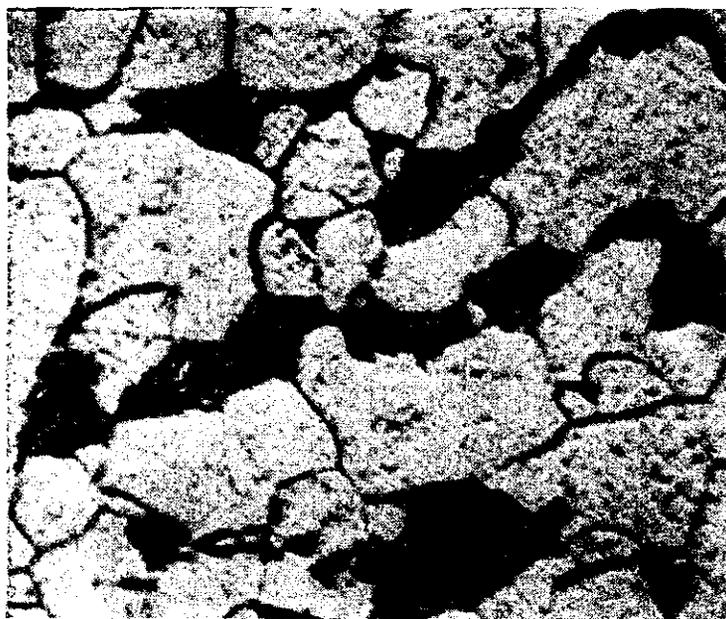
FIG. 3—PHOTOMICROGRAPH OF NORMAL STRUCTURE OF TUBES NOS. 6 AND 7. THIS IS A MIXTURE OF PEARLITE AND FERRITE—USUAL FOR AN APPROXIMATELY 0.25 PER CENT CARBON STEEL (400 ×)

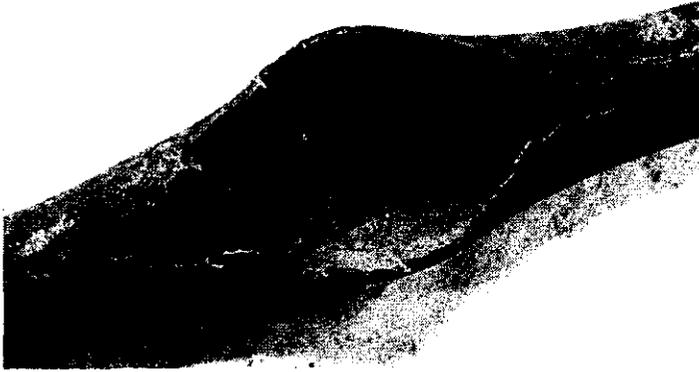
FIG. 5—THE BURST TUBE A25

The burst tube, A25, is shown in FIG. 5. There appears to be no metal wastage and this was confirmed by measurement. There was only a minor amount of stretching and the metal had parted along apparent 'plates'. Cracked metal would give a plate-like appearance on fracture. In fact, near the edge of the burst, many fine cracks,  $\frac{1}{8}$  in. to  $\frac{1}{4}$  in. long, were to be seen.

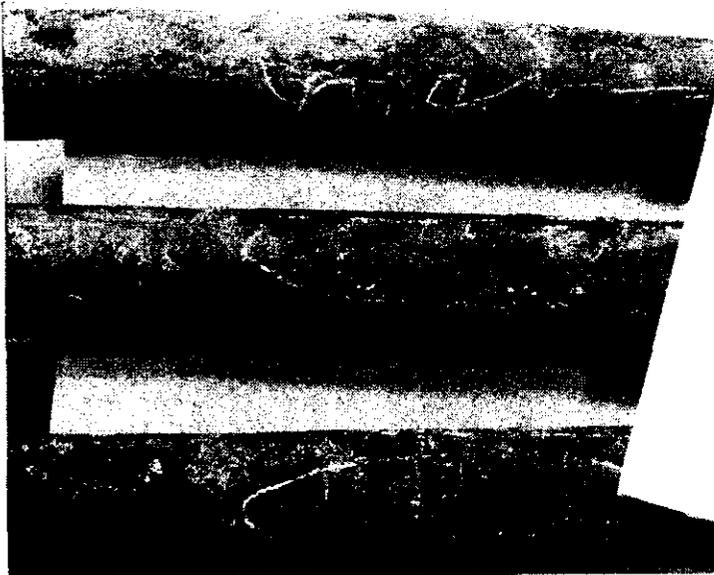
FIG. 6—RUPTURES ON TUBES B39, B40 AND B41 ALSO FROM R.H. SIDE OF BOILER

Among other tubes in which cracking was noted were B39, B40, and B41, shown in FIG. 6. Although these tubes had opened slightly, rather than bursting open, they had apparently been subjected to a similar mechanism. The typical internal cracking is shown in FIG. 7.

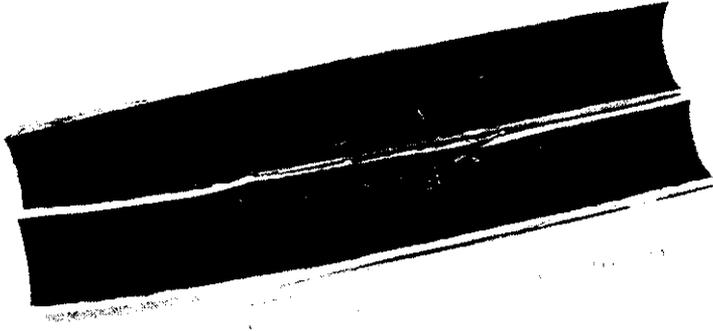
FIG. 7—TUBE B40 SPLIT IN RUPTURED SECTION TO SHOW CRACKING

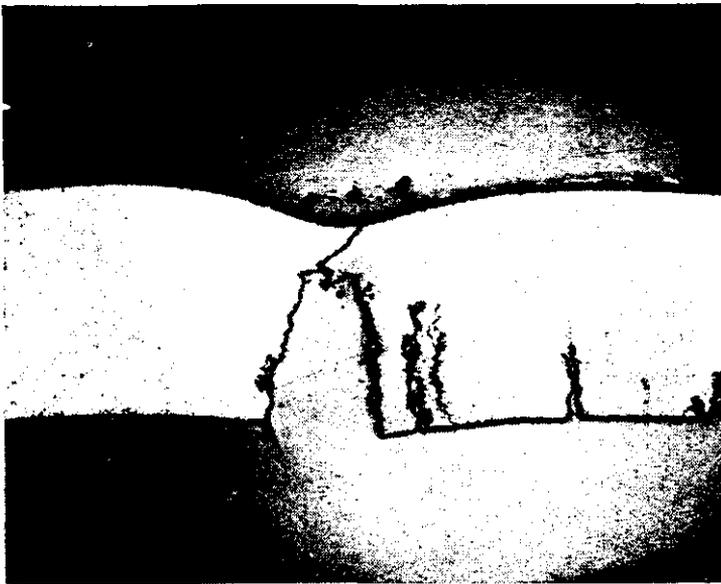
FIG. 8—SECTION THROUGH TUBE WALL NEAR END OF BURST (A25) SHOWING DUCTILE NECKING-DOWN FROM OUTER METAL AND FINAL RUPTURE ON A 45-DEGREE PLANE. ALSO SHOWN ARE THE FIVE ADDITIONAL CRACKS WHICH PROGRESSED IN AN INTERGRANULAR MANNER

Tube A25, whose bursting initiated the investigation, was given a thorough and detailed micro-examination. Sections were cut from the tube near the burst. A particularly interesting section, FIG. 8, shows the presence of several cracks in addition to the main one which is a continuation of the burst. Evidence of normal ductility of the metal may be noted in the outside 25 per cent of the tube wall where the final break was on a 45 degree plane at the necked-down region. FIGS. 9 and 10 show some of the intergranular cracking found in A25, as well as including evidence that the metal had been overheated, and then rapidly cooled.

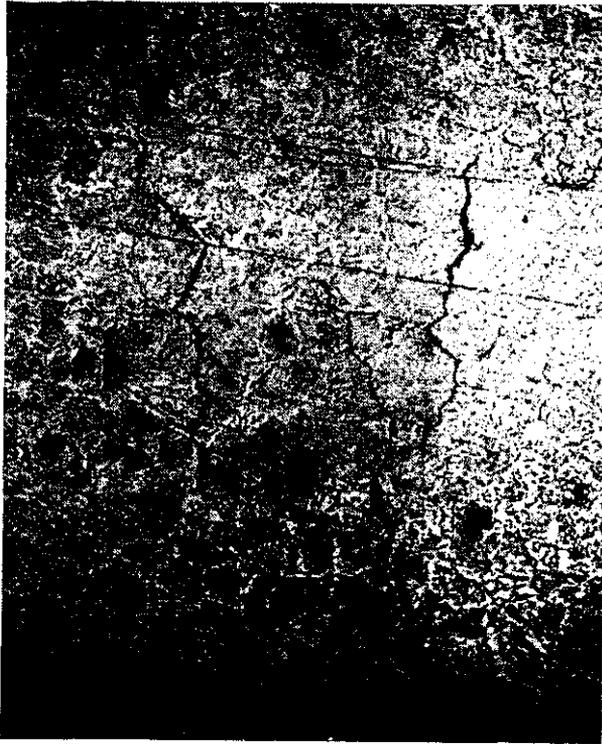
FIG. 10—FINE INTERGRANULAR CRACKING ON NON-FIRE, INSIDE SURFACE OF TUBE A25 NEAR THE BURST

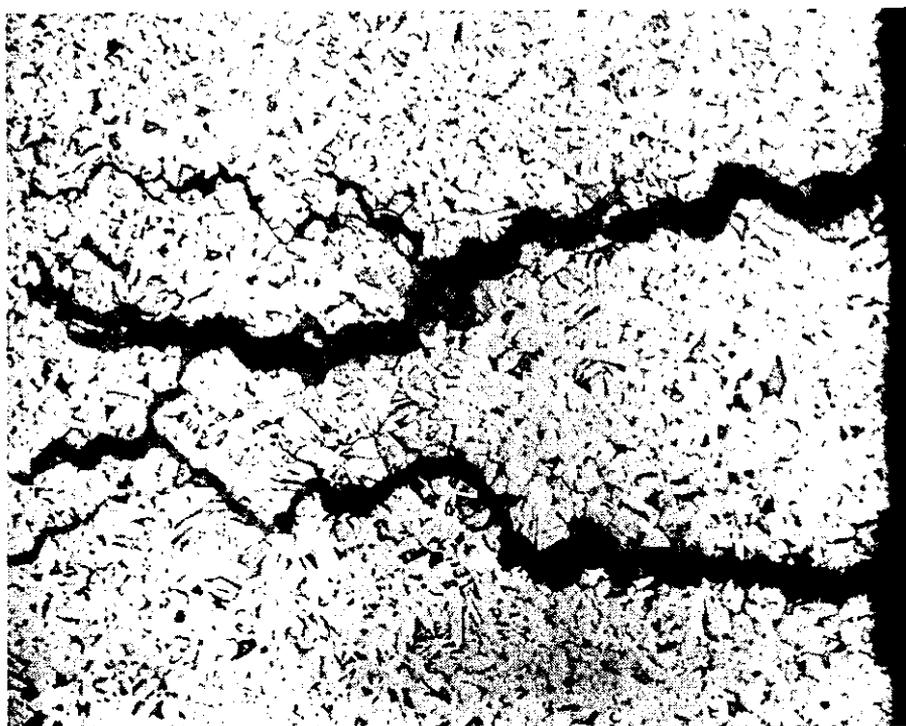
FIG. 11—SECTION THROUGH TUBE WALL, B39, SHOWING DETAIL OF INTERGRANULAR CRACKING

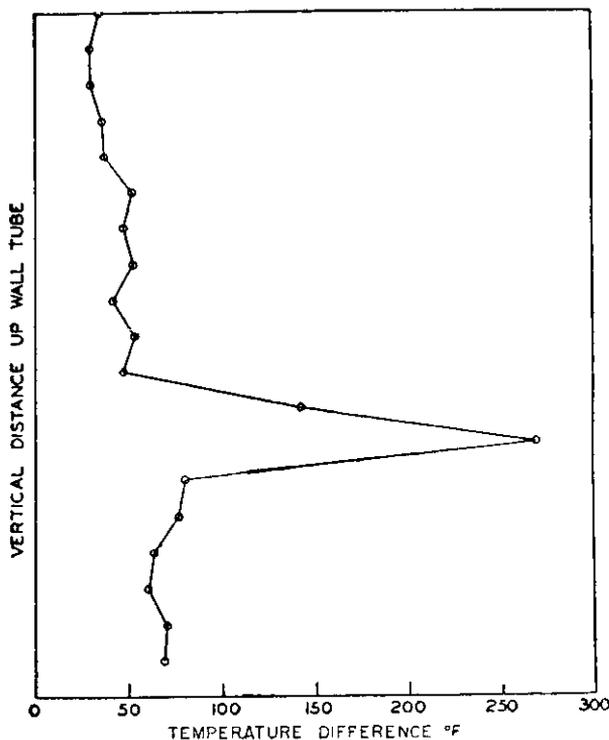
FIG. 12—EVIDENCE OF HOT SPOT IN A 50-FT VERTICAL WATER WALL TUBE

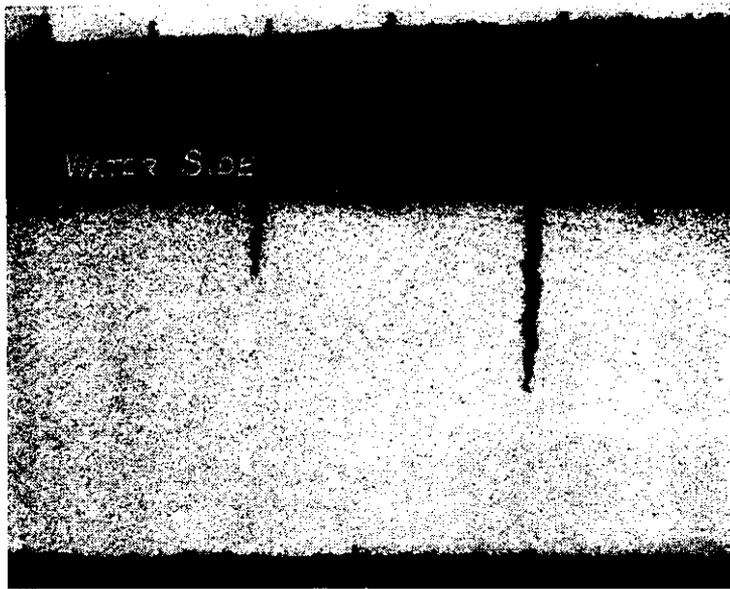
*Tube A30 R.H.* A low magnification, longitudinal section (i.e., to show transverse cracks) is shown in FIG. 17. Among the points which may be noted are :—

FIG. 17—SECTION THROUGH WALL OF A30 SHOWING TRANSVERSE CRACKS

- (i) The incidence of cracks — rather numerous.
- (ii) Great distribution in depth (five cracks, although not shown here, went right through in the 2-ft length affected)
- (iii) Negligible penetrating action on the outer surface.

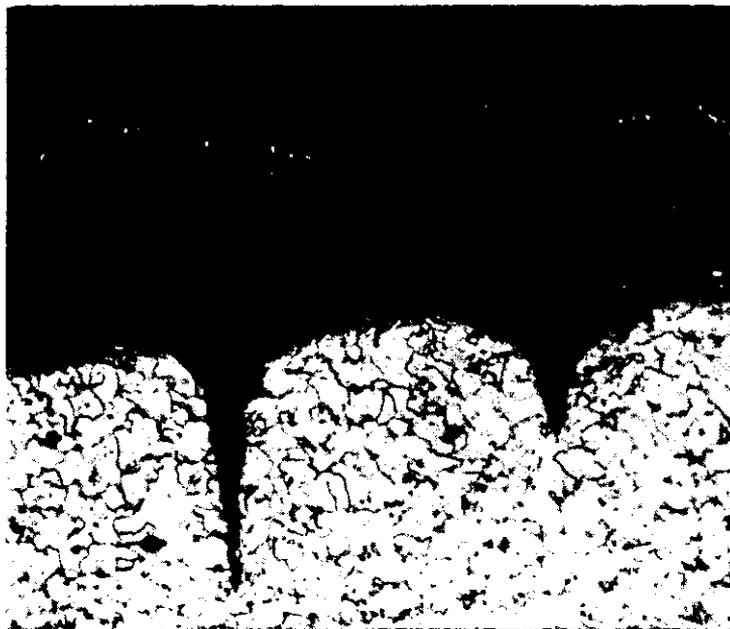
FIG. 18—DETAIL OF FIG. 17. NOTE CRACKS IN OXIDE (BRIGHT PARTICLES ARE COPPER)

A close-up of one of the cracks is shown in FIG. 18. From this, additional details may be noted :—

- (iv) The cracks are generally insensitive to grain boundaries (although an occasional fine branch showed such sensitivity)
- (v) There is generally little, if any, oxide in the larger cracks
- (vi) There is generally an oxide layer on the tube surface (water side) in which are scattered particles of copper. The layer was thin —approximately 0.0012 in.—and in some areas almost one-third of it was copper particles.

As shown in FIG. 18, there appears to be some correlation between cracks in the oxide layer and the beginnings of a crack in the metal. This is confirmed in FIG. 19, in which are shown 'embryo' cracks—the earliest stages in corrosion of the tube, the formation of cracks in the oxides, and the apparent pointing-up of the general oxide layer at the location of these cracks—in fact, the initiating points of cracks in the tube wall. There is no copper in this microsection.

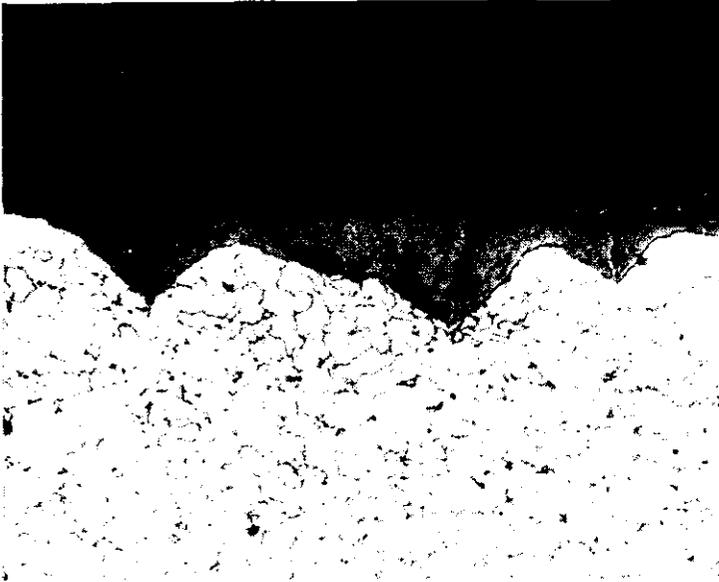
FIG. 19—SIMILAR SECTION TO FIG. 18 SHOWING EARLIER STAGE IN CRACK FORMATION. NOTE CRACKS IN OXIDE LAYER

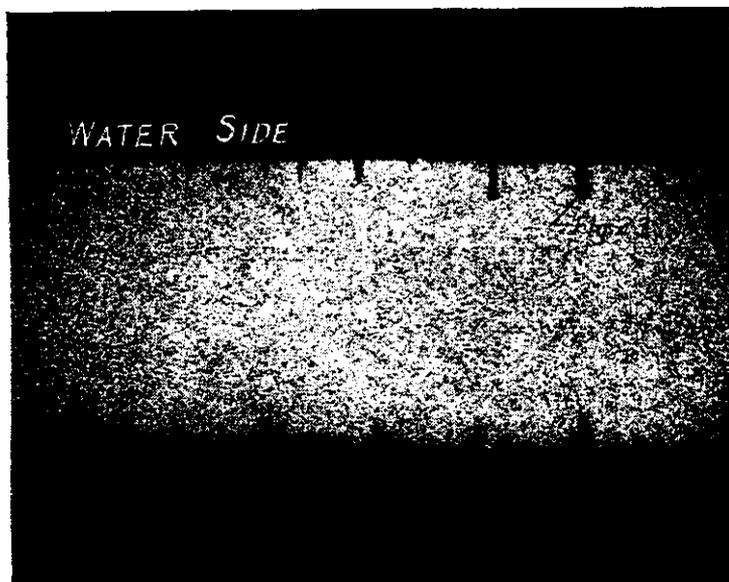
*Tubes A28 R.H. and A.31 L.H.* A low magnification, longitudinal section (i.e. to show transverse cracks) is shown in FIG. 21. These two tubes, incidentally, were essentially free of longitudinal cracks.

- (i) At least as many cracks, and possibly more, in some areas than A30
- (ii) The distribution is limited to generally shallow cracks (only exception, the major one which perforated in A28). There was no perforation in A31.
- (iii) Considerable and practically equivalent cracking on the outer surface (i.e., fire side) in contrast with A30, in which this was almost completely absent.

FIG. 21—SECTION THROUGH WALL OF A28 SHOWING TRANSVERSE CRACKS

The external cracking in A31 and A28 (FIG. 21) but absent in A30, is a little strange. It probably was the result of a similar mechanism to that which cracked these tubes internally, but high temperature oxidation rather than corrosion was the mechanism by which it progressed from cracks in the oxide scale.

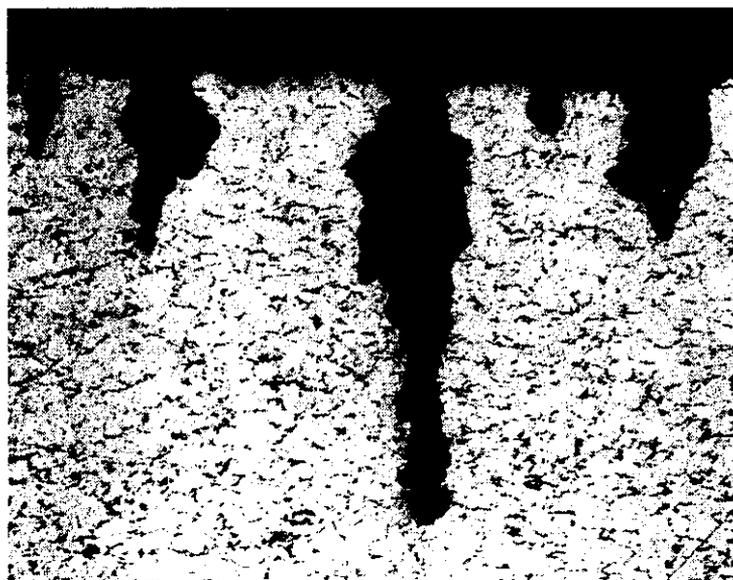
A close-up of one of the cracks (from A28) is shown in FIG. 22. Although some cracks in A31 and A28 are sharper, there are a number that show these characteristics :

FIG. 22—TYPICAL CRACK IN A28 SHOWING OXIDE ON SIDES AND ABSENCE OF SHARPNESS NOTED IN FIG. 18. THE SPHEROIDIZED MICROSTRUCTURE MAY BE NOTED

- (iv) Generally wider and more oxide on the sides
- (v) The rounded bottom suggests a termination of what had already been a more leisurely progress than for cracks in A30. It also indicates a corrosive action at work in enlarging the terminus (particularly FIG. 23).

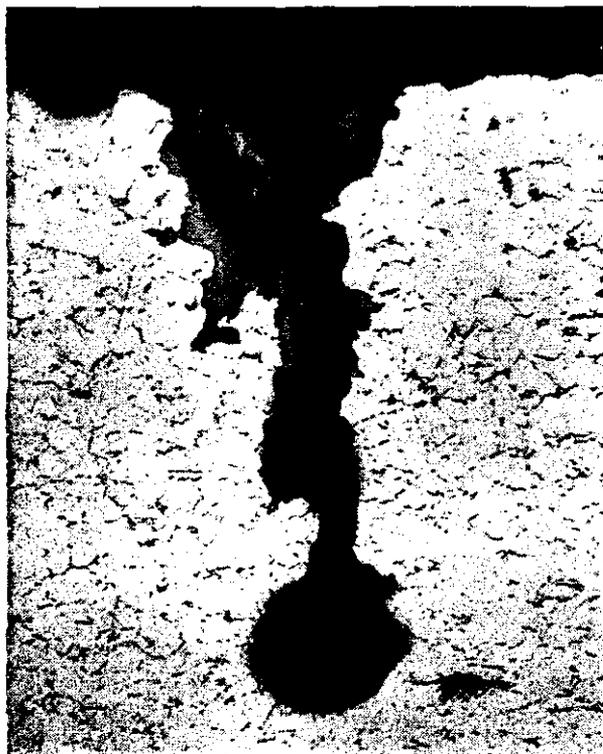
There is little doubt that the cracking in A28 and A31 was a slower process than in A30, as evidenced by FIGS. 22 and 23. It would appear that the mechanical forces partly responsible for the cracking were not present, or only very slightly after a certain stage. At this point the corrosion component had a chance to proceed alone.

FIG. 23—DETAIL OF ONE OF THE CRACKS SHOWN IN FIG. 21. THE ROUNDED BOTTOM IS UNUSUAL AND SUGGESTS ABSENCE OF STRESS AFTER A TIME
