MARINE BOILER TUBE FAILURES

R. D. BARER, B.A.Sc. S.M.

Pacific Naval Laboratory, Defence Research Board of Canada

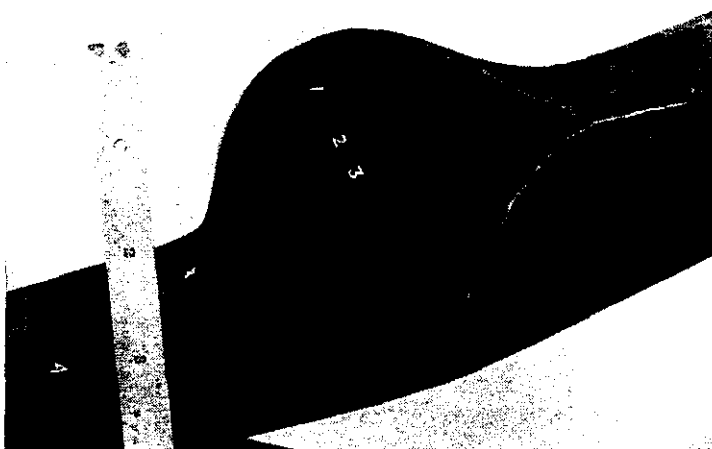
FIG. 2—THE BURST ON THE DESTROYER ESCORT VESSEL

Small pieces of metal were cut from the location indicated on FIG. 2.

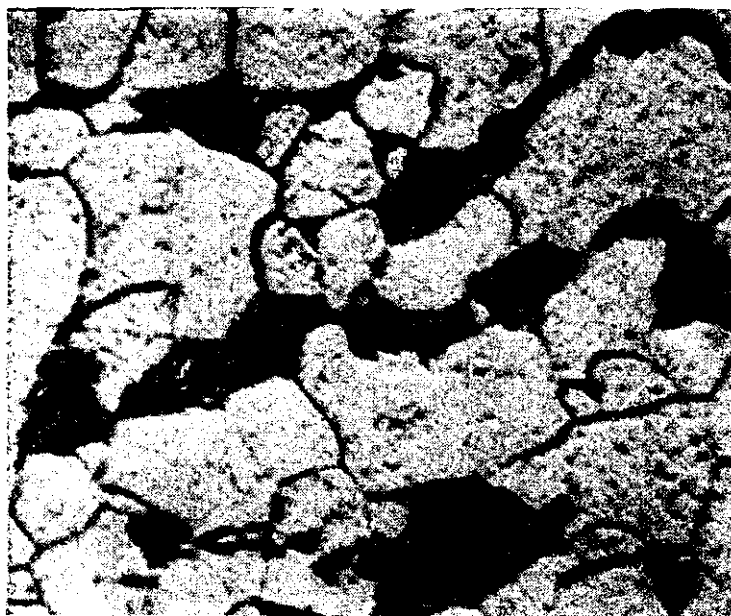
FIG. 3—PHOTOMICROGRAPH OF NORMAL STRUCTURE OF TUBES NOS. 6 AND 7. THIS IS A MIXTURE OF PEARLITE AND FERRITE—USUAL FOR AN APPROXIMATELY 0.25 PER CENT CARBON STEEL (400 ×)

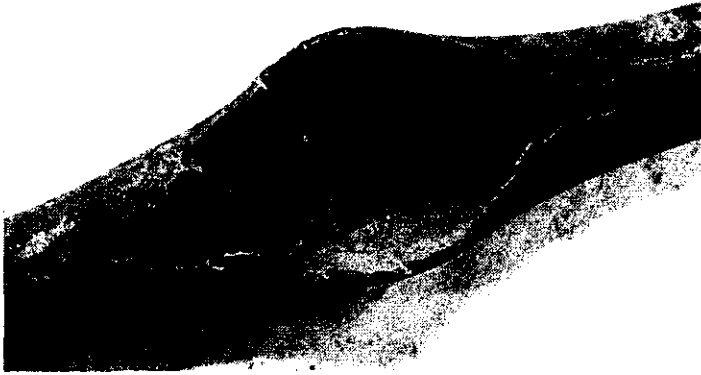
FIG. 5—THE BURST TUBE A25

The burst tube, A25, is shown in FIG. 5. There appears to be no metal wastage and this was confirmed by measurement. There was only a minor amount of stretching and the metal had parted along apparent 'plates'. Cracked metal would give a plate-like appearance on fracture. In fact, near the edge of the burst, many fine cracks, $\frac{1}{8}$ in. to $\frac{1}{4}$ in. long, were to be seen.

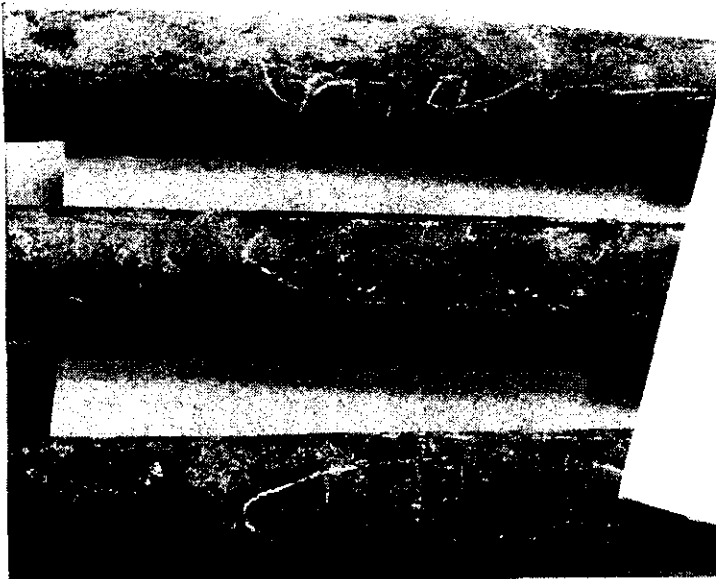
FIG. 6—RUPTURES ON TUBES B39, B40 AND B41 ALSO FROM R.H. SIDE OF BOILER

Among other tubes in which cracking was noted were B39, B40, and B41, shown in FIG. 6. Although these tubes had opened slightly, rather than bursting open, they had apparently been subjected to a similar mechanism. The typical internal cracking is shown in FIG. 7.

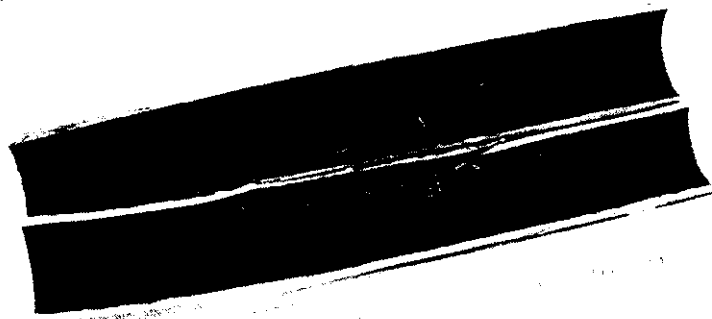
FIG. 7—TUBE B40 SPLIT IN RUPTURED SECTION TO SHOW CRACKING

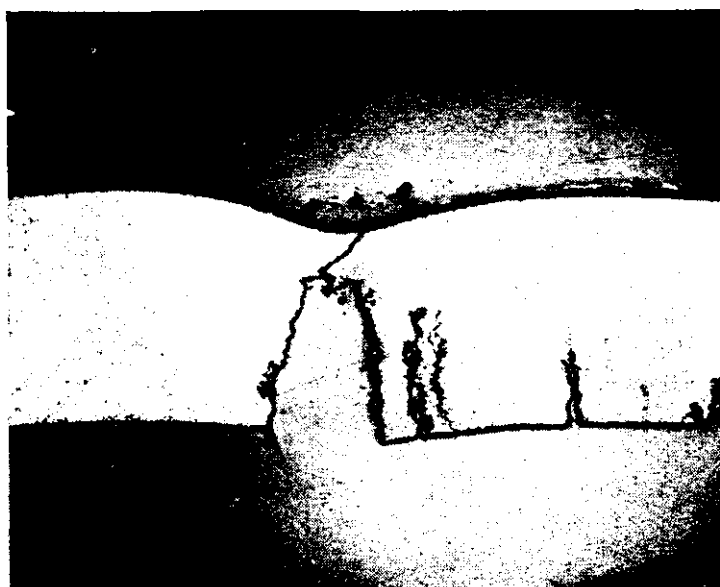
FIG. 8—SECTION THROUGH TUBE WALL NEAR END OF BURST (A25) SHOWING DUCTILE NECKING-DOWN FROM OUTER METAL AND FINAL RUPTURE ON A 45-DEGREE PLANE. ALSO SHOWN ARE THE FIVE ADDITIONAL CRACKS WHICH PROGRESSED IN AN INTERGRANULAR MANNER

Tube A25, whose bursting initiated the investigation, was given a thorough and detailed micro-examination. Sections were cut from the tube near the burst. A particularly interesting section, FIG. 8, shows the presence of several cracks in addition to the main one which is a continuation of the burst. Evidence of normal ductility of the metal may be noted in the outside 25 per cent of the tube wall where the final break was on a 45 degree plane at the necked-down region. FIGS. 9 and 10 show some of the intergranular cracking found in A25, as well as including evidence that the metal had been overheated, and then rapidly cooled.

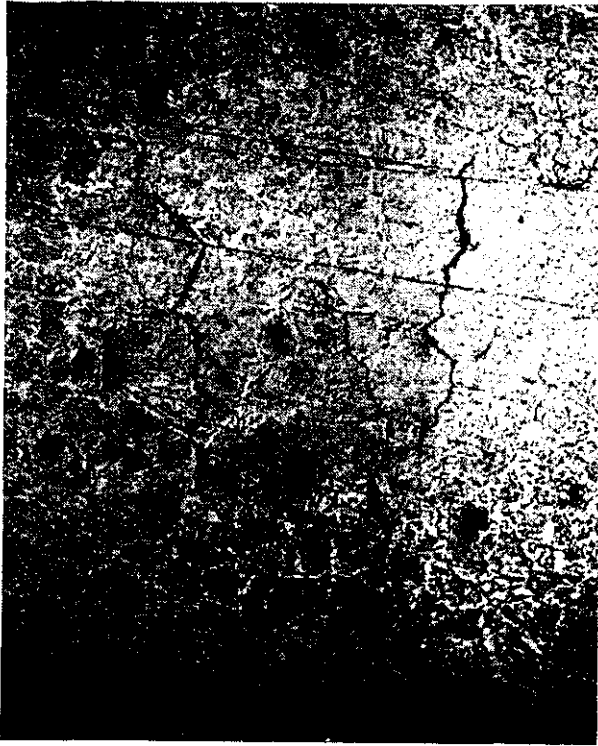
FIG. 10—FINE INTERGRANULAR CRACKING ON NON-FIRE, INSIDE SURFACE OF TUBE A25 NEAR THE BURST

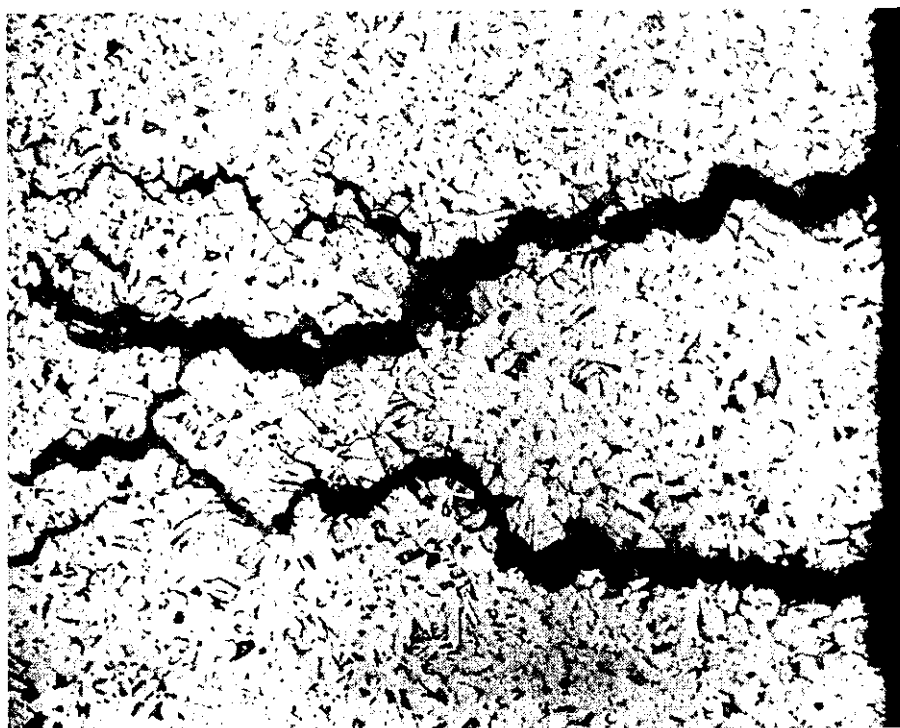
FIG. 11—SECTION THROUGH TUBE WALL, B39, SHOWING DETAIL OF INTERGRANULAR CRACKING

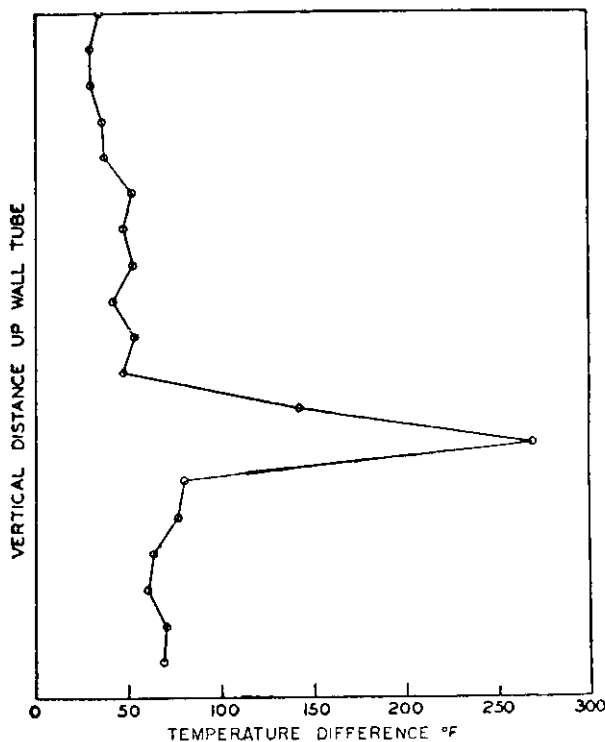
FIG. 12—EVIDENCE OF HOT SPOT IN A 50-FT VERTICAL WATER WALL TUBE

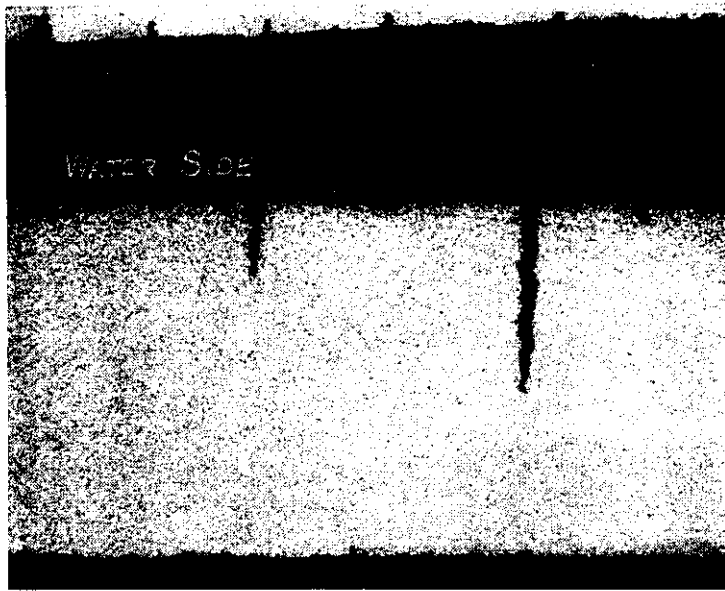
Tube A30 R.H. A low magnification, longitudinal section (i.e., to show transverse cracks) is shown in FIG. 17. Among the points which may be noted are :—

FIG. 17—SECTION THROUGH WALL OF A30 SHOWING TRANSVERSE CRACKS

- (i) The incidence of cracks — rather numerous.
- (ii) Great distribution in depth (five cracks, although not shown here, went right through in the 2-ft length affected)
- (iii) Negligible penetrating action on the outer surface.

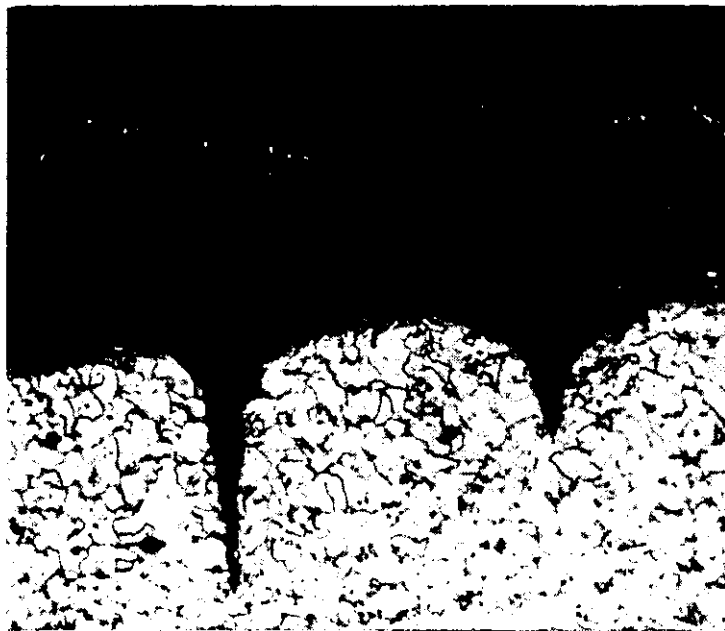
FIG. 18—DETAIL OF FIG. 17. NOTE CRACKS IN OXIDE (BRIGHT PARTICLES ARE COPPER)

A close-up of one of the cracks is shown in FIG. 18. From this, additional details may be noted :—

- (iv) The cracks are generally insensitive to grain boundaries (although an occasional fine branch showed such sensitivity)
- (v) There is generally little, if any, oxide in the larger cracks
- (vi) There is generally an oxide layer on the tube surface (water side) in which are scattered particles of copper. The layer was thin —approximately 0.0012 in.—and in some areas almost one-third of it was copper particles.

As shown in FIG. 18, there appears to be some correlation between cracks in the oxide layer and the beginnings of a crack in the metal. This is confirmed in FIG. 19, in which are shown 'embryo' cracks—the earliest stages in corrosion of the tube, the formation of cracks in the oxides, and the apparent pointing-up of the general oxide layer at the location of these cracks—in fact, the initiating points of cracks in the tube wall. There is no copper in this microsection.

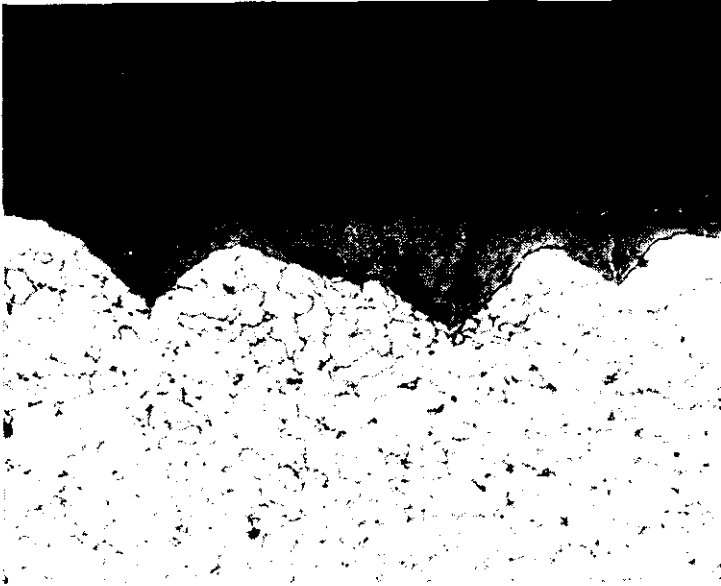
FIG. 19—SIMILAR SECTION TO FIG. 18 SHOWING EARLIER STAGE IN CRACK FORMATION. NOTE CRACKS IN OXIDE LAYER

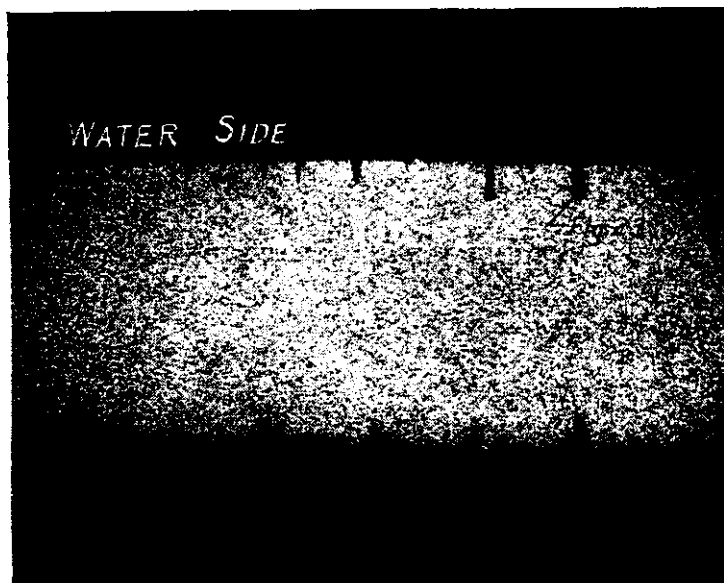
Tubes A28 R.H. and A.31 L.H. A low magnification, longitudinal section (i.e. to show transverse cracks) is shown in FIG. 21. These two tubes, incidentally, were essentially free of longitudinal cracks.

- (i) At least as many cracks, and possibly more, in some areas than A30
- (ii) The distribution is limited to generally shallow cracks (only exception, the major one which perforated in A28). There was no perforation in A31.
- (iii) Considerable and practically equivalent cracking on the outer surface (i.e., fire side) in contrast with A30, in which this was almost completely absent.

FIG. 21—SECTION THROUGH WALL OF A28 SHOWING TRANSVERSE CRACKS

The external cracking in A31 and A28 (FIG. 21) but absent in A30, is a little strange. It probably was the result of a similar mechanism to that which cracked these tubes internally, but high temperature oxidation rather than corrosion was the mechanism by which it progressed from cracks in the oxide scale.

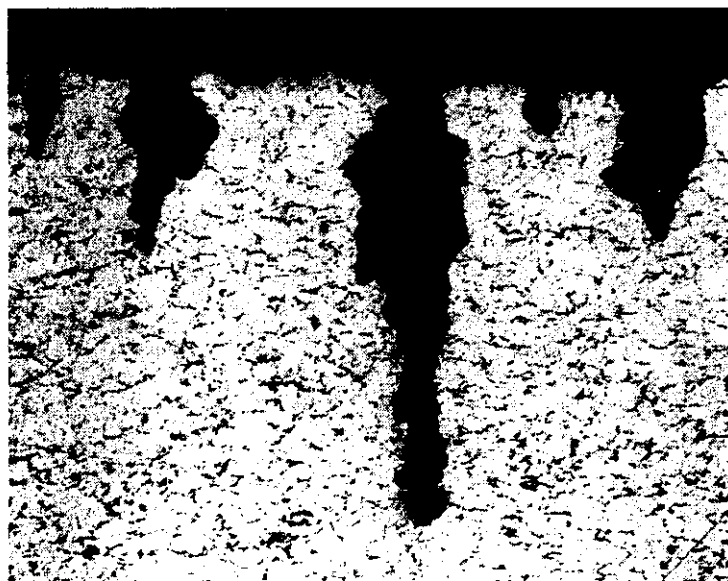
A close-up of one of the cracks (from A28) is shown in FIG. 22. Although some cracks in A31 and A28 are sharper, there are a number that show these characteristics :

FIG. 22—TYPICAL CRACK IN A28 SHOWING OXIDE ON SIDES AND ABSENCE OF SHARPNESS NOTED IN FIG. 18. THE SPHEROIDIZED MICROSTRUCTURE MAY BE NOTED

- (iv) Generally wider and more oxide on the sides
- (v) The rounded bottom suggests a termination of what had already been a more leisurely progress than for cracks in A30. It also indicates a corrosive action at work in enlarging the terminus (particularly FIG. 23).

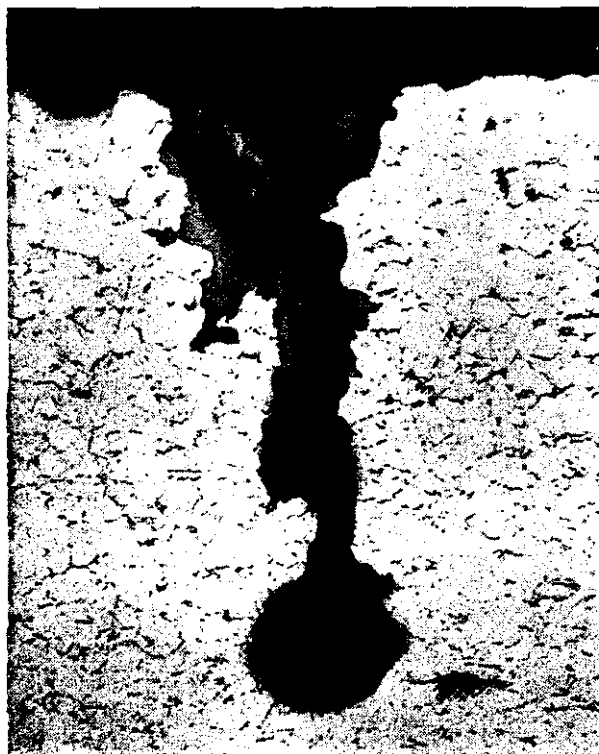
There is little doubt that the cracking in A28 and A31 was a slower process than in A30, as evidenced by FIGS. 22 and 23. It would appear that the mechanical forces partly responsible for the cracking were not present, or only very slightly after a certain stage. At this point the corrosion component had a chance to proceed alone.

FIG. 23—DETAIL OF ONE OF THE CRACKS SHOWN IN FIG. 21. THE ROUNDED BOTTOM IS UNUSUAL AND SUGGESTS ABSENCE OF STRESS AFTER A TIME
