CAISSON FAILURE AND H.M.S/M. 'TALENT'

SENIOR COMMISSIONED ENGINEER P. A. KNOWLES, R.N.

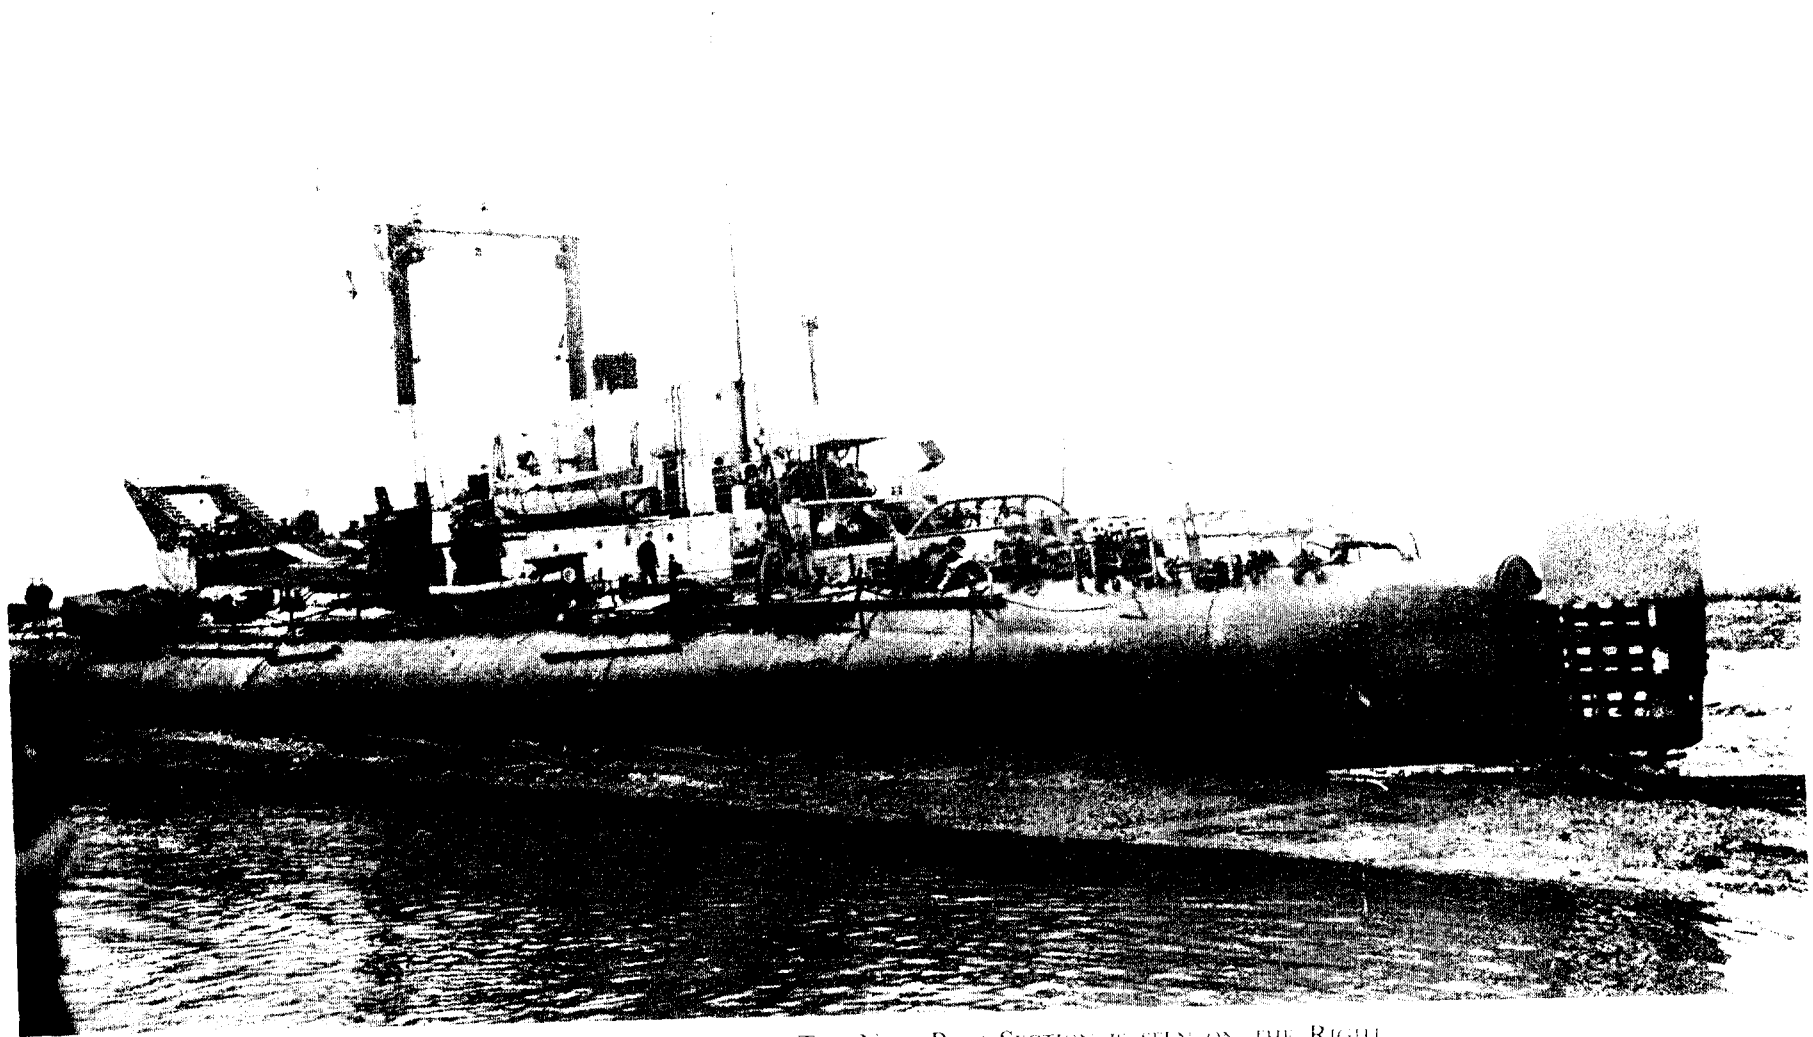
THE SECOND GROUNDING. THE NEW BOW SECTION IS SEEN ON THE RIGHT
(Keystone Press Agency)

At the following high tide in the afternoon, the fog cleared, and the tugs pulled *Talent* off the mud again and towed her to the locks and safety. During this manœuvre the new bow portion of the casing, which had only been tack welded in position, caught in a projection on the salvage vessel, broke away and fell into the river. Much publicity was given to this incident in the newspapers, and one would have thought that this was indeed the death blow of the unfortunate *Talent*. But far from it, for the following day it was salvaged !
