H.M.S. "AMETHYST"

IN THE YANGTZE—ENGINEERING EXPLOITS

LIEUTENANT (E) E. G. WILKINSON, R.N.

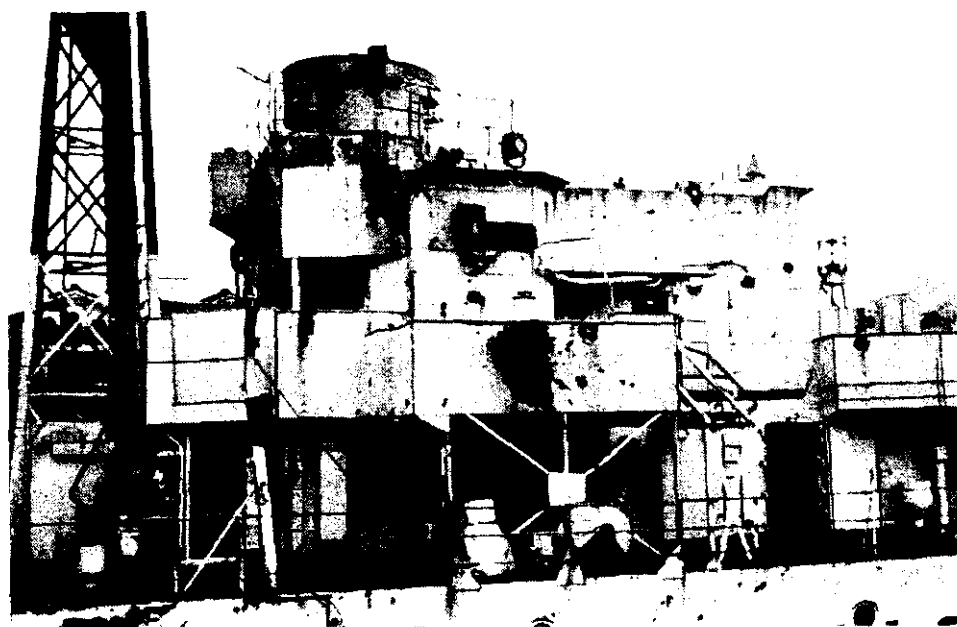
BRIDGE STRUCTURE

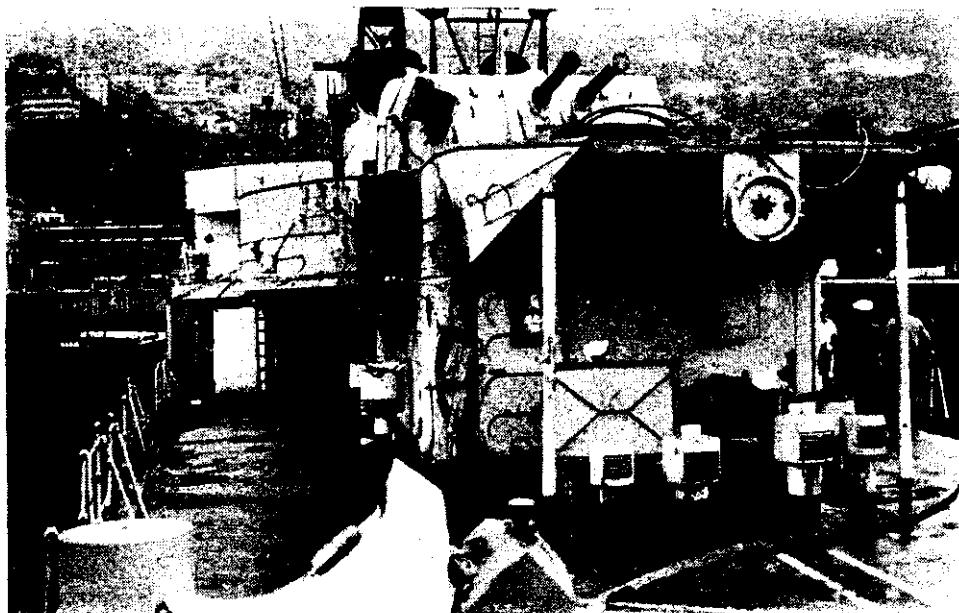
Only one shell caused real structural damage inside the ship. This burst in the lobby between the Depth Charge Lockers and the Wardroom Store, distorting three bulkheads and blowing off the hatch above.

QUARTERDECK—HITS ON X GUN AND DEPTH CHARGE STORE

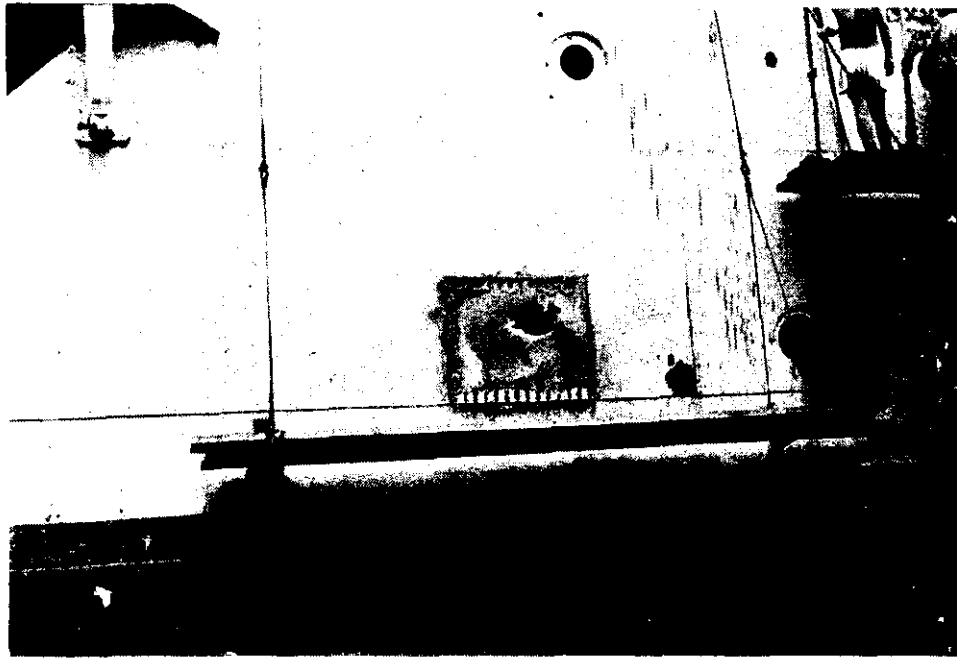
The starboard T.G. Room was hit but the generator, which was on load, escaped damage. A hole in a bathroom scupper pipe which passes through

the Turbo-Generator Room and a broken salt water service pipe in the bathroom started a flood in the T.G. Room, which was stopped by isolating the salt water service.

HITS IN CH. & P.Os.' BATHROOM (TOP) AND STARBOARD
TURBO-GENERATOR ROOM (BOTTOM)
