CONDENSER DEFECTS

COMMANDER (E) I. G. AYLEN, O.B.E., D.S.C., R.N.

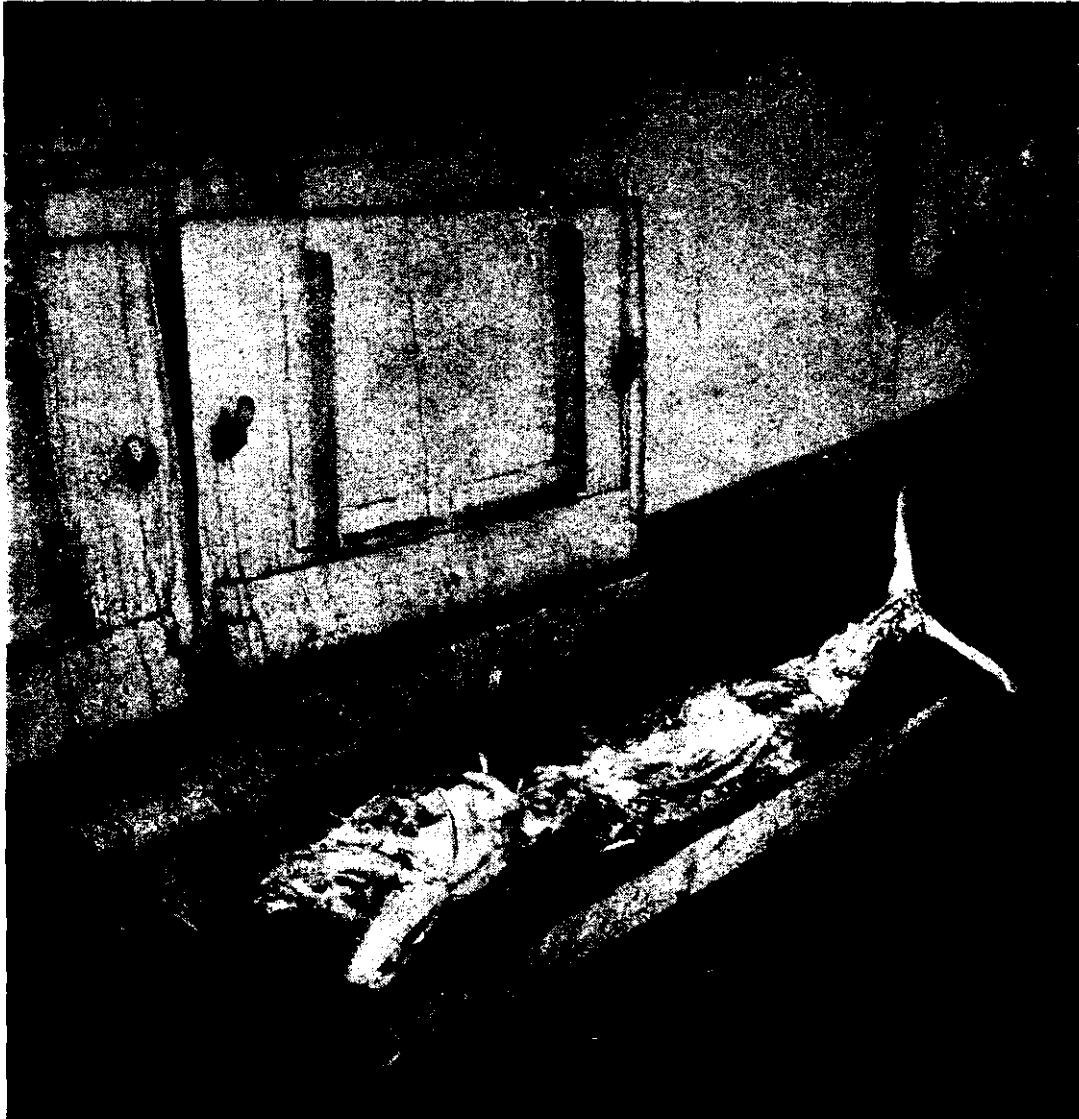
FIG. 1

Slight condenseritis had been experienced soon after the ship had been accepted, but this was followed by several months of trouble-free running. The starboard condenser, however, developed a nasty trick of shedding its main inlet gratings soon after undocking. The first indication of this was provided in an amusing way before leaving a shallow water berth at Tokyo, when on opening the starboard strainer box, in addition to the normal small live fish, a 40 lb barracuda was found, in two portions (Fig. 1). The small

fry were rapidly cooked and devoured by the Chinese stewards, but the barracuda had gone a considerable way towards joining its ancestors, and required very early disposal. On another occasion, on attempting to shut the starboard main inlet valve for a routine condenser examination, debris from Hong Kong harbour had collected under the valve disc, preventing it shutting. By screwing up on the small screw at the bottom of the valve box, and running the circulator at full speed with the main outlet valve wide open, an 8 inch length of 2 in \times 2 in timber was forced clear and later retrieved from the strainer box.

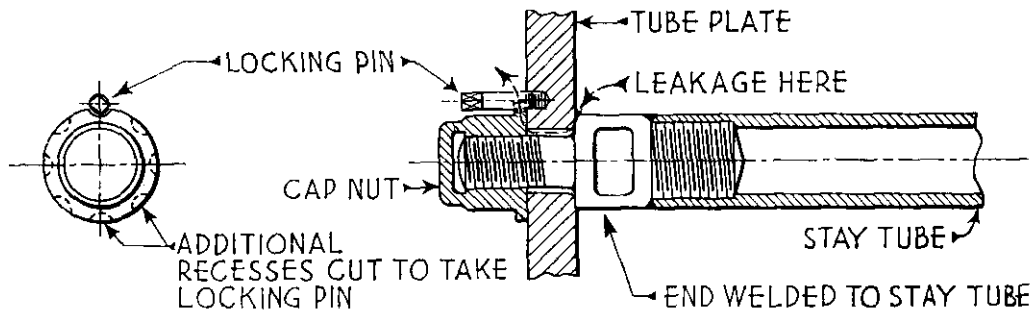
FIG. 2

The condenseritis in *Cossack* still persisted. It seemed possible that leakage was taking place at the stay nuts. Each stay nut was therefore removed in turn, its face machined true, and additional small nicks cut round the periphery of the "flange" (Fig. 2). This allowed each nut to be taken up hard and still admit the locking pin. Jointing paste was used.

In the course of carrying out this test it was noticed that there were heavy rust streaks on the inner sides of the tube plates from below such stay tubes as were visible. It was quite evident that sea-water leakage had taken place into the condenser around the stay tube stub-ends despite the work done on the stay nuts described above. The decision was therefore given that both condensers were to be re-stayed. This, of course, entailed the removal of all tubes (7,900 total in the two condensers), the tube plates and all auxiliary machinery in front of the condensers. The heavily-loaded Hong Kong Dockyard estimated three months for the job, and in fact achieved it in exactly that time, during the hottest part of the summer.

The cause of the leakage was found to be some very rough machining of the faces of the stub ends butting on the inner sides of the tube plates (Fig. 2). New stub ends were screwed and welded into the stays. Some difficulty was experienced in making the assembled stays the correct length, as the tube plates now free of constraint, were found to have an appreciable curvature. Each stay assembly had therefore to be fitted individually for length. The air ejector baffles bolted to the tube plates were found to be $\frac{1}{16}$ in short of the tube plates inner faces, and were corrected by washers to avoid distortion of the tube plates.

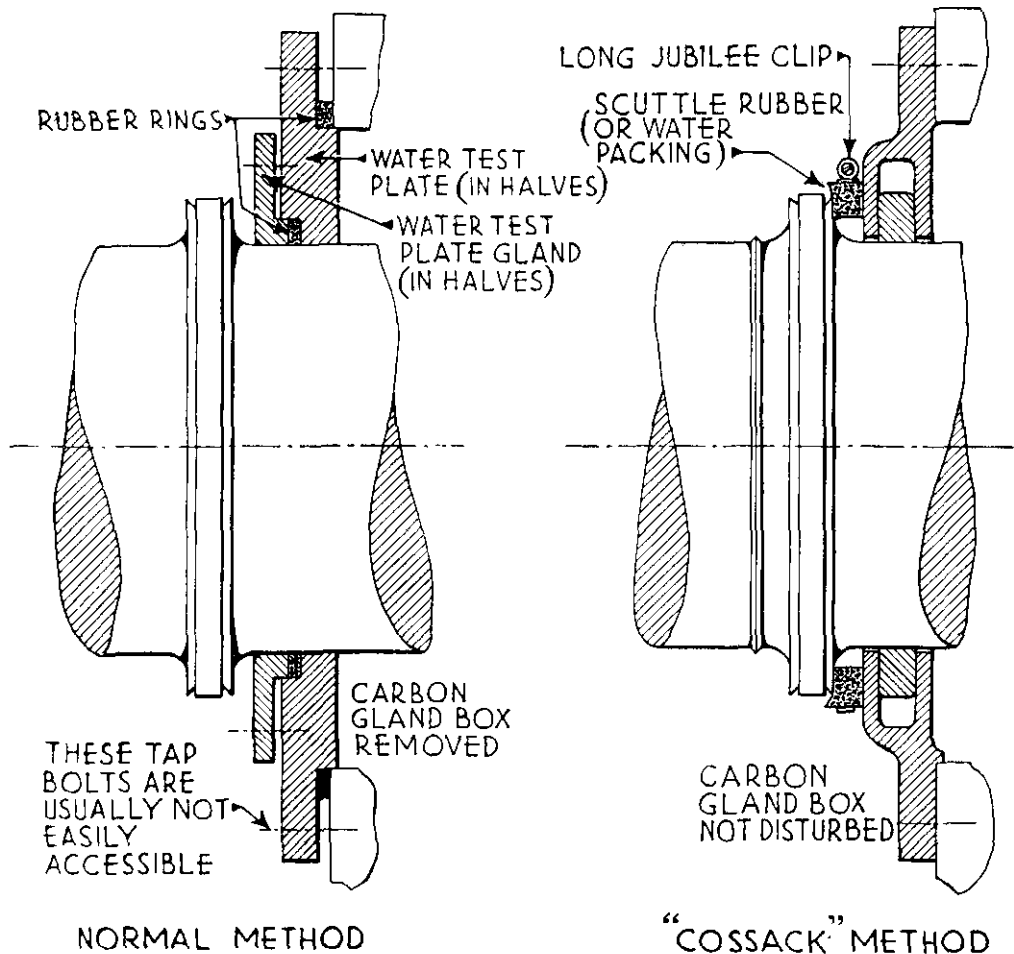
APPENDIX 1

“Cossack” Method of Packing Turbine Glands for Testing Condensers

Insert suitable length of scuttle rubber or similar material between oil thrower and carbon gland box : tighten in place with a long Jubilee clip.
