NOTES ON MACHINERY DEFECTS AND PRACTICE.

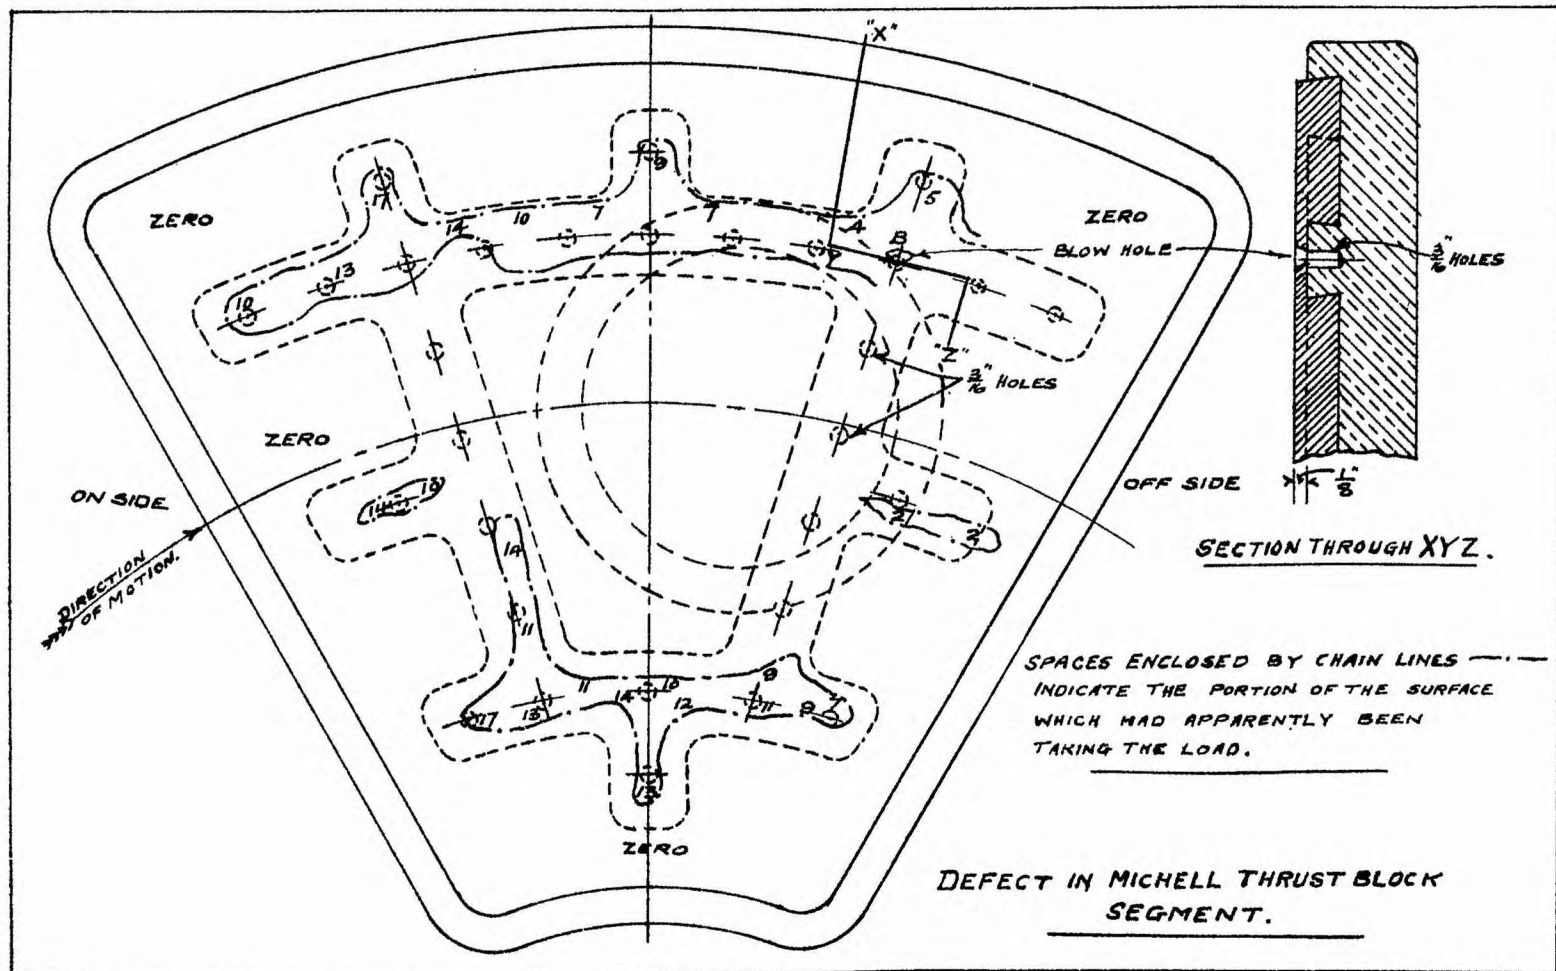
An investigation of the failure of a segment from a Michell thrust block of a 5,000 k.w. generating set yielded a somewhat curious explanation which proves of interest, if only in emphasising the principle of action of this class of bearing. The sketch shows the contour of the white metal surface as received, the figures thereon indicating in thousandths of an inch, the height

of the surface above or below what appeared the original surface. It will be seen that a considerable proportion of the bearing surface is below the datum level and the appearance of the surface indicated that this portion had not been under load. Portions of the white metal surface in the wake of the ribs were carefully removed and revealed the facts that there was a considerable amount of oil behind the white metal in these positions, and that the metal was only about $\frac{1}{8}$ in. in thickness and had not adhered properly to the gun metal. Further, that the white metal had not penetrated into the peg holes provided for anchoring the metal. Exploration of the white metal from the thicker portions of the white metal away from the ribs also showed that the metal had not adhered and oil was also found.

A blow hole in the white metal was also found in the position marked B.

The explanation of the defect was that the oil under pressure generated between the thrust collar and this pad entered the blow hole at this region of relatively high pressure, found its way between the white metal and gun metal and, acting on the thin portions of the white metal, forced these portions into relief. This view is supported by the fact that the elevation of the metal is greater towards the "on" side of the pad which is to be expected, seeing that the oil film pressure is less towards the "on" side, whereas the internal oil pressure leaking by way of the blow hole between white metal and gun metal would be equal to the higher oil film pressure generated in the region of the blow hole.

This defect indicates the importance of taking the utmost precautions to ensure effective adhesion between the white metal and the gun metal by careful tinning and preheating of the brass to avoid sudden chilling of the white metal when running. It indicates also that the thickness of metal allowed over the supporting ribs is insufficient and that the method of anchoring by peg holes of this size is not likely to prove an effective one.
