EXAMINATION OF FRACTURED COPPER OIL-FUEL PIPE.

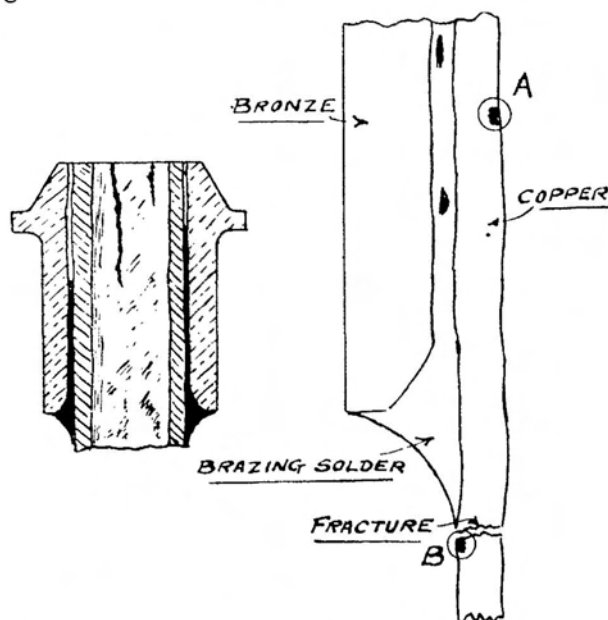
The nipple with the broken end of the pipe was cut open and examined. The appearance of the interior surface of this part of the copper pipe is indicated in the sketch. This surface was covered with a black deposit which was partly oily carbon and partly black oxide of copper. Beneath the oxide the metal was finely roughened as is the usual result of oxidation. The interior of the copper pipe inside the nipple was uneven in a very marked wavy manner, probably as the result of hammering to make the end of the pipe fit the nipple, and near the end were a number of longitudinal cracks, some of which extended nearly half the length of the nipple.

Two photographs, Figs. 1 and 2, Plate I., show the structure of the copper tube in the positions marked A and B respectively on the enlarged view of a longitudinal section of the copper pipe, the brazing metal and the bronze nipple.

The brazing metal, except for a few holes, formed a fairly continuous layer between the bronze and the copper over, on an average, about two-thirds of the length of the nipple, and apparently formed a perfectly tight joint, the metal being well alloyed to both bronze and copper. At the junction of the brazing metal with the copper, i.e. at the place where the fracture occurred, the thickness of the copper tube had been reduced slightly by filing, and it will be noticed that where the brazing metal is thickest and where, presumably, it was hottest, the

thickness of the copper tube has been further reduced by alloying.

With regard to the general quality of the copper pipe, examination shows that this was of sound copper in the soft condition. There is no sign of general "burning" of the copper in the neighbourhood of the brazed joint. The interior surface inside the nipple, however, shows some signs of "burning"—or probably, more correctly, "gassing"—but this extends only a short way into the tube (as shown in Fig. 1), and may possibly have resulted after the fracture occurred. There are also visible a few small cracks in one place on the outer surface of the tube, just below the brazed joint and at the point where fracture occurred. This is shown in Fig. 2. Although the general structure of the pipe shows that the copper is in the annealed condition, the crystals near the braze are of considerably larger size than those of the rest of the tube, indicating that during the brazing the copper had been subjected to a higher temperature than that of the ordinary annealing operation.

It should be pointed out that at the point where fracture occurred the stresses due to any vibration of the pipe would probably be at a maximum, owing to the end of the pipe being held rigidly in the nipple. In any case, therefore, if fracture is to occur, the chances are that it will take place at this point, *i.e.* just at the commencement of the brazed joint, where there is the sudden change from the comparative flexibility of the copper pipe as a whole to the stiffness of the end held firmly in the nipple. In view of this, it is evident that any weakening of the pipe in this region is to be avoided. In the present case

the evidence of any burning or gassing of the copper during brazing is not strong, since the superficial effect of such action noticed on the interior surface of the pipe inside the nipple may have been produced after fracture occurred, while the slight cracking and weakness on the outer surface of the metal, illustrated in Fig. 2, was not general. On the other hand, slight as such injury may have been, it must, together with the coarser crystalline structure of the copper in the neighbourhood of the brazing compared with that of the rest of the tube, be considered as a source of weakness. A more serious fault which the dissection of the nipple revealed is the mechanical injury due to the rather severe treatment of the end of the pipe in its preparation for brazing into the nipple. It seems to have been very roughly hammered, and the amount of filing seems to have been unnecessarily large and roughly done.

The conclusion is, therefore, arrived at that the brazing operation in this case had not been carried out in an entirely satisfactory manner.
