REPAIR OF TURBINE ROTOR.

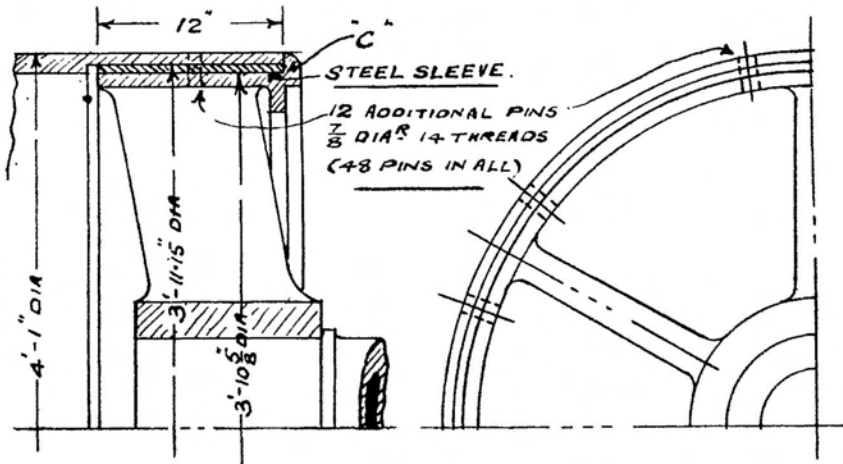
The somewhat unusual case where the attachment between the forward wheel and the drum of an L.P. turbine of an "M" class T.B.D. (fitted with the three-shaft arrangement of machinery with Parsons turbines), became loose on Service, affords an interesting example of a quick repair. Examination, when hot, showed that clearance up to about 10 thousandths of an inch existed between the drum and the wheel rim in two places extending about 18 inches around the circumference. On opening up the turbine and examining the rotor cold, it was found that the circumferential collar at the forward end of the wheel, marked C in the sketch, was close to the drum at the top, but open at the middle line about 25 thousandths, which would represent 50 thousandths at the bottom.

The rotor was turned round in its bearings, and in every position the collar butted the drum at the top, indicating that the turbine wheel was slack in the drum and that the securing pins had failed. On removing the wheel in the shops it was found by careful measurement to be from 8 to 10 thousandths slack in the drum.

It was decided to carry out the repair by reducing the diameter of the wheel rim somewhat and boring out the drum slightly, thus permitting a steel liner to be shrunk on the wheel rim, the liner being made up from 1/2-in. plate, with a welded joint, turned down to the required thickness. The shrinkage allowed for fitting the liner upon the rim was 30 thousandths, and it was further secured to the wheel rim by several 3/8-in. pins.

The wheel and the spindle were then put into the lathe, and the rim turned down to the dimensions required. The rotor drum was similarly treated, the forward end being supported in a stay; the diameter of bore was arranged to be such as to provide for a shrinkage of 45 thousandths. The holes in the drum for the securing pins were increased from $\frac{3}{4}$ -in. diameter to $\frac{7}{8}$ in., fitted with fine threads, and 12 additional $\frac{7}{8}$ -in. diameter pins were provided in the positions indicated.

After assembly, the rotor was put into the lathe and found to be out of truth at the forward end by 13 thousandths, and at the main bearing by 4 thousandths. The spindle was then turned true to the drum, being thus reduced by 5 thousandths in diameter at the main bearing journal; the cone at the forward end of the spindle (cruising turbines were fitted forward of the L.P. turbines) had also to be slightly reduced in diameter to bring it true with the drum, the result being that when the claw-piece of the flexible coupling was refitted it took up a position $\frac{3}{16}$ in. aft of its original position. This difference was machined off, the after end of the claw piece and a plate of the same thickness was fitted to the forward end.
