REPAIR TO L.P. VALVE FACE OF TRAWLER.
FIGURE I.-SHOWING DEFECTS.

REPAIR TO AN L.P. CYLINDER OF A TRAWLER.

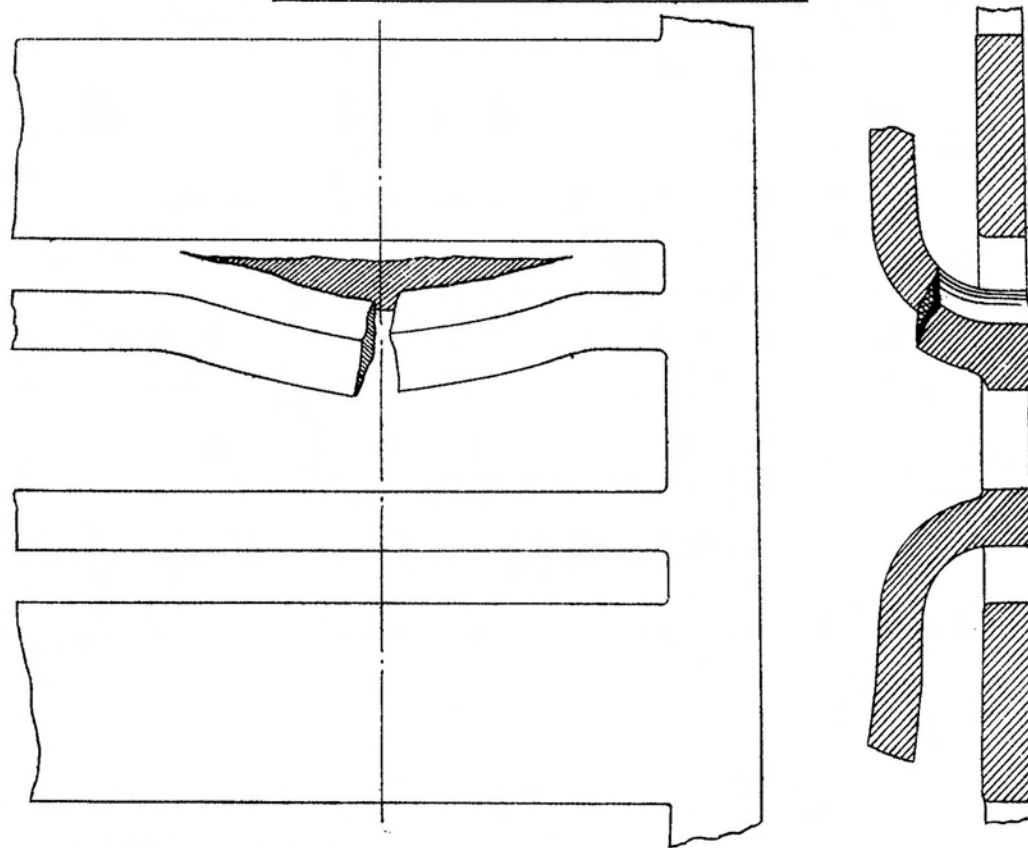
The damage was caused by a spanner which had been placed at the top of the steam port during an examination of the L.P. piston rings, and which had slipped down the port unnoticed by the ratings employed on the work. The turning of engines by hand on the completion of the work failed to indicate any obstruction, but during a basin trial preparatory to putting to sea, the spanner was carried into the slide valve with resultant damage to cylinder port and slide valve (*see* Fig. 1).
