EXPLOSION OF A STEAM DRUM OF A WATER-TUBE BOILER, LAND TYPE.

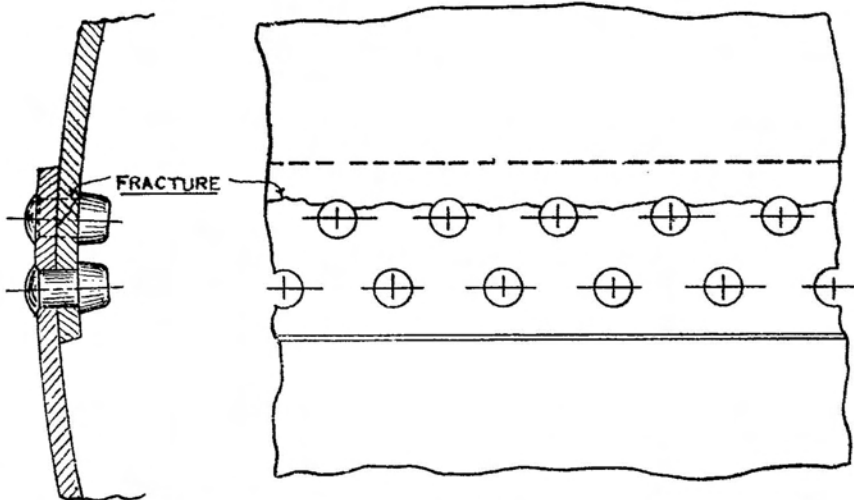
There was nothing unusual in the design of the boiler and it is therefore only necessary to consider the defective steam drum. This drum, which was 54 ins. diameter, was built up of three belts of $\frac{1}{2}$ -in. steel plates, the two end belts being lapped over the centre belt at the circumferential seams. These seams were single-riveted. The longitudinal seams of the belts were double-riveted zig-zag, with a total lap of seam of $4\frac{1}{2}$ -ins. These

longitudinal seams were situated in the steam space and were all above the normal water-level maintained in the boiler. The two seams of the end strakes of plate were on one side of the drum and the centre strake seam diametrically opposite.

As far as the case can be reconstructed, the crack in the plate started at the inside edge where hidden by the lap and probably at the time of the caulking, it may have already been at places through the plate, although not observable at the internal surface. This fracture gradually extended the greater length of the plate till the reduced section was insufficient to stand the stipulated working pressure. After the explosion the longitudinal seam of the back-end ring of the drum was cut out complete by means of the oxy-acetylene flame, and all the rivets were then carefully drilled out and the two pieces of plate forming the lap separated, the one from the other. These pieces of plate were thoroughly examined in strong sunlight with a magnifying glass, but no fractures could be discovered. This seam had the

same characteristics of workmanship as the others, and so far as could be seen was influenced by the same circumstances and conditions as the one that failed, but had not developed the slightest sign of a crack. At the fractured seam, a portion of the underlap, almost the full length of the plate, was left in place held on by the inner row or rivets. The rivets were all carefully drilled out in a machine, and the pieces of plate separated. Before they were separated there was but very slight indication of cracks apart from that which caused the main failure, but as soon as the plates were separated and the inner surfaces exposed, a series of small fractures were discovered radiating principally but not entirely, from some of the rivet holes. The cracks all started from the surfaces of the plates that were in contact at the lap. These small cracks could not have been seen in the ordinary way, even with a careful examination when the drum was in position before the explosion, unless some suspicion had been aroused at the time of the leakage of the seam, but having regard to the fact that leakage from the riveted seams of boilers is not an uncommon occurrence, it was not held at the time to be an occasion for polishing and microscopical examination internally. Although the examination therefore revealed that the cause of the explosion was due to the slow failure of a plate, which was shown to be brittle, in the neighbourhood of the part that failed, the exact stage at which this brittleness was brought about, either in the original manufacture, or construction of the boiler, was not established.
