## FAILURES OF DETAILS OF MACHINERY AND BOILERS SUBJECTED TO STEAM PRESSURE.

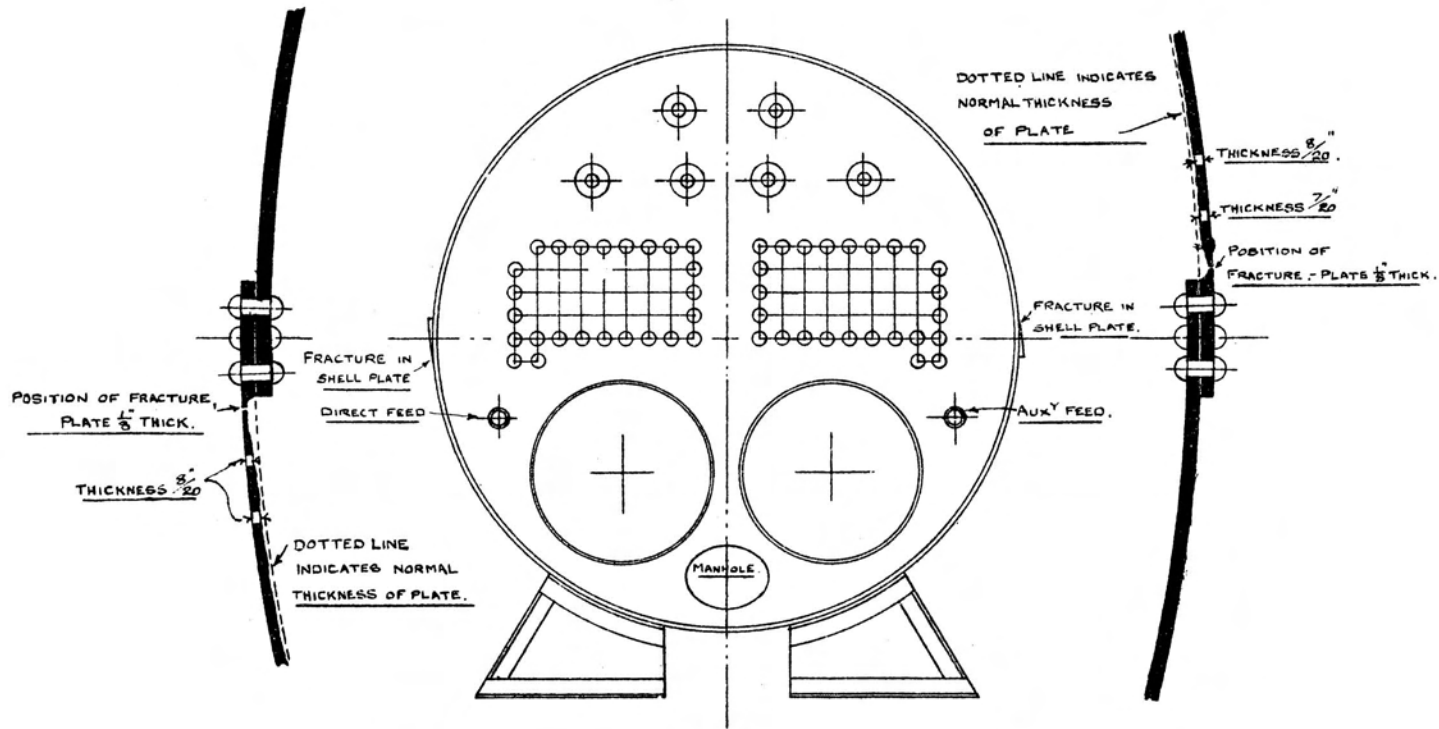
FIGURE 1.

20 years old at the time of the explosion. The cause of the failure was the wasting of the shell plates, in particular at the lap joints, in consequence of which the boiler was unable to withstand the pressure of steam to which it was subjected. The explosion was very violent and attended with a fatality and much material damage.

The boiler had been tested hydraulically to  $1\frac{1}{2}$  times the working pressure after retubing, less than 2 years previously, and had been certified about 12 months before the failure as approved for its stipulated working pressure of 80 lbs. per sq. inch as the result of a thorough internal examination. The general structure of the boiler and enlarged views at the lap joints are shown in Figure 1, and the non-observance of the serious corrosion seen requires a little explanation.

Unfortunately there was no evidence of any defects having been observed during the re-tubing when the facilities for a very thorough examination existed, and when it is considered that some wasting should have been revealed in the neighbourhood of the lap joints. When examined later with the tubes in position it will be noted that the wasting at the port side in any case would not be observable, whilst that on the starboard side, although somewhat more accessible, was likely to pass unobserved if the wasted plate presented, as it did, a comparatively smooth surface down to the lap. Conclusive evidence could, however, have been obtained if a drill test had been carried out and positions in the neighbourhood of the lap joint had been selected. The Surveyor was probably also misled by the fact that he observed no pitting on the lap, stays, etc., and, therefore, suspected no wastage.

A Surveyor who was employed to investigate the cause of failure had had considerable experience in these lap-jointed boilers, and the result of his experience is that the lap-joint inasmuch as it takes the boiler out of the circular form to the extent of the thickness of the lap, sets up a breathing action, the axis of which is at the joints and that this produces a wasting of metal, reducing it not only in thickness, but also in strength owing to the fatigue of the metal caused by the constant movement. Action of a similar nature has been found from experience to take place in fittings in the naval service, viz., the D-shaped water pockets of boilers.

As a matter of fact it can be demonstrated that in the absence of fatigue in the metal, the boiler in spite of the reduced local thickness of the plating could have withstood the pressure at which it burst. The opinion was expressed that the corrosion arising from the breathing action would after it had reached an advanced stage, become very rapid and that considerable extension had probably occurred in the time following the hydraulic test two years previously.

BOILER EXPLOSION DUE TO WASTING OF SHELL PLATES.

The conclusion arrived at was that boilers of this size and thickness of metal with lap joints must be considered as having a shorter life than those with butt-strap joints in which the

circular form is preserved, and that the life can only be permitted to be prolonged if the condition of the shell plates about the lap joints is closely watched. Absolute reliance cannot be placed on a hydraulic test and, moreover, if local wasting has taken place, the boiler may be strained by subjecting it to excessive pressure. The hydraulic test to be applied should depend on a knowledge of the thickness of the parts being tested, and it can then be used to verify the proper working pressure as previously estimated by calculation, depending always upon the margin of safety desired or demanded.

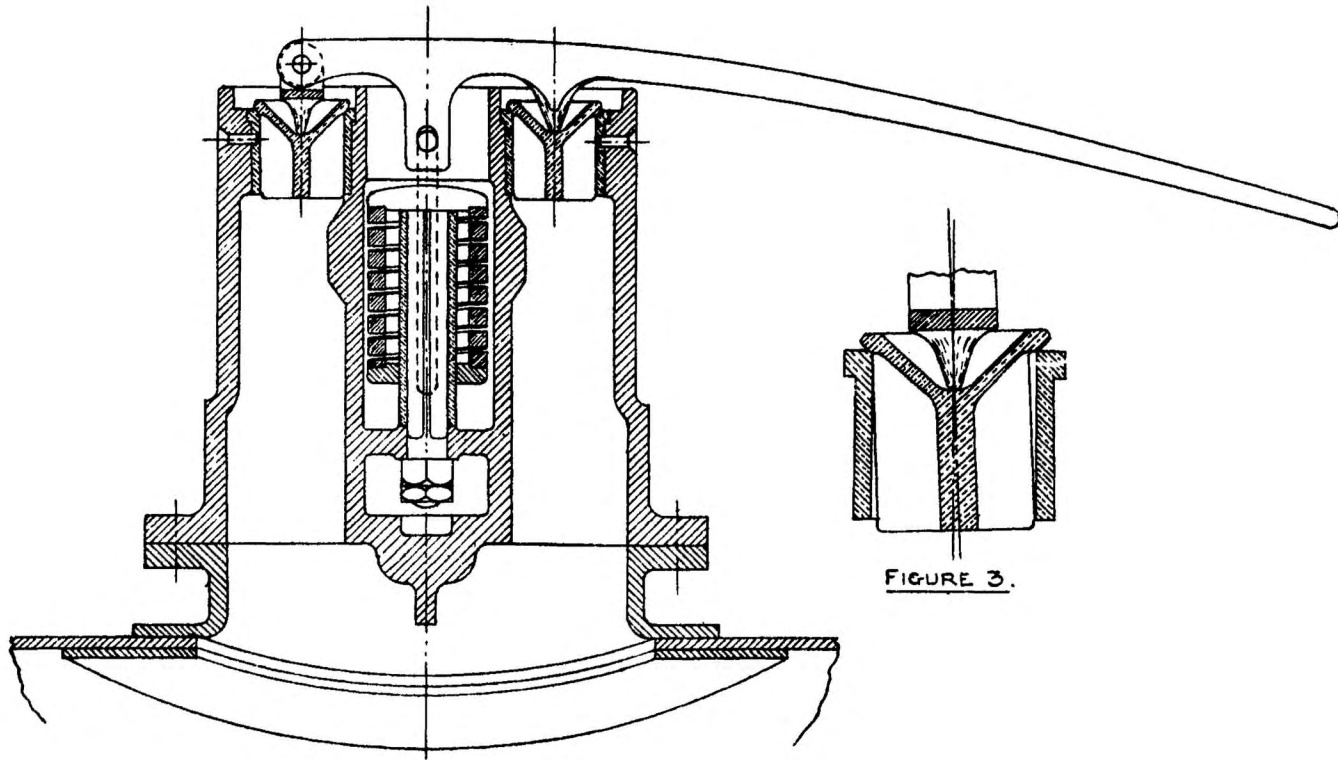
FIGURE 2.

The safety valve was of the ordinary duplex type, Fig. 2, the casing being of cast iron and the valves and valve seatings of brass. The valves were provided with three webs and fitted with conical recesses at the tops to ensure that the pressure of the spring was applied centrally. The examination of the valves after the explosion revealed the following relevant details. The width of the bearing surface of the valves seat was  $\frac{1}{8}$ -inch and the angle between the webs and the valve face was  $150^\circ$  in each case. (Such a steep angle is not desirable in valves and particularly in safety valves. To obtain the maximum area of valve opening for a definite lift, and to minimise the wedging effect of a conical seat, it is desirable in safety valves to have an angle of  $90^\circ$  as is always the case in the naval service.) The webs of the front and back valves projected  $\frac{5}{16}$ -inch and  $\frac{3}{16}$ -inch through their respective bushes, the ends of the webs were not bevelled and the marks of the webs were visible in each bush. The valve seats were not truly circular and the webs of the valves were not uniform in diameter, the minimum clearance between valve webs and the respective bushes being  $\cdot0095$  inch for the front valve and  $\cdot012$  inch for the back valve when the valves were cold. This clearance is small and would be less under working conditions.

The main contributory cause of the non-functioning of the safety valves was the small clearance between the valve webs and the seats when cold; the difference in the expansion of the cast-iron chest and the brass valves and seats and probable distortion of the latter would reduce this clearance under steam to a dangerously small amount, accentuated if, as was the case, the air temperature was low at the time. It was noted that the pressure gauge had at times been previously reported defective by the drivers, always during cold weather, but no complaints had been made during warm weather when the valves would appear to have operated satisfactorily. If the valves were not free to lift owing to the binding of the webs at normal lifting pressure, any increase of pressure and corresponding temperature of the steam would tend to bind the valves more firmly. It was obvious that the dividing line between freedom and jamming of these valves was very fine, and that a combination of several factors, of which the cold weather was one, was required to produce a dangerous condition. Another contributory cause appears to have been due to the valve faces being machined to a steep angle resulting in the valves being lowered in their bushes. This would not in itself necessarily lead to any danger, but such steep angle may have facilitated slight tilting of the valve and the possibility of increased resistance to lifting being set up owing to the pro-longations of the webs bearing against the lower corners of the valve bushes (Fig. 3).

LOCOMOTIVE SAFETY VALVE.

Apart from the number of the small defects in the valves the disaster would in all probability have been prevented if two pressure gauges had been fitted to the boiler, a desirable arrangement in important units, as it is not conceivable that two such gauges recording similar pressures would be looked upon as less reliable than a safety valve. In any case unless a pressure gauge is known to be defective, the non-lifting of the safety valves at the stipulated pressure evidently requires immediate investigation. It is, perhaps, difficult to conceive a failure of this nature in ordinary installations as the presence of pressure gauges on the ranges would generally indicate if excess pressure were being generated in the boiler, but in the case of a locomotive or similar arrangement there is no direct indication of this nature.
