REPAIRS.

H.M.S. "VANCOUVER."

REPAIRS TO PORT SHAFTING CARRIED OUT AFTER COLLISION.

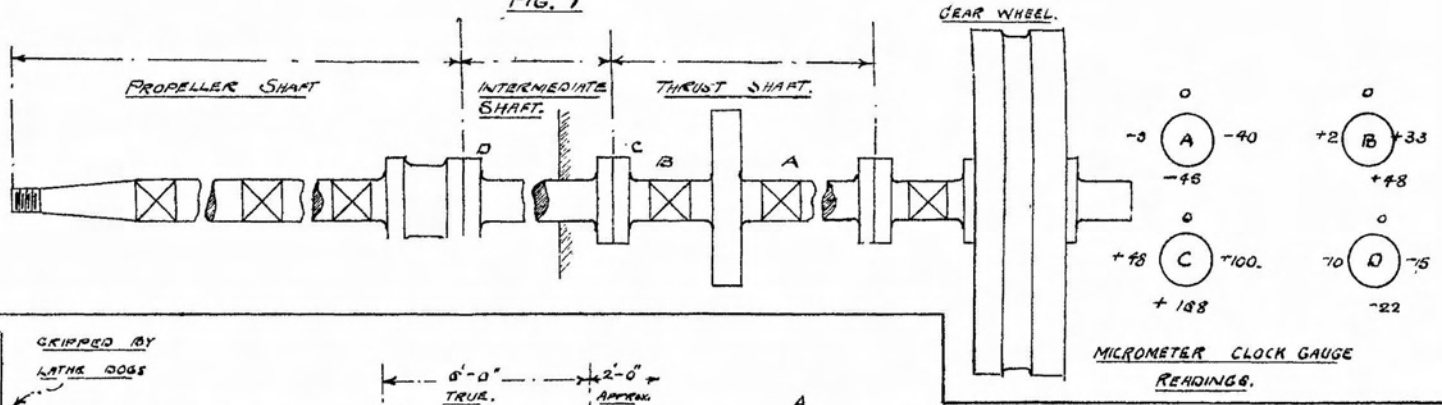
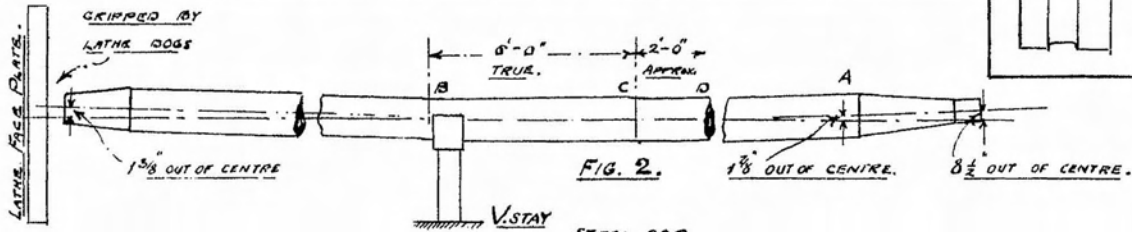
FIG. 1

When docked at Portsmouth, Micrometer clock gauges were placed in positions A, B, C, and D, with the result shown in figure 1. This gauging showed both shafts to be bent—the intermediate shaft being 0.084 " out of centre, and the thrust shaft 0.023 " and 0.024 " out of centre respectively at the forward and after journals. Both these shafts together with the propeller shaft were then removed from the ship for straightening.

From this wire, the "A" bracket was found to be slightly twisted in both the vertical and horizontal plane—the maximum amount of eccentricity being $\frac{3}{32}$ ". It was decided not to reset the "A" bracket, but to correct the error by boring the "A" bracket bush to thickness gauges made from place when the shaft was placed in position after straightening.

The ship had reported that the port thrust block moved on its seating when trying engines after the collision, and the alignment of block was therefore checked. It was ascertained that the thrust block was lying outboard $\frac{1}{2}$ " (full) from the centre line shown by the wire. The thrust seating was carefully examined but no signs of distortion could be found. As it was necessary to remetal the thrust shaft plummer bearings and

pivot bearings of the Michel thrust owing to skimming of the journals after straightening, it was decided (as an alternative to broaching bolt holes and fitting new thrust block holding down bolts), to fit eccentric bearings to accommodate the error in athwartship position of the thrust block.

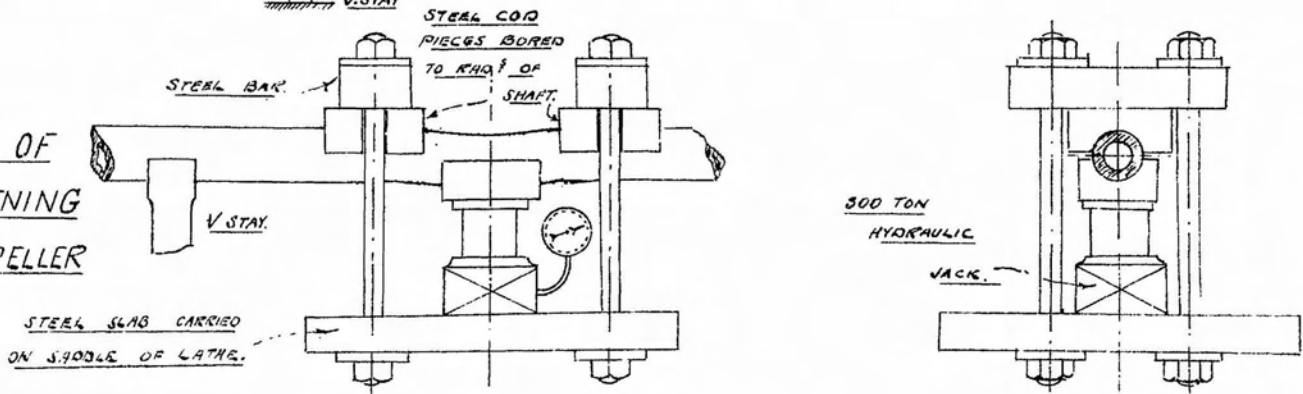
METHOD OF STRAIGHTENING A BENT PROPELLER SHAFT

The shafts were sent to the shop for straightening. An examination there with straight edges showed that the tail shaft was bent through practically the whole length with the exception of about 6 ft. near the middle of shaft which was true, the portion immediately forward of propeller cone having the greatest angle (about 20°). The shaft was placed in the lathe, the forward end being gripped central in dogs and the forward end of straight portion placed in a "V" stay; the shaft was then revolved and it was found that the after end of straight portion was running out of truth; the portion gripped in lathe dogs was then moved out of centre until the 6 ft. straight portion was running true and it was found that the shaft was then lying in the lathe as shown in Figure 2.

Straightening of tail shaft.—The points "B" and "C" on Figure 2 are respectively the forward and after ends of the 6 ft. straight portion, and "D" is a position immediately aft of the $10\frac{1}{2}$ -in. steel cross beam.

The hydraulic jack was placed directly beneath "C" and shaft was revolved until bend at "D" was pointing away from jack. The top nuts were screwed down hand tight and the load put on by jack; this in the first instance raised shaft off stay and then commenced to bend shaft at "C"; the amount of set put on shaft was noted by means of scribing blocks and when slightly less than required amount, reading of pressure gauge was noted; the load was released; the top nuts eased back and cod pieces lifted clear of the shaft; shaft was then turned in lathe and amount of bend remaining at "D" was noted. An increased load indicated by the reading on pressure gauge, was then put on shaft and a further check made; this process being continued until portion "C," "D" was running true.

The slab was then moved along lathe bed by means of saddle, until jack was immediately below commencement of next bend; the foregoing process repeated and so on to the end of the shaft, new cod pieces being provided for the cone portion as necessary.

On completion of the straightening of the after end, the shaft was reversed in lathe, and straightened end being gripped in dogs and set true and position "B" resting in "V" stay. The straightening operation was then repeated on the forward end of shaft.

It was found that a load of 230–250 tons was sufficient to straighten shaft cold with the exception of portion "A" at the forward end of propeller cone. This part was beyond capacity of hydraulic jack to deal with when cold, owing to the large angle of bend, and it was therefore heated to a dull red by paraffin blow lamps and could then be straightened with a pressure load of 280–290 tons. The diameter of shaft was $12\frac{1}{4}$ in.

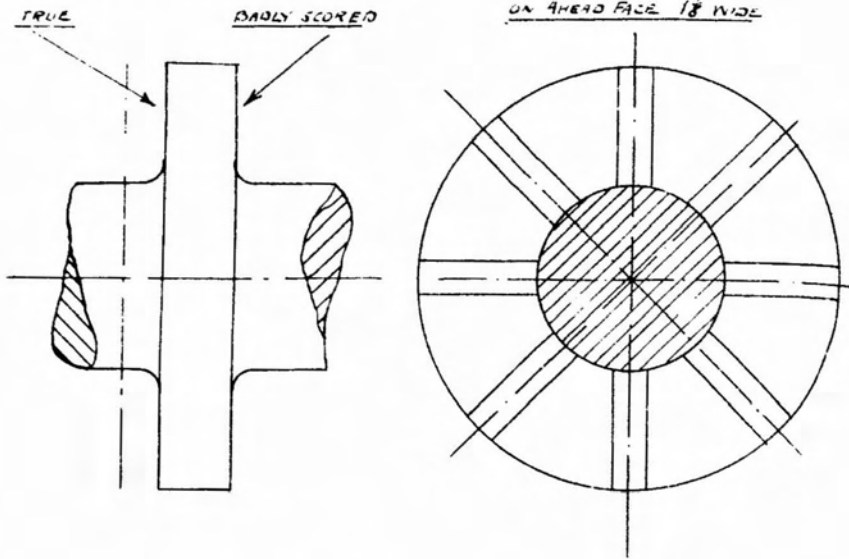
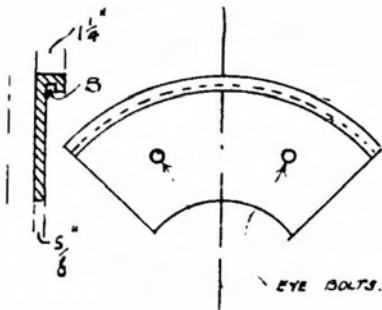
FIG. 1

A modern Geared Turbine Destroyer came into port reporting that its Port Main Thrust had become excessively heated and that the whitemetal had run from the pads. On examination it was found that the metal had run from the Thrust Pads on the Ahead Side, choking the lubricating oil pipes, etc. The Ahead face of the collar was deeply grooved over its entire surface but not regularly, one groove extending around nearly the complete circle and reaching a depth of $1\frac{3}{10}$ in. at its maximum.

The damaged surface was first divided into eight sectors as indicated in Figure 1, and grooves $1\frac{1}{8}$ in. wide filed so as to get below the scored surface. By repeated trials it was ascertained that $1\frac{3}{10}$ in. would need to be removed from the entire face in order to obtain an acceptable working surface.

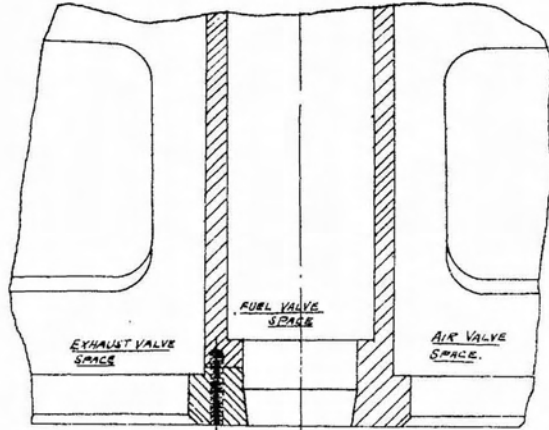
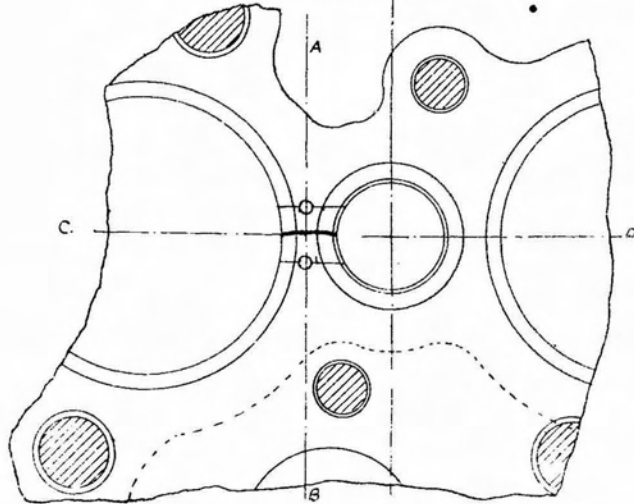
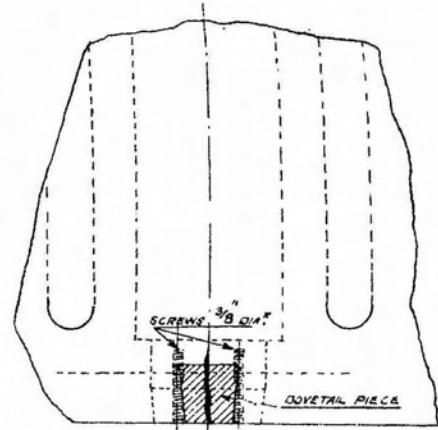
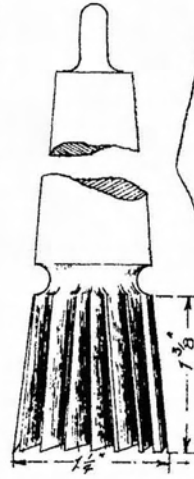
METHOD OF REPAIR OF
FRACTURED DIESEL
CYLINDER HEAD

In the Diesel Electric Generating Machinery of a Capital vessel, the frequent development of cracks in the cylinder heads in the metal of the region bounding the exhaust valve spaces on the under side, permitted the exhaust gases to pass through the crack into the space between the exhaust valve cover and the cylinder head, thus leading to erosion of the seating between them, and ultimately to erosion of the exhaust valve itself, and so to loss of compression and misfiring. In some cases cracks also appeared in the metal between the air inlet space and fuel valve space, but this was a development following the growth of the crack in the exhaust space. The circumstances being such that a sufficiency of spares could not be assured, the following method of lengthening the life of the defective heads was followed with success.

As soon as a crack became evident, the head was removed and the material in way of the crack removed for a depth extending to about $\frac{1}{8}$ in. beyond the seating of the exhaust valve cover. The machining was commenced with a 1-in. drill and finished with a bevelled milling tool. A piece of cast iron of dovetailed shape was then fitted carefully in the milled groove, and secured from movement by two in number $\frac{3}{8}$ -in. grub screws about $1\frac{3}{8}$ in. in length. The cast iron stop piece was then filed to the circular form of the pocket, and the exhaust valve cover seating was trued up with a morse cutter, which as in the case of the milling cutter was made on board.

The drawing shows the details of the method and the milling tool.
