## DAMAGE AND REPAIR OF AN IMPULSE TURBINE.

The following account of the partial stripping of an H.P. turbine in one of H.M. ships, together with a brief description of the subsequent repairs, is of interest as an example of the importance of investigating the cause of any unusual vibration.

### DEFECT IN A HEAVY OIL ENGINE.

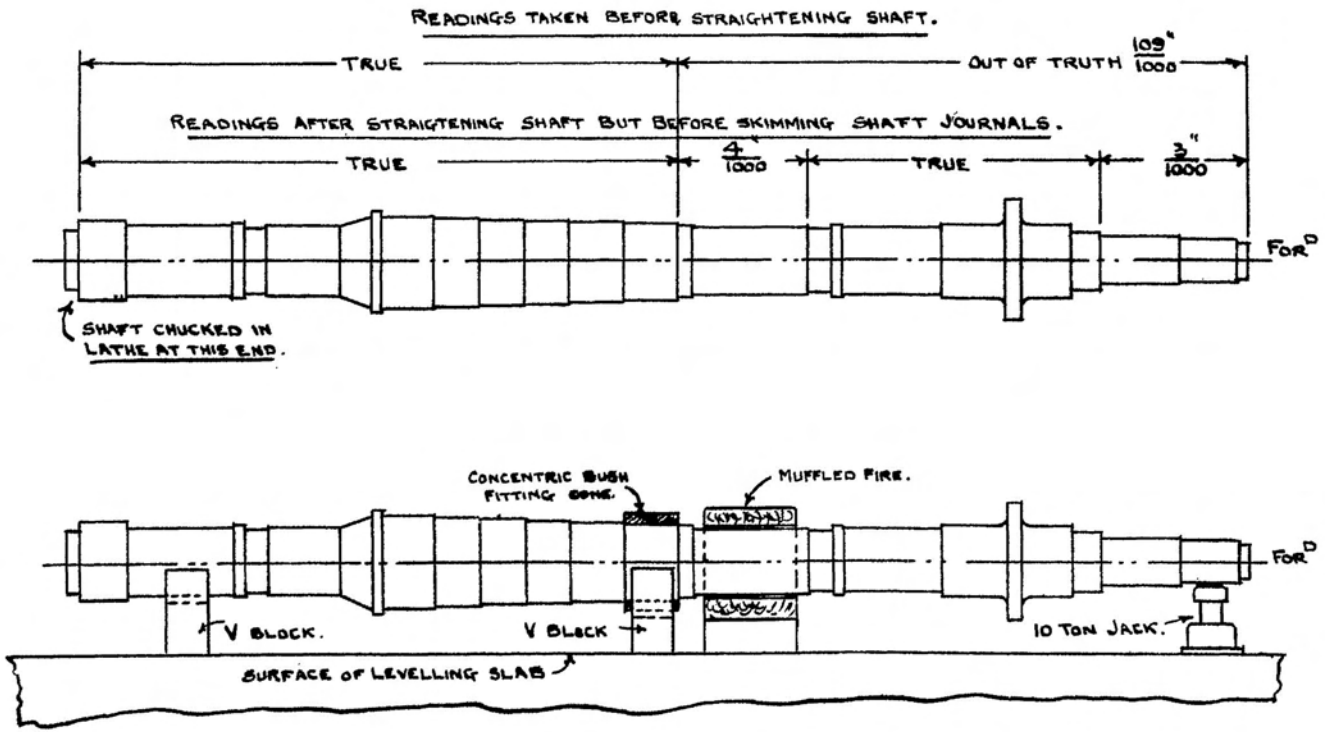
FIGURE 1.

SKETCH SHOWING METHOD OF STRAIGHTENING A BENT ROTOR SPINDLE.

*Rotor Spindle.*—The spindle was discovered to be bent to a maximum of  $107/1000$ " between the first stage wheel and the forward end of the shaft, as indicated on Fig. 1. The spindle was worn by  $39/1000$ " and  $18/1000$ " in way of the forward and after carbon glands respectively.

After removing the rotor wheels and diaphragms from the shaft, the after end was secured in the chuck of a lathe, a steady bearing being provided at that part of the shaft which carried the first stage wheel. Under this condition the shaft between the lathe chuck and the steady (A and B) was true within 1/1000" while the extreme forward end, which was unsupported, was 109/1000" out of truth (Fig. 1).

A bush was then turned to fit tightly on the shaft in the place of the steady bearing, the outside of the bush being concentric with the bore of the shaft. The shaft was removed from the lathe and set up in V blocks laid on a suitable straightening slab, one block supporting the after shaft journal, while the other was placed under the bush. A strong back was fitted for use at the latter point, and a muffled fire arranged under the shaft at the position at which the bend commenced.

The shaft was then slowly heated and at the same time revolved on the V blocks. When sufficiently hot, the fire was removed and the shaft firmly bolted down by means of the strong back, straightening being effected by means of a 10-ton jack applied under the shaft between the bend and the forward end. The operation of heating and jacking the shaft was carried out several times until the error had been practically eliminated.

The truth of the shaft was then ascertained by placing it in a lathe with the after end in a chuck, the bush being supported in a steady, leaving the forward end of the shaft free. Under

these conditions the shaft was true within  $3/1000''$  at the extreme end. After the bearing journals and the badly scored portions of the shaft in wake of carbon packing had been machined, the shaft was revolved in supports placed at the main bearings and found to be true with  $1\frac{1}{2}/1000''$ .

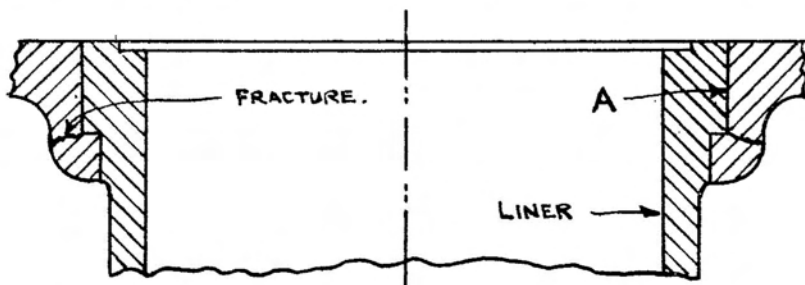
Removal of the liner revealed the fact that the portion of the cylinder casting which supports the upper portion of the liner had fractured in a complete ring along the section indicated in the figure. The fracture was clearly of long standing and undoubtedly was the cause of the initial drop of the liner.

It appears evident that the liner was retained in its displaced position by the effects of friction at the part A and at the lower joint, this being sufficient to meet the normal axial stresses. On the occasion of the final accident however, it is probable that an overcharge of fuel on starting gave rise to abnormal pressures with the result that the liner was forcibly ejected till the skirt came in contact with the crankhead bolts.
