REPAIRS.

(i) REPAIR TO FIRE AND BILGE PUMP CYLINDER COVER.

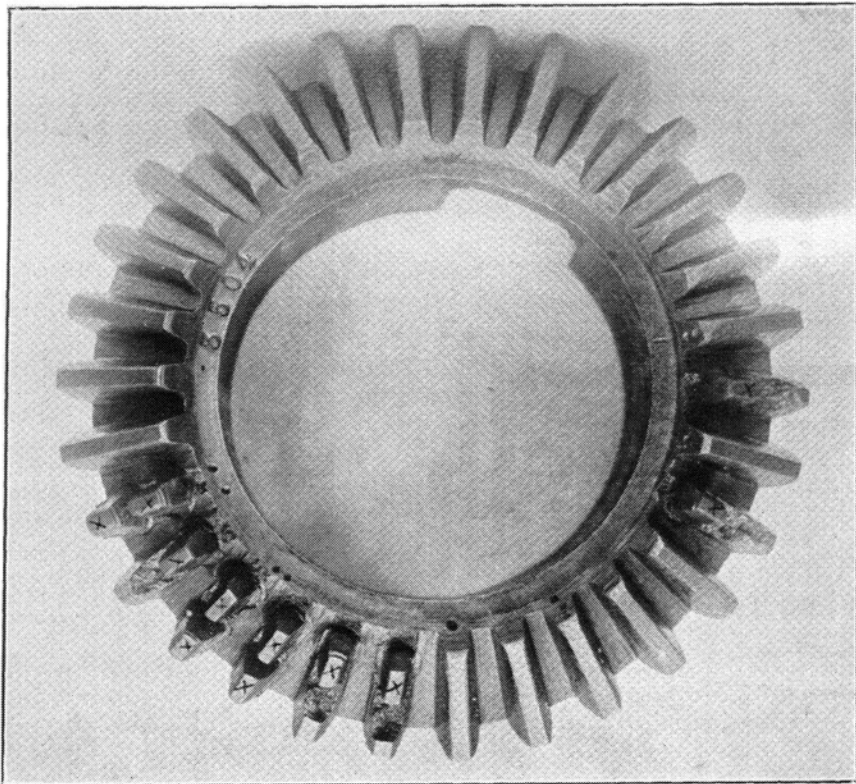
(f)

Whilst entering harbour in a destroyer it was observed that two teeth were missing from the mitre wheel, secured to the main steering shaft, for operating the hunting gear of the steering engine.

The engine continued to function normally until ship was berthed. On subsequent examination it was found that six other teeth were cracked.

Cracked and broken portions of teeth were removed and a temporary repair effected by drilling and tapping the wheel and fitting $\frac{3}{8}$ inch steel studs in place of the missing teeth. The studs were subsequently shaped by filing to gauges made from undamaged teeth.

The method of repair is clearly indicated in the accompanying photograph, in which the steel studs are marked with a cross.

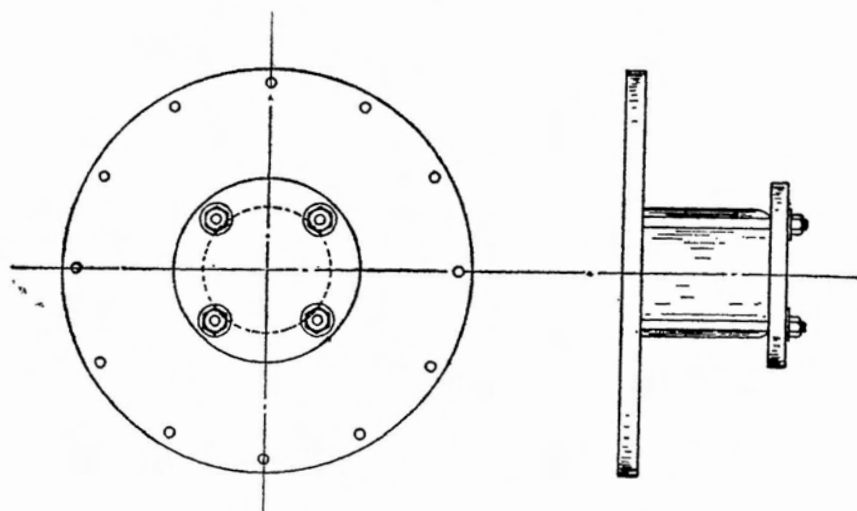
The breakdown was due to the excessive wear between the valve steam cap and the end of the main shuttle valve. This caused the main shuttle valve to stick in its steam cap, thus allowing the piston to travel beyond its normal stroke and come in contact with the cover, the result being that the cover was badly smashed into four pieces.

(e) View of cylinder cover as repaired.

The repair was effected by improvising a new cover composed of a piece of steel plate for the flange and an old Weir's Pump Shuttle Valve Cap, with the slot cut off, as the dome—this method being adopted to overcome the difficulty of having a casting made.

The flange was 15 inches diameter and $\frac{3}{16}$ inch thick and had a $4\frac{3}{8}$ inch diameter hole cut in the centre. The dome of the Weir's Shuttle Valve Cap was fitted on to the flange with a serrated joint of permanite and was held in place by four $\frac{7}{8}$ inch steel studs which passed through a circular plate of $\frac{1}{2}$ inch steel, placed on top of the valve cap to form a strongback; the studs screwed into the flange of the cover, and the nuts when tightened up on the strong back, clamped the valve cap securely on to the flange.

The repair was satisfactory in every respect and was used for several months afterwards.
