THE SALVING OF H.M.S. "INFLEXIBLE"

The following account of the damage sustained by H.M.S. *Inflexible* and the subsequent operations was written by an Officer present at the time.

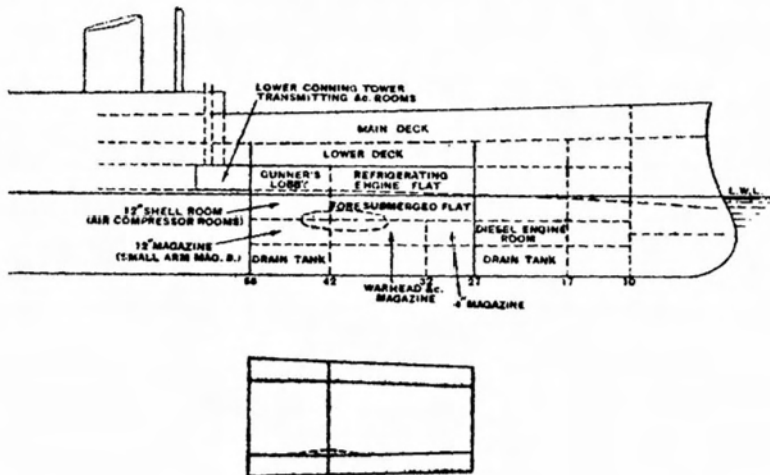
FIG 1.

The mine exploded just abreast the foremost turret on the starboard side and well-below the water line. A large hole about 30 ft. by 26 ft. was made in the ship's side and a number of adjacent plates and rivets were started and damaged, the damage extending right down to the keel. Two main athwartship water-tight bulkheads were also involved, with the result that the following compartments were flooded:—Forward submerged torpedo flat with gun cotton, warhead and other stores below, and the refrigerator flat and bread room above. Forward of the submerged flat the 4-in. magazine was flooded out, whilst the Diesel dynamo room was partially flooded. Aft of the submerged flat the following were completely flooded out, the forward 12-in. shell room magazines and handing rooms; the 4-in. shell room, the small arm magazine, the gunner's stores, the two engineers' stores, the forward air compressor room, the transmitting station and plotting room and the lower conning tower, whilst a considerable quantity of water obtained access to the foremost boiler room and one of the starboard bunkers.

Fig. 1 shows a profile of the ship in the vicinity of the damage and indicates the size and position of the hole made in the ship's side. Considerable structural damage was done in the various compartments, and to add to our difficulties the circuit for the ship's lighting system was cut in two, so that the ship was in darkness fore and aft.

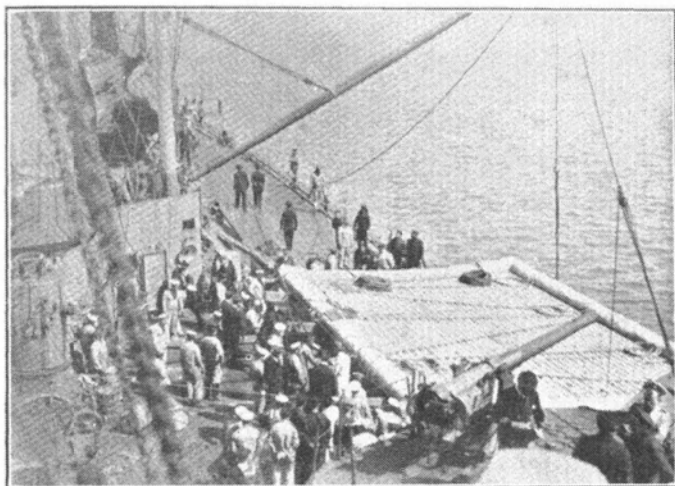
FIG. 2.

Fig. 2 shows the patch being launched over the side of the ship.

By this time a number of planks, spars and other stores had been obtained from Malta and from other ships in the neighbourhood, and the construction of a wooden patch to go on the outside of the ship was commenced. This patch was built up of 3-in. planks, and was made large enough to well overlap the hole and the worst damaged places in its vicinity. Each plank was secured to steel flats running the whole width of the patch, the planks being well butted up to each other throughout their length.

A large bolster of approximately circular section was then made out of canvas, fearnought, oakum and tallow, and this was attached to one side of the patch so as to form a continuous joint round its boundaries. The patch was built on the quarter deck, and when ready was launched over the side, and then one edge was weighted with fire bars until it floated vertically. It was then placed abreast the hole and sunk until in line with it, the bolster being next to the ship's side. Bottom lines going under the ship were then put on the outside and the two ends married on this upper deck with chain blocks. The patch was got into its exact position by divers, and then the whole was frapped close to the ship's sides by means of the chain blocks. As the method of construction of the patch rendered it very flexible it readily conformed to the contour of the ship.

When the frapping lines had been hauled as taut as possible the divers caulked all round the edges of the patch with oakum and wedges, and also caulked the seams of the planks where they had opened out in taking up the shape of the ship.

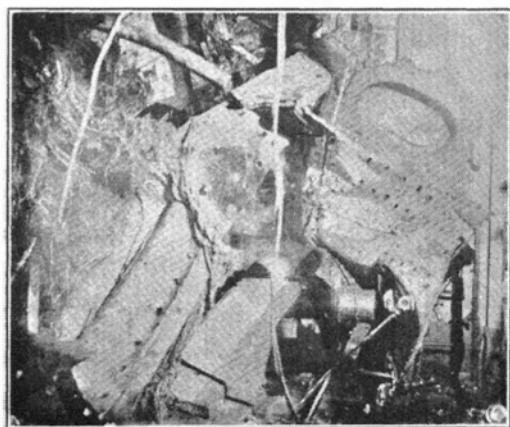
FIG. 3.

Fig. 3 shows the appearance of the inside of the submerged flat after it had been pumped out.

We eventually succeeded in getting rid of the whole of the water in the ship, and were able to get at the inside of the patch, which we proceeded to stiffen and secure from the inside as much as possible.

We next built a dam fore and aft between the bulkheads that were undamaged and up to the lower protective deck. The dam was built up with a double line of baulks and planks, the space between being filled with concrete made of cement, fire bricks and ashes.

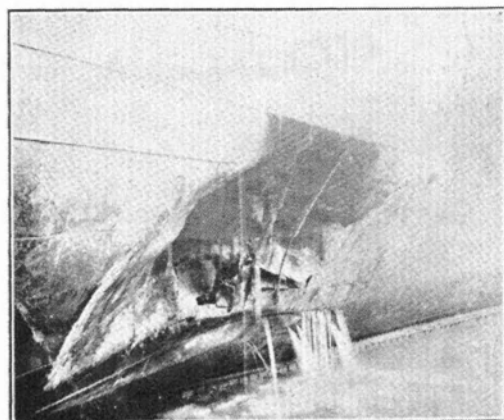
FIG. 4.

Fig. 4, taken with the ship in dry dock, shows the external damage sustained.
