R E N O W N
TURBINE ROTOR.

H. M. S.
STARBOARD L. P. AND

REPAIRS TO LARGE L.P. TURBINE

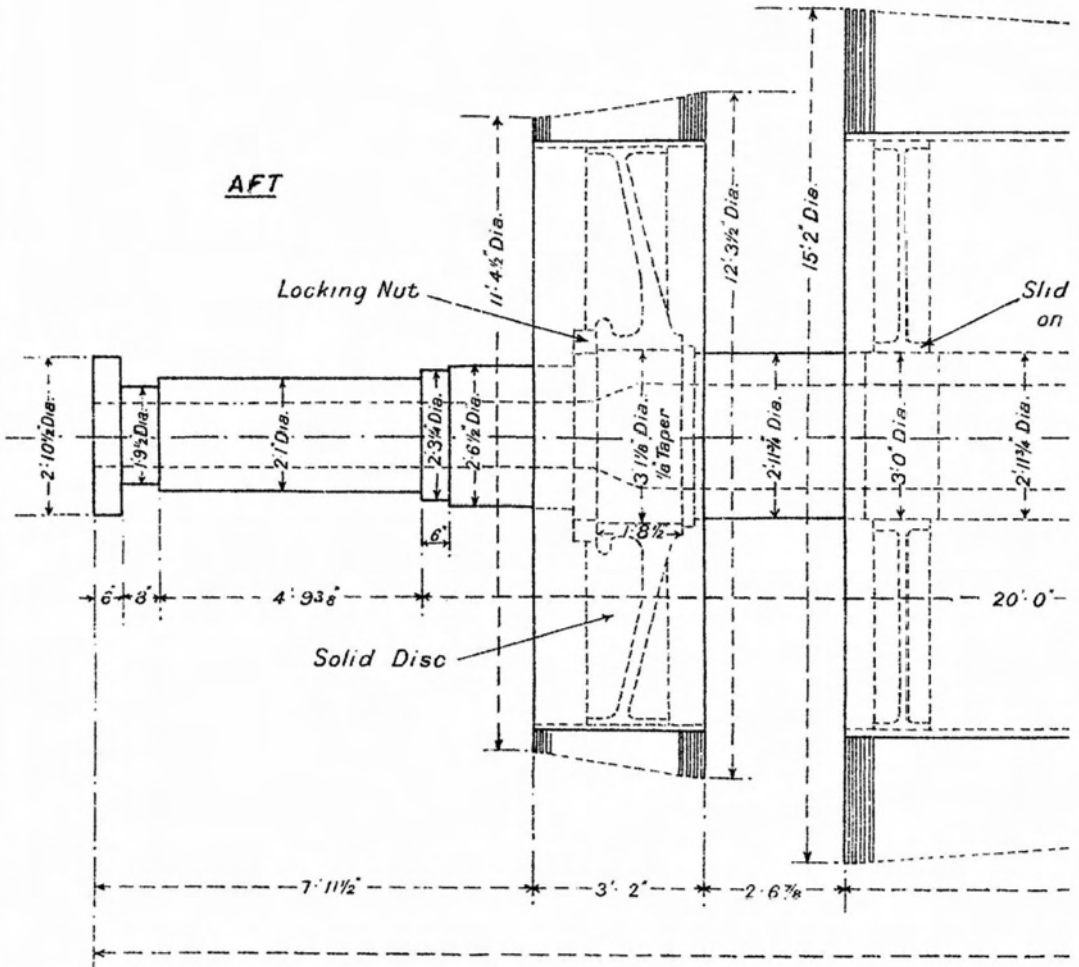
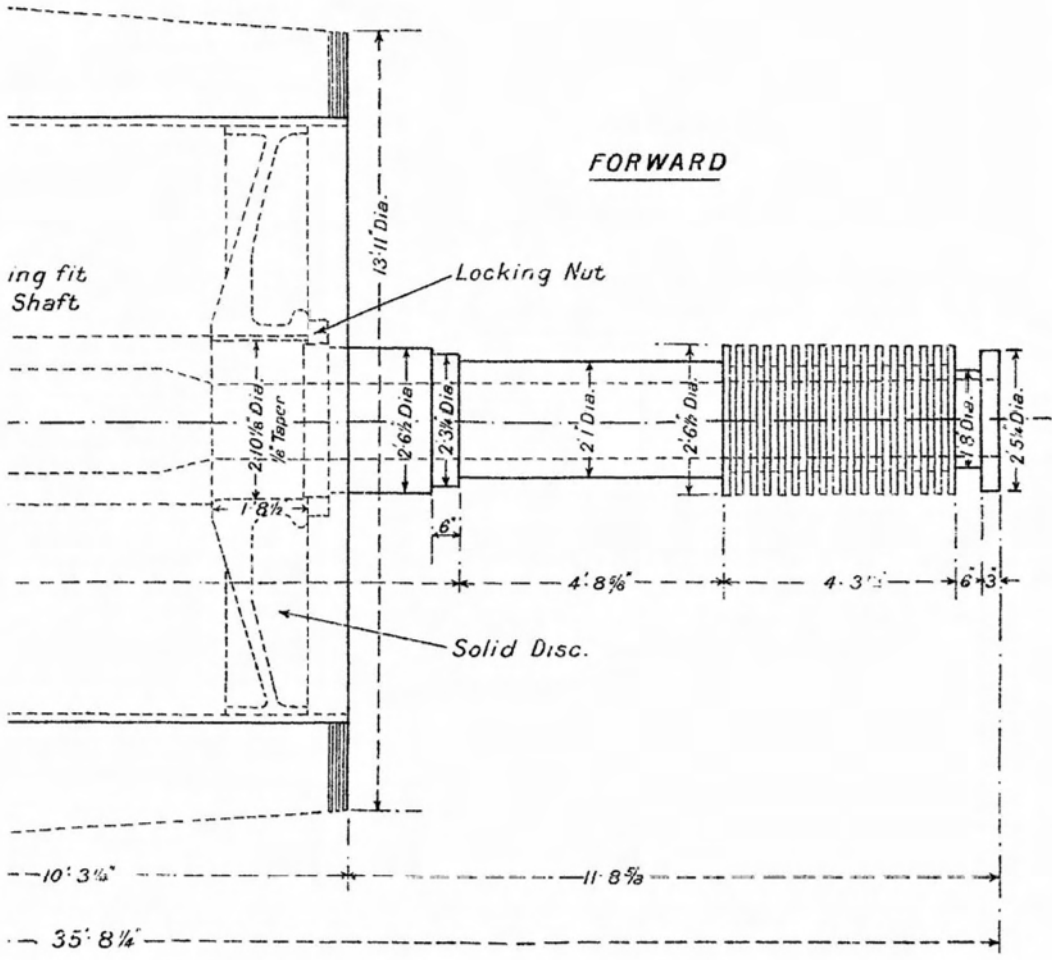
.1.

Periodical examinations of the starboard L.P. rotor of *H.M.S. Renown* showed that the sliding boss at the after end was becoming progressively loose on the shaft. False bosses were fitted with a view to increasing the bearing surfaces but were not entirely effective, and in the course of time the movement at this point prejudiced the tightness of the coned and keyed connection at the forward end and accordingly it was decided to remove the shaft and effect a thorough repair.

It was impossible to carry this out on board, and after careful consideration of the whole problem, it was decided to lift the rotor out of the ship and draw the shaft from the ahead drum for transport to the factory. To re-secure the drum on the shaft, it was decided to reinforce the cone of the shaft by electric welding, bore out the boss of the forward wheel, fit new keys and finally shrink this wheel on to the shaft; in the case of the after wheel to re-bush the bore to give the correct clearance on the shaft. (See Fig. 1.)

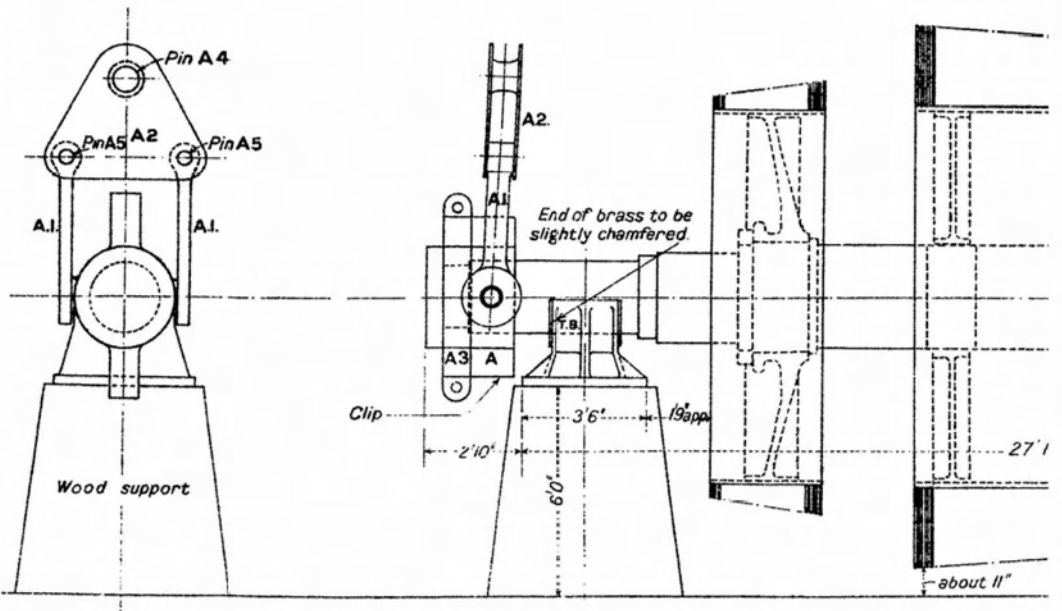
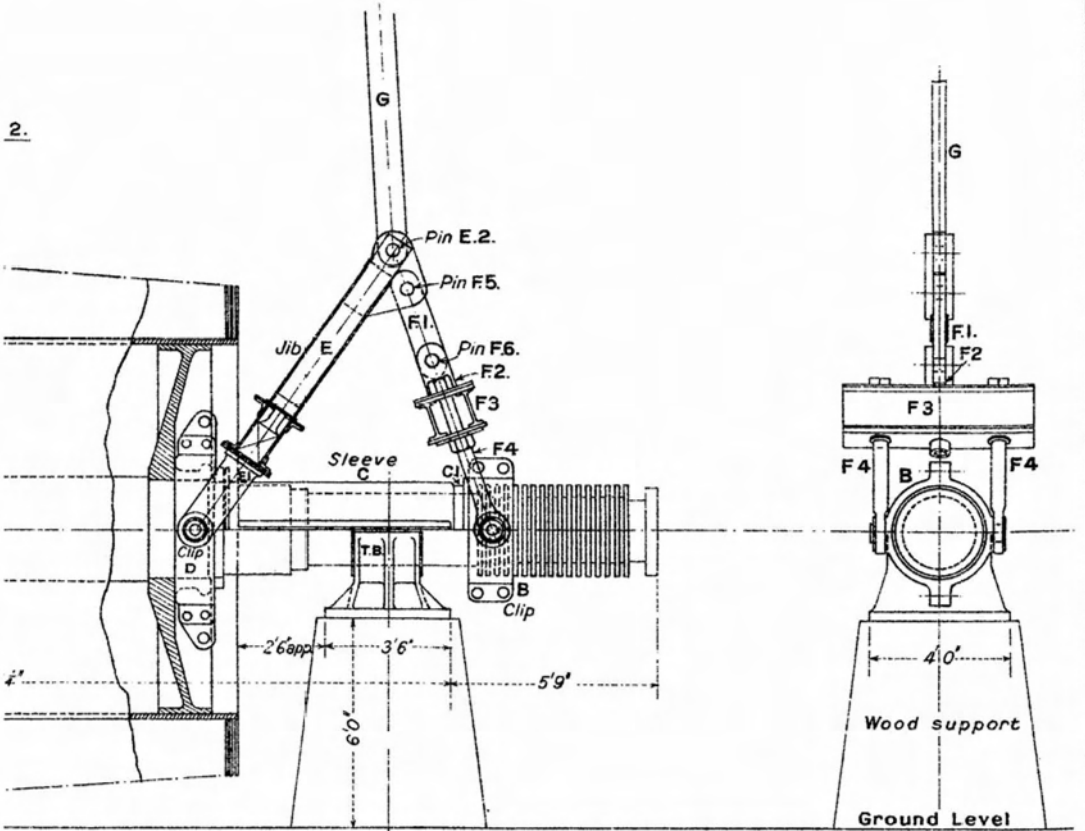
FIG.

The problem of transport had first to be considered, and bearing in mind the size and weight of the rotor, the magnitude of the task can be imagined. Special lifting and "up-ending" gear had to be designed, the latter consisting of the tree trunnion clips A, B and D shown in Fig. 2. A sleeve C was also provided to fit between the forward wheel retaining nut and the nearest thrust collar in order to take the weight of the ahead drum when in the vertical position, should the threads of the retaining nut fail. (See Fig. 3.)

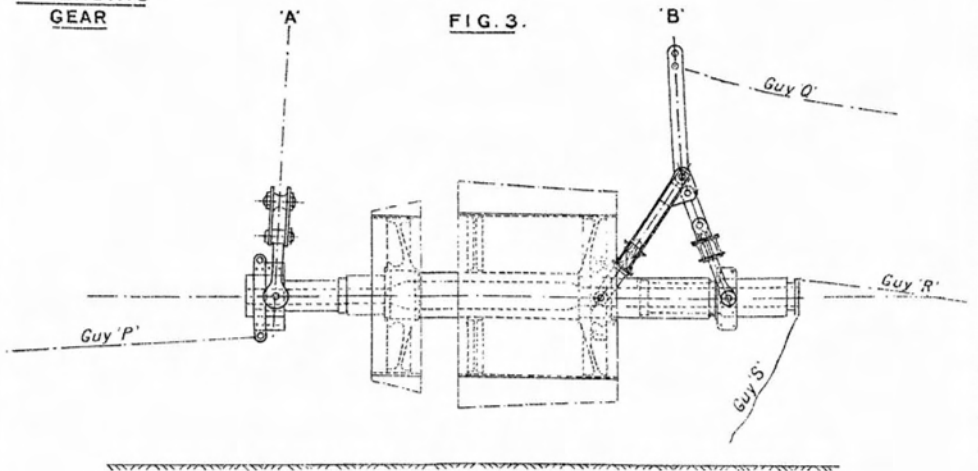
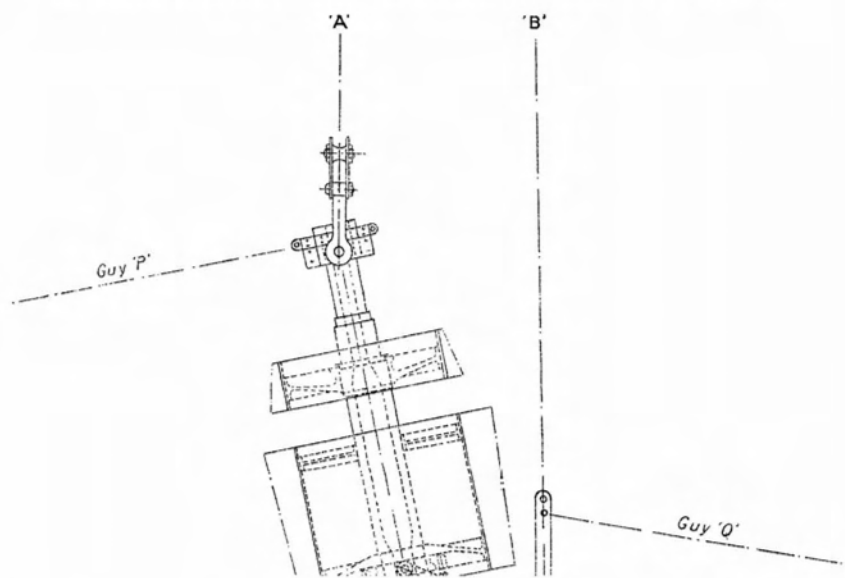
FIG. 3.

"UP-ENDING"
GEAR

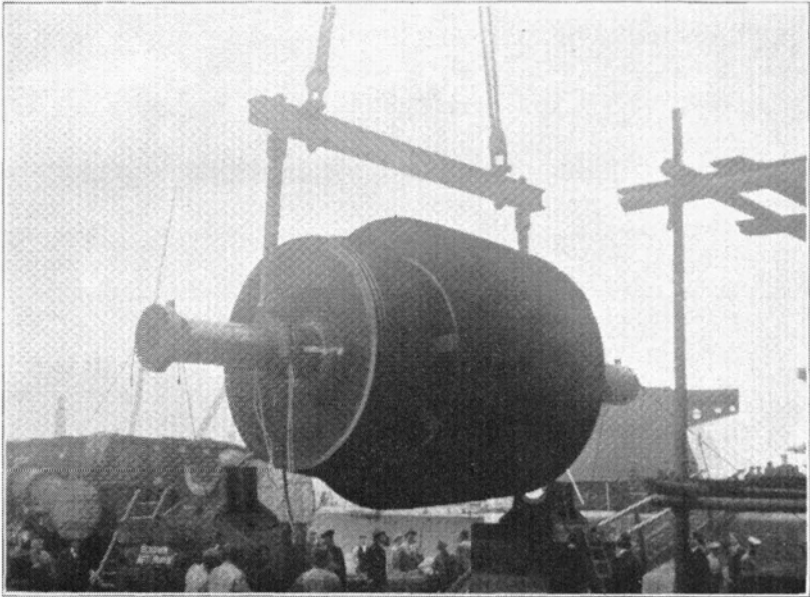
FIG. 4.

Starboard L.P. Rotor, lifted out of ship, being lowered into temporary bearings on shore.

View of aft end of Rotor, with special lifting gear.

Top half S.L.P. Turbine Casing landed on shore is in left-hand bottom corner.

Removal and Parting of Rotor.—The ship's lifting gear was used to raise the upper half of the casing clear of the rotor and the casing supported on the supporting columns. The decks, and consequently the lifting gear, were then removed and the casing lifted out of the ship by means of a 240-ton cantilever crane using long wire pendants attached to two beams placed athwartships on the underside of the cover and bolted to it. The crane was also used to lift out the rotor, the following procedure being adopted: the rotor was lifted some 7 ft. or so using the lifting clips and guide columns provided for the purpose and rested on wooden blocks. The ship's lifting gear was then removed except for the inner clips round the shaft to which special gear, obtained for the purpose, was connected. The rotor was then lifted out of the ship, landed in temporary bearings ashore and the blading was covered with asbestos cloth and heavy canvas. (See Fig. 4.)

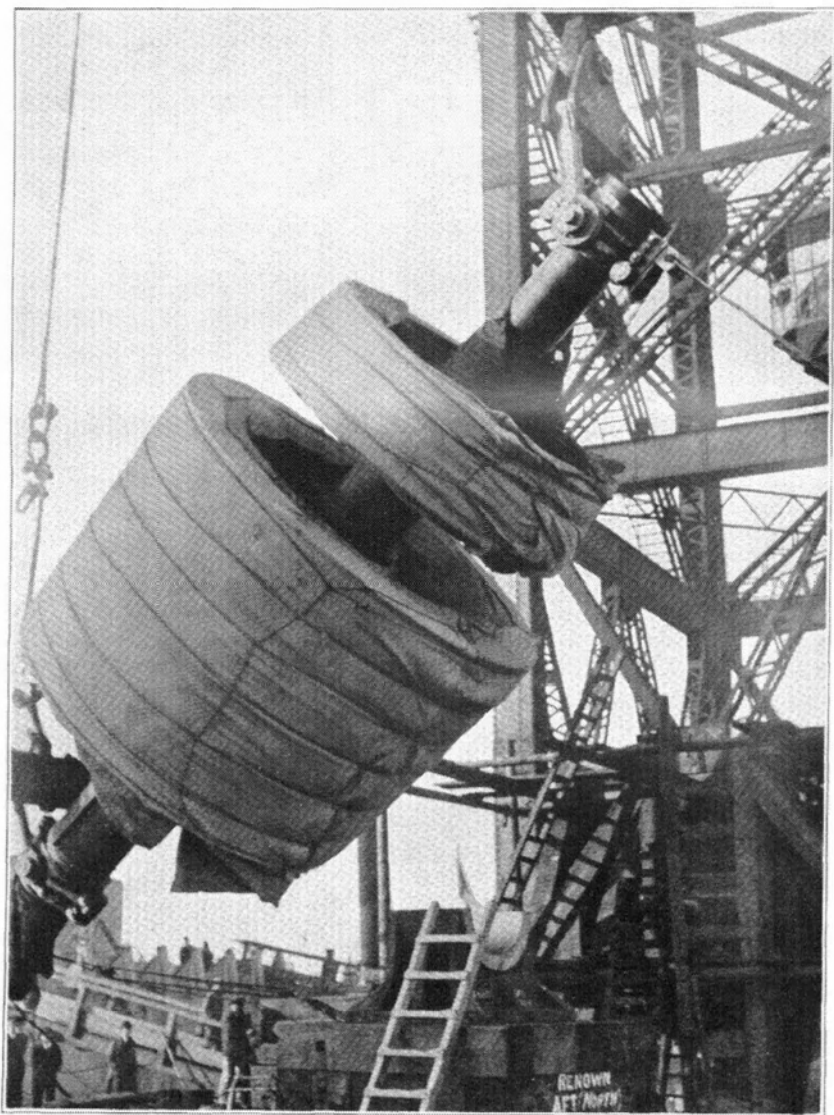
FIG. 5.

Complete Rotor during operation of upending, showing clip "A," aft end.

The special "up-ending" gear was now fitted and actually the operation of "up-ending" the rotor was completed in 20 minutes. (See Fig. 5.) After all redundant gear had been removed, the rotor was landed on a specially constructed wooden structure. (See Fig. 6.)

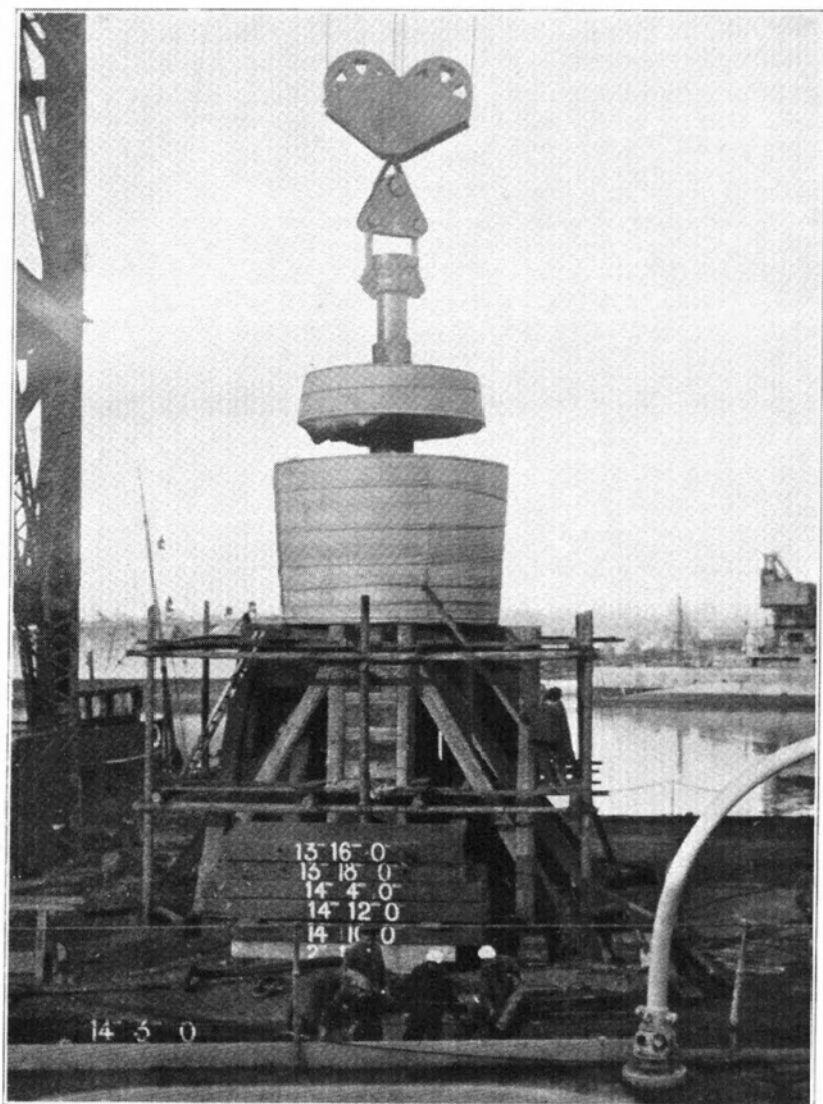
FIG. 6.

Ahead L.P. Rotor landed on wooden structures, and preparations being made for the withdrawal of the shaft.

The lock nut on the shaft was split on both sides and removed. On taking the weight of the rotor shaft, it drew out of the fixed boss immediately, the two keys falling out as their securing screws had sheared.

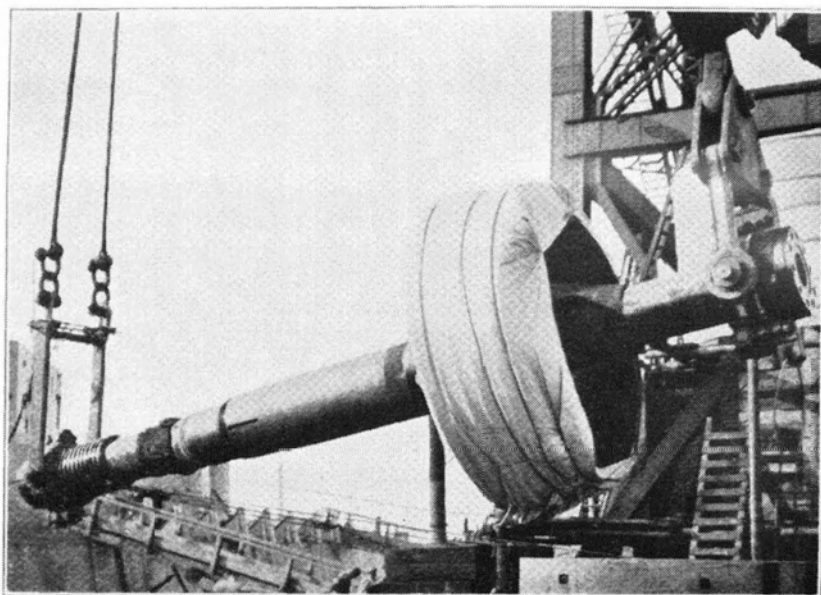
FIG. 7.

Shaft, after withdrawal, being turned horizontal, for transport to Factory.
Shaft, landed on bearings fitted on crocodile truck, ready for transport to Factory.

Simplified "up-ending" gear was fitted, including clip "B" with plain links attached. (See Fig. 7.) The shaft with the astern rotor was returned to the horizontal, placed on a crocodile truck and transported to the factory.

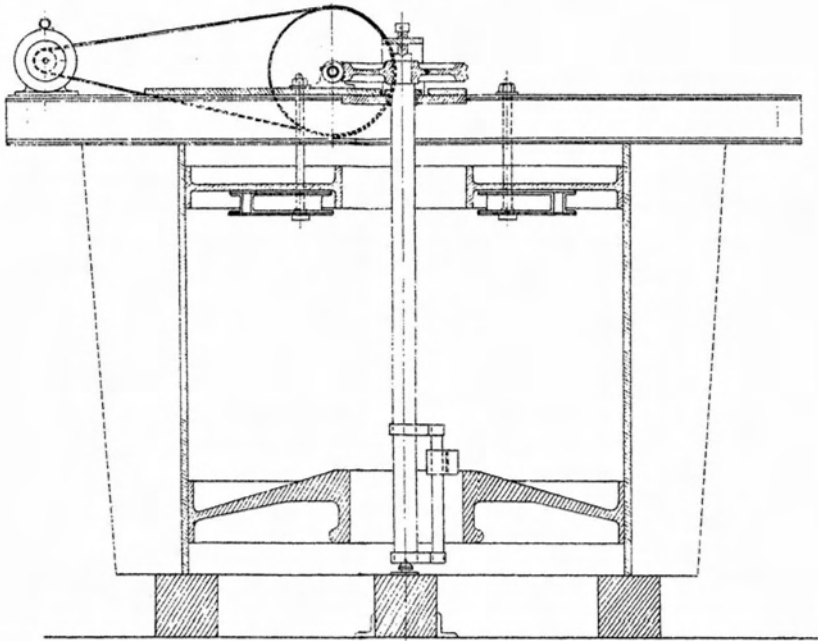
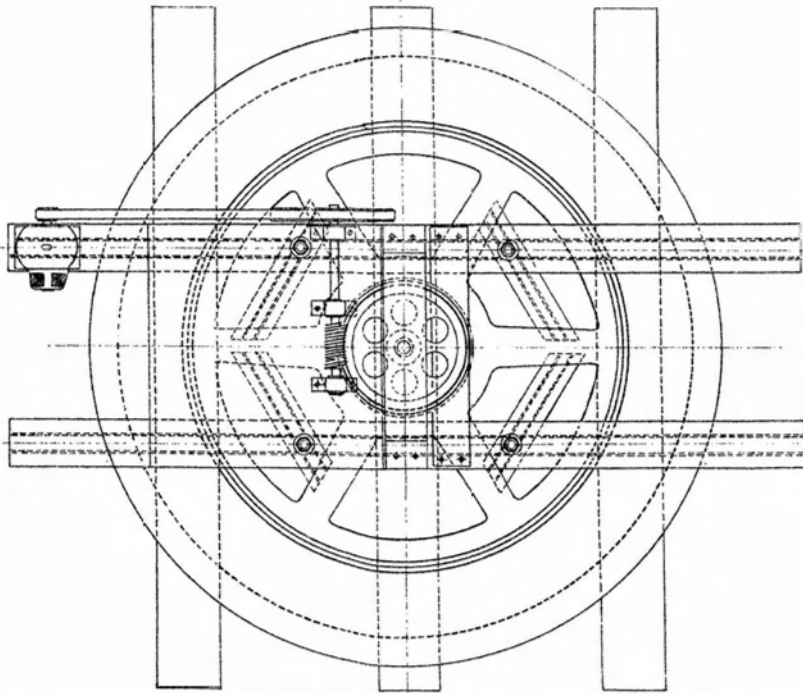
FIG. 8.

ARRANGEMENT OF BORING GEAR.

(a) The ahead rotor drum was placed on end on 18-in. distance blocks on a rigid levelling slab. The boring bar was rigged through the wheel bosses and operated by a motor on top of the drum. (See Fig. 8.) A special attachment was made and fitted to the boring bar to enable accurate taper boring to be carried out. The boss was bored with a taper in diameter of $\cdot030$ in. over its whole length. The two keyways were then dressed up and given a taper in width of $\cdot009$ in. over the whole length, and two keys were made and fitted to within $1\frac{1}{2}$ in. of the lower end of the keyway. Their thickness was such as to allow a clearance of $\cdot015$ in. on the backs.

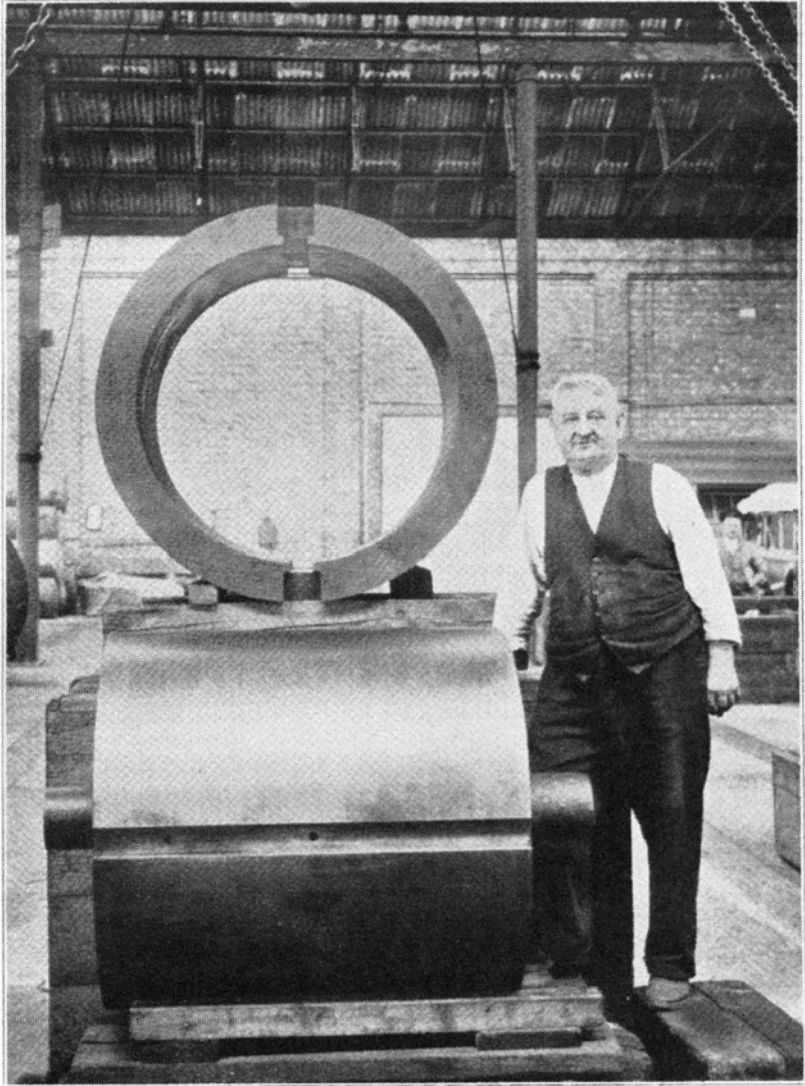
FIG. 9.
View of Male and Female Gauges.

The female gauge was then bored to fit the male gauge and the keys were fitted by the same method as above, using the male

gauge for marking off. The bore of the gauge was then increased by $\cdot 015$ in. (See Fig. 9.)

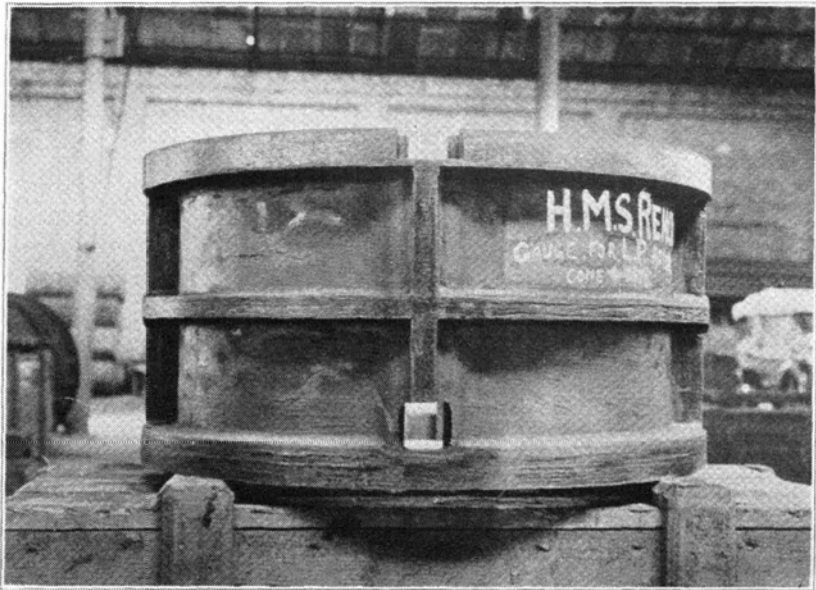
FIG. 10.
Female Gauge—Side view, showing "windows."

The keyways were transferred from female gauge to spindle cone by the use of blocks as before except that, as the keys did not extend for the full length of the cone, in this case "windows" had to be cut in the female gauge in the wake of the extremities of the keyways and the work carried out through them. (See Fig. 10.)

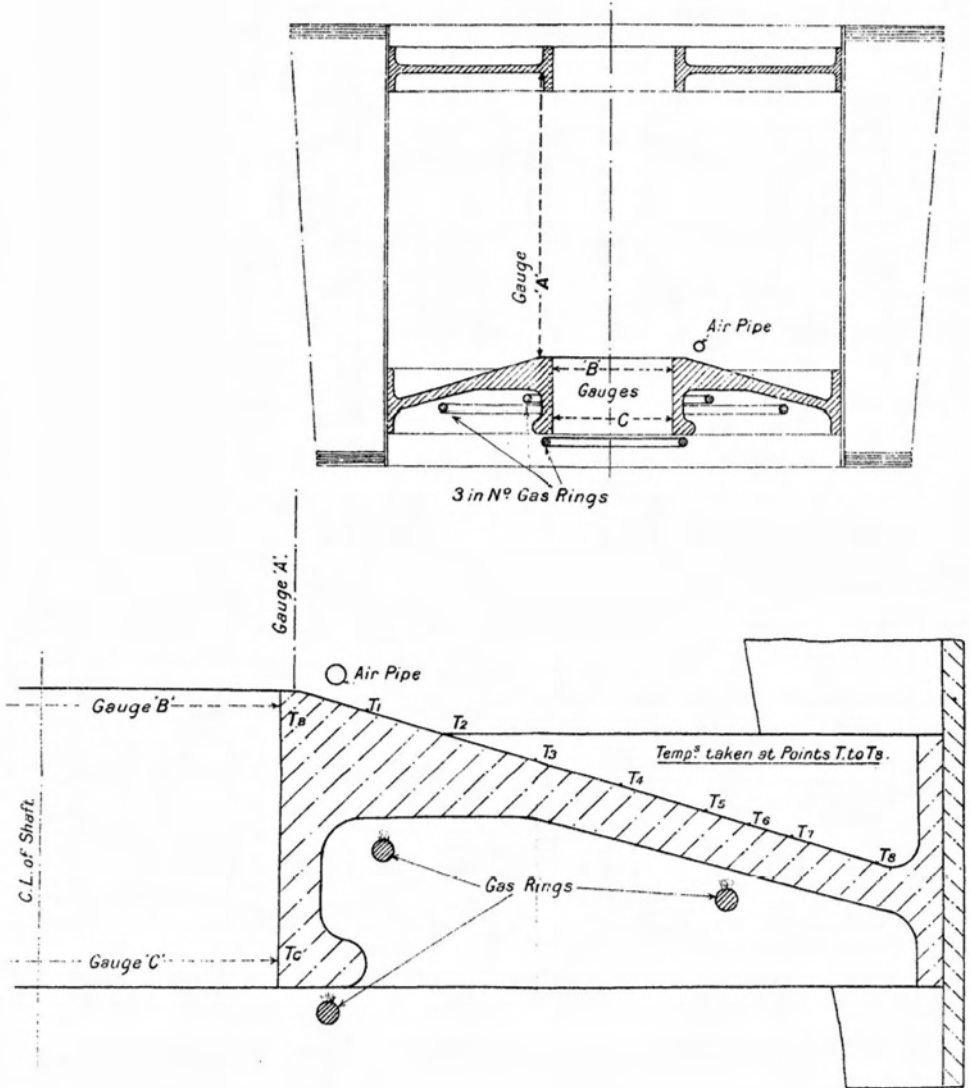
FIG. II.

SHRINKING OF S.L.P. ROTOR DRUM ON SPINDLE.

Reassembly and Replacement of Rotor.—The ahead drum was placed in its previous position on the wooden structure and the gas rings were fitted, the results of the previous experiments having indicated the best positions (see Fig. 11). These were started at their lowest capacity to heat the mass of the metal as uniformly as possible. The rise of temperature and the resulting expansion were checked by frequent surface pyrometer and trammel readings. Control was maintained by regulating the individual gas rings or by varying the number of jets in use in any ring, by means of plugs in the form of brass spills. The intention was to give the boss an expansion of $\cdot 050$ in. on the diameter, which would mean an increase in the breadth of the keyway of about $\cdot 004$ in. This would allow sufficient margin over the $2\frac{1}{4}$ in. draw of the keys to prevent jamming when lowering the rotor into place.
