Notes on the Management of Marine Diesel Engines.

REPLY BY THE AUTHOR, HOMER MCCRIRICK
(MEMBER AT SINGAPORE).

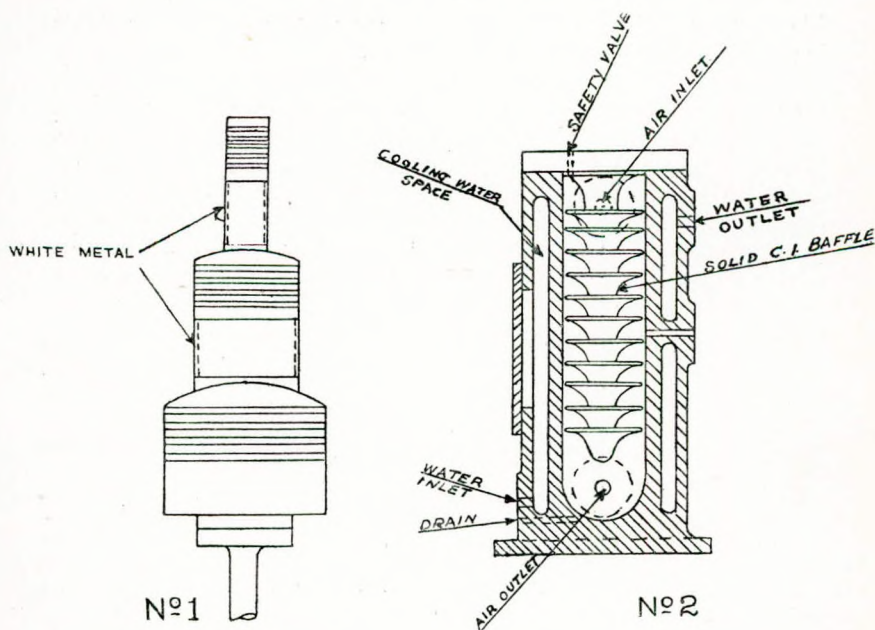
three-stage air compressor direct driven from the main shaft. The piston for this three-stage air compressor is fitted with white metal, as shown in sketch No. 1, for the purpose of reducing friction between the walls and piston. During this particular voyage, overheating of the air compressor piston occurred to such an extent that the white metal became partially melted. The engine was therefore stopped and the piston taken out and replaced with the spare one. When things were all coupled up,

the engine was again started and everything seemed to be in order. In less than an hour a loud report was heard in the engine room and on examination being made it was found that the I.P. intercooler had burst and scattered in all directions; water service and oil service pipes in the vicinity of the same were crushed and fractured, and a bulkhead three feet away had a hole pierced in it three inches long by two inches wide.

This particular intercooler was made of cast-iron, and a section of the same is shown in sketch No. 2. Various parts of the cast-iron were examined for deterioration that would have been likely to account for the bursting, but no extensive wasting could be found and therefore the cause of the accident had to be looked for in other places. The outlet pipe from the cooler although badly fractured and twisted, appeared to have been choked, so it is to be assumed that some of the white metal and carbonised oil from the piston found their way into the cooler, and after the engine had run for a little while the thin pieces of white metal must have become fixed in such a position as to choke the discharge pipe.

When this stoppage occurred, the pressure started to rise above normal, and as the safety valve failed to lift, it resulted in the cooler bursting. Had a thin disc been fitted in some place on this cooler the bursting would have been avoided; on the other hand also, had the safety valve been in working order the engineer would have had warning of an excessive rise of pressure and taken steps to remedy the same. Take the case of the explosion now, this I consider much more dangerous than a gradual rise of pressure, as the safety valve was able to release the sudden increase of pressure. Of course there is no reason why we should not have as many safety devices as possible, but I think if an engineer knows that all his safety valves are in working order he can go about with very little worry him as far as bursting of air receptacles goes. Where I do think that pressure discs could be fitted to an advantage are at various places along the air starting and blast pipe lines, as should fuel oil find its way into them, there are chances of a violent explosion taking place.
