# Service Performance of Boiler Brickwork—The Causes and Extent of Wastage

BRYAN TAYLOR, B.Sc.(Eng.) (Member) and H. BOOTH

The investigation described in this paper was undertaken by the British Shipbuilding Research Association and the British Ceramic Research Association with the following objects: to determine the extent of deterioration of refractory materials in watertube boilers in the merchant service; to formulate the main causes of wastage; to consider ways of improving the life of furnace brickwork; and to provide a background for any experimental work that may be desirable.

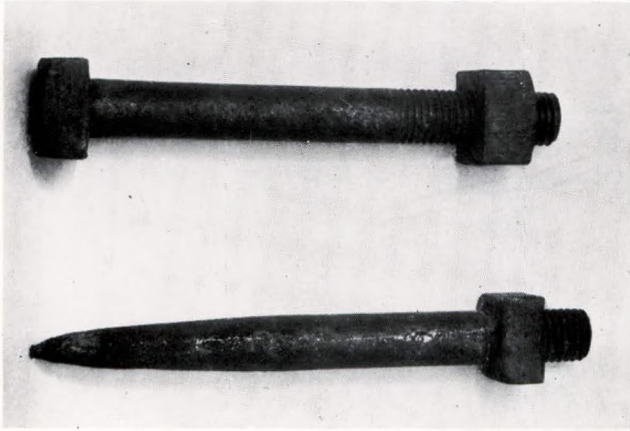
When thin firebrick tiles backed by a considerable thickness of insulating material are used, there is only a very small drop in temperature through the thickness of the refractory. Consequently the bolt head is subjected to a temperature almost as great as that of the hot face of the firebrick tile in which it is buried. Where the hot face temperature is much above 500 deg. C. there is, therefore, a great danger of the bolt head oxidizing. A typical example of such a failure is shown in Fig. 7 (Plate 1).

FIG. 7—Wastage of mild-steel brick bolt

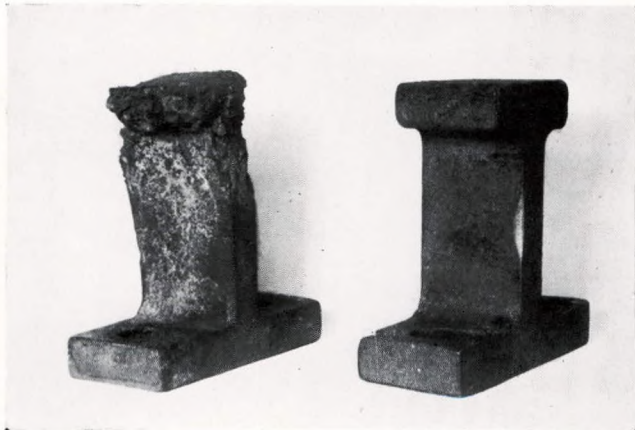
The use of attachments not made from heat resisting material in brickwork directly exposed to the furnace may result in failure after prolonged service. Fig. 9 (Plate 1) shows the extent of oxidation of a cast iron key removed from the lining of a header type boiler after about four years' service.

FIG. 9—Wastage of cast-iron brick key

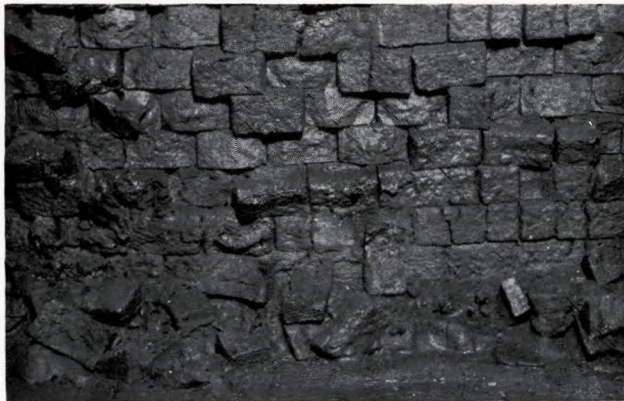
FIG. 11—Spalling damage to side wall of header type boiler  
I.Mar.E.1953]

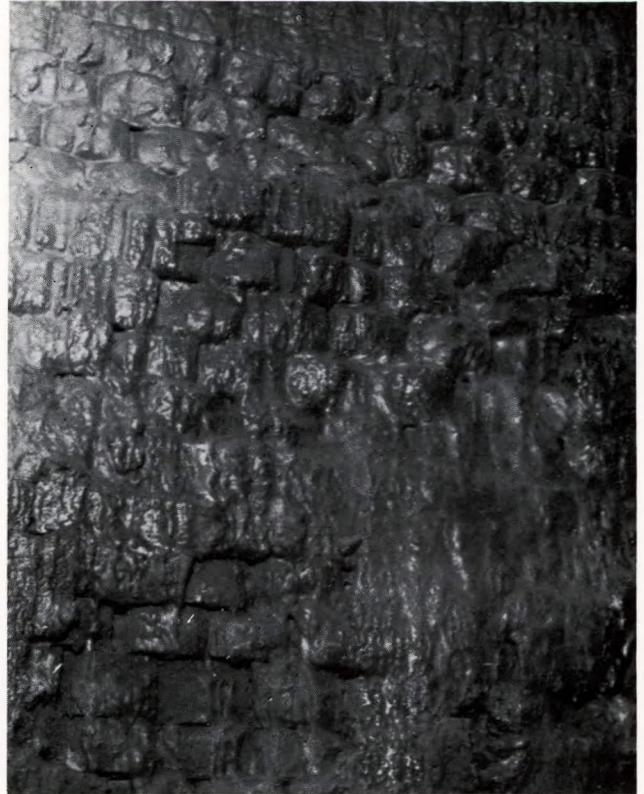
FIG. 10—Spalling damage to back wall of header type boiler

In general the spalling damage to back walls of 9-inch header construction brickwork was due to the loss of corners and edges by cracks entering at approximately 45 degrees, giving the walls a "cobblestone" appearance as illustrated in Fig. 10 (Plate 1). This condition is typical of spalling caused by sudden heating and most likely occurs during manoeuvring when rapid temperature fluctuations cannot be avoided.

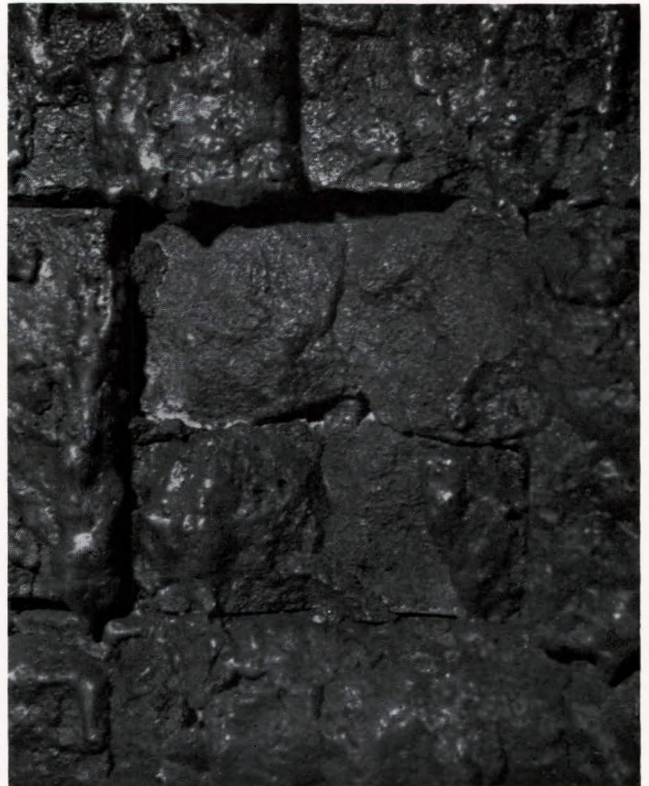
FIG. 12—Spalling damage to bolted blocks: end wall of  
end-fired Yarrow boiler

In those boilers having all-refractory furnaces lined with bolted blocks, the most common cause of failure was by cracking of the blocks parallel to the edges and through the central bolt hole. This type of damage is referred to in greater detail later. For the most part there was little loss of surface from such blocks by spalling although in a few instances one or more of the quarters formed by the cracks had spalled off. An example is illustrated in Fig. 12 (Plate 1) where the face has spalled off to a depth of about  $1\frac{1}{2}$  inches leaving the head of the securing bolt exposed.

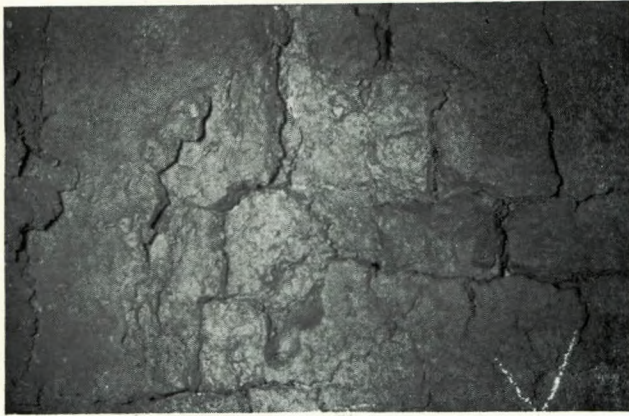
FIG. 13—*Spalling damage to rammed plastic refractory monolithic wall: twin furnace controlled superheat boiler*

In some boilers of this type the original  $4\frac{1}{2}$ -inch brickwork of the side walls had been replaced by rammed plastic refractory. This was said to give rather better service but it was noted that in three voyages (about six weeks' steaming time) some spalling had occurred and the section affected most severely, where the wastage had extended to a depth of 4 to 5 inches, is illustrated in Fig. 13 (Plate 2).

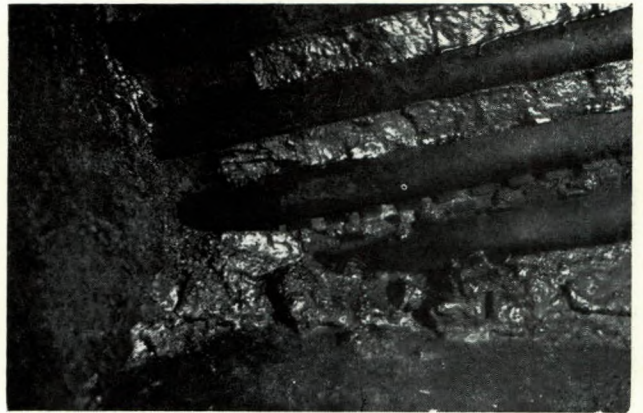
FIG. 14—*Damage to plastic refractory side wall of single-pass header boiler*

The plastic chrome refractory used in water walls of stud-tube construction was found to give little trouble on the whole but some replacement had been necessary owing to the difficulty of patching up this material satisfactorily after being in service for any length of time. In one boiler where this material was used the refractory had fallen away in many places; this could be attributed largely to the fact that the rather unorthodox arrangement of the securing lugs practically separated the plastic refractory towards the front of the tubes from that at the back, as shown in Fig. 14 (Plate 2).

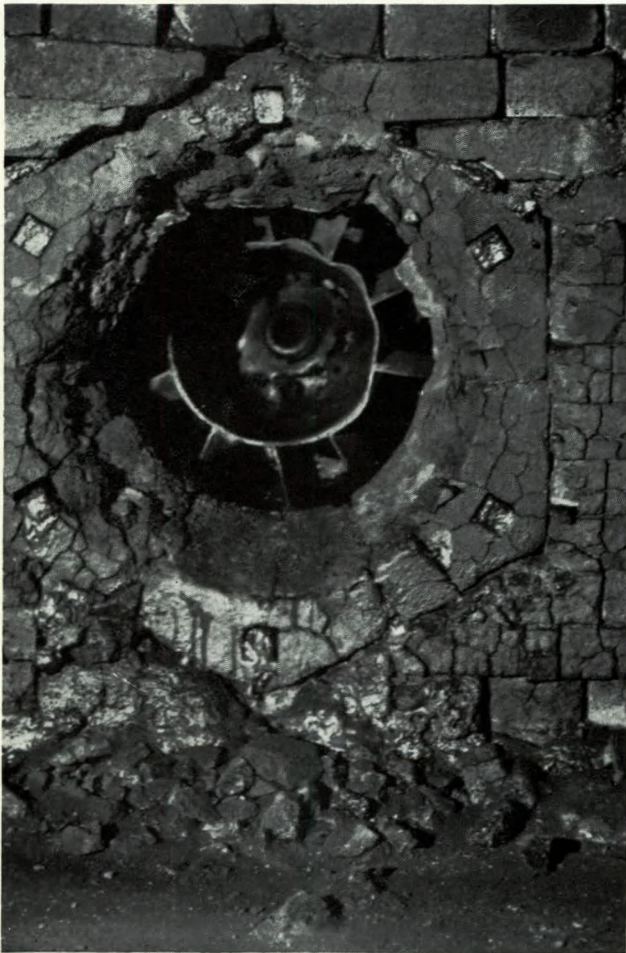
FIG. 15—*Spalling damage to quarl blocks: header type boiler (six months' service)*

Most of the damage to firebrick quarl blocks, which formed the burner openings in about two-thirds of the combustion chambers examined, was due to thermal spalling and varied from a few surface cracks to almost complete disintegration. Fig. 15 (Plate 2) shows a particularly severe example of such damage; this burner throat, in a three-pass header boiler, had only been in service for approximately six months (about  $3\frac{1}{2}$  months' steaming time).

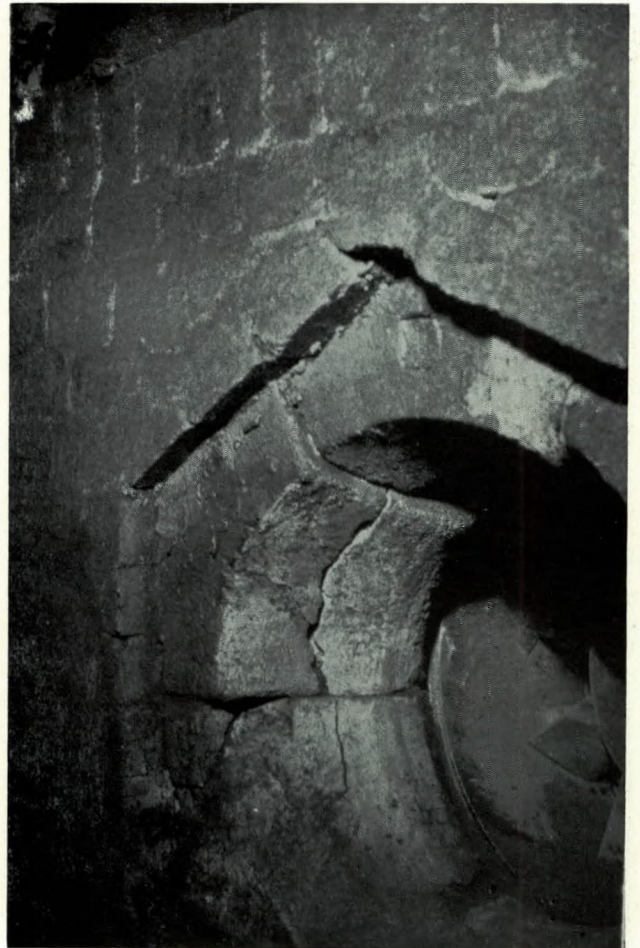
FIG. 16—*Cracking of quarl blocks: header type boiler*

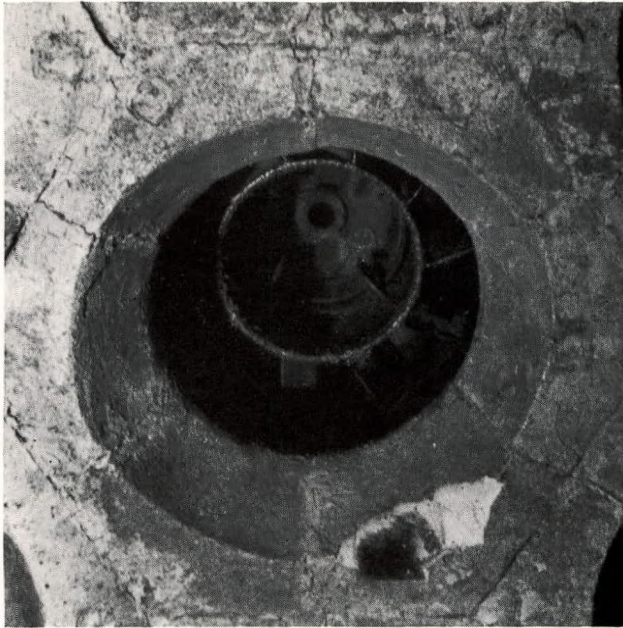
FIG. 17 (left)—Commencement of spalling damage to quarl blocks, D-type boiler (three weeks' service)

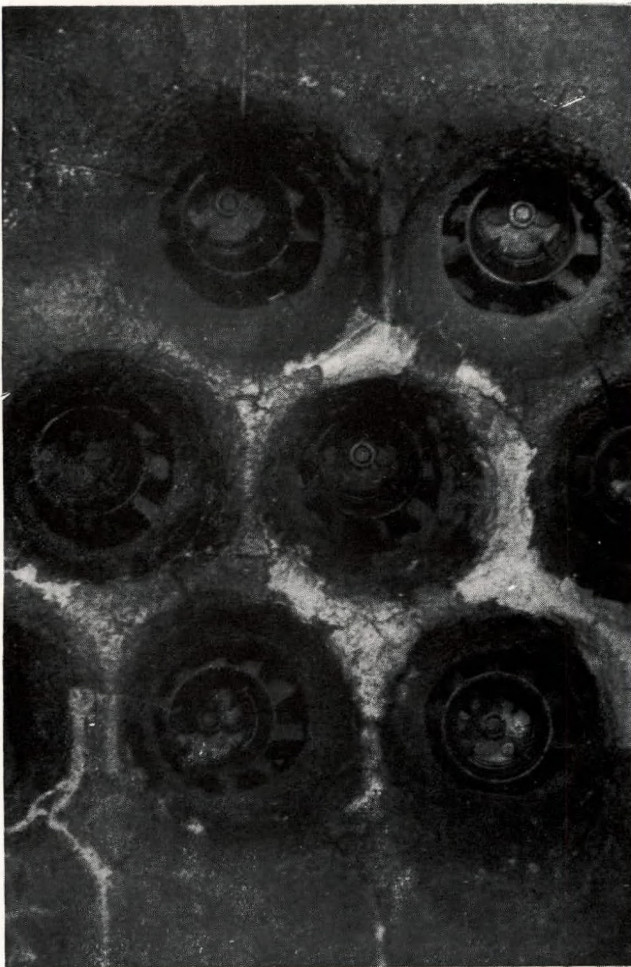
FIG. 19 (bottom left)—Rammed plastic monolithic front wall: twin furnace controlled superheat boiler (eighteen months' service)

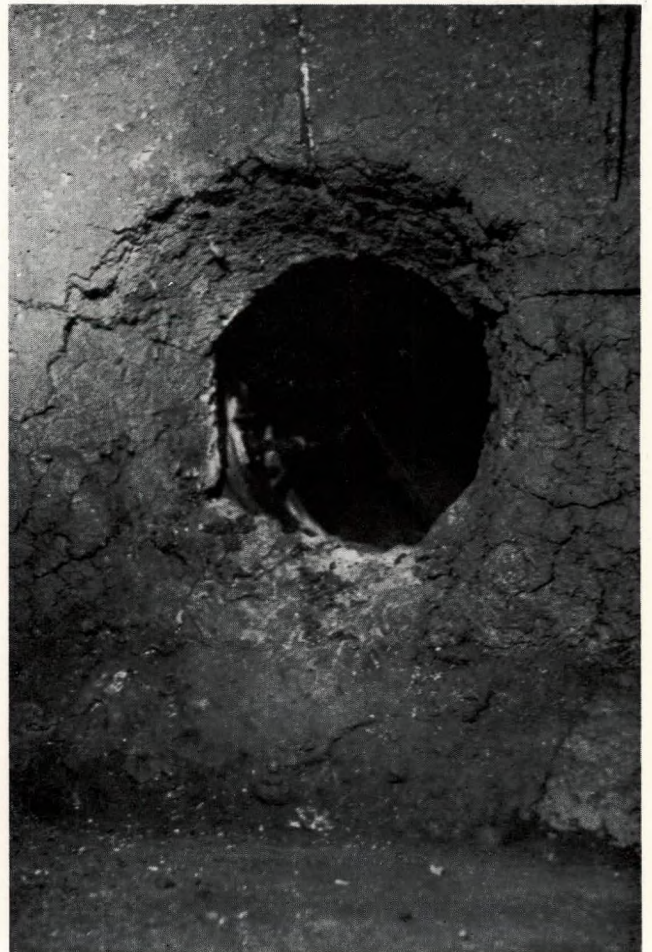
FIG. 20 (bottom right)—Burner throat of plastic refractory monolithic construction: header type boiler (twelve months' service)

In another vessel which had four header boilers of the same size, each having six burners in a horizontal row, one front wall had been rebuilt as a monolith. This wall had been in service for one year at the date of inspection. As will be seen from Fig. 20 (Plate 3), damage was relatively slight; there was some disintegration of the surface to a depth of about 1 inch in the lower part of the burner throat in several openings and a few deep cracks had formed in the face of the lining. The condition of this wall should, however, be compared with that shown in Fig. 15 (Plate 2), which was typical of the damage to quarl blocks in another boiler of the same ship after only six months' service.

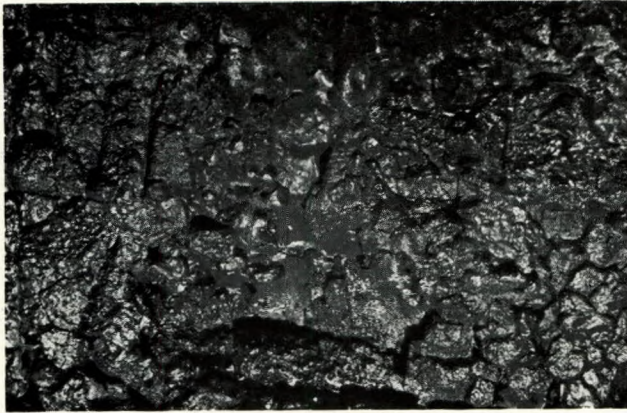
FIG. 21 (top left)—*Spalling and slag erosion damage to plastic refractory monolithic wall: twin furnace controlled super-heat boiler*

In one or two instances there was evidence of some erosion by fluid slag where there had been direct flame impingement on the brickwork within three or four feet of the burner. Such an example is shown in Fig. 21 (Plate 4) which illustrates a section of the low side wall in a controlled superheat boiler. There is a possibility that local reducing conditions could exist at points where the lining is swept by the flame and since under reducing conditions, the reactivity of slags containing iron oxide is greatly increased, this may account for such damage.

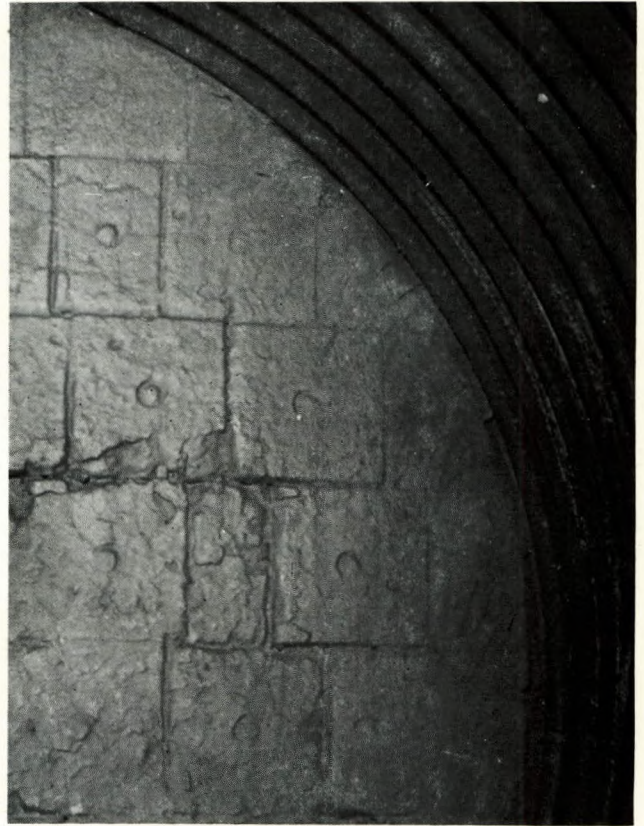
FIG. 22 (top right)—*Slag erosion at joints of bolted blocks: back wall of Babcock-Johnson boiler*

Even in boilers where the conditions were such that the slag was more fluid, there was little evidence of slag erosion except at the edges of bolted blocks. Slight damage of this nature is illustrated in Fig. 22 (Plate 4) which gives a view of the back wall of a Babcock-Johnson boiler after being in service for about six months (approximately twelve weeks' actual steaming time).

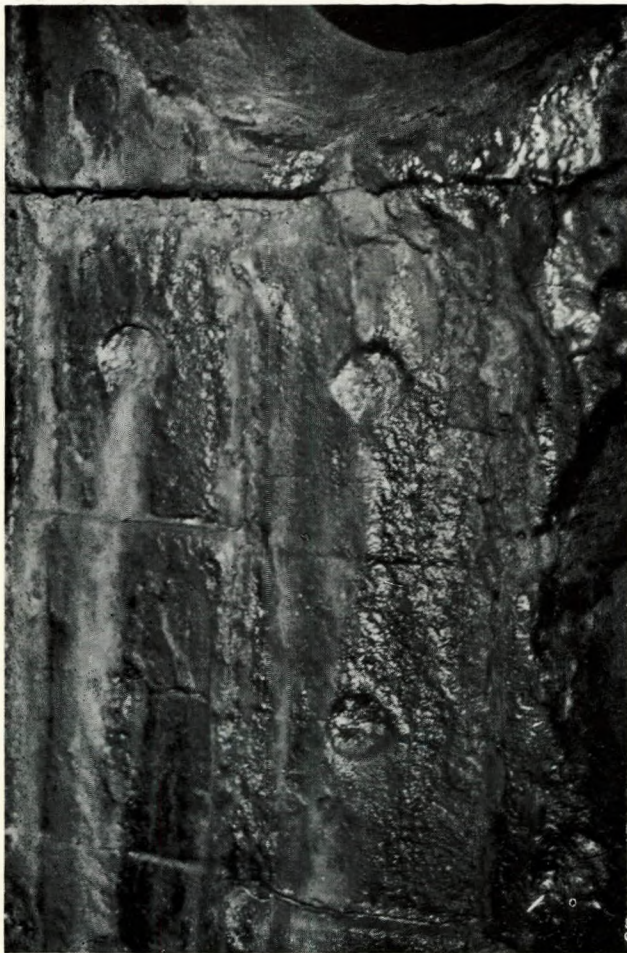
FIG. 23 (left)—*Slag erosion of bolt hole stopping material: D-type boiler*

Fig. 23 (Plate 4) is included to show the effect of an unsuitable combination of materials. In this boiler the front wall had been coated with a proprietary sealing compound which had produced a glazed surface. There was, however, a marked tendency for the cement in the bolt holes to be attacked and eroded away, owing to the effect of the fluxing material on an air-setting cement containing sodium silicate. The products of the reaction which ran down from the bolt holes had attacked the firebrick blocks but elsewhere the face of the lining was not damaged, although there was a tendency for the joints to be eroded.

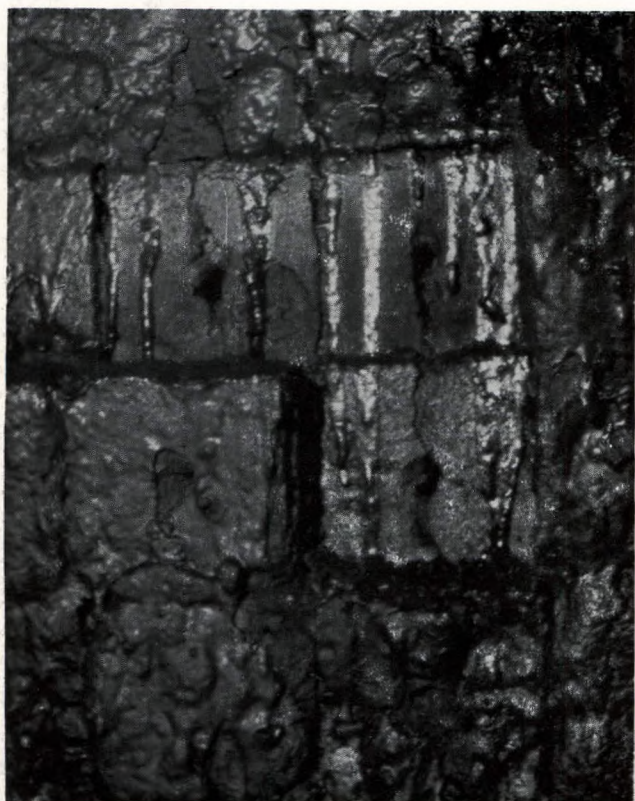
FIG. 24 (top left)—Damage due to failure of brick bolts: end wall of side-fired Yarrow boiler

It is not suggested that slagging is uncommon in the types of boilers examined. On the contrary, particularly in those having all-refractory furnaces, a coating of slag up to an inch thick was often found towards the bottom of the walls and the layer of glass-like slag over the floors was often several inches thick. In general, the thickness and character of the slag coating varied with the distance from the bottom of the walls. On the upper sections of Yarrow boiler end walls, for example, the coating was thin and glassy but towards the lower part of these sections vertical slag trails became more numerous and there were patches of thicker slag; these can be seen quite clearly in Fig. 24 (Plate 5).

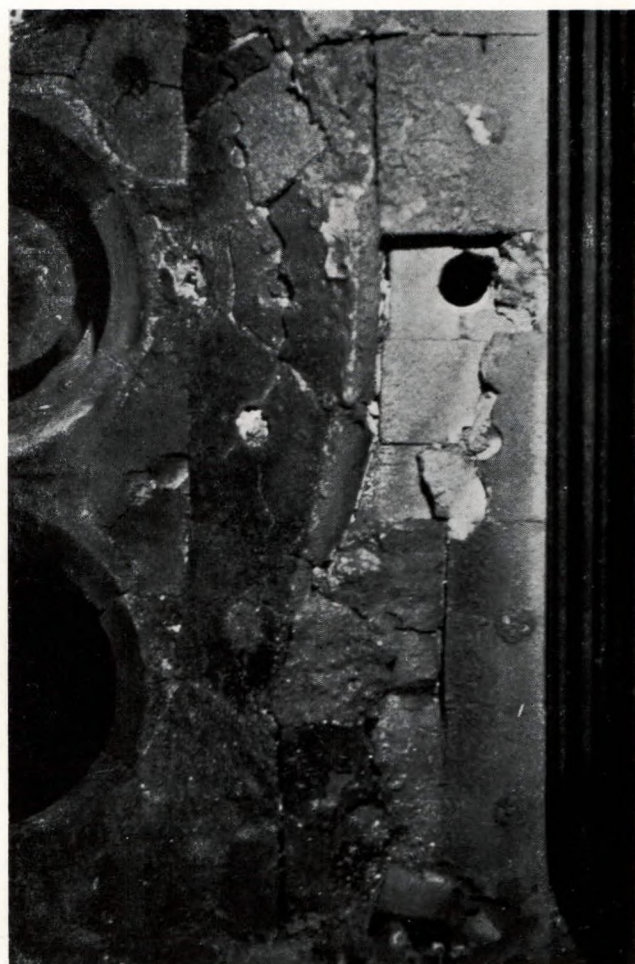
FIG. 25 (top right)—Cracking of bolted blocks and failure of brick bolts: twin furnace controlled superheat boiler

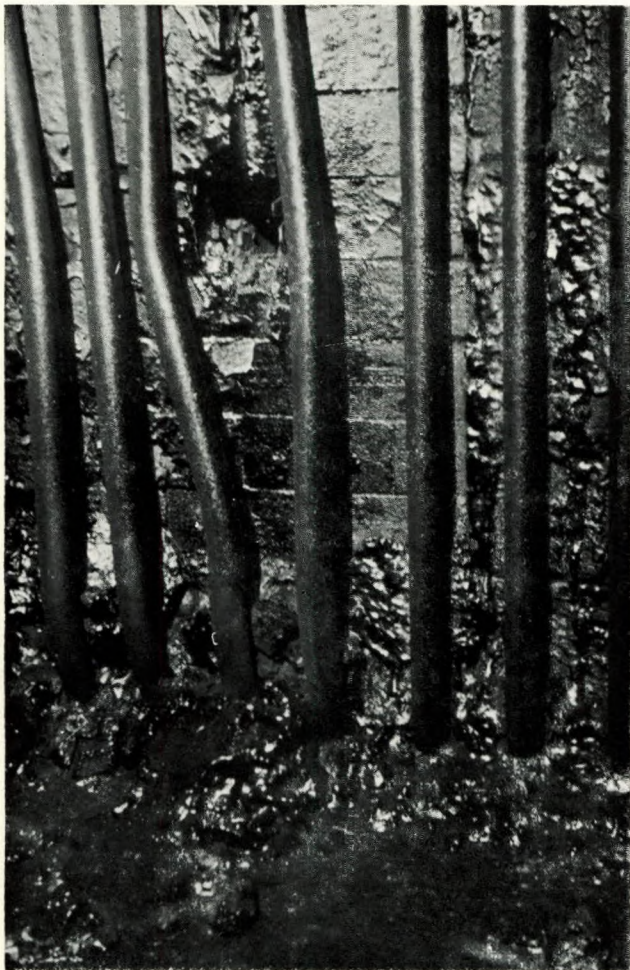
FIG. 27 (above)—Damage to back wall of superheater-side furnace: twin-furnace controlled superheat boiler

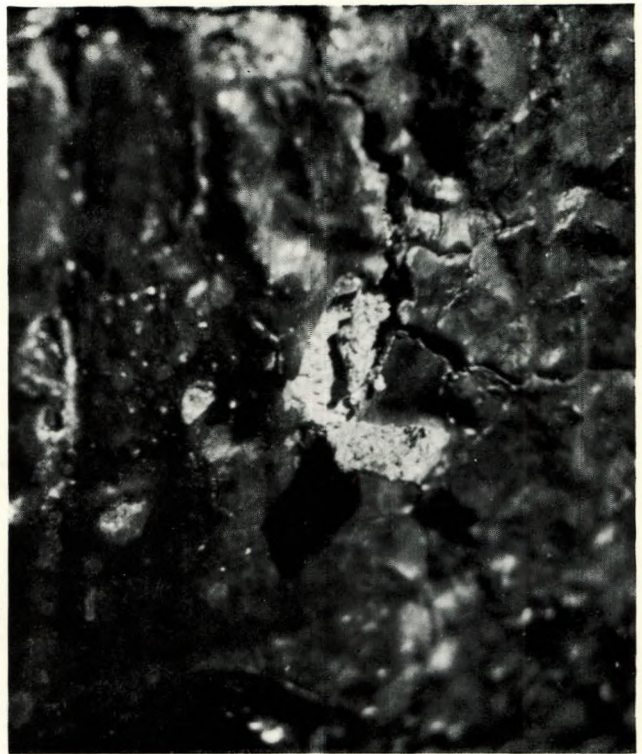
FIG. 28 (top right)—Flaking of cement coating from front wall of header type boiler

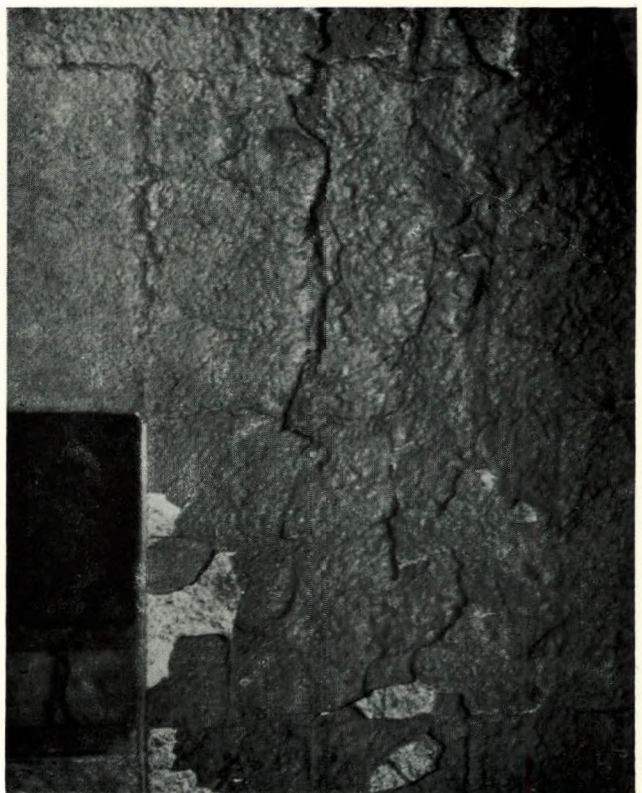
FIG. 29 (bottom right)—Coating of sintered ash: front wall of integral furnace boiler
