Some Interesting Ship and Machinery Defects, Their Investigation and Cure

A SYMPOSIUM OF SHORT PAPERS

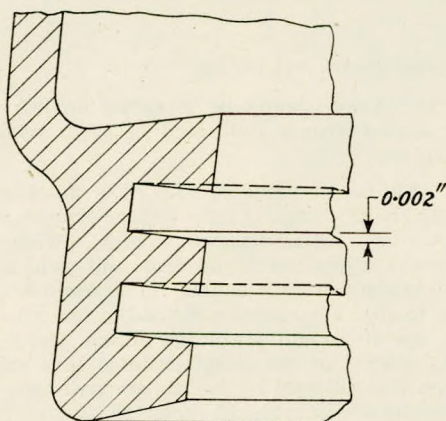
FIG. 1—Section of scraper box grooves showing conical lands

It was at this time that the builders learnt of a somewhat similar experience in the motor industry, in which grossly excessive oil consumption on new engines had been found to be attributable to conical landings of the scraper ring grooves, the coned effect being quite minute but sufficient to lead to the generation of an oil wedge against the working face of the scraper ring.

With this knowledge available, the scraper box which had been replaced, and which appeared by normal examination to be satisfactory, was then returned to the manufacturers and subjected to stringent gauging of the scraper ring landings. It was in fact found that the grooves were of conical formation to the extent of 0.002 inch over the radial width of the landing, as shown in Fig. 1. The direction of the coning was such as to provide for the generation of an oil wedge during the scraping stroke.

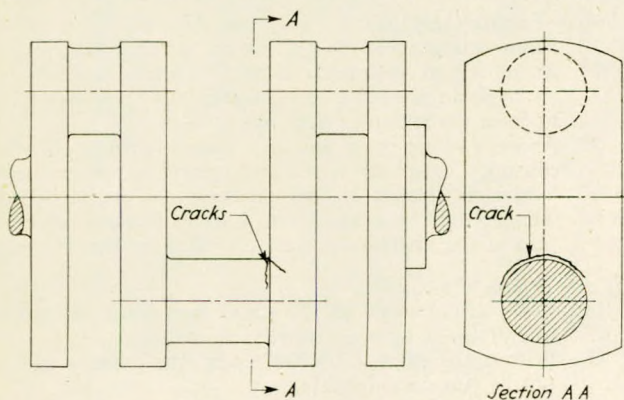
FIG. 4—Cracked main engine crankshaft

The crankshaft was cracked at the forward end of the centre crank pin (Fig. 4). The fracture was approximately 18 inches long and extended around the pin for approximately one-third of its circumference. The crack also extended into the integrally forged crank web.

The first step in the repair was to vee out the crack, both in way of the crank pin and the web, to a depth of about three-quarters of an inch. The crank section was then preheated to between 200 and 300 deg. F. and the fracture welded. The welds were peened after each layer of weld metal was deposited.

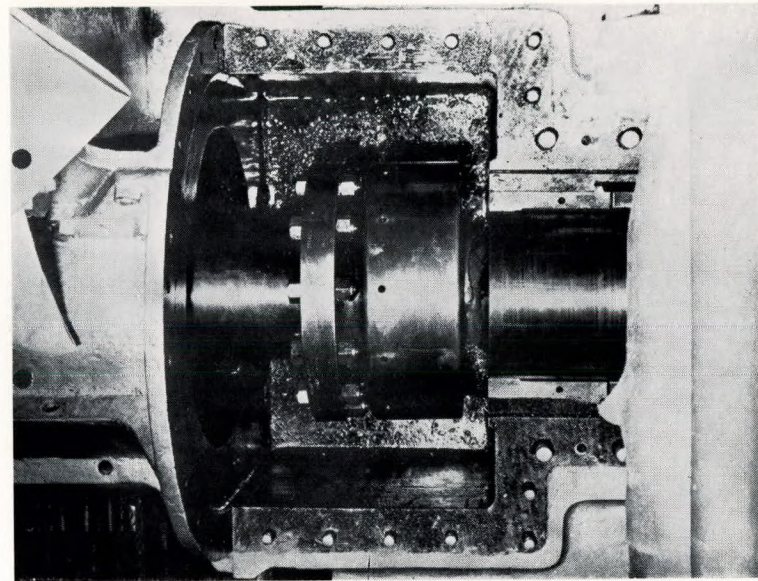
FIG. 14—Fractured low pressure turbine rotor shaft

This vessel is a twin screw, transatlantic passenger liner built in 1939, which saw very arduous duties as a troop transport during the war. It was stated that when the vessel was leaving the dock at Southampton, on opening steam to the starboard unit the turbines would not operate. Examination revealed that the stub portion of the low pressure turbine rotor shaft aft of the after bearing, to which the male claw of the flexible coupling is secured, had completely fractured in such a manner as to cause a jamming between the rotor thrust and the after end of the flexible coupling (Figs. 14, 15 and 16, Plate 2).

Several methods of procedure were considered but since they involved either a long delay in returning the ship to service or a considerable reduction in power and speed, it was finally decided to attempt a temporary repair (Fig. 17).

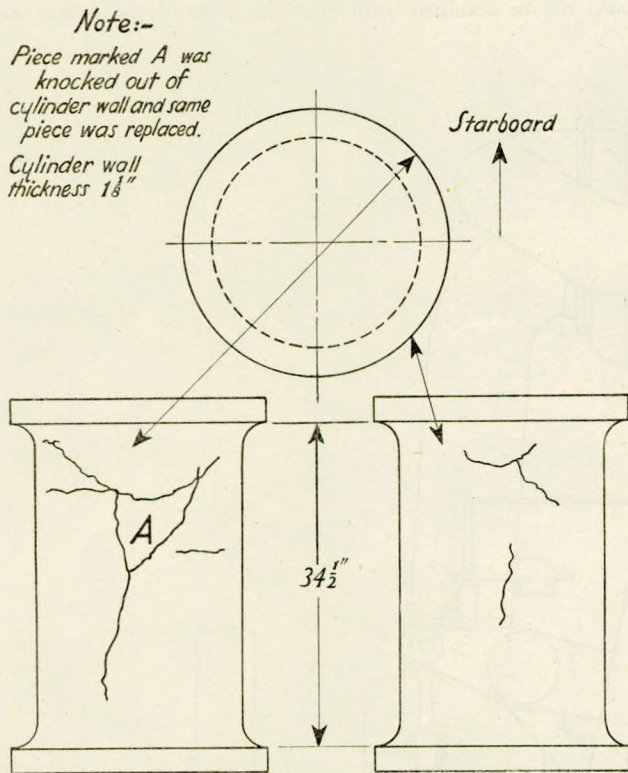
FIG. 9—Fractured main engine air pump cylinder

On the starboard after side of the pump, in addition to the triangular piece "A" which was broken out completely, there was a total of 49 inches of crack extending from within 1 inch of the top flange to within 4 inches of the bottom flange (Fig. 9). On the other side of the cylinder there was an additional 23 inches of crack. It was also found that the cylinder was sprung out of shape.

First, the triangular piece was fitted into its former position and the cylinder was pulled back into shape by the use of strong-backs. The strong-backs remained in position until the repair was completed.

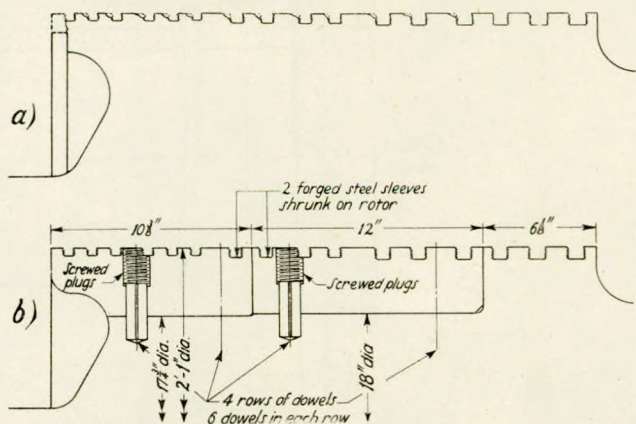
During a periodical survey of the engines, it was found that the l.p. rotor of the port engine was very badly eroded at the exhaust end and the erosion diminished towards the inlet end.

FIG. 19—(a) Section through l.p. rotor, showing erosion of grooves; original outline shown by dotted lines. (b) Section through l.p. rotor, showing repairs effected

This repair involved turning down the existing rotor drum to solid metal to take two forged steel sleeves which were shrunk on to the rotor and secured by four rows of dowels. The sleeves were then turned externally to the size of the rotor, the grooves were recut and complete reblading carried out.

Details of the repair and reblading, which took about four weeks to complete, are shown in Fig. 19.

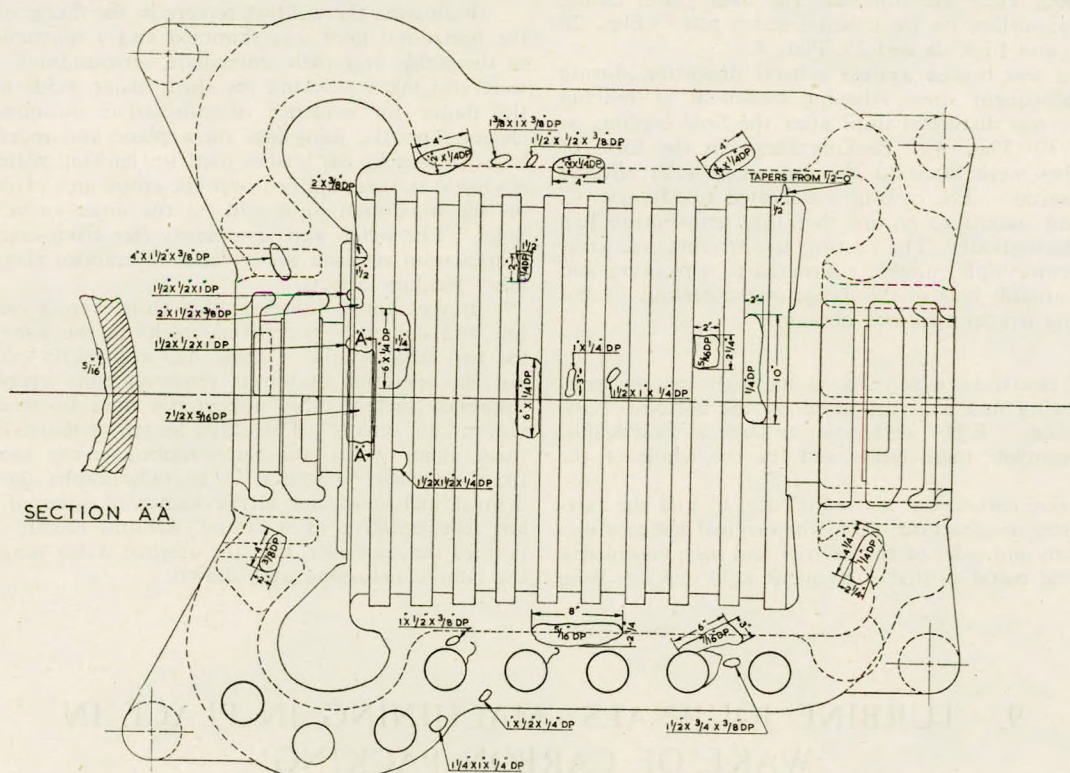
FIG. 21—Sketch showing defects reported by founders

0.026, manganese 0.54, molybdenum 0.55, having a tensile strength of 32 tons per sq. in. Fig. 21 outlines the original casting defects rectified and reported by the foundry during manufacture. However, Fig. 22 shows the larger defects observed before the repair. The discrepancy between the reported and the actual defects should be noted. During the

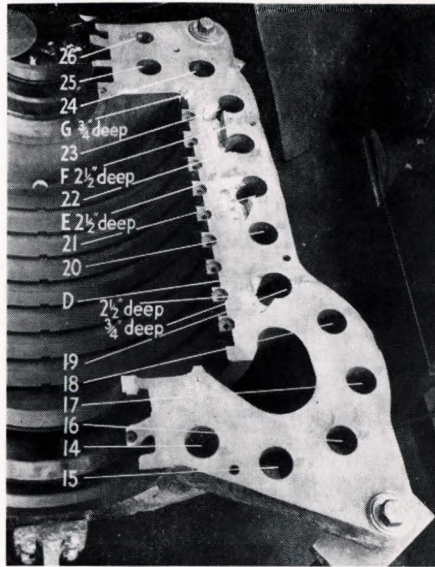
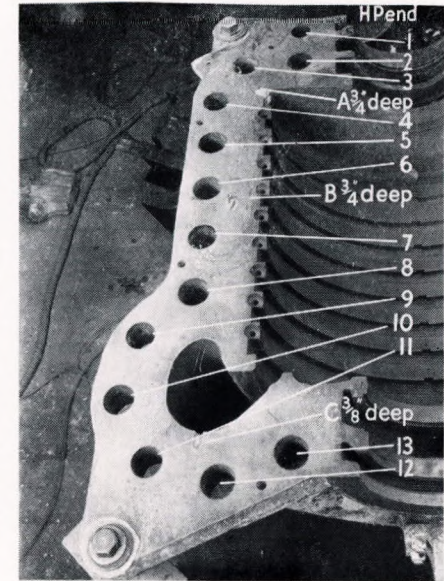
joint were the result of, and ran along, the boundary of previous welding operations and their removal has resulted in three large cavities, as shown in Fig. 24 (Plate 3), between the bolt holes and the bore of the cylinder. During the machining out, one or two blow holes were exposed at a depth of $1\frac{1}{2}$ inches from the surface of the joint. They showed clearly that slag inclusions were the cause of the cavities. A small exploratory cavity (Fig. 26, Plate 3), and three small cavities (Figs. 24 and 25, Plate 3), due to the removal of contraction cracks on the edge of the joint face and bore, complete the record of repairs required on this face. All the external radii were ground and polished, thus revealing five contraction cavities, four of which required attention, viz., one alongside the inlet gland casing and three on the surface on the exhaust steam belt. (Figs. 26 and 27, Plate 3, and Figs. 28 and 29, Plate 4.)

FIGS. 24 and 25—Views of defects chipped out for welding in top half h.p. cylinder. The dimensions given indicate depth of holes

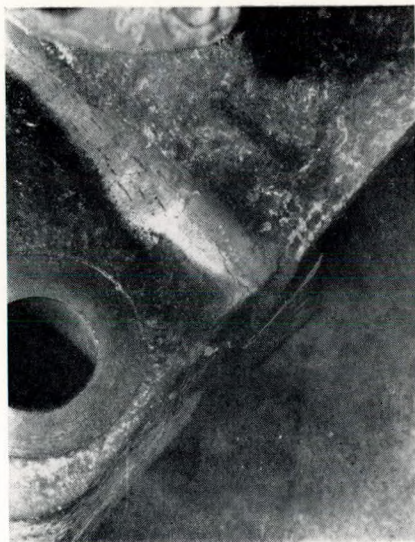
FIG. 28—Top half of h.p. cylinder:
view of defect "D"

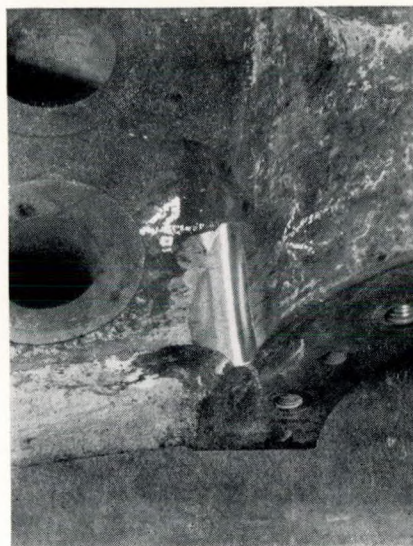
FIG. 29—Top half of h.p. cylinder:
view of defect "D" chipped out for
welding

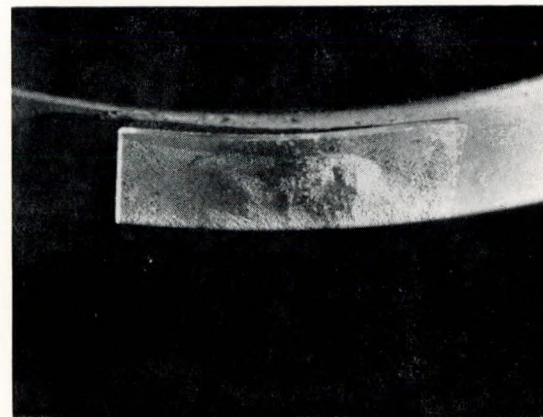
FIG. 31—View of sand patch in steam belt of top
half of h.p. cylinder

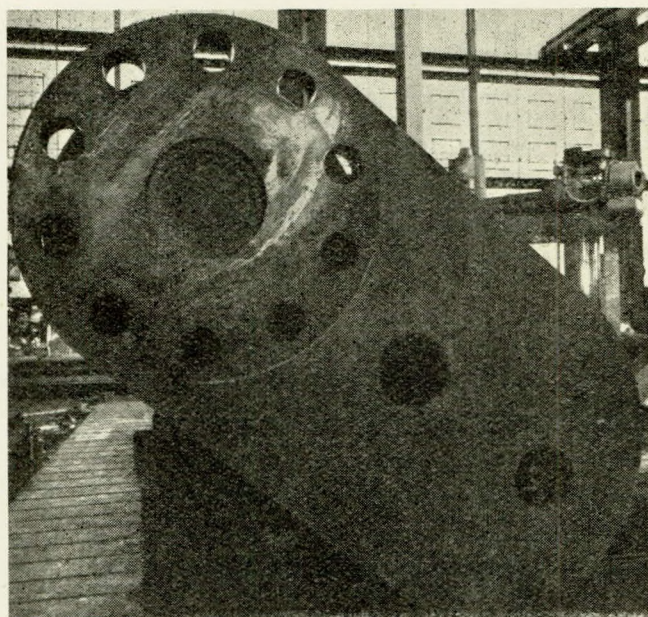
In the meantime, the heavily fretted coupling faces of the first vessel were being machined and an interesting problem presented itself. It was not intended to remove the crankshaft but to reface these couplings in place. The couplings of the bobbin piece, which could be removed from the engine

FIG. 39—Showing fretting pattern on coupling face
