# The Significance of Apparently Minor Factors in Corrosion Problems Affecting Condenser and Cooler Tubes\*

C. BRECKON, B.Sc. (Member)† and J. R. T. BAINES (Associate)‡

\* Presented at a meeting of the Kingston upon Hull and East Midlands Section of the Institute, on 17th February 1955.

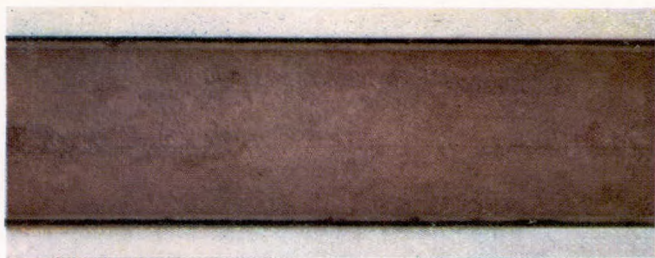
FIG. 1—70/30 brass tube (arsenic-free) attacked by layer type dezincification

In layer type dezincification the whole of the brass surface exposed to sea water is uniformly attacked, giving the appearance, in the case of a tube, of a copper lining on the inside surface. A tube so attacked is shown in Fig. 1 (Plate A).

Uniform attack has developed from the inside surface, giving the appearance of a copper lined brass tube. The attack has penetrated approximately halfway through the wall of the tube. The tube shown was  $\frac{3}{4}$ -in. outside diameter  $\times$  18 WG.

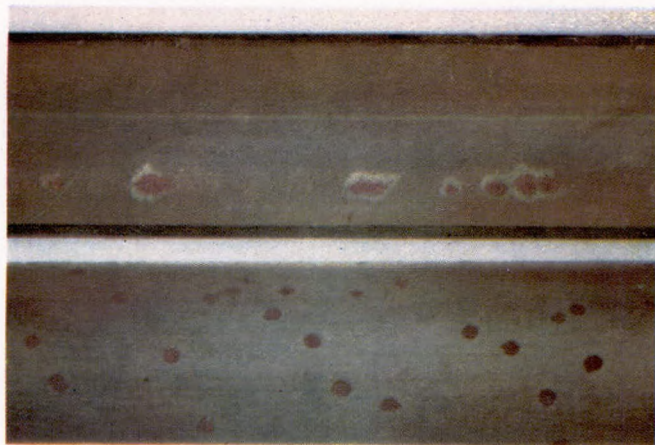
FIG. 2—Aluminum-brass tube (arsenic-free) attacked by plug type dezincification

In plug type dezincification, attack takes place at a number of separate areas on the tube wall, giving the appearance of a brass tube with a number of copper plugs set in it. This type of attack is illustrated in Fig. 2 (Plate A). It is, perhaps, interesting to note that in the early days many people were inclined to believe that attack of this nature was not due to service corrosion but due rather to inferior tubes, suggesting that the plugs of copper were due to insufficient mixing of the copper and zinc during manufacture. It would be generally agreed today that dezincification is due to the use of inferior tubes, but inferior in their composition rather than in any deficiency in the melting or fabrication technique.

The main body of the tube is free from attack by corrosion, but a number of small plugs of dezincification have developed from both the outside and inside surfaces of the tube. The plugs of porous copper completely penetrate the tube wall and will tend to fall out in service, resulting in perforation of the tube. The upper photograph is of the inside surface and the lower photograph is of the outside surface of a  $\frac{3}{4}$ -in. outside diameter  $\times$  18 WG tube.

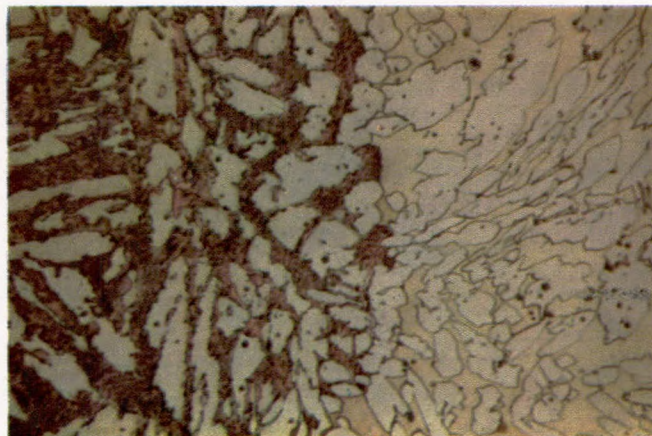
FIG. 6—Duplex structure brass attacked by dezincification

This discovery solved the problem as far as alpha brasses were concerned. With the duplex structure alpha-beta brass, however, the addition of arsenic was not effective in preventing dezincification, and even today there is no known inhibitor which, when added to a duplex alloy, prevents attack by dezincification. A duplex brass which has been attacked by dezincification is shown in Fig. 6 (Plate A). It can be clearly seen that this attack is preferential to the beta phase, with the islands of alpha as yet unattacked.

The specimen of duplex brass shown here is at a point where the alloy has been attacked by dezincification. The beta phase has been attacked and has been replaced by a mass of spongy, porous copper. The alpha has remained unattacked at this stage, and in the photograph the islands of unattacked beta alpha can be seen surrounded by the dezincified beta phase.

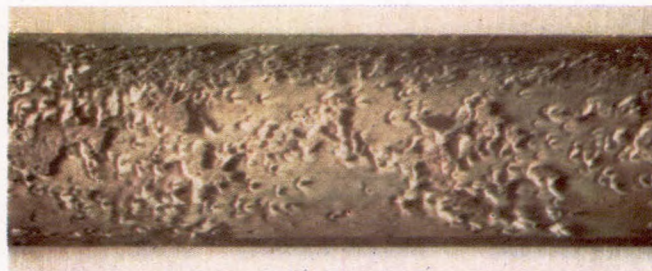
FIG. 7—70/30 brass generally attacked by corrosion erosion

The characteristic horseshoe shaped pits can be seen, all pointing in the same direction. The flow of water through the tube was from the left-hand side of the photograph, i.e. in the direction indicated by the open ends of the horseshoes. The original tube was  $\frac{3}{4}$ -in. outside diameter  $\times$  18 WG.

In these days impingement attack, or corrosion erosion, is almost a thing of the past, but Fig. 7 (Plate A) illustrates a piece of brass tube which has been attacked in this way. One important characteristic to be noted in this case is the horseshoe shaped pits, and these always indicate the direction of flow of the water. It is just the same as when a receding tide flows round a pebble on the beach, the points of the horseshoe pointing in the direction of the flow of the water.

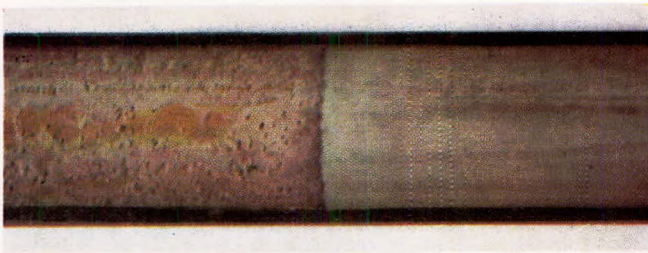
FIG. 8— $\frac{3}{4}$ -in. outside diameter  $\times$  18 W.G. aluminium brass tube after twenty years' service in a passenger liner

On the left-hand side of the photograph the tube is shown in the service condition, covered with a brown film. This film has been removed by acid cleaning over half the length of the tube to show the underlying metal surface, which is smooth and free from corrosion.

For comparison purposes, Fig. 8 (Plate B) shows a portion of an aluminium-brass condenser tube which was fitted in a ship over twenty years ago and which, until its removal, was in continuous service during that period. To all intents and purposes this tube is in as good a condition as the day on which it was installed. In actual fact, to be strictly accurate, the tube is better than when it was installed because it has developed to the full the optimum corrosion resistance which depends on film formation.

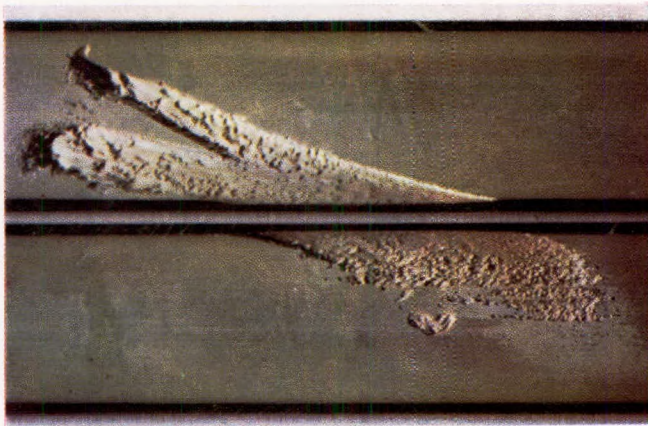
FIG. 9—A service failure due to an obstruction

Intense local attack has developed on the inside surface of the aluminium brass condenser tube. The bore of the tube has become partially blocked by the presence of a foreign body, thus increasing the local speed and turbulence at this point. The excessive turbulence created is sufficient to break down the protective oxide film, and rapid impingement attack develops in the violently turbulent area.

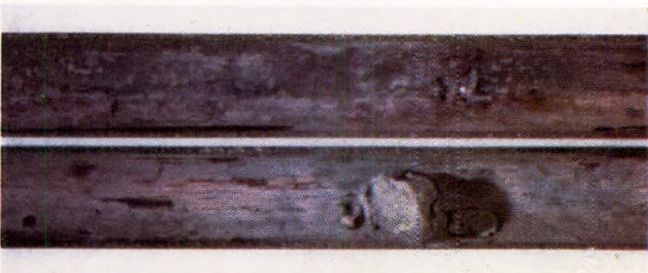
FIG. 10—Service failure due to an obstruction, with the obstruction in position

A failed tube which was sent for examination. On splitting the tube the partial obstruction, a small piece of pebble, was still in position in the tube. Severe local attack has developed on the surface of the tube, and the perforation can be seen in the opposite half section to that containing the pebble.

To come to another point in the consideration of this problem, which is really not concerned with composition. The problem of impingement attack was solved by the introduction of aluminium-brass tubes, and also, incidentally, cupro-nickel tubes, at about the same time. There were, however, a number of cases where isolated tubes suddenly developed extremely local areas of attack. This caused very much concern and conjecture at the time, and Fig. 9 (Plate B) shows a typical area of corrosion. The attacked area might occur anywhere throughout the length of a tube, and the whole of the remainder of the tube would be free from attack. This type of trouble usually occurred only on a small number of tubes. Careful comparison of analysis, mechanical condition and every other factor showed that these tubes were in every way similar to the tubes which were not attacked, and any tests carried out on portions cut from the tubes showed them to be perfectly normal in every way. The attack might lead to failure in a matter of only two to three weeks, and after the condenser had been running for several weeks or months it was unlikely that further trouble would arise. Eventually, it was realized that this local form of attack was due to partial obstructions in the bore of the tube. In many cases, the obstruction, or partial obstruction, causing the excessive local turbulence was still present in the tube at the time failure occurred. Fig. 10 (Plate B) shows a tube where this attack had developed and where the stoppage was still lodged in the bore of the tube when removed for examination.

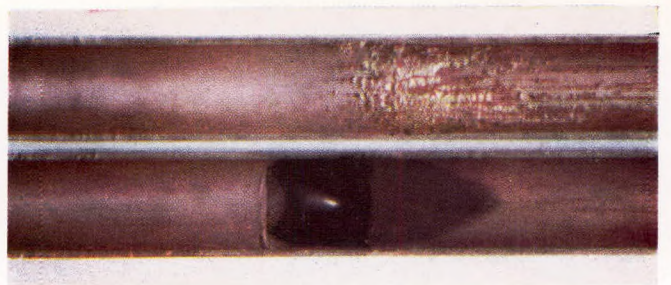
FIG. 12—Brass tube containing artificial obstruction

A laboratory experiment in which an ebonite obstruction of special shape and size was secured in the bore of a condenser tube. Aerated sea water was pumped through the tube at a known speed. The photograph shows the intense local attack which has developed immediately downstream of the obstruction, and the characteristic horseshoe shaped pits can be seen.

Fig. 12 (Plate B) shows the result at a partial obstruction which has been produced artificially in the laboratory on a piece of aluminium brass tube. The very sharp and local nature of the attack is easily seen, and a careful examination shows some horseshoe shaped pits indicating the direction of flow. It is interesting to note in passing that the resistance to attack of alloys such as aluminium brass and the cupro-nickel alloys is now generally accepted as being due to the development on the surface of these alloys of a tough oxide, or hydrated oxide, film, and that these films achieve their optimum strength after some few days' exposure to moving sea water. If, therefore, areas of local turbulence arise in the very early life of a condenser tube, it is much more likely to be corroded than is the case if the obstruction becomes lodged after several months' service. With any alloy, however, a very bad case due to this type of obstruction could cause trouble even after a very long period of service.

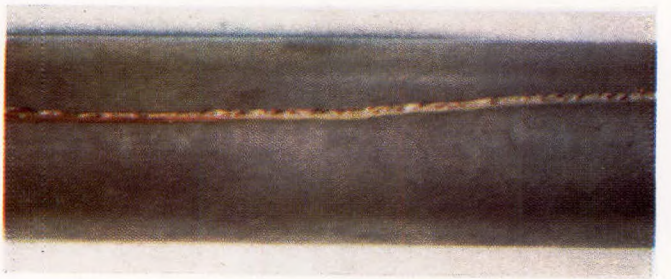
FIG. 13—Season cracked tube

Service failure due to unbalance stresses in the tube wall introduced during the manufacturing process. A typical longitudinal crack has been produced which completely penetrates the tube wall.

Up to now the matters referred to have been mainly variations in alloy composition. The behaviour of a tube in service does, however, depend on many other factors besides composition. Some of these points are very obvious and others not so obvious. One of the earliest and most obvious manufacturing shortcomings which was revealed in tubes, not only in ships' condensers but in other types of plant, was the question of season cracking. This type of failure was liable to occur suddenly without warning, and resulted in a substantial longitudinal crack appearing in the tube wall. This crack might extend only a few inches or from one end to the other of the particular tube concerned. A tube so attacked is shown in Fig. 13 (Plate B). It was soon established that this form of cracking was really a special case of stress corrosion cracking in which the stress was an unbalanced stress put in the tube as a result of an incorrect method of manufacture.

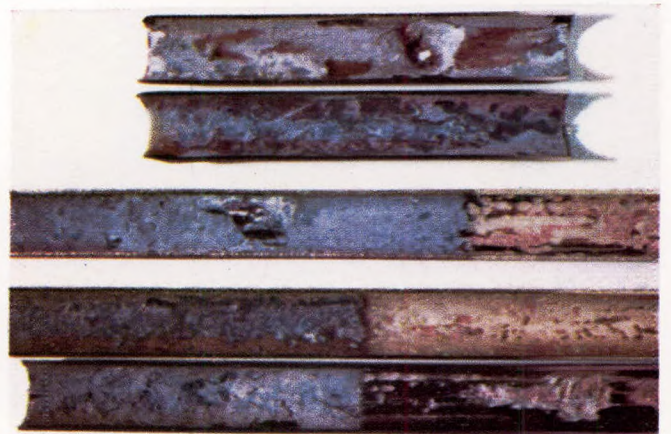
FIG. 24—Service failure by pitting attack

Examples of failed tubes which have failed due to severe pitting attack, the attack possibly being due to the condition of the tube prior to installation, as referred to in the previous illustration. The pieces shown are all half sections and the right-hand ends of the lower three have been acid cleaned.

Fig. 24 (Plate B) is a colour photograph of a service failure due, it is thought, to this cause. The right-hand end of some of the pieces have been cleaned.

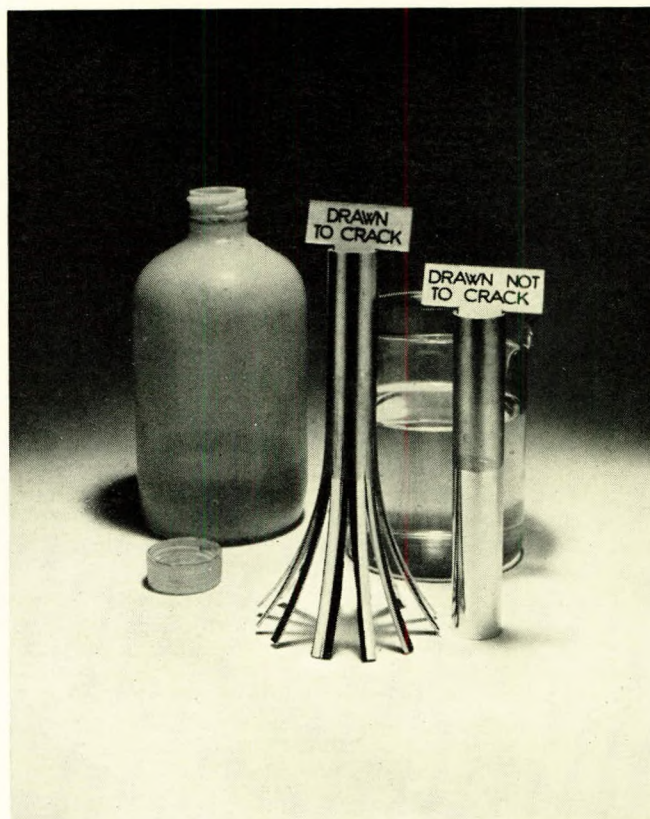
FIG. 15—Season cracking test (b) after immersion of specimens

After fifteen minutes' immersion in the solution the specimens are withdrawn. Each specimen has a layer of mercury deposited on the surface which acts as a rapid stress corrosion agent. The tube drawn to crack has failed by stress corrosion, resulting in numerous longitudinal cracks. The tube wall has also belled out due to the relief of the unbalanced compressive stresses. The tube drawn by normal methods has remained free from cracks.

There is a very good test which illustrates when a tube is liable to fail by season cracking, in which the tube is immersed in a dilute solution of mercurous nitrate. The mercury liberated by chemical interchange on the surface of the brass tube acts as a very rapid stress corrosion agent and a tube which is liable to fail after a prolonged period in service can be cracked by a period of only a few minutes in this solution. Figs. 14 and 15 show tubes before testing and again after a period of only fifteen minutes in this solution. The correctly drawn tube has developed no cracks, but the one containing unbalanced stresses is very badly cracked and has been distorted by the stress.

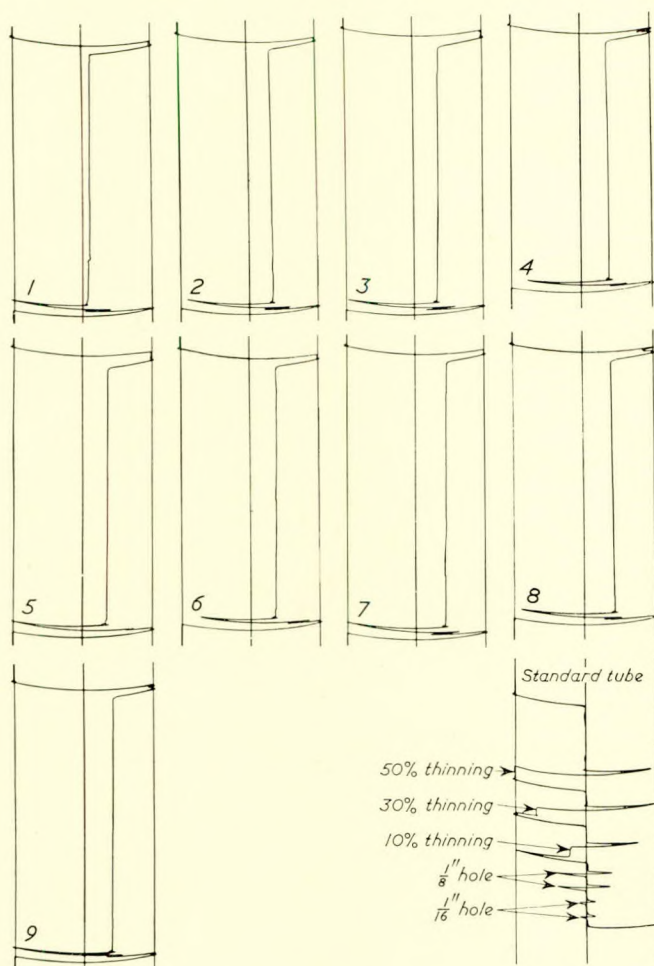
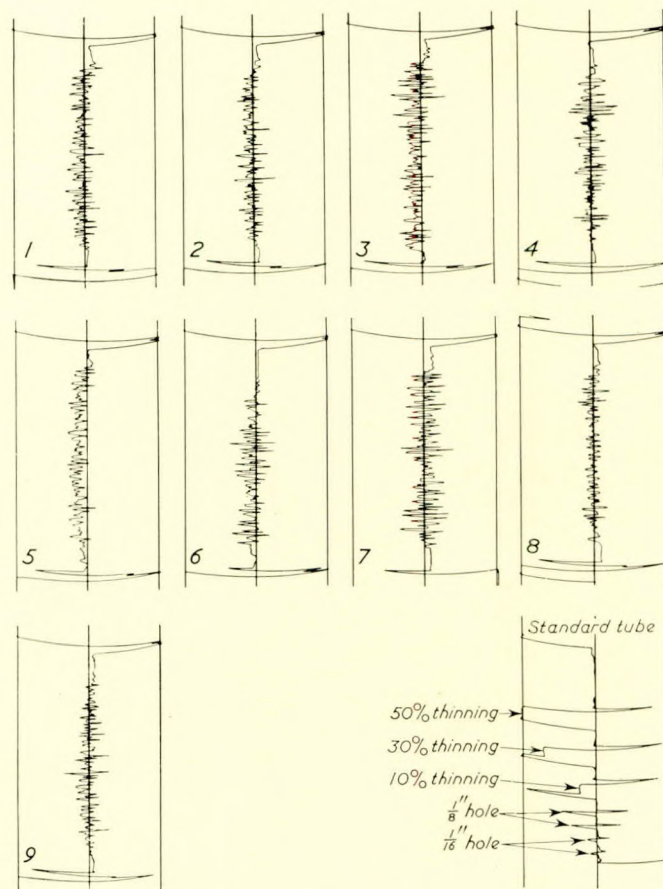
FIGS. 22 (original) and 23 (after service)—Probolog charts of aluminium brass tubes made in special manner

Fig. 22 shows the fourth set of tubes before the test. The traces are all straight lines, but it will be noticed that they are displaced a little to the right of the centre line as they come from the machine. This indicates a slightly greater average thickness than the standard tube. The condition of the tubes after test is shown in Fig. 23 and it can be seen that corrosion has taken place throughout the length of all these tubes. The irregular nature of the trace indicates a general pitting type of attack, but it will also be noticed that the average centre line of the trace is displaced to the left, indicating a removal of metal sufficient to give the effect of a general thinning operation.

It will be seen that there is a significant difference in the two sets of traces obtained. Before going into service each tube gave a straight line trace but after six months' service the traces have generally moved to the left, indicating general thinning, the number of small deflexions on each chart showing that pitting corrosion has taken place.

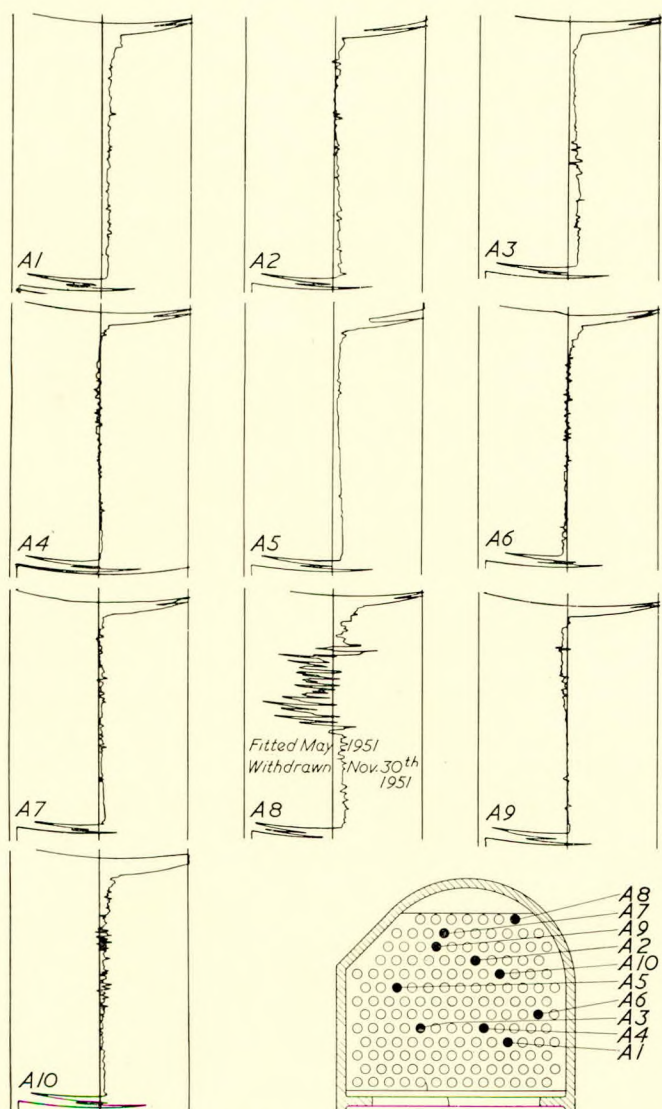
FIG. 25—Probolog charts of 70/30 cupro-nickel tubes installed in coastal tug: first period

Figs. 25 and 26 illustrate some results which show how position in the plant can have a very remarkable effect on the behaviour of tubes, even though each tube in a condenser might be thought to be working under the same conditions.

alloys which they have examined regularly with the Probolog. Fig. 25 shows the Probolog traces for the ten 70/30 cupronickel tubes installed, and their positions are indicated in the diagram. This shows the conditions after the condenser had been in operation from May 1951 to November 1951 and it will be seen that there is little attack on any of the tubes except for one designated A8, on which there is a very severe area of attack. In November 1951 this single tube was replaced by another of the same alloy which gave a straight line trace on the Probolog. After a further ten months' service all the tubes were again tested by the Probolog and the results are shown in Fig. 26. It will be seen that this replace tube had developed an area of attack in exactly the same position as the previous tube, although the other tubes were not appreciably changed. In fact, it will be noticed that the particular tube A8 is at the top of the condenser and the area of attack is opposite the steam inlet. The engine in this instance is a reciprocating engine with a higher exhaust steam temperature than is usual in the case of a turbine. Their explanation of this corrosion (of which there is other evidence in support) is that the very slow rate of flow of the highly polluted water through the tubes is such that a stagnant layer is formed in contact with the tubes, and in the portions opposite the steam discharge this stagnant layer becomes much warmer than the average temperature in other parts of the condenser. The very great difference in behaviour, for example, between tube A8 and tube A5 shown above it on the diagram is due simply to a very

The position of each tube in the condenser is shown on the diagram at the bottom right hand side of the photograph. After six months' service, severe attack has taken place on tube A8, the remaining tubes being free from corrosion. Tube A8 was replaced by a new tube of the same alloy after the examination.

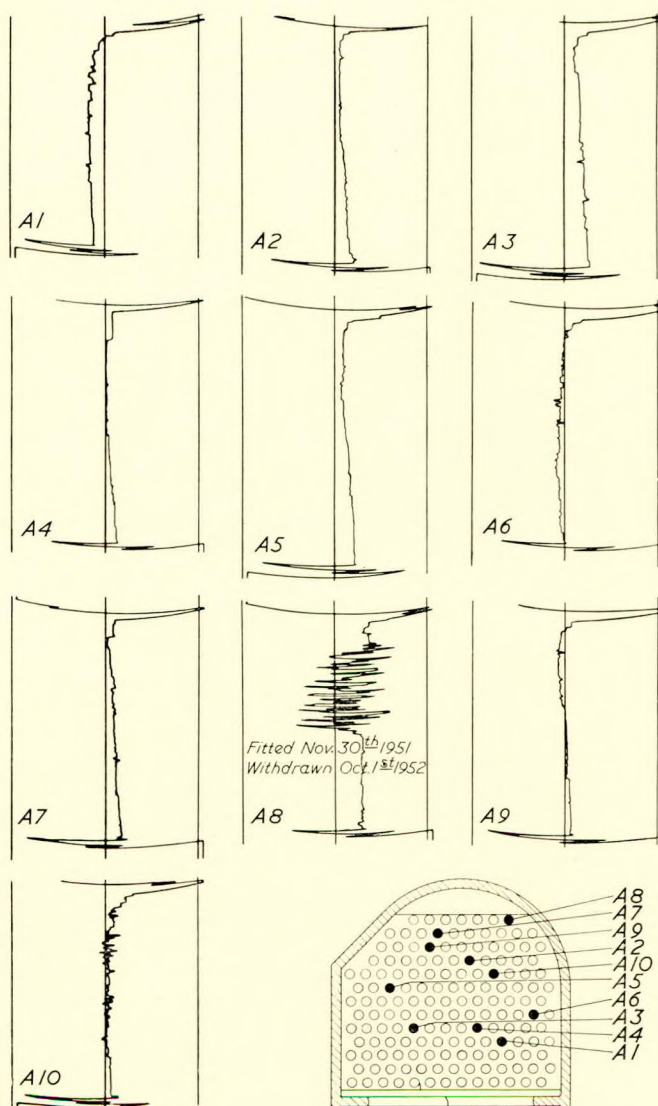
FIG. 26—Probolog charts of 70/30 cupro-nickel tubes installed in coastal tug: second period

Replace tube A8 has been attacked in a similar manner to the original tube A8 after a further ten months' service. The remaining tubes are still relatively free from attack by corrosion.

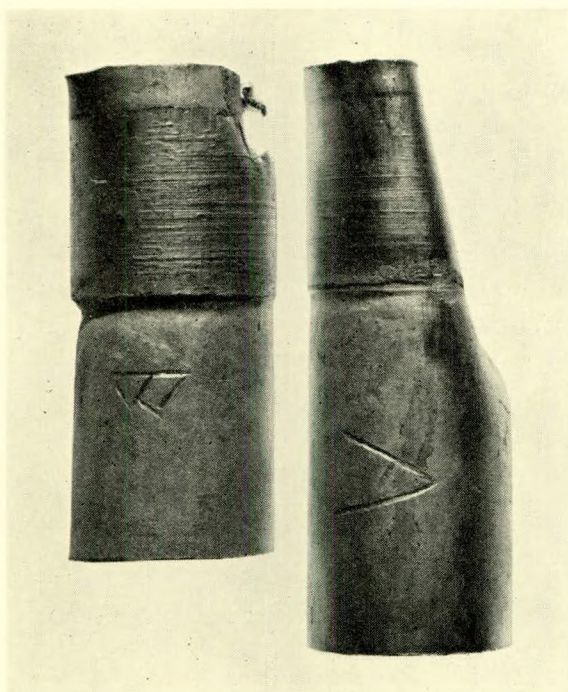
FIG. 27—Brass tube removed from sugar evaporator, outside surface

The photograph shows the severe thinning of the tube wall which has taken place just below the top tube plate due to the attack by incondensable gases. Except for the short distance near the top where corrosion has taken place, the tube wall is of the original thickness and is free from attack by corrosion.

There have been many cases where severe corrosion of non-ferrous tubes due to these incondensable gases has been much reduced or even completely eliminated by simply modifying vents or opening up existing vents. Figs. 27 and 28 show two half sections of tube from a sugar evaporator. In this plant the tubes are fixed vertically. It will be seen that very rapid and locally severe corrosion has taken place where the condensate has hung between the top tube plate and the tubes. The tubes in this plant were 70/30 brass and lasted only one year. The interesting point about this story is that when this problem was investigated the use of some of the cupro-nickel alloys, which are more resistant to this type of attack, was suggested. It was also suggested that the vents which were at that time mid-way down the steam space should be moved to immediately underneath the top tube plate and on the opposite side to the steam inlet to ensure that no stagnant pocket of vapour could form. Cupro-nickel alloy tubes were installed for test along with 70/30 brass tubes, and one year later these were examined when it was found that there was

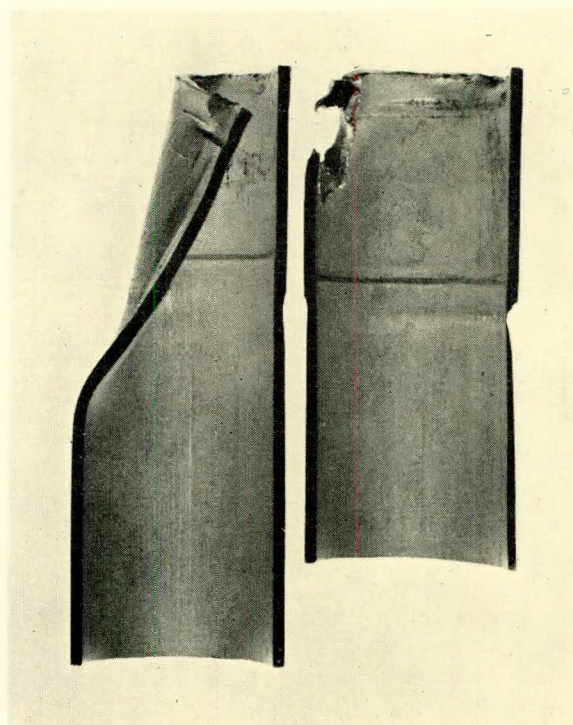
FIG. 28—Brass tube removed from sugar evaporator, inside surface

The photograph shows the severe thinning of the tube wall which has taken place just below the top tube plate due to the attack by incondensable gases. Except for the short distance near the top where corrosion has taken place, the tube wall is of the original thickness and is free from attack by corrosion.
