THE INSTITUTE OF MARINE ENGINEERS

Some Operating Experience at 950 Degrees F.

L. BAKER, D.S.C. (Vice-President)* and W. H. FALCONER (Associate)†

The paper gives an account of the two years' experience of the operation of s.s. *Nestor* and s.s. *Neleus*, which were the first two British ships to operate at 950 degrees F.

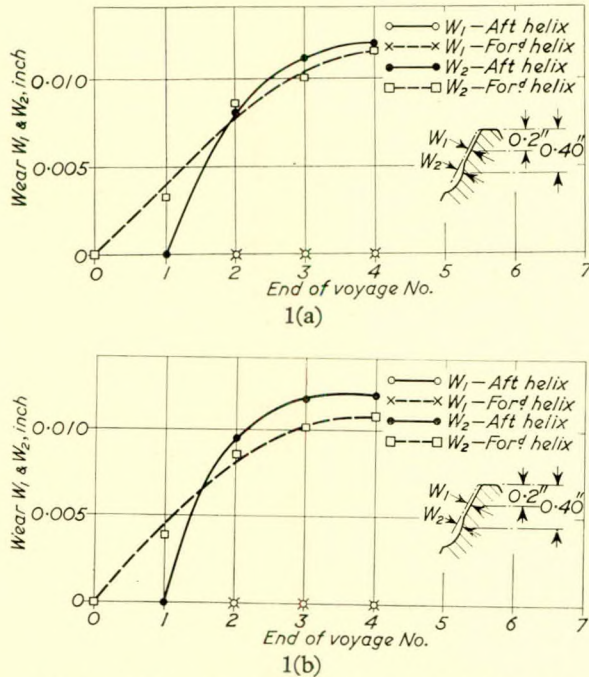
FIGS. 1(a) and 1(b)—Profile of wear on secondary pinions and main wheel, determined by pantographic enlargements from sulphur casts

The primary pinions and wheels have never shown any signs of wear but the secondary train of the first ship, *Nestor*, has been subject to some unusual wear. During the test bed trials of the first set, it was observed that the after end of the after helix (the loaded end) of the secondary i.p. and h.p. pinions were showing hard marks. Time did

not permit of a detailed investigation but subsequent to the ship trials considerable marking was observed over the last 6 inches of the helices. This gradually developed into pitting and spread over the whole of both helices, resulting in an unusual form of wear as shown in the large scale reproductions taken from casts of selected parts of the defective teeth (Figs. 1, 2 and 3).

These defects fitted none of the previously experienced patterns of gearing failures and were not unnaturally the subject of considerable thought and investigation and also caused some apprehension regarding the probable life of the teeth. Fortunately, the rate of wear has steadily decreased and now appears to be settling down. Despite the appalling appearance of the teeth, this set of gears, together with those of the other ship, are the quietest gears in the fleet.

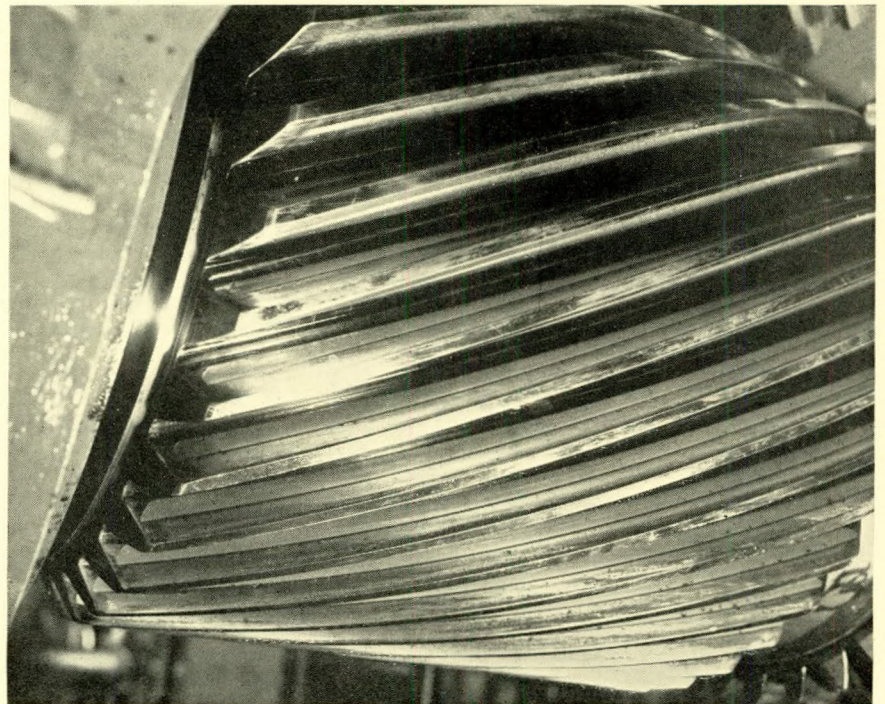
FIG. 2—Main gearing in s.s. *Nestor*: after helix of secondary i.p. pinions

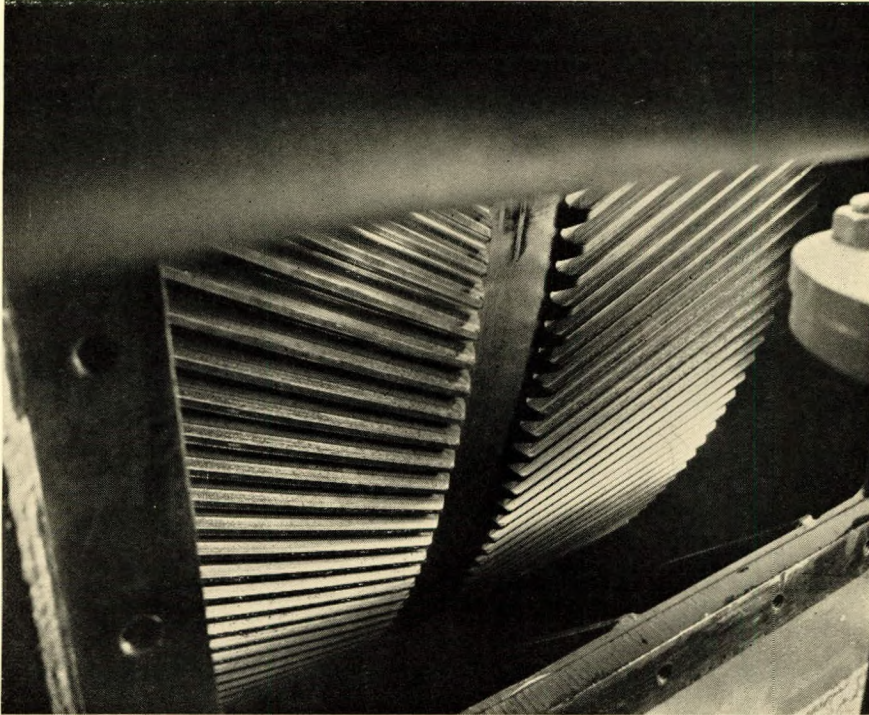
FIG. 3—*Main gearing in s.s. Nestor: main wheel ahead faces*

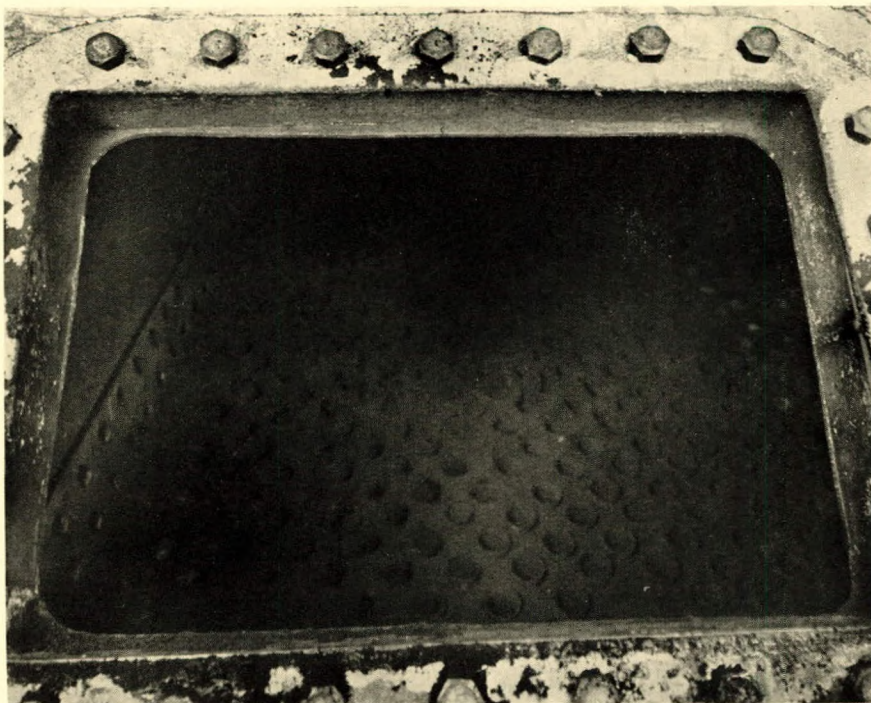
FIG. 4—*Air heaters in s.s. Neleus: view of top of air heater tubes before cleaning*

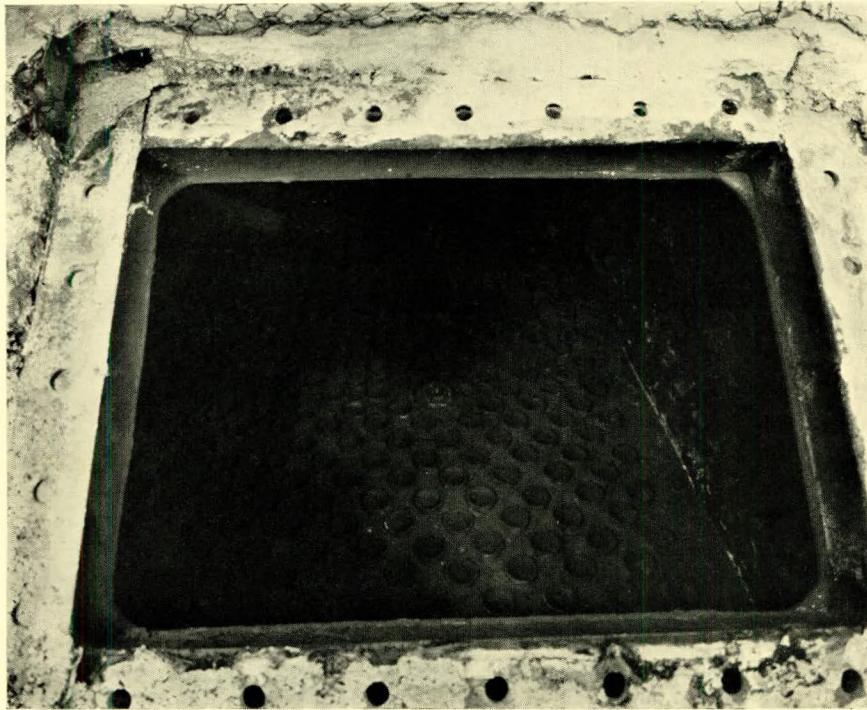
FIG. 5—Air heaters in s.s. Neleus: view of top of air heater tubes after cleaning

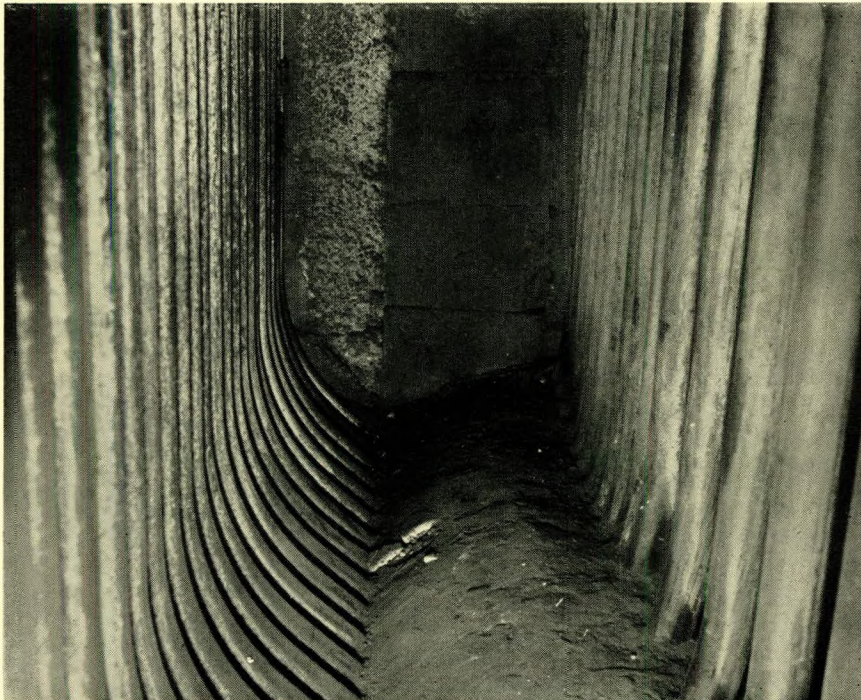
FIG. 6—Main boiler in s.s. Nestor: view between generating tube bank and starboard superheater support tubes (water drum)

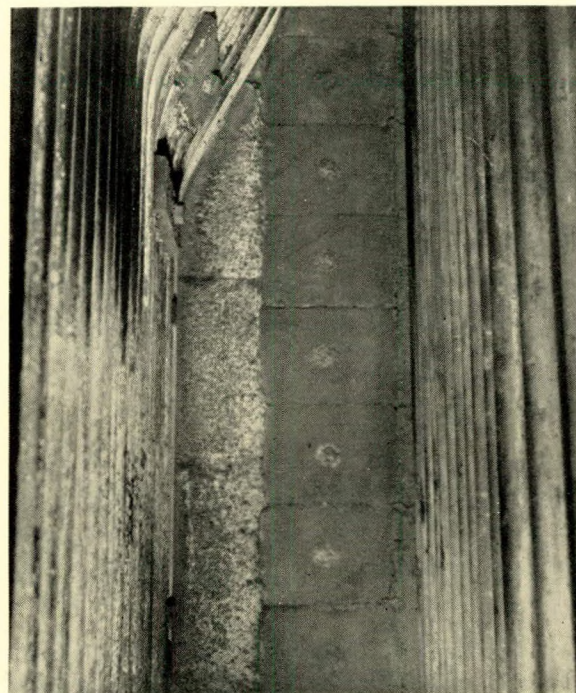
FIG. 7—Main boiler in s.s. Nestor: view between generating tube bank and starboard superheater support tubes (top)

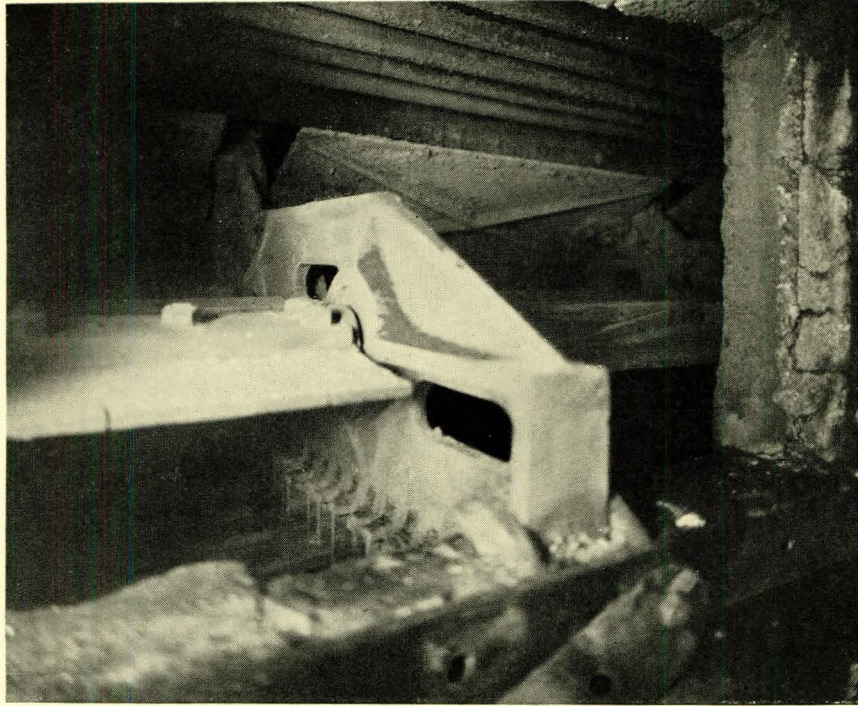
FIG. 8—*MeLeSco superheaters in s.s. Nestor: intermediate pass of starboard superheaters from below*

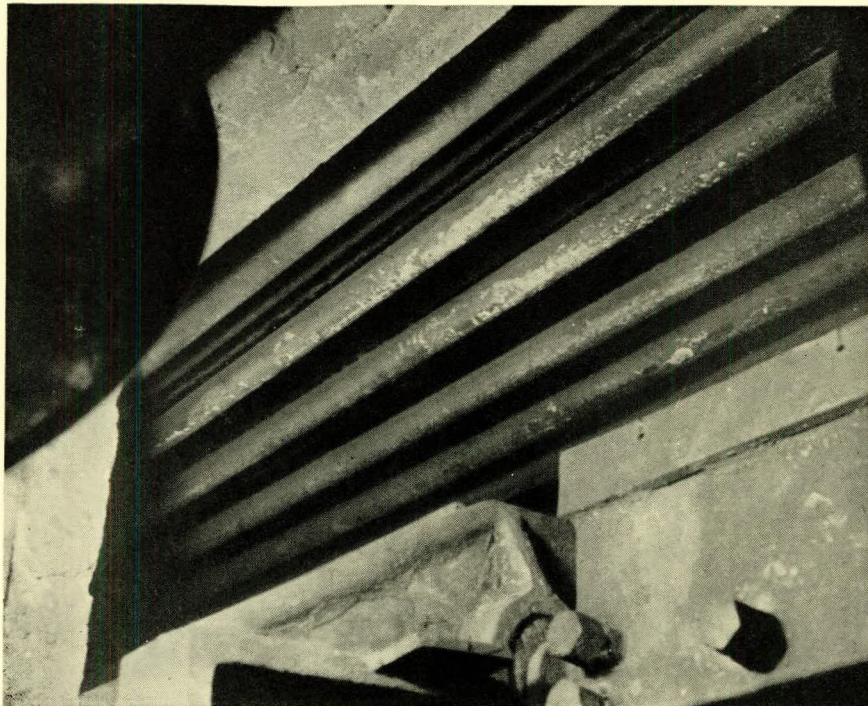
There had been some hesitancy regarding the use of dampers in the high temperature zone of the boiler and it is, therefore, the more pleasing to report that the design has been entirely free from bearing troubles. The dampers of the first ship were coated with a ceramic paint and they had given no trouble due to burning or distortion at all (Figs. 8 and 9); those of the second ship were not so treated and despite the use of high grade heat-resisting alloys, difficulty with burning of the edges has been experienced; this has resulted in one or two of the second-stage superheater elements being subjected to a temperature in excess of design so that they have sagged and have fouled the damper. The support of these lower legs has now been improved and the use of the ceramic coating has obviated further trouble from this cause.

FIG. 9—*Main control dampers in s.s. Neleus: view of superheater control dampers and cronite support bracket looking through inboard access door*

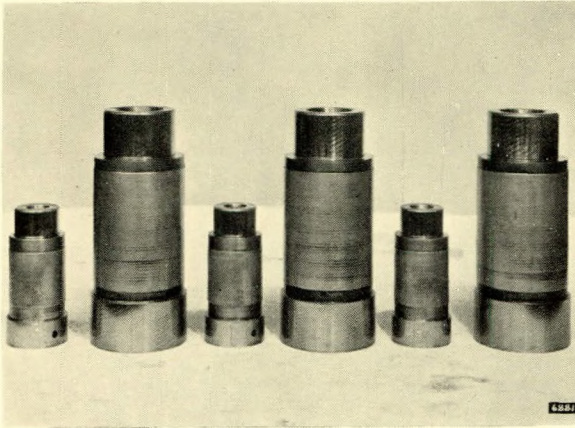
FIG. 10—Turbo-generator gearing in s.s. Neleus: planet pins of first and second train; loaded side of pins

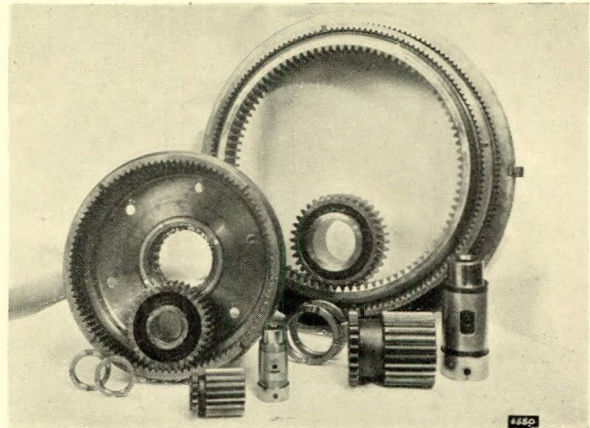
FIG. 12—Turbo-generator gearing in s.s. Neleus: first and second train components of double reduction gear

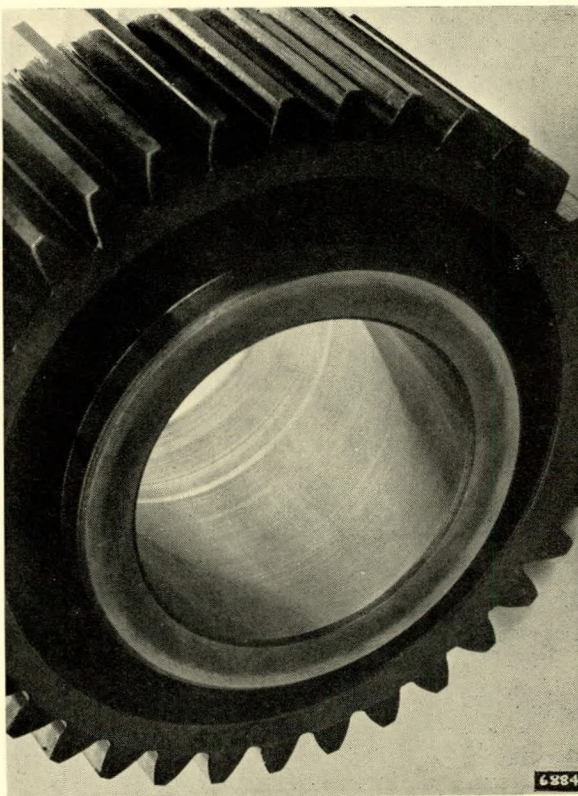
FIG. 11—Turbo-generator gearing in s.s. Neleus: planet wheel of second train showing bore and teeth

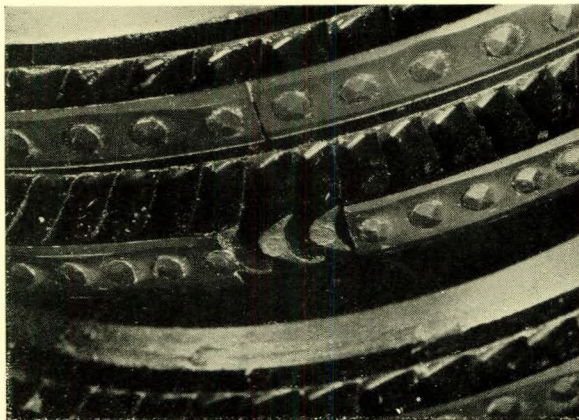
FIG. 15—Turbo-generator rotor in s.s. Nestor

The rotor of the turbo-generator of the *Nestor* has suffered an unusual defect, viz.:—

- (a) failure of a coupling bolt;
- (b) heavy wear of the driving wheels of the oil pump;
- (c) failure of some shrouding.

The first two are believed to have been due to the occurrence of oil film whirl which is always possible with a high-speed machine but which presents no serious problem in elimination once it has been detected. In this case the vibration caused was so slight that it passed unnoticed for some time and only gradually became pronounced enough to be detected.

The last failure is thought to have been due to the use

of blades and shrouds of different material—this was the result of the difficult supply position at the time of construction and not of design. These different materials had slightly different coefficients of expansion which caused excessive stresses to be induced particularly at the end of the shroud strips. No trouble has been experienced to date in the second ship, in which the materials are the same.

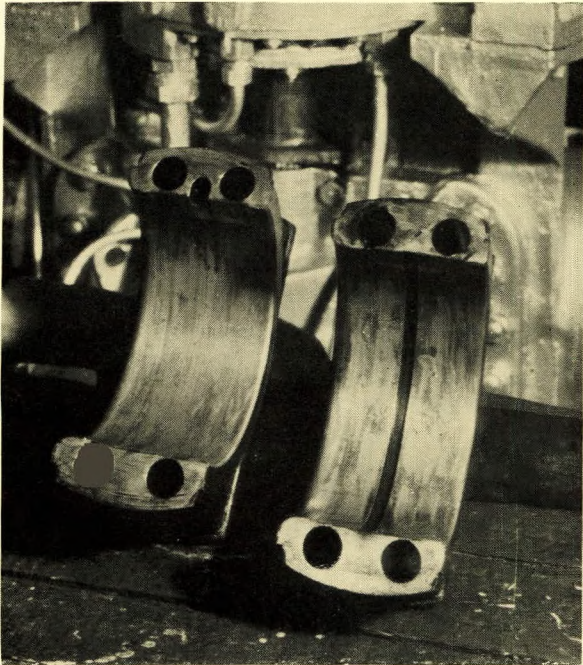
FIG. 18—Diesel generator in s.s. Neleus: view of bottom end as removed after 4,596 hours' service

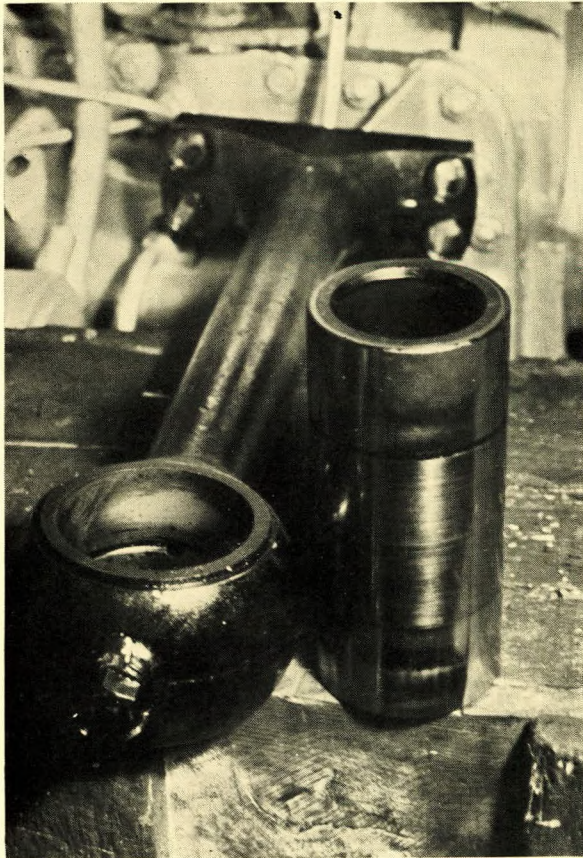
FIG. 19—Diesel generators in s.s. Neleus: view of gudgeon pin and top-end bush as removed after 4,596 hours' service

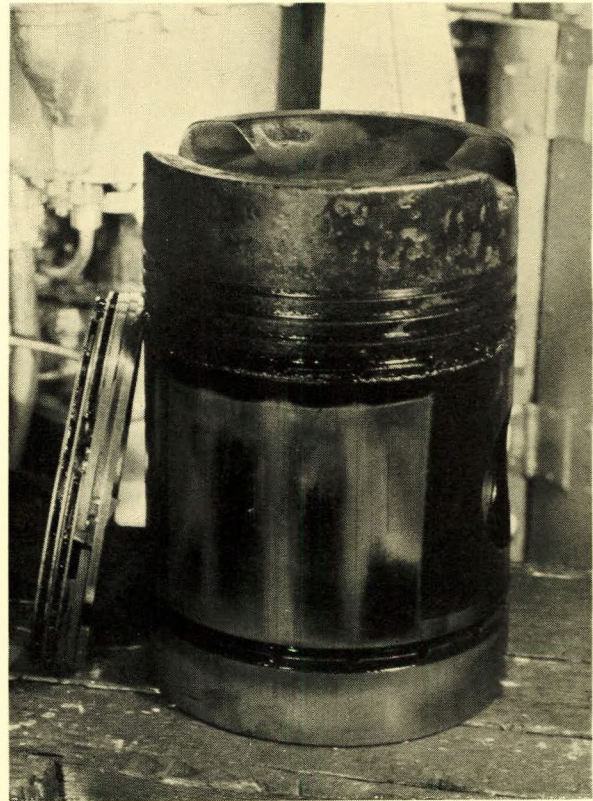
FIG. 20—Diesel generators in s.s. Neleus: view of piston and rings as removed before cleaning

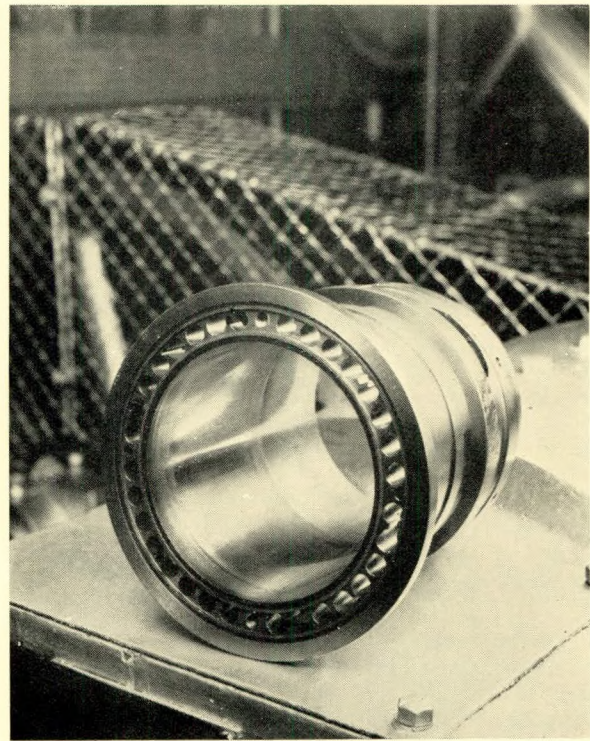
This high-speed Freon compressor has behaved very satisfactorily and has proved to have only one drawback from the point of view of the ship's staff, viz. that its capacity is so large that it requires no assistance from the other compressors fitted! It is obvious from Figs. 21, 22 and 23 that mechanically the condition is perfect.

FIG. 23—Vee-block refrigerating compressor in s.s. Neleus: liner as removed from machine

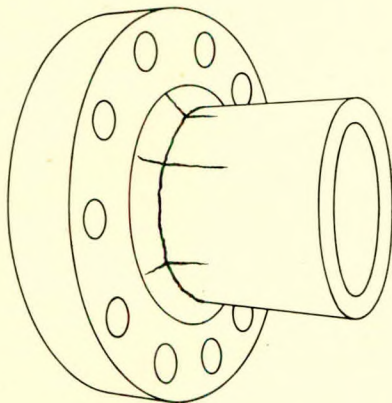
FIG. 26—Sketch showing typical cracks in pipe flange weld

Fig. 26 was a sketch of a main steam pipe and its flange with typical cracks. These were both transverse and circumferential in direction and intercrystalline in nature.

The cracks appeared to have propagated only into the steam pipes and not the flanges. This might be associated with the higher hoop stress in the pipe.

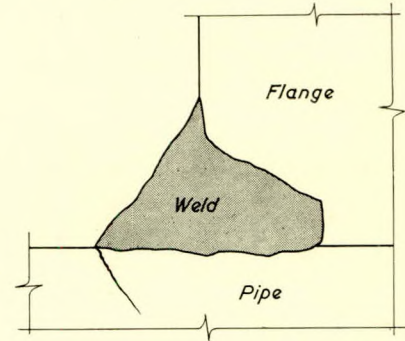
FIG. 27—Sketch showing typical section of weld with junction crack

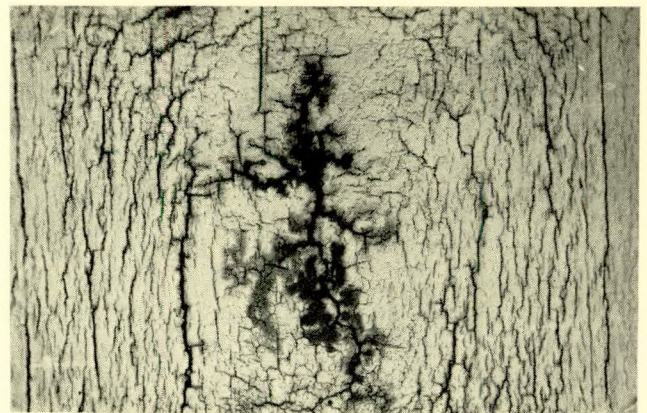
As he had mentioned in the verbal discussion, corrosion fatigue was an old favourite, but he did feel that a certain amount of apathy was once more creeping in with regard to this trouble. The advent of all-welded steam mains from boiler to turbine tended to create an "out of sight out of mind" attitude which was not only unfortunate, but, he would say, disastrous

FIG. 28—Bore of steam pipe branch showing corrosion fatigue cracks (surface cleaned prior to photographing)
