Some Considerations of Wear in Marine Gearing

W. H. DARLINGTON, M.B.E., Ph.D., M.Sc.(Eng.), A.M.I.Mech.E.*

The paper deals with the design, manufacture and operation of three sets of marine double reduction gears, having a tooth loading indicated throughout by a Lloyd's K value of 120. They were also the first set of marine gears to be shaved throughout by the author's company. The first two sets of gears had a transient wear problem associated with the dedenda of the second reduction pinions and wheel which cured itself on continued operation and has now ceased. The third set was fitted with hardened and ground pinions but soft main wheel. This had no wear problem.

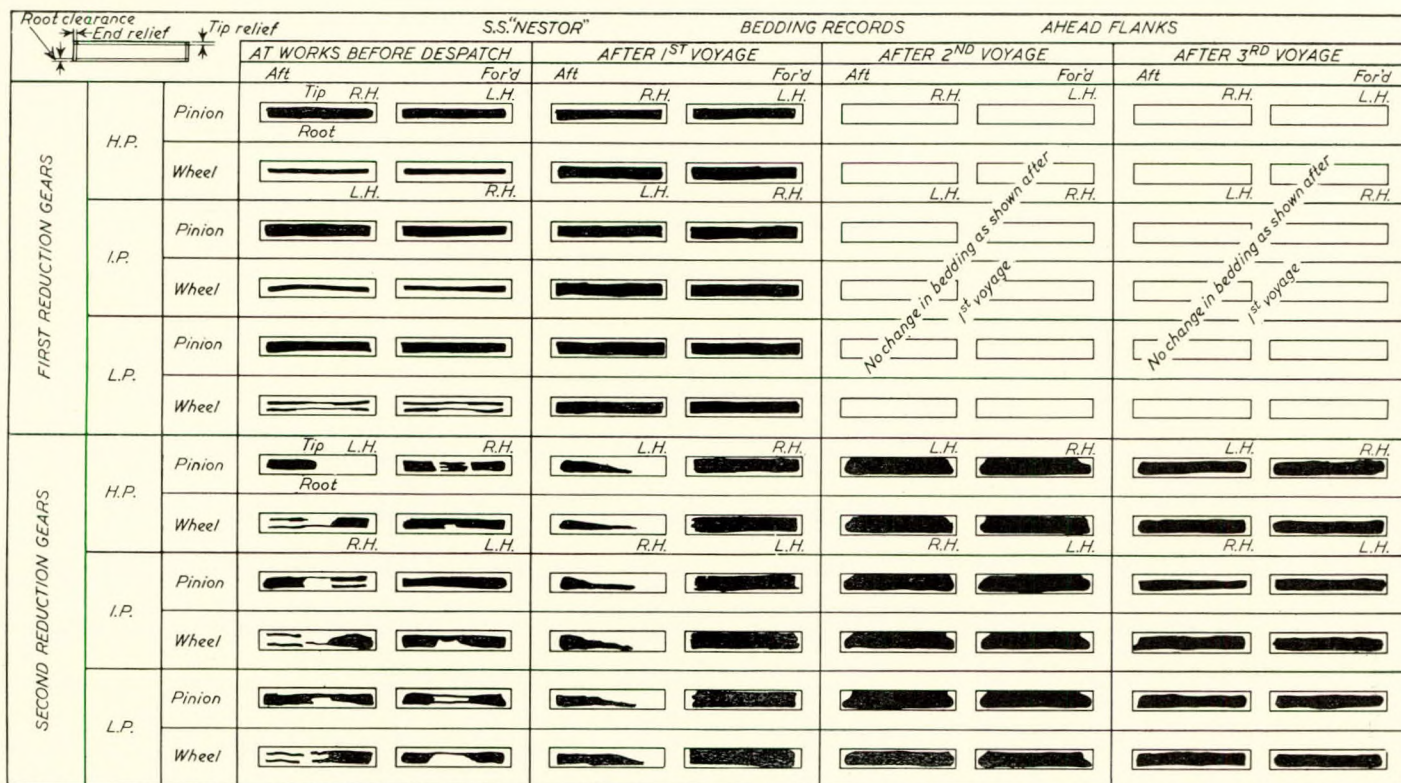
FIG. 7—Record of bedding after service: s.s. Nestor

Helix correction by selective shaving to match wheels and pinions was applied, using the "crowding in" method. This was found to be a very "hit-and-miss" process, particularly at the ends of the teeth, where cutter run-out produced a variation in metal removal and hence helix angle and tooth thickness. This and gear case distortion probably contributed to produce the heavy end bedding which was corrected by hand work on set 1.

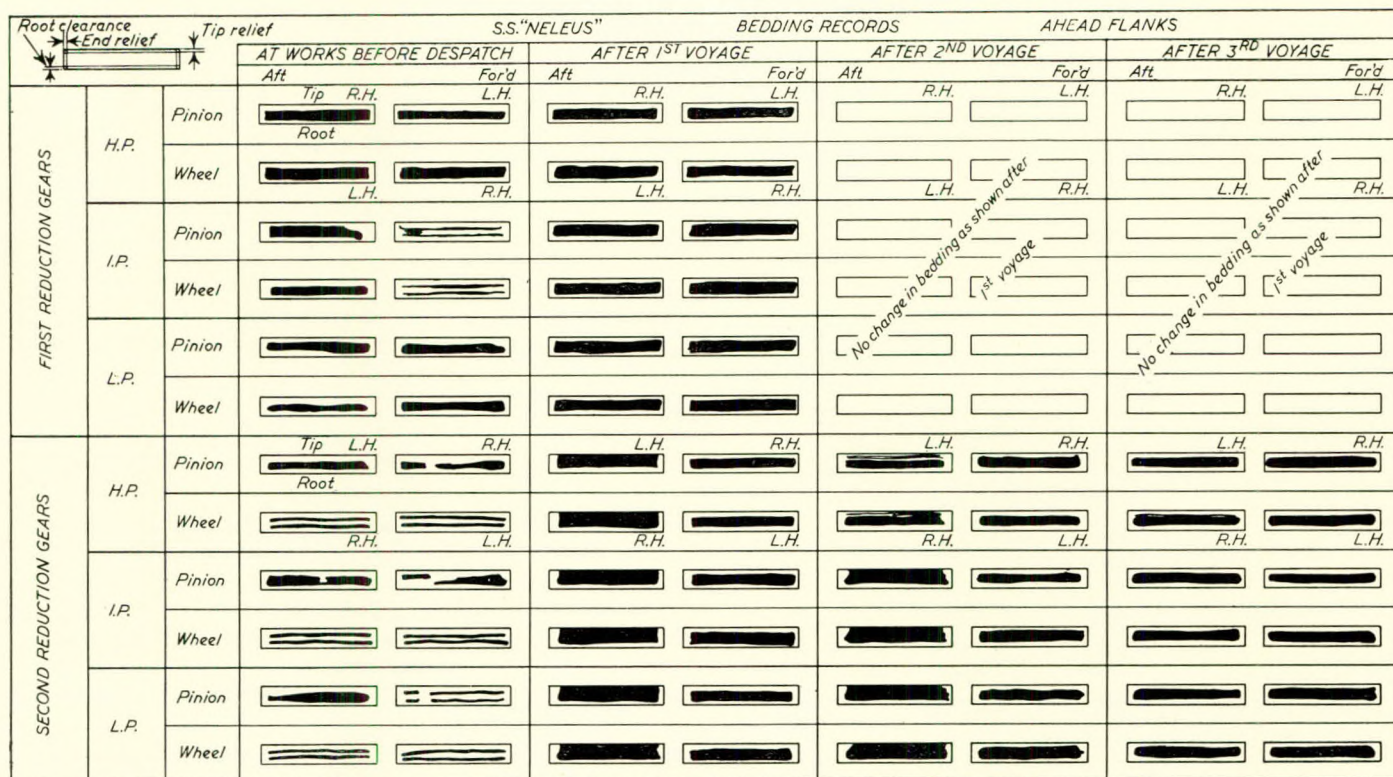
FIG. 8—Record of bedding after service: s.s. Neleus

The *Neleus* has now completed five voyages and the wear of the gears has followed a similar pattern to that of the *Nestor*, and has now also ceased (see Fig. 16). In this gear case better bedding was obtained on the test bed due to improved shaving technique, and no subsequent hand correction was necessary. The writer is certain that this is why pitting on this set has been negligible. One difference which has not been explained was that the ridging at the end of the first voyage was on the after helix and the forward part of the forward helix, and not,

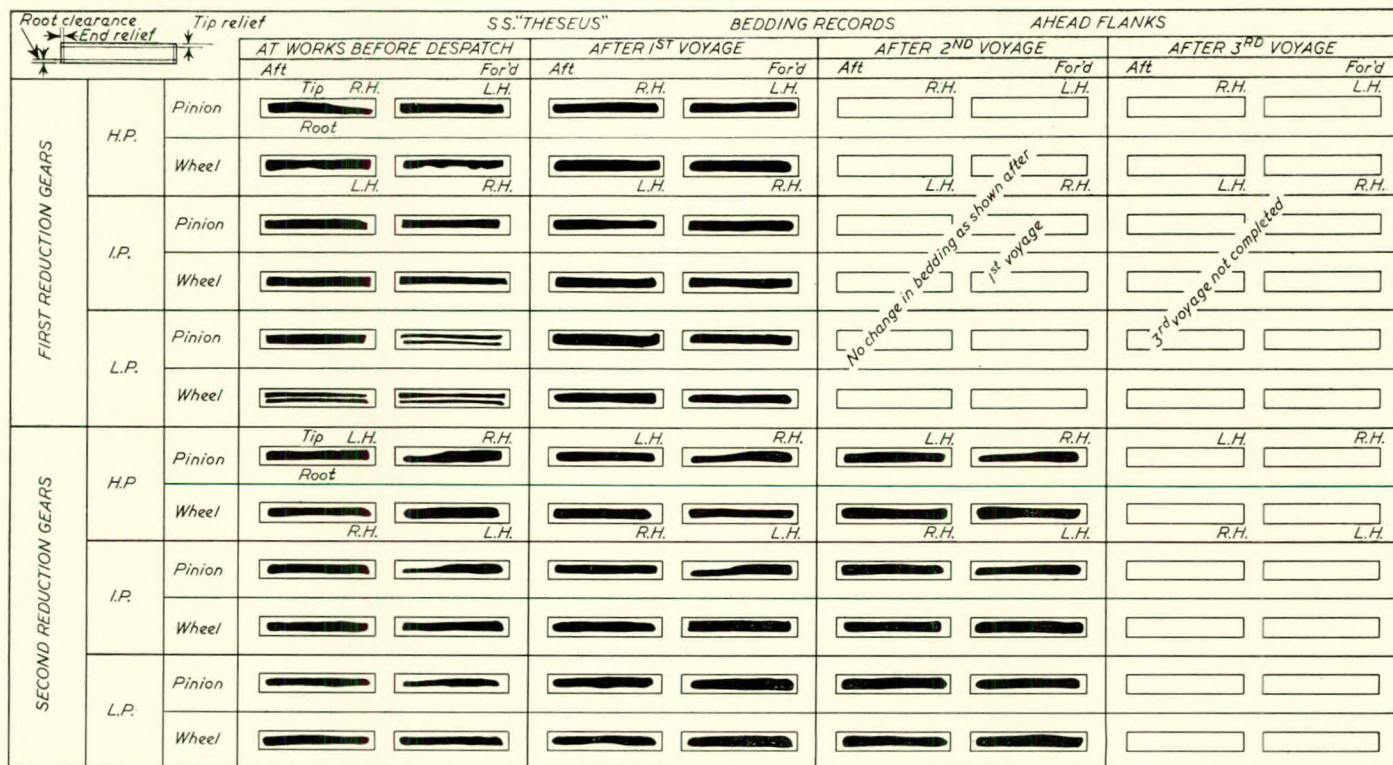
FIG. 9—Record of bedding after service: s.s. Theseus

When the gears were examined after the ship's second voyage, which was shortly before the completion of this paper, they were found to be in excellent condition on both the first and second reduction units. The bedding of the secondary pinions and wheel was continuous over both helices and over the full flank, except that the depth of the bedding on the forward helices of the i.p. and l.p. members was reduced to about 60 per cent over the after 40 per cent of their length. The filters contained no discernible detritus from the gears.

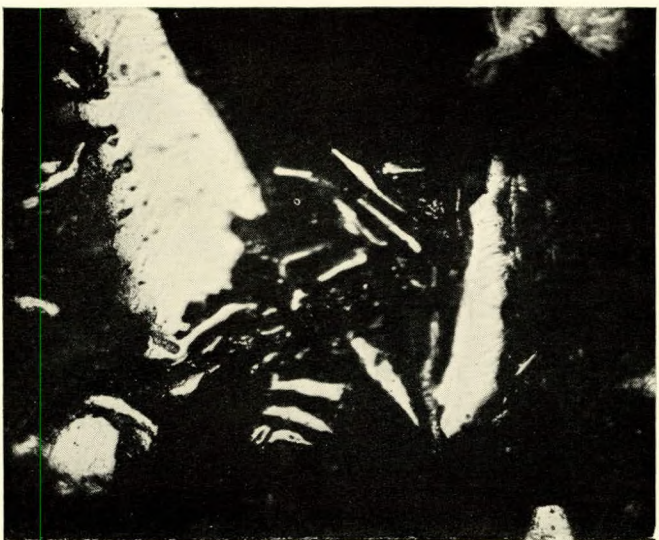
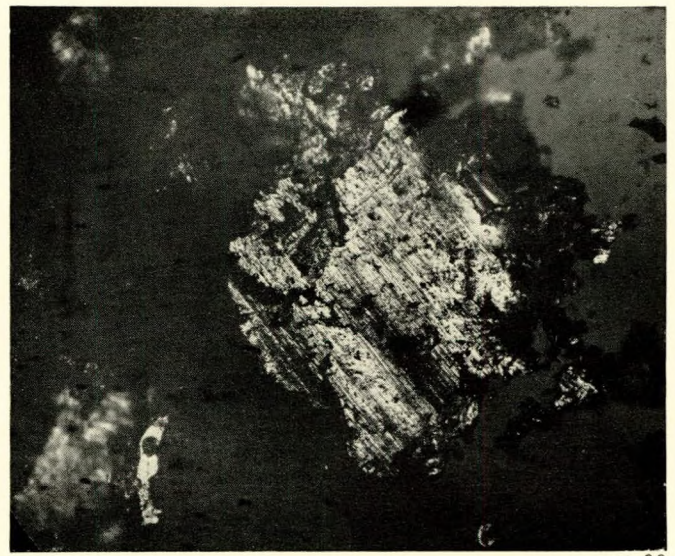
FIG. 10—Particles mounted in bakelite

FIG. 11—A particle suspended in ethylene glycol showing the clean cut nature of its surface

There was a considerable amount of grey dust collected from the magnetic filter in the lubricating system, which was analysed and photographed (see Figs. 10 and 11). It was shown to be metal from the gear teeth and appeared to consist of flakes of varying sizes all about 0.0001 inch thick. The initial pitting had increased very slightly but was not progressing at any serious rate.

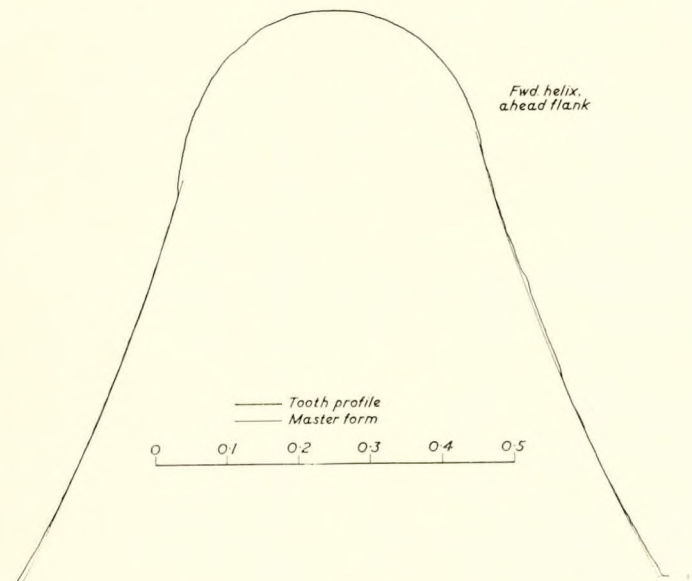
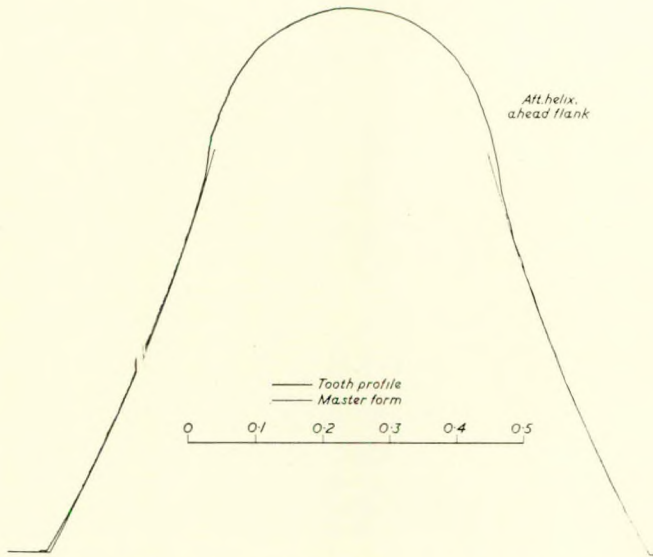
After the first voyage, the ahead flank of the forward helix was ridged along the pitch line with a polished addendum and a matt dedendum. The aft half of the aft helix was similar, but the remaining part of the aft helix was polished, with normal bedding. The tip relief on all pinions appeared to be reduced somewhat but that of the wheel was untouched.

FIG. 12(a)—Inspection record: i.p. pinion after first voyage

FIG. 12(b)—Inspection record: i.p. pinion after first voyage

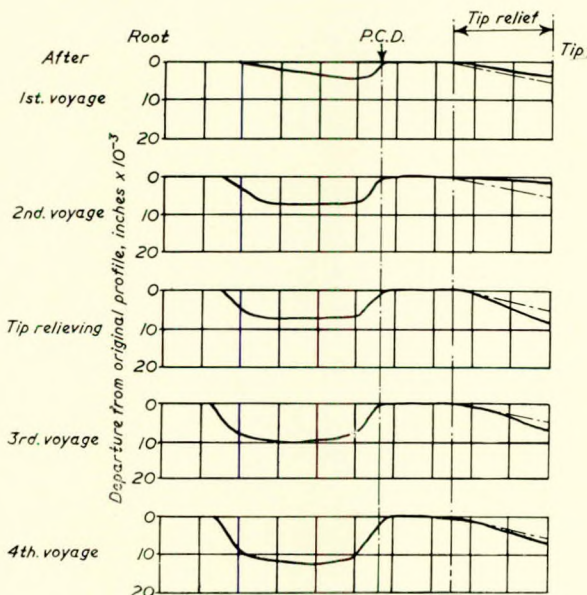
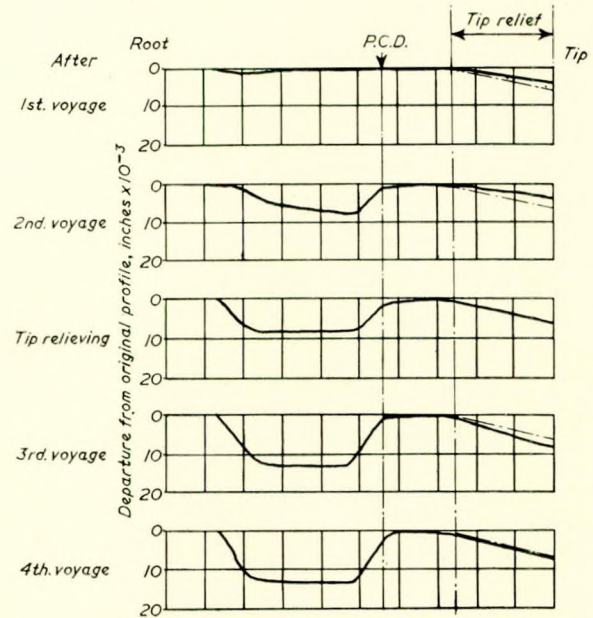
After the second voyage the ridge on the second reduction elements had progressed so that it was uniform across both helices of all second reduction pinions and wheels, and profiles

FIG. 13(a)—S.S. Nestor: second reduction i.p. forward helix, ahead flank

FIG. 13(b)—S.S. Nestor: second reduction i.p. aft helix, ahead flank

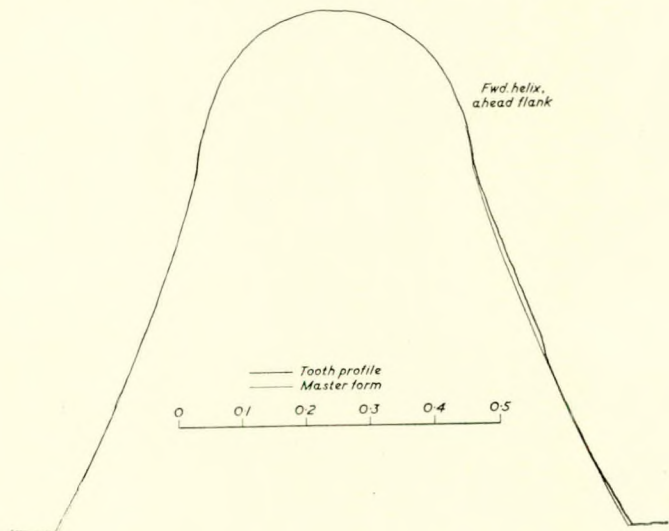
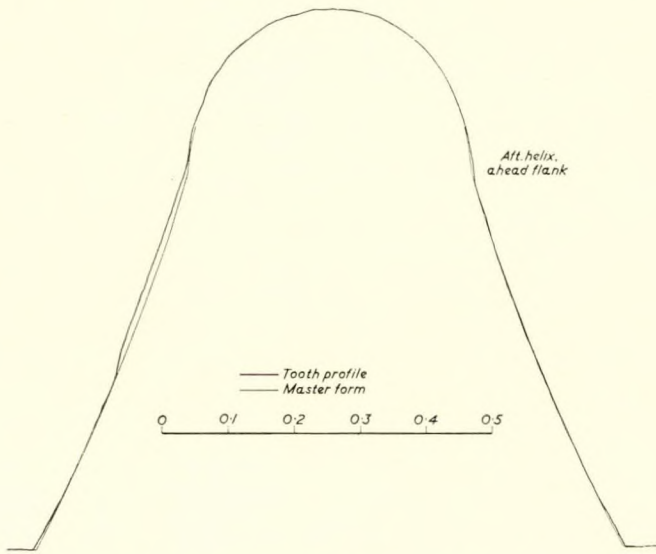
indicated further wear, with again slight loss from tip relief (Fig. 14). First reduction elements were still excellent. An impression of the teeth at this stage can be obtained from Fig. 15.

FIG. 14(a)—Inspection record: i.p. pinion, forward helix, after second voyage

FIG. 14(b)—Inspection record: i.p. pinion, after helix, after second voyage

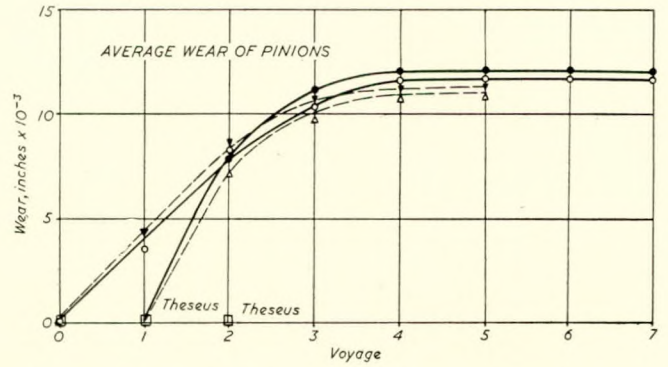
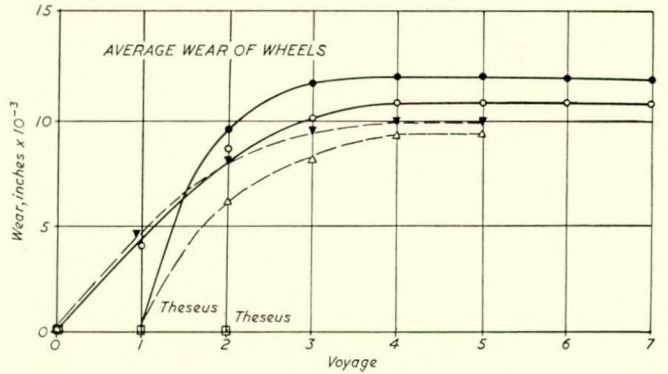
FIG. 16—Wear of second reduction gear

Fig. 16 shows the variation of wear to date. It can be seen that on this basis of measurement the wear has ceased. There was from time to time some doubt (due to the apparent loss of tip relief on the first two voyages) whether the addendum portions, although polished, were also wearing.

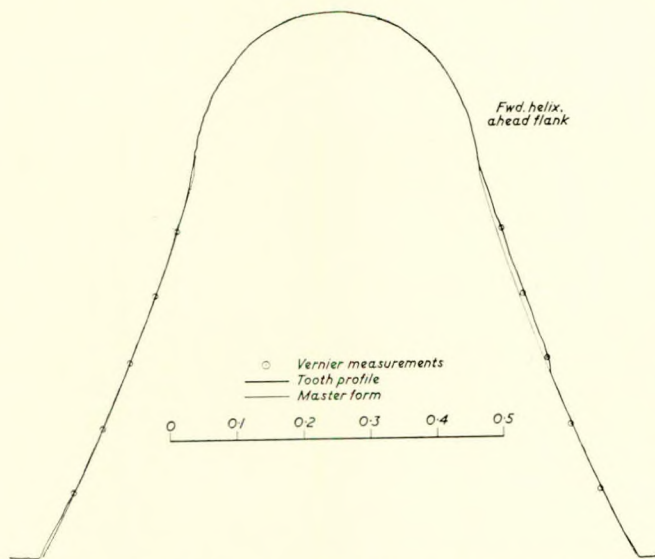
A check was made on tooth thickness for the h.p. and i.p. pinions, using a tooth thickness vernier gauge (see Fig. 17). It can be seen to confirm the pantograph results. No measurable wear was shown on the addendum, which indicated that it (if it existed) was certainly less than 0.0005 inch. It is interesting to note that the h.p. and i.p. pinions now show some signs of polishing on the hitherto matt dedendum. The

FIG. 17—Tooth profile with Vernier confirmation, after second voyage
