OPERATING VLCC—WHAT HAVE WE LEARNT?

D. L. Saunders-Davies, M.A.(Cantab), C.Eng., M.I.Mar.E.*

and G. L. Cunningham, C.Eng., M.I.Mar.E., M.R.I.N.A.†

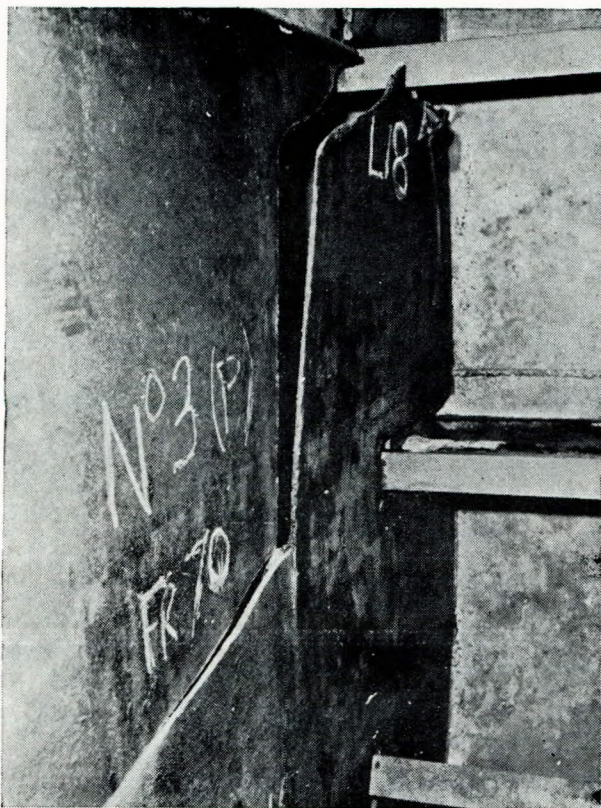
- fractures originating from notches or cutouts in transverses in way of longitudinals, and stringers in way of vertical stiffeners;
- fractured connexions of end brackets to transverses, centre girders and side girders;
- buckled and fractured stringers at connexions to transverse bulkheads;
- fractured connexions between shell longitudinals and the transverse bulkheads where the longitudinals did not pass through the bulkheads;
- random fractures in the forward and aft ballast tanks.

FIG. 1—*m.v. Dorcasia—fracture of transverse originating at cut out*

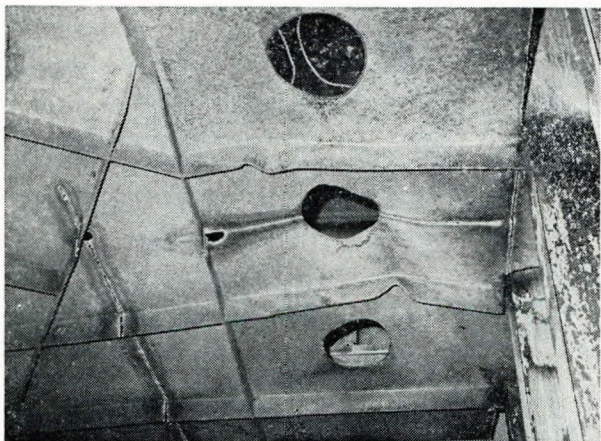
FIG. 2—*s.s. Murex—buckling of top stringer, underside looking outboard*

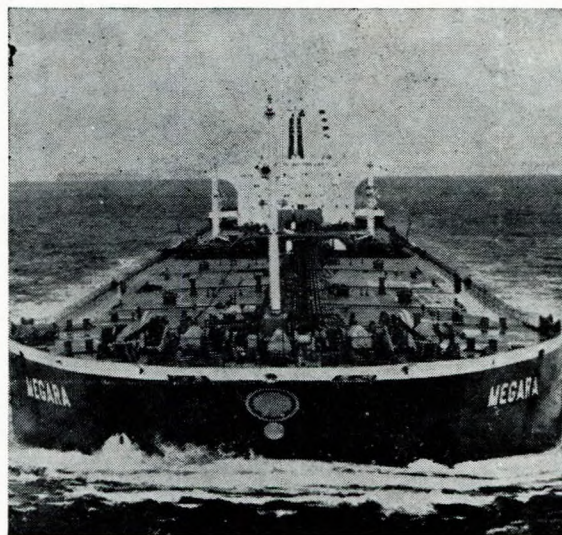
To enable the anchors to be dropped clear of the bulbous bow they were positioned further aft and outboard than hitherto. This resulted in comparatively short, vertical hawse pipes with anchors close to the load line (Fig. 3) and it proved difficult to stow them securely enough to prevent movement at sea. This problem has not been completely solved and anchor damage is still sustained. In two ships anchor pockets were

FIG. 3—*s.s. Megara—at sea showing anchors awash*

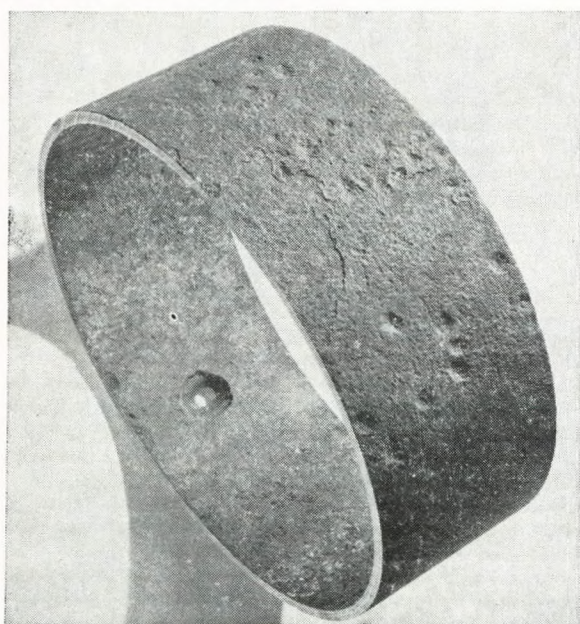
the latter. Both internal and external pitting has been experienced and often perforation occurred after about four years' service. The type of damage is shown in Fig. 5. It is believed that external pitting was caused by high resistance between the pipes and the hull and this problem has been virtually eliminated by bonding the pipeline to the hull with copper strips, together with fitting of additional anodes in the most vulnerable areas. Internal pitting in the bottom of the

FIG. 5—Internal and external pitting of "M" class stripping line

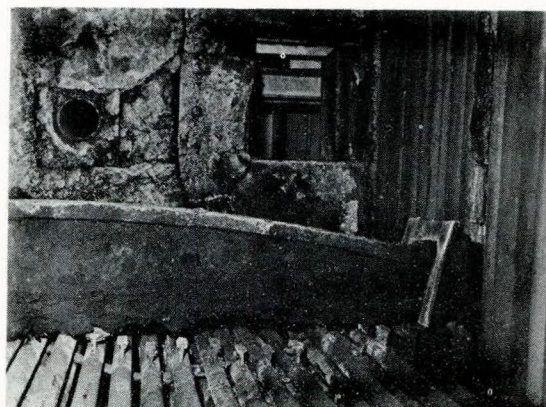
In another design, the primary and secondary superheaters were suspended by connecting lugs from uncooled heat-resisting beams made from 18 per cent Cr 55 per cent Ni alloy steel. These were satisfactory for the primary superheater located in the cooler, downstream gas pass but the beams and lugs for the secondary superheater suffered severe high temperature corrosion from the vanadium and sulphur in the fuel. Fig. 7 illustrates the damage in way of the T-slots

FIG. 7—s.s. Meta—corrosion of secondary superheater support beam

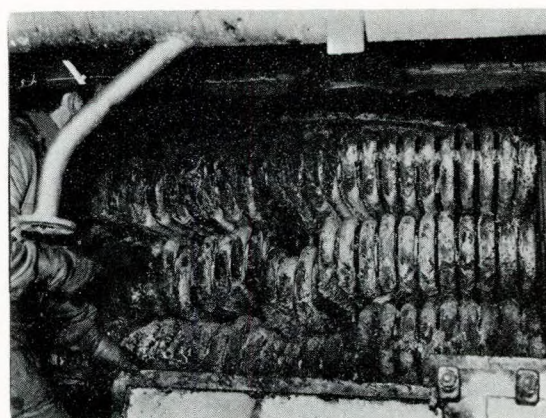
FIG. 8—s.s. Meta—sagging of superheater tubes

in the beam, resulting in total loss of support and sagging of the tubes as shown in Fig. 8. Renewal proved extremely difficult due to lack of access and, due to the design of the

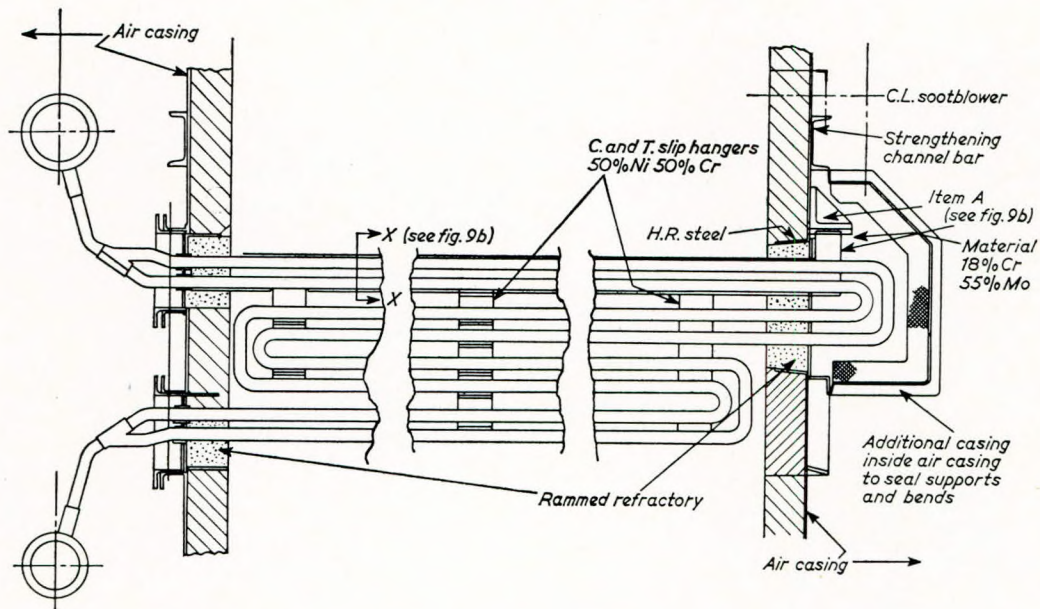
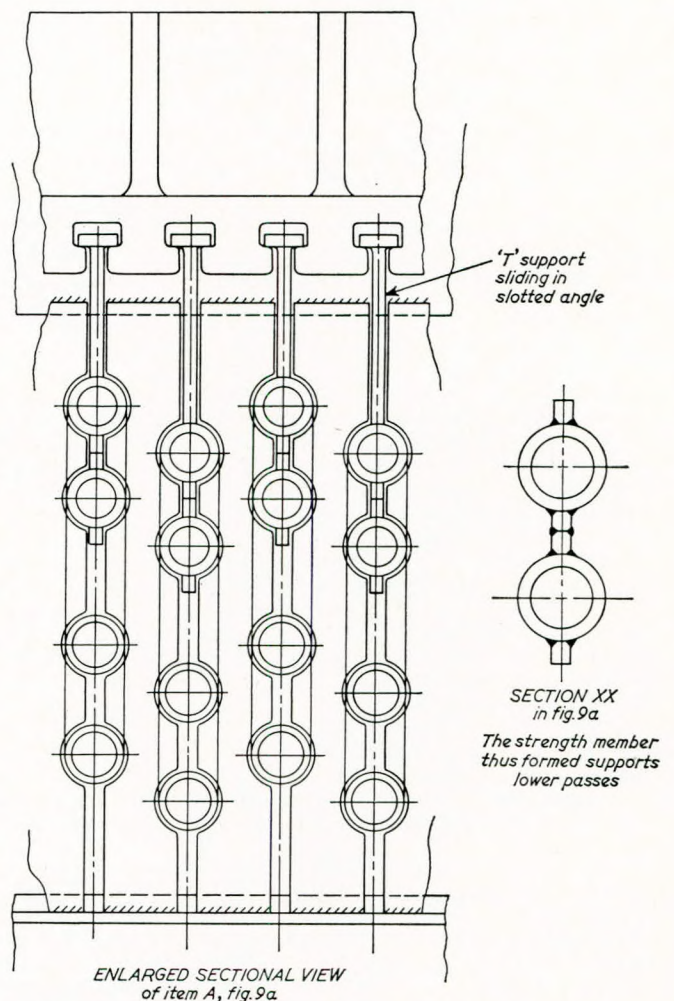
Figs. 9a and b—Arrangement of modified superheater support

beams, it was necessary to remove the entire superheater. Finally, redesigned superheaters were installed which were self-supporting, as illustrated in Fig. 9, thus eliminating the need for beams. This solution, whilst very costly, has been satisfactory.

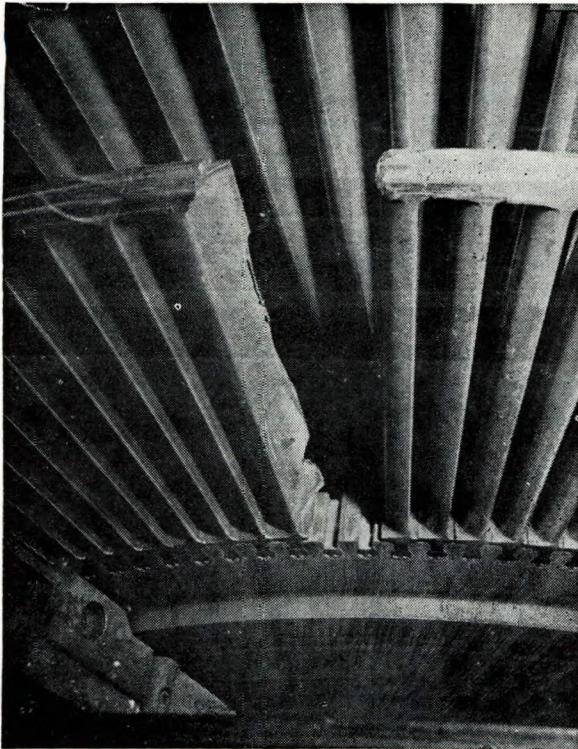
- c) the fifth stage blades in *Marticia's* LP turbine failed by fatigue, following a similar pattern to a number of previous failures encountered in container ships with slightly larger power output. The only difference in the blades was the length which was 10 mm longer in the case of the tanker. The failure is illustrated in Fig. 10a and a remarkable feature was the very small amount of consequential damage. This was confined to the adjacent diaphragm and a heavy rub in the astern turbine glands. The severity of the rub could

FIG. 10a—s.s. *Marticia*—failed LP fifth stage blades

have been due to metal pickup from the rotor locking ring triggering off a machining type of wear. The glands contained appreciable quantities of ring material which had been welded in during the rotor/ring contact. The two materials involved were carbon steel from the ring and 13 per cent chrome steel in the glands;

With the exception of b) above, all the cases of blading damage necessitated modification to the root design and in one case, c) above, a change also in the blade material. In every case, investigation showed that whilst the blade design was adequate for normal operating conditions, other factors such as corrosion may have reduced seriously the fatigue life.

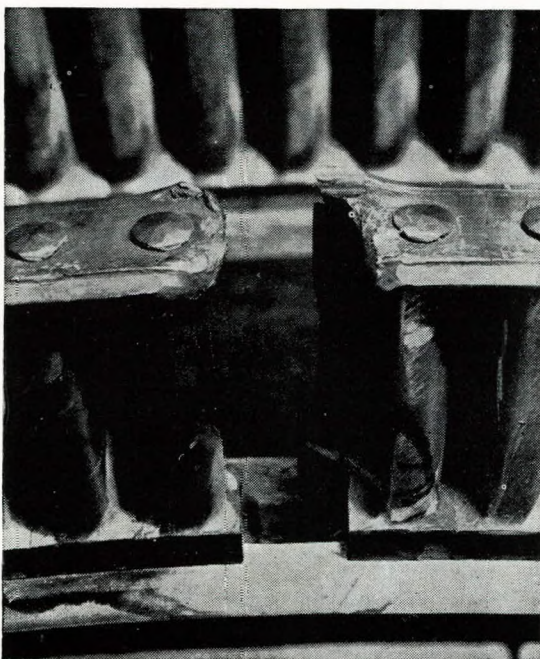
FIG. 10b—s.s. *Marisa*—failed LP second stage blades

- d) the second stage of *Marisa's* LP turbine suffered partial loss of shrouding and fracture of some blades. Although the material was well up to specification and design stresses low, the cause of failure was again fatigue. The damage is shown in Fig. 10b.

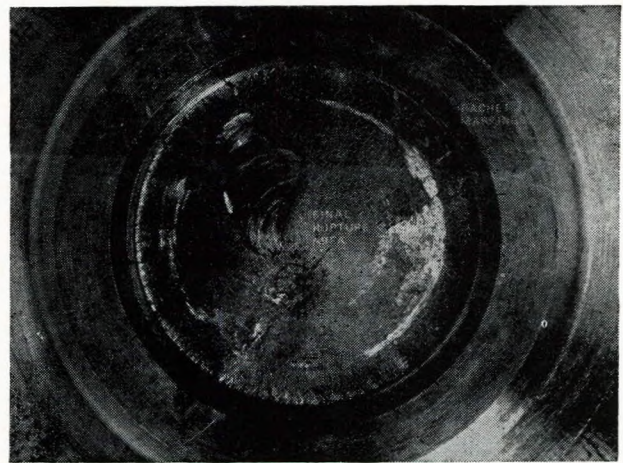
Other turbine problems included a major failure when complete severing of *Mactra's* HP rotor occurred in way of the thrust collar. This is illustrated in Fig. 11 from which the

FIG. 11—s.s. *Mactra*—fractured turbine rotor

fracture can clearly be seen to have originated from fatigue. In this particular design, the thrust collar was shrunk onto the rotor shaft. The fatigue fracture was caused by stress raisers in the shaft and initiated by fretting corrosion in way of the thrust collar.

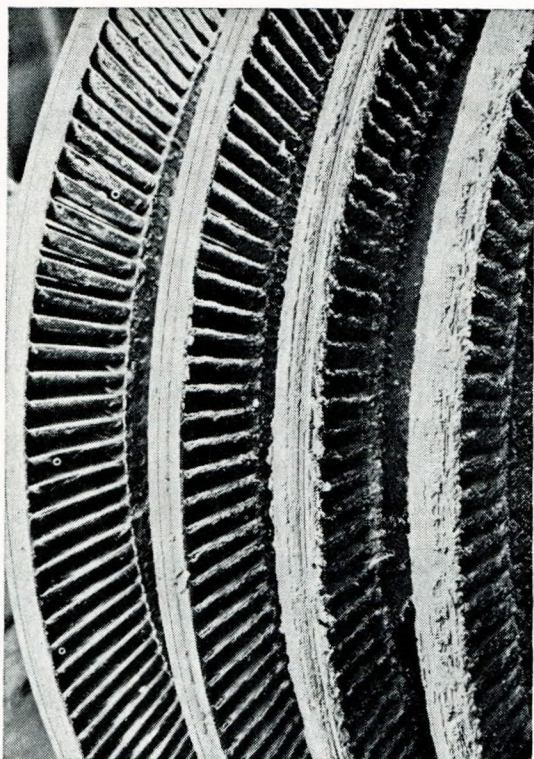
FIG. 12—s.s. *Melania*—fouling of HP turbine blades

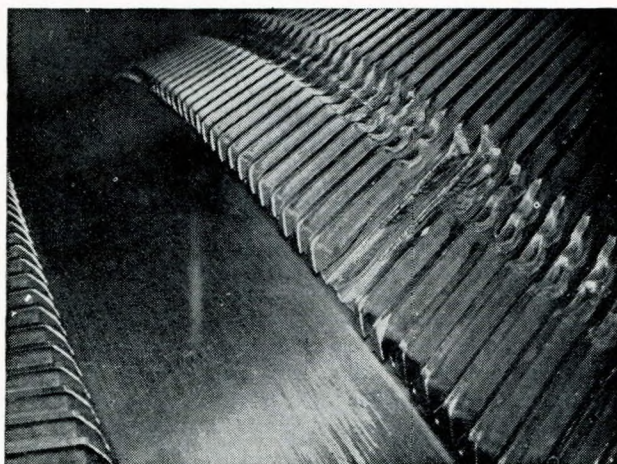
Turning to transmissions, in none of the VLCC have there been any problems with final reduction gearing and the Japanese-built ships have a completely trouble-free record for both primary and secondary gears. In only one other ship with parallel shaft gearing was there a serious failure when the primary wheel teeth of *Murex's* HP train fractured (Fig. 13a). This was due to distortion of the teeth following failure of the

FIG. 13a—s.s. *Murex*—damage to primary gear wheel

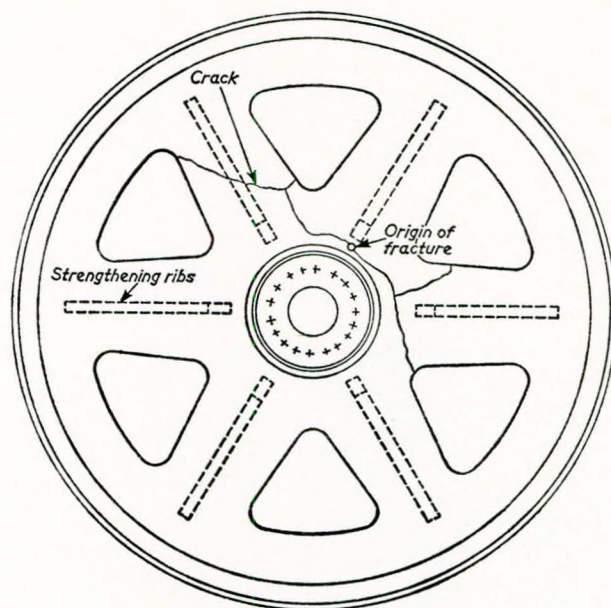
forward web plate which had cracked due to bending fatigue. The crack, originating near the welding around the wheel boss and web stiffeners (Fig. 13b), was due to axial thrust forces transmitted from the propeller. Modifications carried out were only minor and served to relieve the stresses near to the welds.

FIG. 13b—s.s. *Murex*—cracking of primary gear wheel forward web

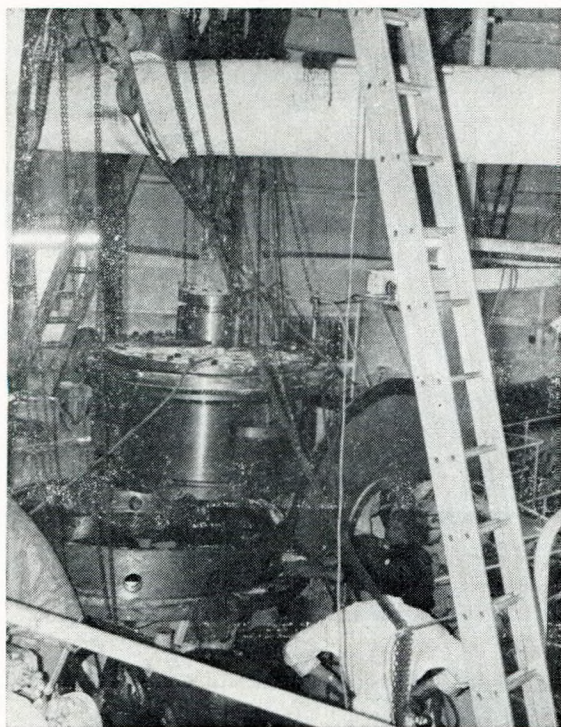
For a number of the VLCC the results in the above directions left something to be desired. This was partly due to inexperience but, in general, it was failure to appreciate the importance of integrating pipe systems with the rest of the plant layout. The result has been that, in a number of ships, accessibility is poor and there is a lack of proper lifting facilities, particularly in respect of larger items of plant. Fig. 14 demonstrates this, depicting a main steam supply line running directly above the centre of the epicyclic gearing. In this particular ship two failures of epicyclic gearing occurred; dismantling and reassembly was therefore a much bigger problem than it should have been. As a further example, a number of steam joint failures occurred in the early days of operation, and here too lack of accessibility to the failed joints made life difficult for the ship's staff.

FIG. 14—s.s. Mysella—view of pipework over epicyclic gear

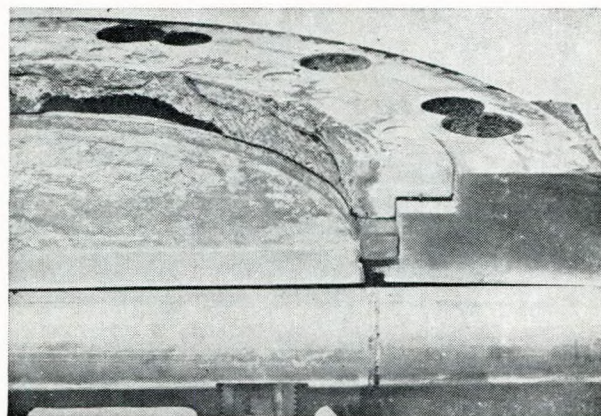
brought problems unforeseen by component suppliers who continued to use materials which had been satisfactory in systems designed for lower velocities. As a result, severe corrosion/erosion damage to pump and valve components, heat exchangers and in some instances lines, at sharp bends and T-junctions, has been experienced. Matters have been sometimes aggravated by the use of poor quality or incompatible materials. One of the worst errors was the fitting of valves having unprotected cast iron bodies in systems of aluminium brass or cupronickel. Due to preferential corrosion of the cast iron, wholesale replacement of these valves was necessary after only a few months of service; Fig. 16 shows a typical

FIG. 16—Top of sectioned butterfly valve showing graphitization of retainer ring and crevice corrosion of shaft

example. Various makes of rubber-lined cast iron valves are now being used with success. In addition, evaluation has been carried out on different makes of valves for periods of up to two years in normal sea service. The results of this work have been passed to the manufacturers, making improvements possible.

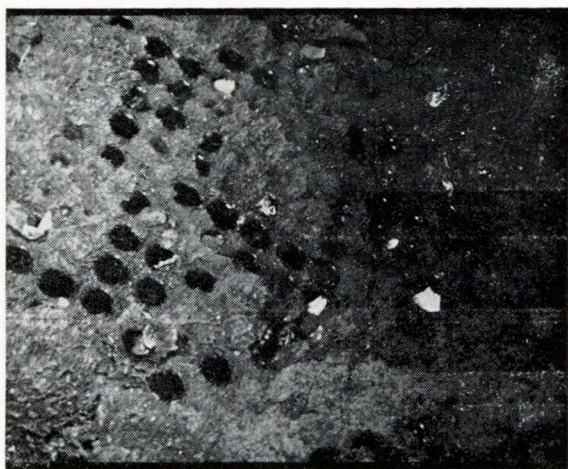
Marine fouling has been a continuing problem, particularly with extended docking periods. Main condensers have, on occasion, been heavily fouled (Fig. 17) but rarely to the

FIG. 17—s.s. Mitra—condenser tube fouling—inlet end

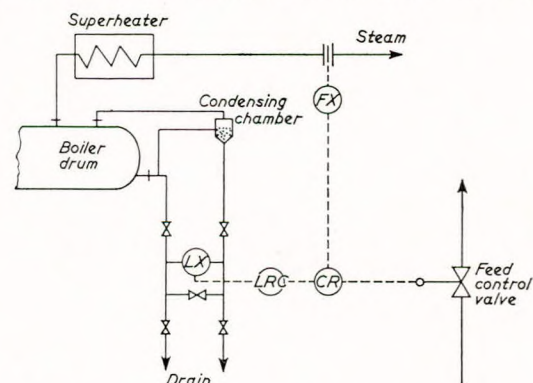
A serious accident occurred in *Marinula* when the boiler suffered major damage following failure of both the drum water level control and fuel oil trip systems. The simplified schematic in Fig. 19a illustrates the principle of the automatic

FIG. 19a—s.s. *Marinula*—schematic of level control

control. Feed water flow is adjusted to match steam flow with the water level control overriding when necessary to maintain steady conditions. Control, alarm and indication were all performed originally by a single transmitter.

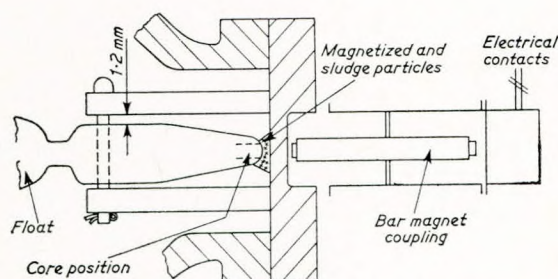
FIG. 19b—s.s. Marinula—sketch of float switch

- for low level trip initiation and the second transmitter for remote level indication and high/low alarms;
- 2) the polarity of the magnetic float switch was changed so as to repel rather than attract any magnetic particles.
