MEDIUM SPEED DIESEL ENGINES IN BULKCARRIERS

N. K. Bowers, C.Eng., F.I.Mar.E.*

By mid 1972, twin Ruston and Hornsby 'A.O.' medium speed diesel engines had been installed in each of 11 bulkcarriers in the 22/24 000 dwt class. During the period from May 1973 to August 1974 these engines were replaced by the Stork-Werkspoor TM 410. This paper examines the reasons that made the change unavoidable.

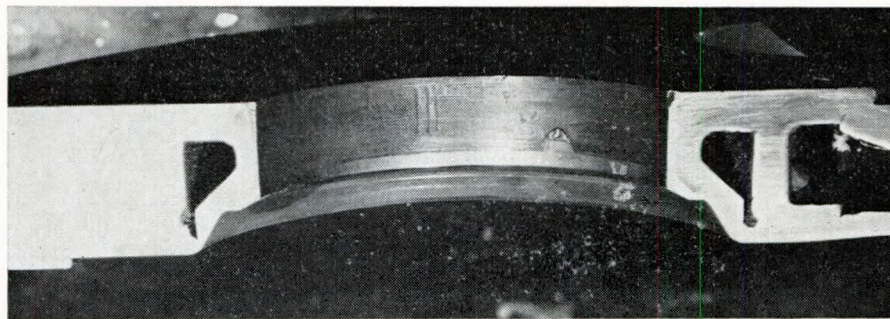
FIG. 2—Cross section of A.O. flame plate showing corrosion/erosion in the cooling water passage surrounding the valve seat (1070h)

With regard to flameplate failures, the author had reproduced a photograph showing corrosion/erosion in the cooling water passages surrounding the valve seats. Approximately 18 months ago, he had asked BSRA to undertake a metallurgical examination of a section cut from a welded flameplate and the location of the corrosion was as shown in Fig. 24 and details of the welded joints as in Fig. 25, from which it could be seen that weld B contained a root gap. If welding did not ensure full penetration the joint was liable to be associated with a crevice.

It was also reported that a nitrite/borate anodic inhibitor was used in the cooling water, and such an inhibitor could be considered "dangerous" if the concentration became too low, as would occur at the root of a crevice. In this instance, leakage of cooling water was considered to be due to the initiation of a differential aeration cell at the root of the crevice, and to failure of the nitrite/borate inhibitor to prevent localized corrosion.

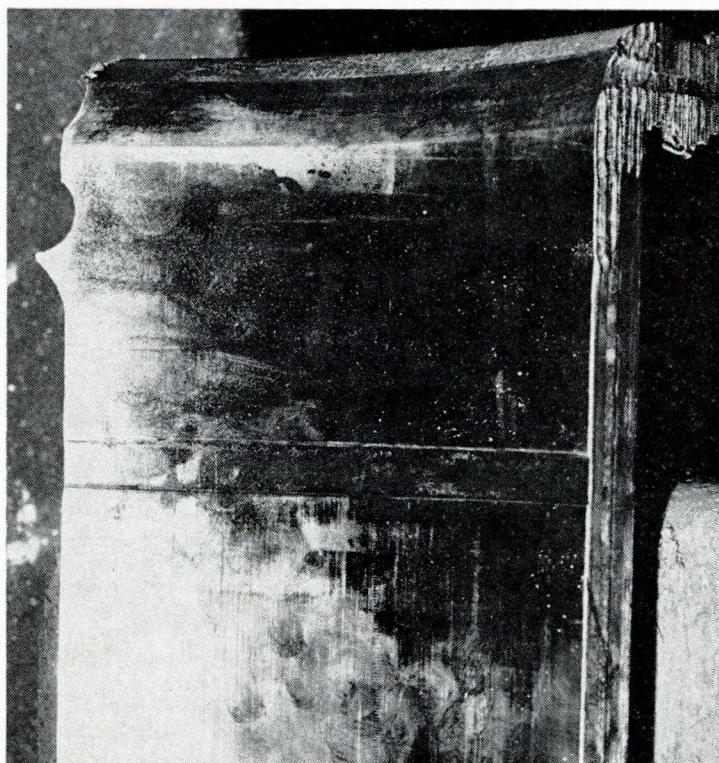
Fig. 3 illustrates the top dead centre region of an A.O. liner after 1897 hours running in *Baron Wemyss*. The circumferential groove is typical of the wear that occurred in a random fashion in every engine. A few liners showed two grooves approximately in line with the top and second compression rings at T.D.C. and the depth of such grooves could reach 1 mm in less than 500 hours.

At first sight the problem appeared to be lack of oil on the upper part of the liner. As the piston passes over the scavenge ports on the compression stroke, oil is scraped off into the scavenge space, leaving insufficient oil to form a lubricating film under the rings. Most of this oil is blown out with the scavenge air and escapes through the exhaust valves. This theory might perhaps explain the heavy lubricating oil consumption as well as the lack of sufficient oil to form a film. However, it does not explain why the wear continues to increase rapidly, even when an engine is using 300 gallons (1364 litres) of lubricating oil a day. With this quantity flowing through the cylinders it would be expected that some, at least, would stick on the liner surface above the scavenge ports.

An alternative or perhaps complementary explanation could be that excessive blow-by prevents a film of lubricant forming under the compression rings even when there is an adequate supply of oil in the vicinity. Blow-by has occurred on almost every A.O. engine, sometimes so vigorously that it has caused a very rapid deterioration of the lubricating oil in the drain tank. However, blow-by always appears to be accompanied by seized piston rings, badly scored pistons and heavy liner wear and it is difficult to say which comes first.

It was possible that the trouble might be caused by the use of a chromium plated liner. Depending on the nature of the surface treatment, chromium is usually rather more difficult to lubricate than good quality cast iron but it is unlikely that the use of this material would, by itself, cause such a peculiar pattern of localized wear. Moreover, had the

FIG. 3—Inside sectional view of an A.O. liner showing circumferential groove region of the top ring

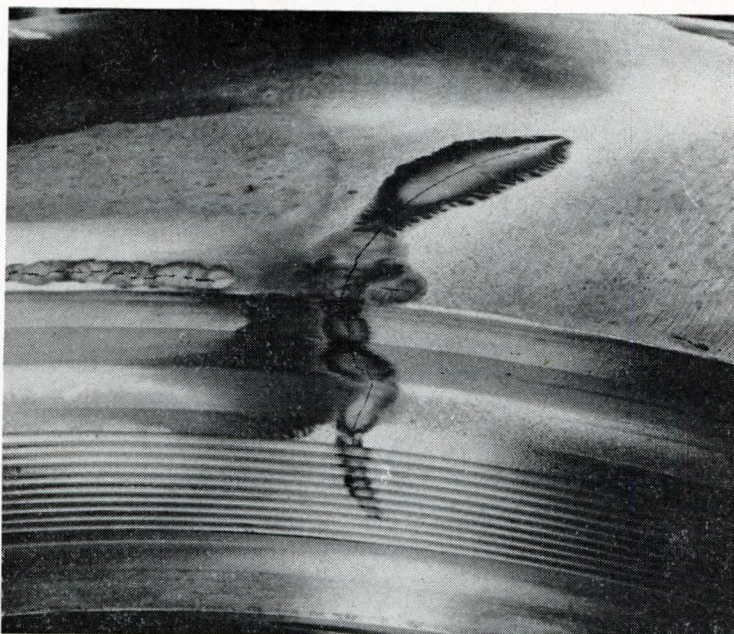
The most expensive and time consuming operation in drydock was the refitting of the KaMeWa controllable pitch propellers. Cracks and corrosion were found in the stainless steel propeller hubs and in the blade roots (Fig. 8). The propeller hubs had to be sent back to the manufacturers for re-conditioning and the cracks in the blade roots removed by grinding. Sharp edges around the bolt holes were also faired off. A second drydocking was required to replace the hub assembly. Later in the re-engining programme it was possible to obtain a spare hub and blades before the vessel docked and thus avoid a second costly period in drydock with the inevitable interruption of the work on board.

FIG. 8—Typical crack in stainless steel hub of a KaMeWa propeller

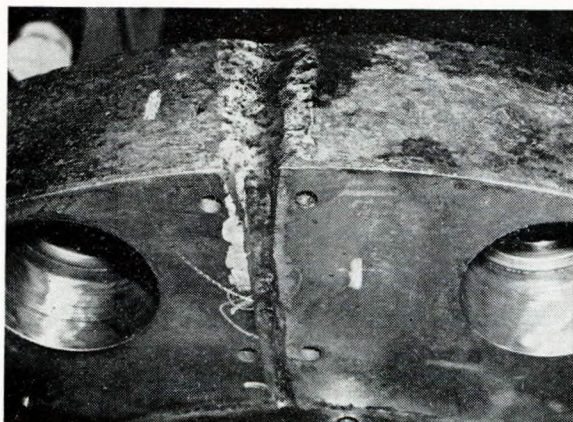
All the tailshafts were found to be corroded in the vicinity of the gaps between the stainless steel covers protecting the main bolts holding the propeller to the tailshaft (Fig. 8a). It was necessary to remove the tailshaft, grind out the corroded area, crack detect the adjacent region and then inhibit the shaft against further corrosion. The opportunity was taken to survey the tailshaft bearing and gland, which in every case was found to be in good condition.

FIG. 8a—Corrosion of a tail shaft, flange adjacent to the Kamewa stainless steel cover plates

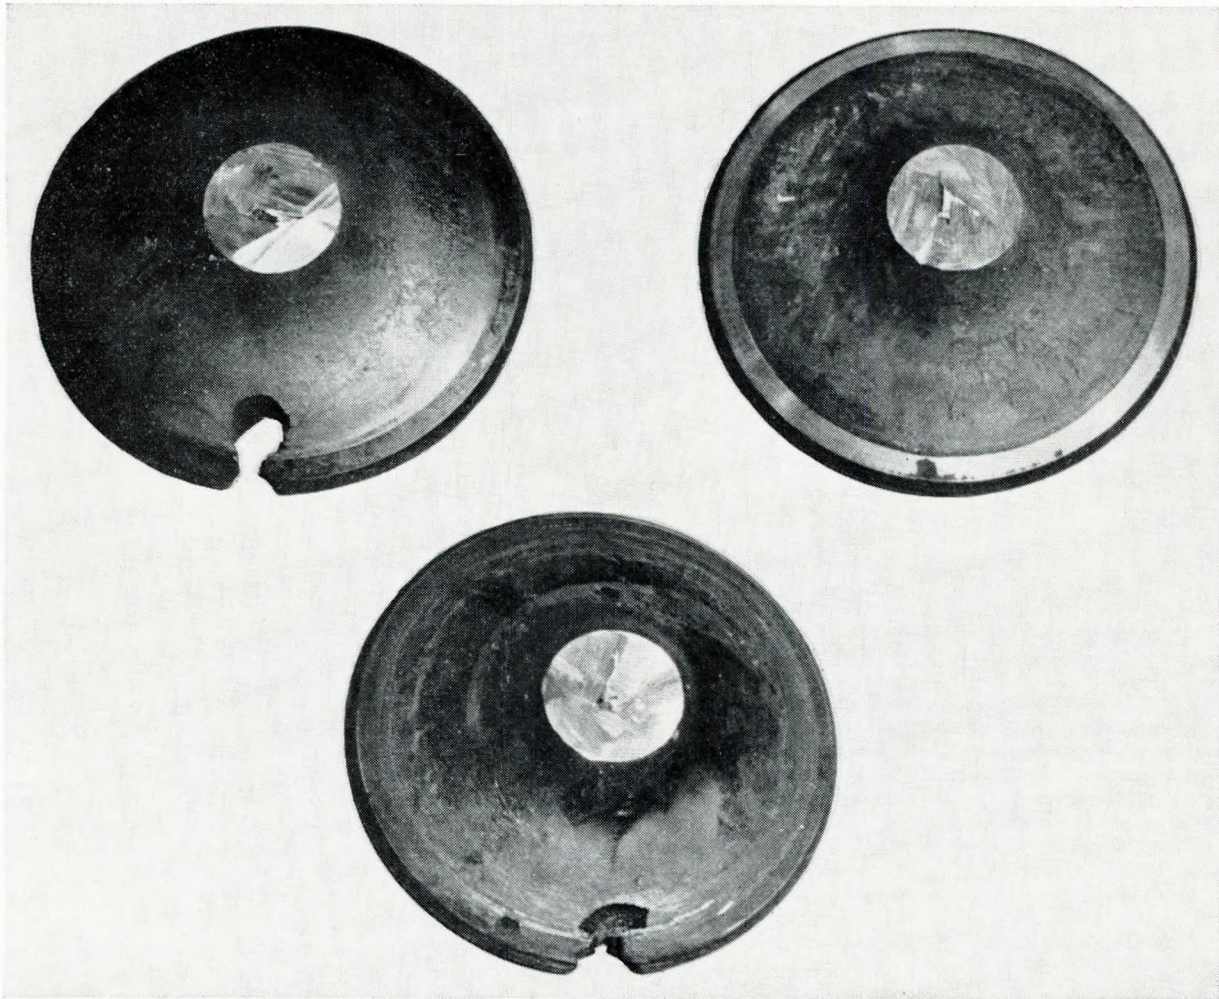
This was followed by a similar exhaust valve failure on 13th April 1973 after 1380 hours running and another failure on 19th May after 2070 hours. Two more valves were found to be slightly burnt when a routine inspection was carried out at Vancouver on 28th May. During this inspection six valve stems were found to be slightly bent.

FIG. 10—Failures of three TM 410 exhaust valves in Cape Grenville port engine

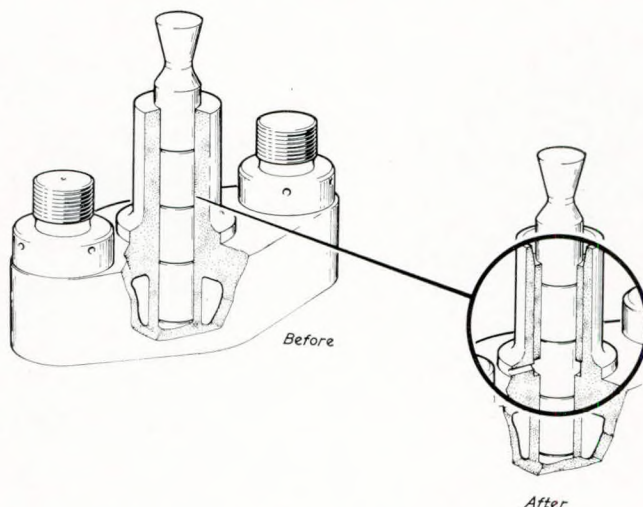
After 2000 hours of operation with this modified system *Cape Grenville* showed no measurable wear on five exhaust valve guides selected at random and there was certainly no

FIG. 11—Modification made to a TM 410 exhaust valve guide in Cape Grenville

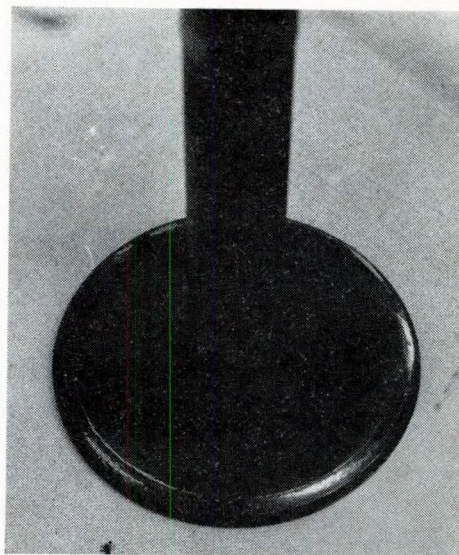
When the two remaining valves from the starboard engine were removed for inspection at Sydney they were both found to be just sufficiently bent to prevent the valve from seating properly all the way round. Part of the valve face was bright and the rest covered with a thin layer of deposit that could easily be removed with emery paper (Figs 12 and 13). Neither of these two valves was burnt, although the cooling effect of the water cooled seat must have been reduced. By contrast, another valve which had run for the same number of hours on the port engine had a hole burnt through the seat

FIG. 12—TM 410 exhaust valve after 500 hours operation with the seat ± 1.5 mm out of true

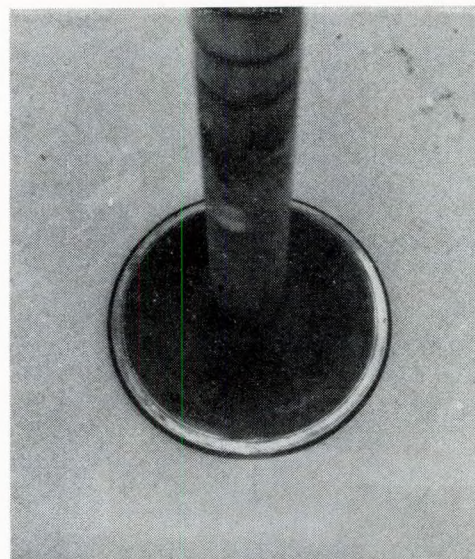
FIG. 13—Exhaust valve in Fig. 12 after rubbing with emery paper showing the seat to be in perfect condition

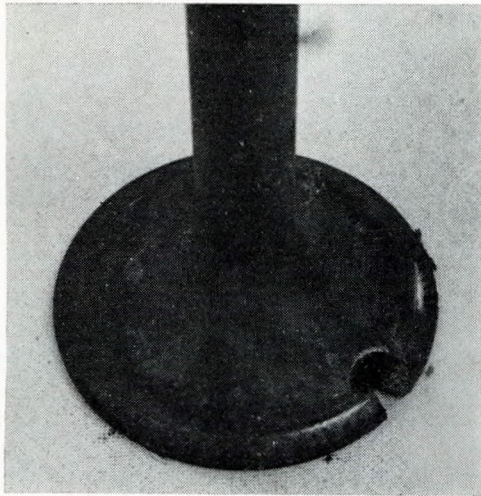
FIG. 14—Burnt TM 410 exhaust valve with the same number of running hours as valve illustrated in Figs 12 and 13 but with a true seat

(Fig. 14). This burnt valve was set up in a lathe and the face found to be true but it had a thick hard deposit round the periphery which could not be removed without scraping. The voyage from Vancouver to Sydney had taken approximately 500 hours. The exhaust temperatures had been about 380°C from both engines. This evidence suggested that:

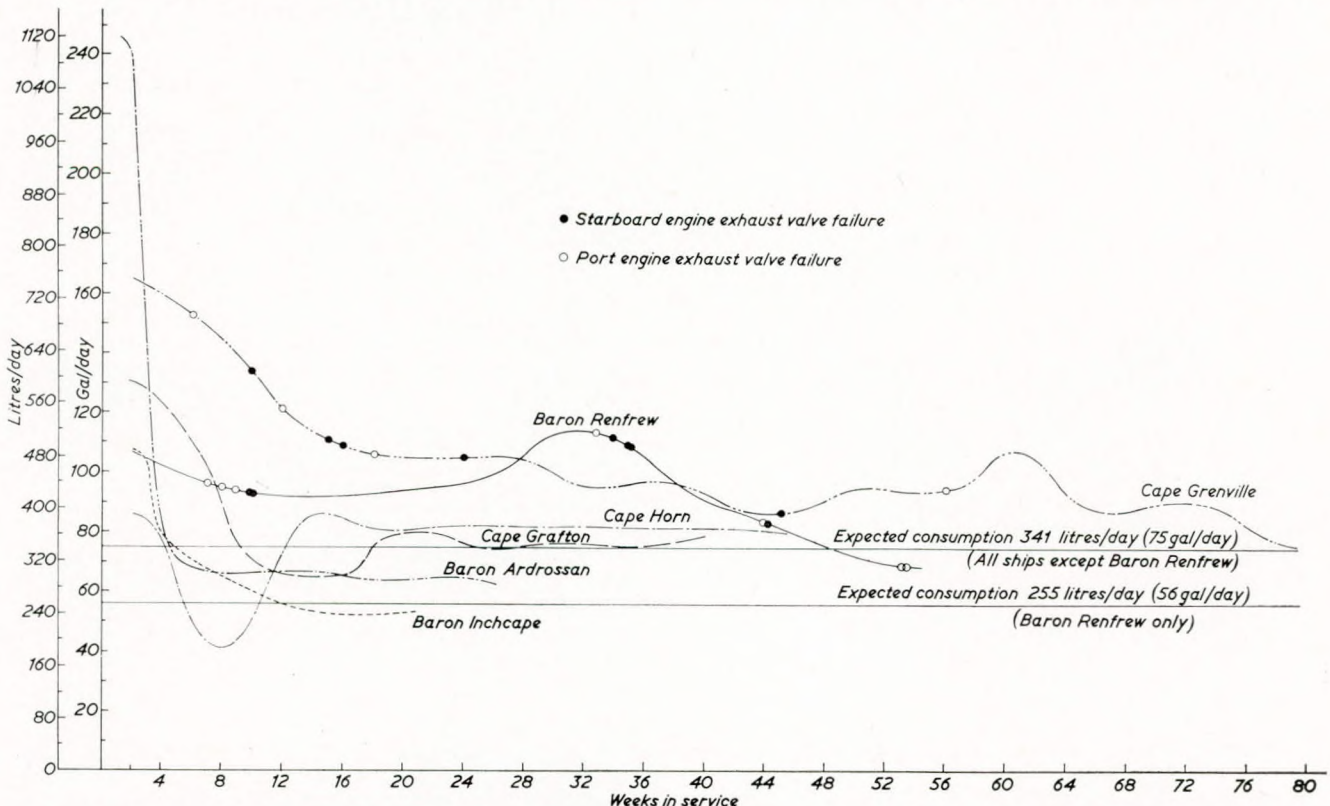
FIG. 15—Curves of lubricating oil consumption showing points at which exhaust valve failures occurred in Cape Grenville and in Baron Renfrew

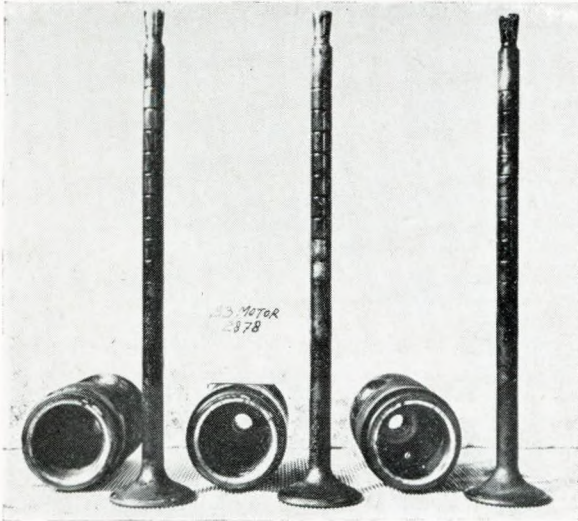
FIG. 17

As could be seen from Fig. 17 all these valves showed some black patches which disappeared by light lapping, and all of them were used again.

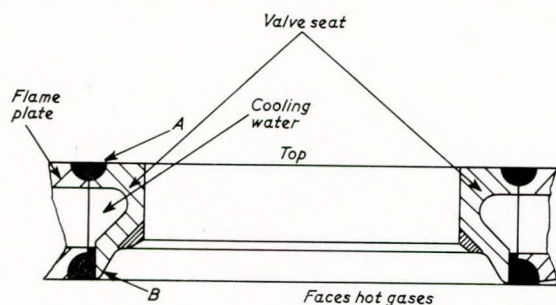
FIG. 24—Illustration of welded joint between exhaust valve seats and flame plate

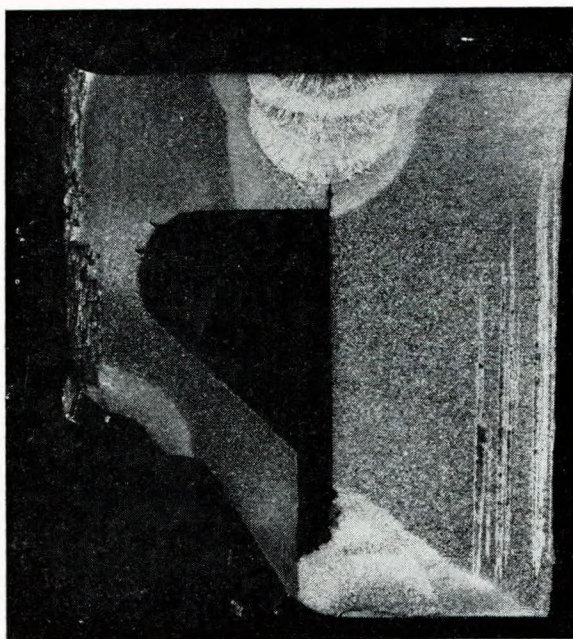
FIG. 25—Macrosection showing two types of weld securing flame plate to exhaust valve seat
