THE INSTITUTE OF MARINE ENGINEERS

Paper read at the Institute on Tuesday, 25 October 1977

METALLURGY OF INERT GAS SYSTEMS

Dr M. Levens, B.Sc., C.Eng., M.I.Mar.E.
Shell International Marine Ltd.

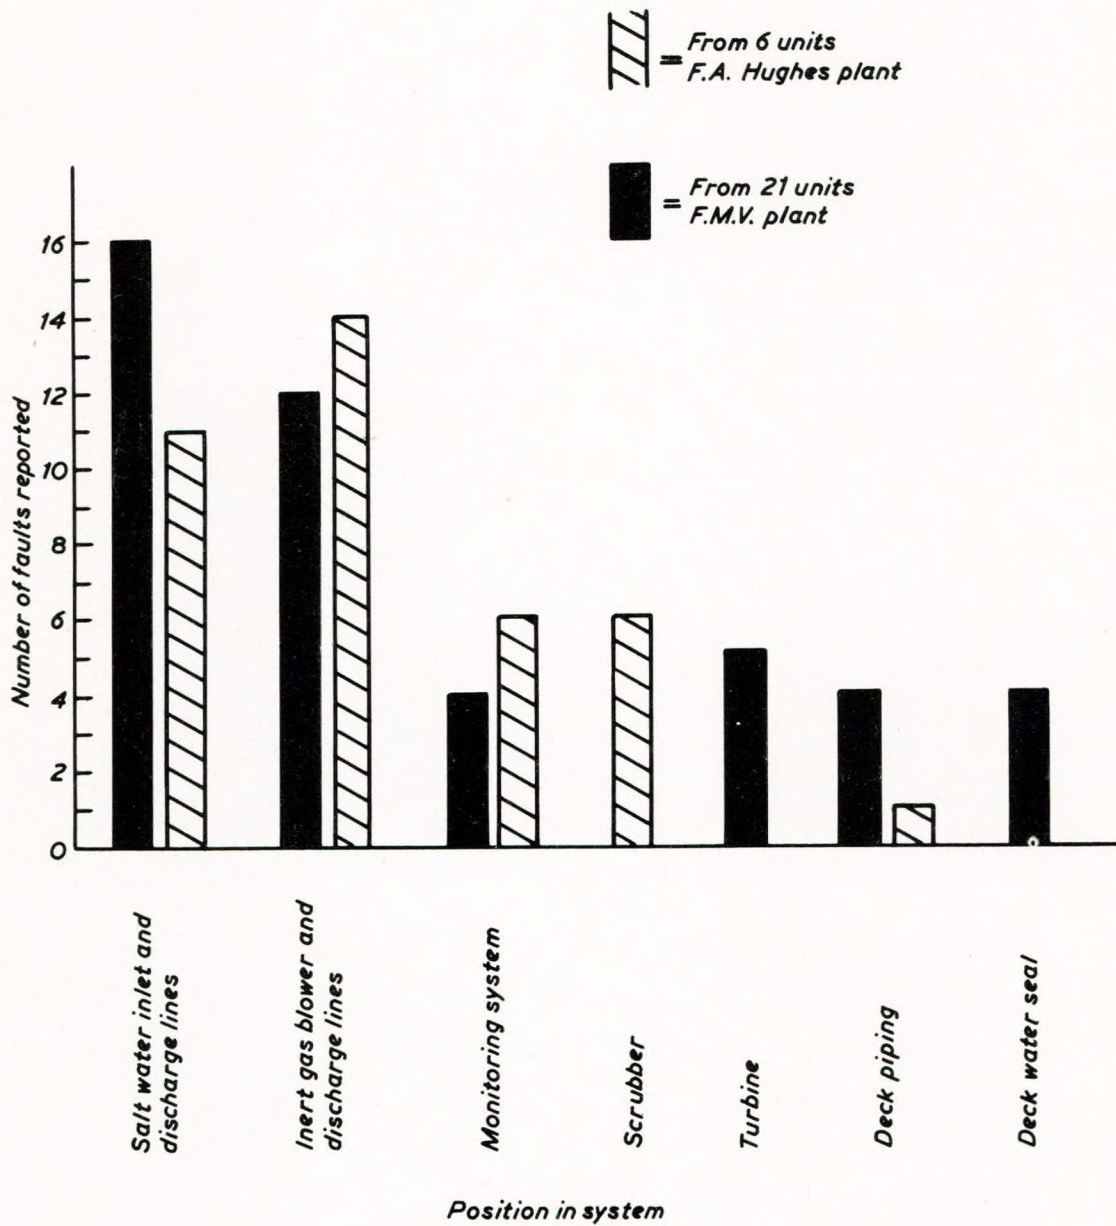
Fig.1 - Histogram to show the position and number of failures in F.M.V. and F.A. Hughes inert gas systems on Shell vessels

Figure I is a histogram showing problems recorded with these units. From this it is apparent that most problems have been experienced with failures affecting the sea water inlet and discharge lines. In the inlet these problems have been mainly concerned with failures of the piping at welded joints and a few problems have recently come to light in regard to the valves in these lines. Aluminium brass is a good choice of materials for these lines but care must be taken to avoid poor internal weld profiles and sharp bends. If problems continue then one solution is to upgrade the erosion resistance of these lines by fitting 90/10 copper nickel piping which is not only more erosion resistant but also readily welded to give a good profile.

Figure I shows that no damage to the scrubber tower itself has been reported within the F.M.V. unit. The units are, however, deteriorating slowly and three areas of concern are manifest. Firstly, damage to the paint in the upper half of the scrubber often occurs at the joint with the lower half of the scrubber and leads to corrosion of the underlying mild steel. This is possibly due to mechanical damage during fitting or the fact that corners are, generally, more difficult to protect successfully with paint. Secondly, pipework associated with the scrubber is often not protected to the same standard as the scrubber itself and

The gas is led via H.B.C.T. epoxy coated steel piping to two blowers, one steam and one electrically driven. The histogram (Figure I) shows that this is the second major problem area. Most of the problems lie with the gears and the bearings of the turbine rather than within the gas system. Within the gas space the problem is the removal of the epoxy paint; this is particularly severe within the blowers themselves, and corrosion and blockage of the stainless steel fan drains also occurs through soot deposition which leads to penetration of the piping around and above the blockage. The paint within the pipework and impellers is subject to corrosion by damp acidic soot. Green and white salts can often be seen in the soot. These are ferrous sulphates and indicate the presence of corrosive acids downstream of the scrubber. The impeller housings suffer most and not one of the eighteen inspected had retained its coating of paint. Clearly this type of paint cannot withstand the duties imposed upon it within the fans, in particular, or the pipework, in general. To overcome these problems, internal surfaces could be either rubber-lined, stove coated or fibreglassed. A stove epoxy lined impeller casing and a glass fibre painted one have been tried. After one year in service these were in good condition but showed some pinhole corrosion from entrained shot blast. Less large blisters were produced with the latter coating which showed no tendency to flaking.
