THE INSTITUTE OF MARINE ENGINEERS

A REVIEW OF MARINE GEARBOX EXPLOSIONS

THE KOOTENAY GEARBOX EXPLOSION

ISSN 0309-3948
Trans I Mar E (TM)
Vol. 93 1981 Papers 10, 11.

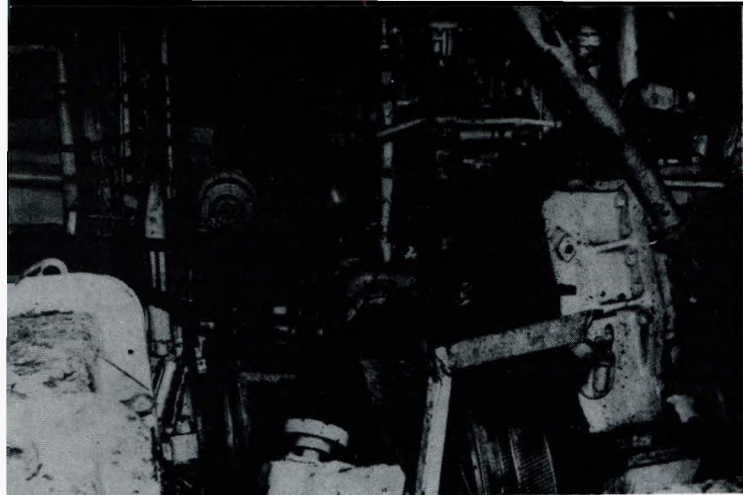
Fig. 1 Gearcase of the 'Seatrain New York'

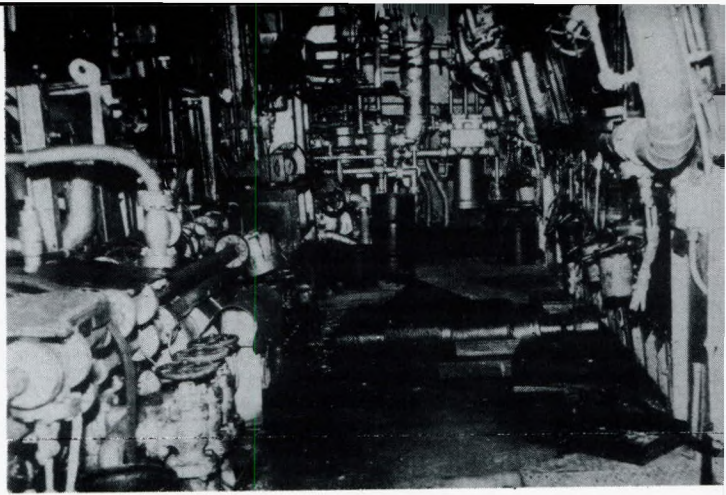
Fig. 2 Fireroom of the 'Seatrain New York'

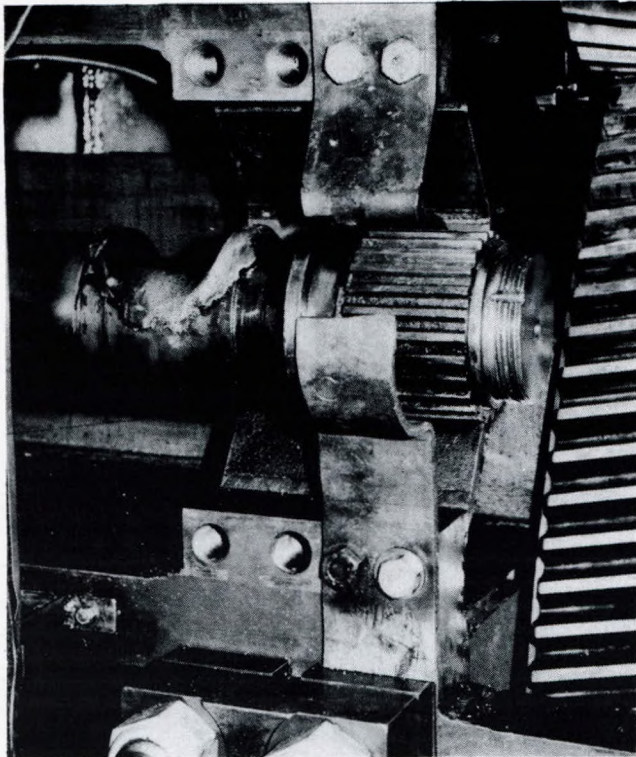
2.9 A better documented case of oil ignition within the gearcase is that in HMS *Zulu* (Figs. 3 and 4) when a lightly loaded steam turbine jackshaft bearing failed. Popping noises and discharge of smoke through joints were reported, followed several minutes later by a heavy grinding noise. Flashing or sparking was also reported at some distance away from the bearing in distress, visible through clutch inspection sight ports.

Fig. 3 Jackshaft bearing journal of 'HMS Zulu'

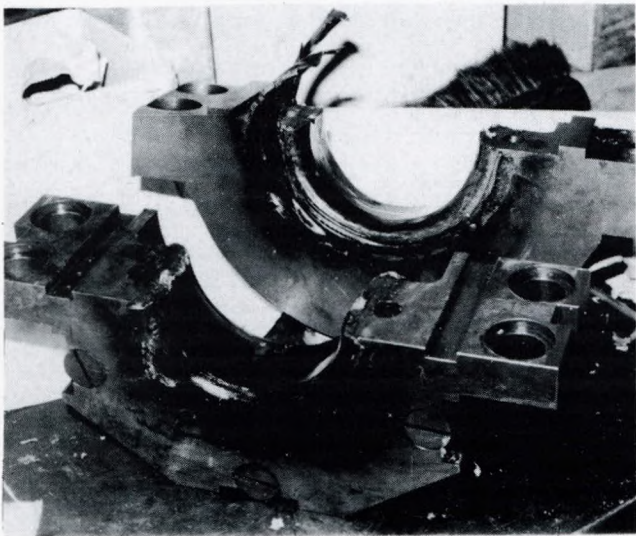
Fig. 4 Jackshaft bearing housing of 'HMS Zulu'

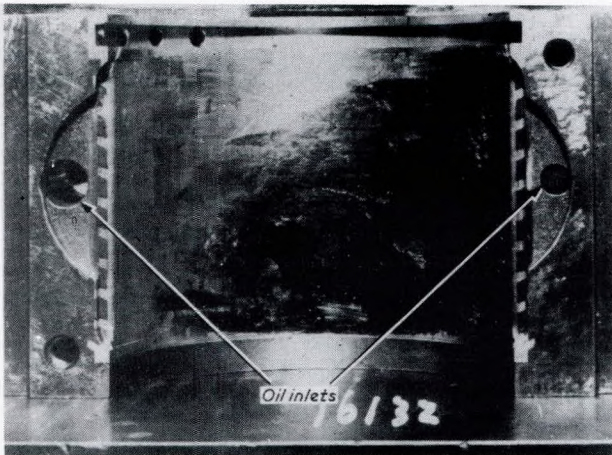
The contractor sea trials conducted on three of the early ships of St. Laurent class revealed a primary pinion bearing problem not experienced in the first ship of the class, nor in the extensive prototype shore trials 2. In each case the routine post-trial gearing and bearing examination showed that in the port unit only, the primary pinions forward bearing, had suffered a white-metal fatigue failure which the bearing thermometer had failed to detect. Fig. 3 shows the failed 2.5mm thick white-metal liner, mechanically anchored to a cast iron backing shell, since a sound chemical bond is difficult to obtain between these two materials.

The cause of failure was also pursued through an analysis of journal load-lines and attitudes over the full range of powers. This revealed that the original bearing design had been based on the cruising power coming solely from the cruising turbine; whereas in fact the cruising turbine exhausts to the main turbine LP stages, which provide approximately one third of the total cruising power. The lower oil inlet to the pinion bearing was then seen to be badly located for the cruising drive (Fig.4) and was, accordingly, eliminated.

Fig. 3 Primary pinion two-inlet, thick shell bearing failure

The loaded top half insert has a full annulus with an auxiliary inlet hole located 80° from the bearing split. Extensive ship trials, with the single-inlet insert shells fitted in the primary pinion bearings, were successfully completed in May 1957 under main and cruising turbine drives. Thermocouples fitted in each bearing half, but not penetrating the insert shells, were sufficiently sensitive to register temperature changes due to major helm movements. The complete insert bearing assembly, shown in Fig. 5 was then fitted in all ships of the class.

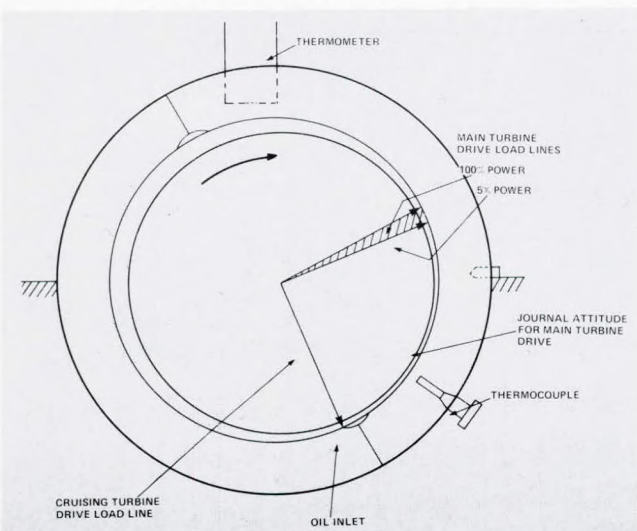
Fig. 4 Primary pinion bearing load lines

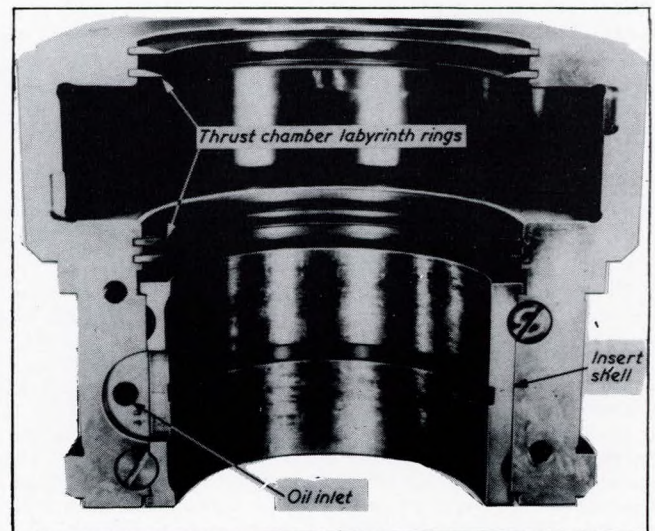
Fig. 5 Primary pinion single inlet insert shell bearing.

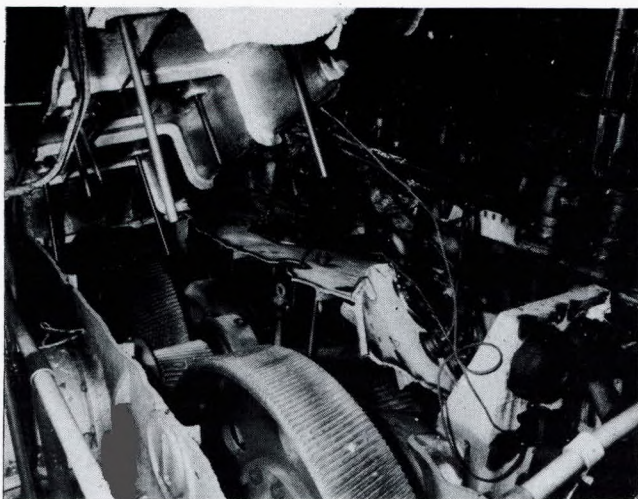
Fig. 8 Kootenay gearbox explosion damage

The resulting fire and smoke disrupted communication and access to the boiler room, leaving the ship to steam on out of control for about 30 minutes with the engines at more than half power. During this time oil from the sprayers, mounted in the ruptured gearcase cover and supplied by the turbine-drive lube oil pump, continued to feed the fire.

The Engineer Officer, who was one of the three badly burned engine room survivors, reported that the only warning had been "a loud hissing and sparking noise like an oxy-acetylene torch." Experienced off-duty engine room personnel in the cafeteria on the deck, near the engine room hatch, heard a pronounced organ-like note of 5 to 10 seconds' duration, followed by a short pause immediately before the explosion. This noise was later attributed to the discharge of gases under pressure through the gearcase vent.

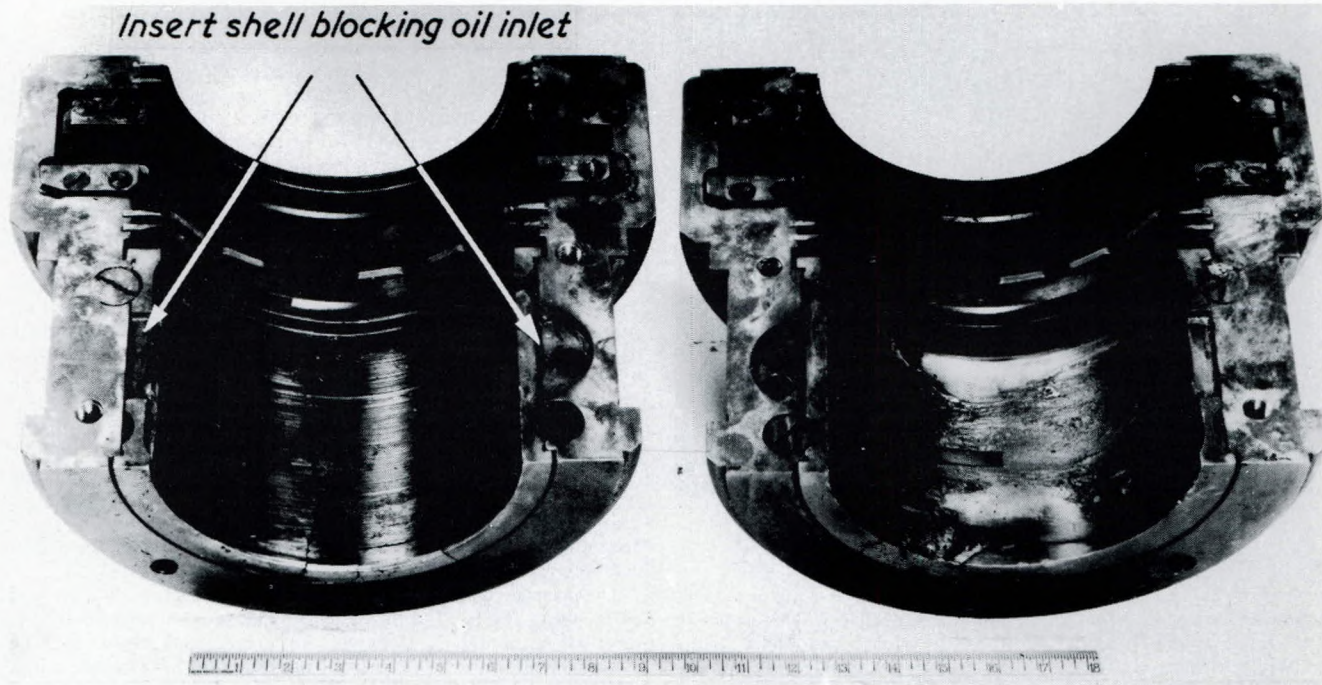
Fig. 10a Kootenay pinion for 'd top (L) and bottom (R) bearing halves

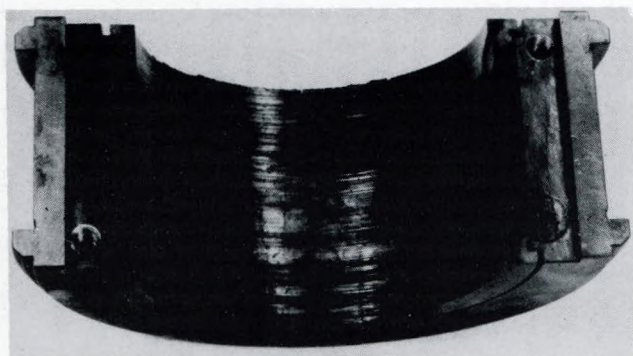
Fig. 10b Kootenay pinion aft bearing top half

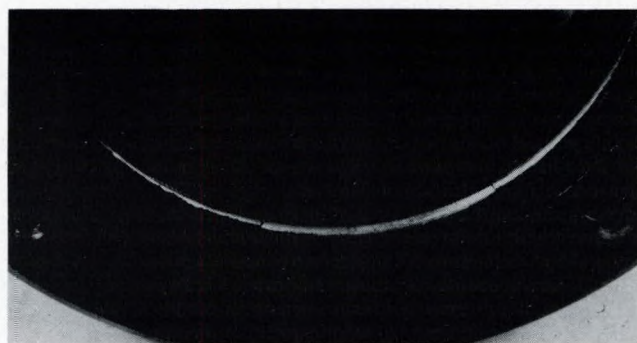
Fig. 10c Kootenay pinion for'd bearing end rubbing contact

The loud 'scream' would have occurred immediately the thrust wear had advanced to bring the pinion and bearing end faces into rubbing contact, although the pinion's axial load would still be absorbed mainly at the thrust bearing. The heat generated at the thrust bearing was drastically reduced as the shaft rev/min was dropped to 100-200 rev/min for six hours, so that the pinion length would contract and leave the axial thrust to be absorbed solely at the rubbing end faces. In this condition, the heat generated at 140 rev/min between the rubbing end faces was sufficient to cause oil ignition.

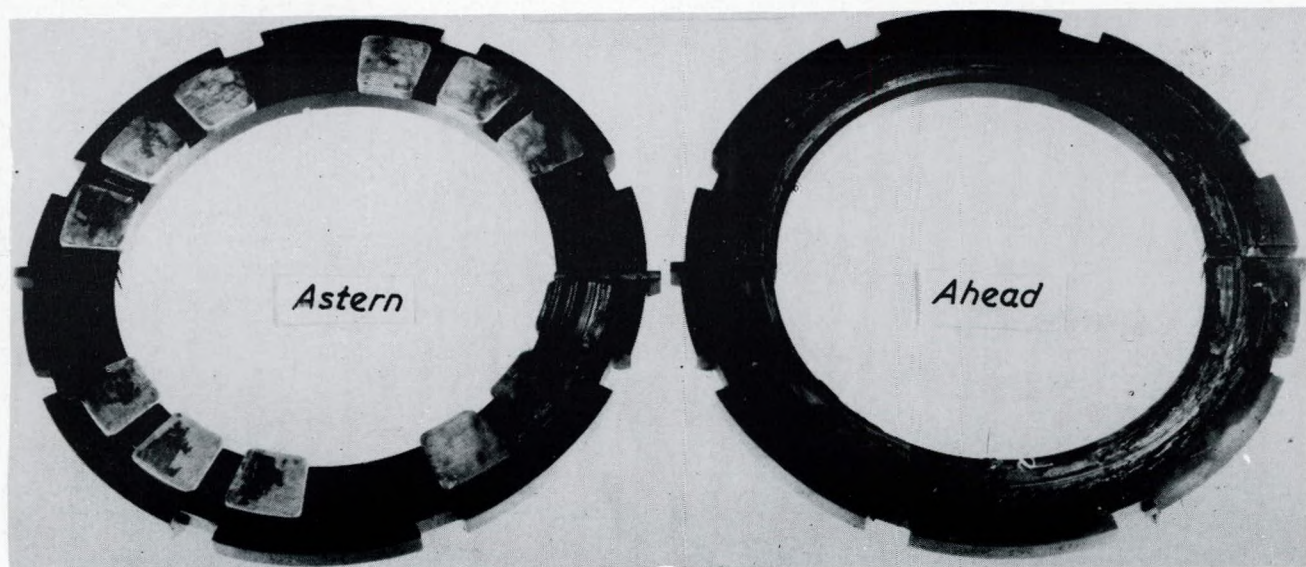
Fig. 11 Kootenay pinion thrust bearing pad assemblies

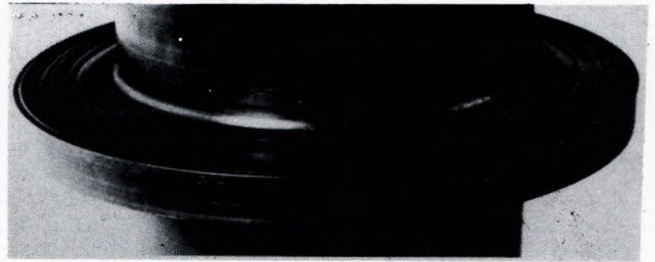
Fig. 12 Kootenay pinion thrust collar wear

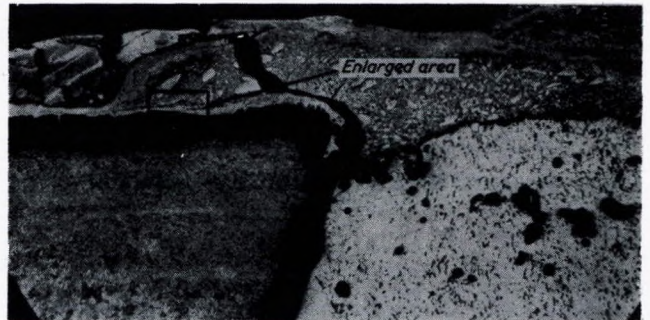
Fig. 13a Melted debris overlaying pinion thrust pad and steel backing ring

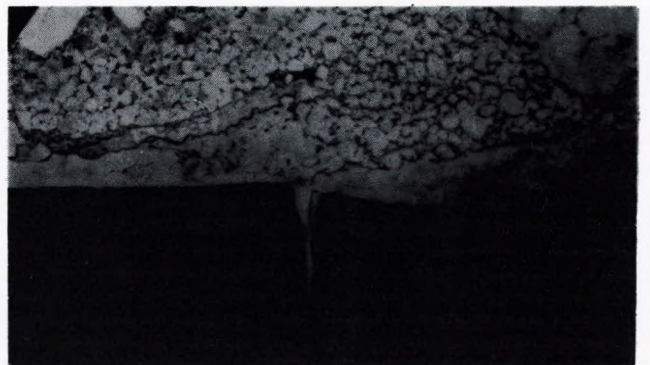
Fig. 13b Enlarged area showing penetration of molten thrust bronze into steel backing ring

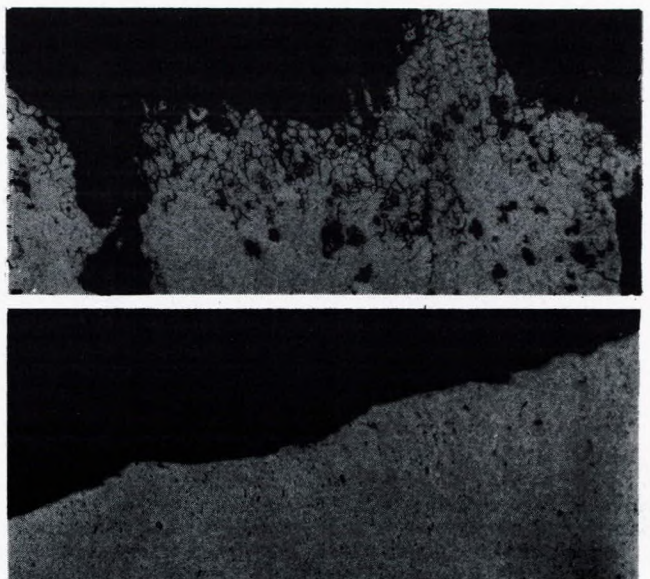
the turnings taken from the port vent (Fig 14b) or from other areas of the starboard vent basket.

Fig. 14 Micro photos of aluminium turnings (above) from centre of starboard gearbox vent basket (below) from centre of port gearbox vent basket

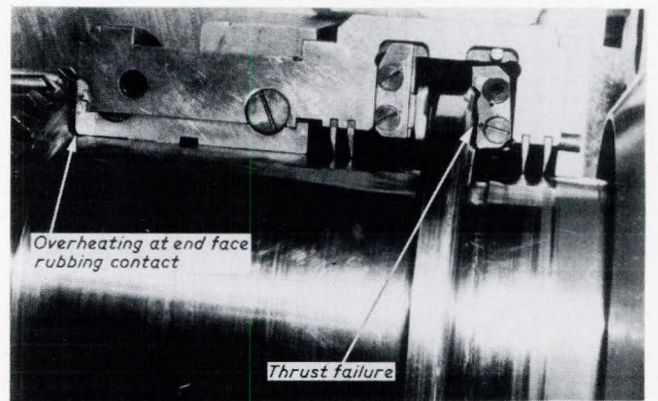
Fig. 16 Chaudiere primary pinion thrust failure

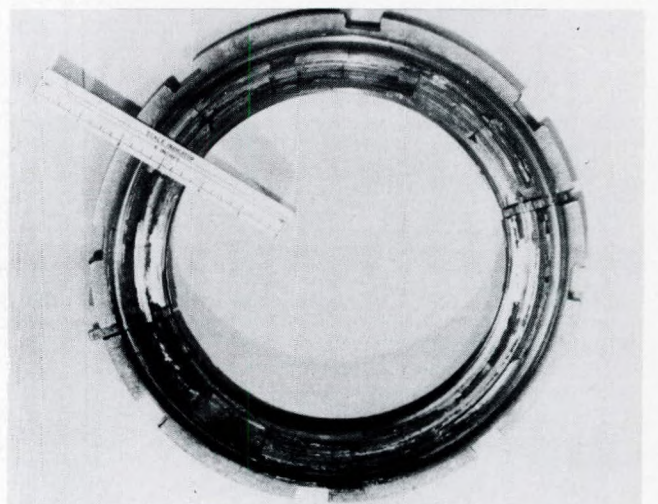
Fig. 17 Chaudiere primary pinion ahead thrust ring damage
