# SOME MEMORABLE BREAKDOWNS AND RESULTING IMPROVEMENTS

T. W. Bunyan

ISSN 0309-3948  
Trans IMarE(TM)  
Vol 93 1981 Paper 5

The author describes some of the more interesting hull and machinery problems in ships with which he has been personally involved during his career. He covers trouble shooting, redesign and improved construction with particular reference to vibration and bearings.

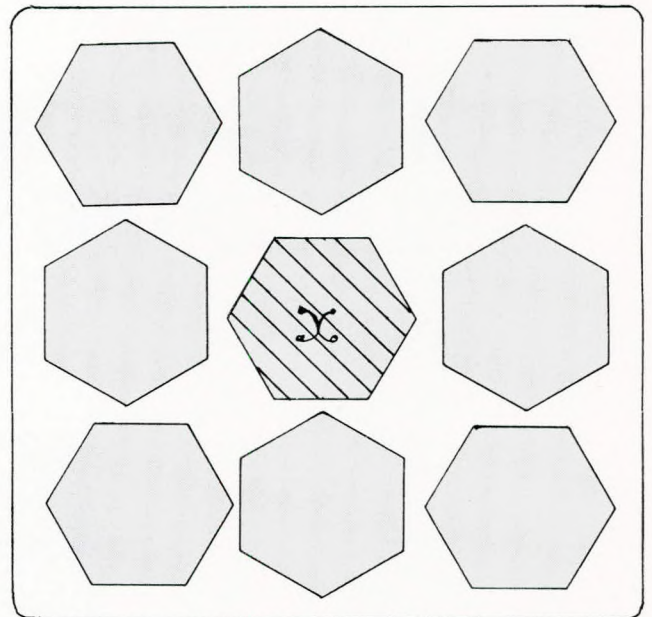
The gear rims were made of silicon manganese steel, (C. 0.46%, Si 0.9%, Mn 1.0%, S and P 0.4%). However, in this case, due to some confusion, the steel maker had not been aware that the ring forgings were required for anything other than the hoops, normally made by them for shrinking on to the casings of blast furnaces! The trouble, which involved eight ships, with failures occurring after six months to two years service, was caused by choosing the wrong ingots.

For ingots used for forging gear rims it is vital that the non-metallic segregates are concentrated concentrically about the axis so that, when the ingot is pierced before forging, most of them are discarded. What is left must remain concentric so that it lies near the bore of the forged rim where it is totally removed by the rough machining. To centralise these segregates, uniform cooling must be achieved around the periphery of the ingot.

Fig 1 shows nine ingots in the soaking pit: only the central one is suitable for gear rims. After rough machining and smooth turning the cheeks of the rim, the soundness of the forging can be checked by sulphur printing and magnetic crack testing before the expensive finish machining and gear hobbing proceed.

FIG 1 Ingots in soaking pit. Only X is suitable for gear rims as the remainder are unevenly cooled.

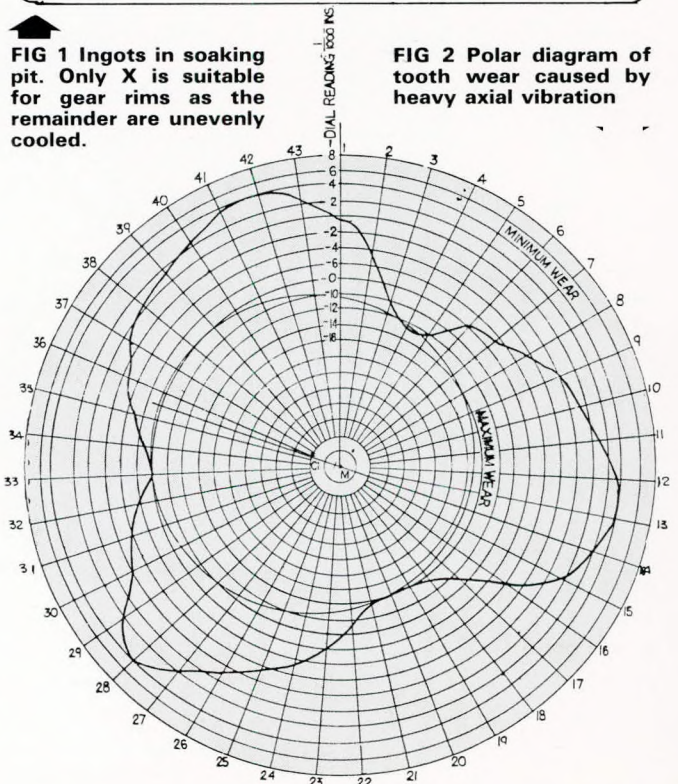
FIG 2 Polar diagram of tooth wear caused by heavy axial vibration

Fig 2 shows a three-lobed pattern which was worn into tooth flanks of an IP secondary pinion towards the end of the useful life of a twin-screw liner. The cyclical errors in the 12-tooth claw coupling excited a multi-noded mode of torsional vibration near the running speed.

The resulting axial vibration levels and tooth wear would reach unacceptable limits in about two years, when the pinion would be changed for the rehobbed spare. This was the cheapest practical solution, causing minimum disruption of voyage schedules, etc.

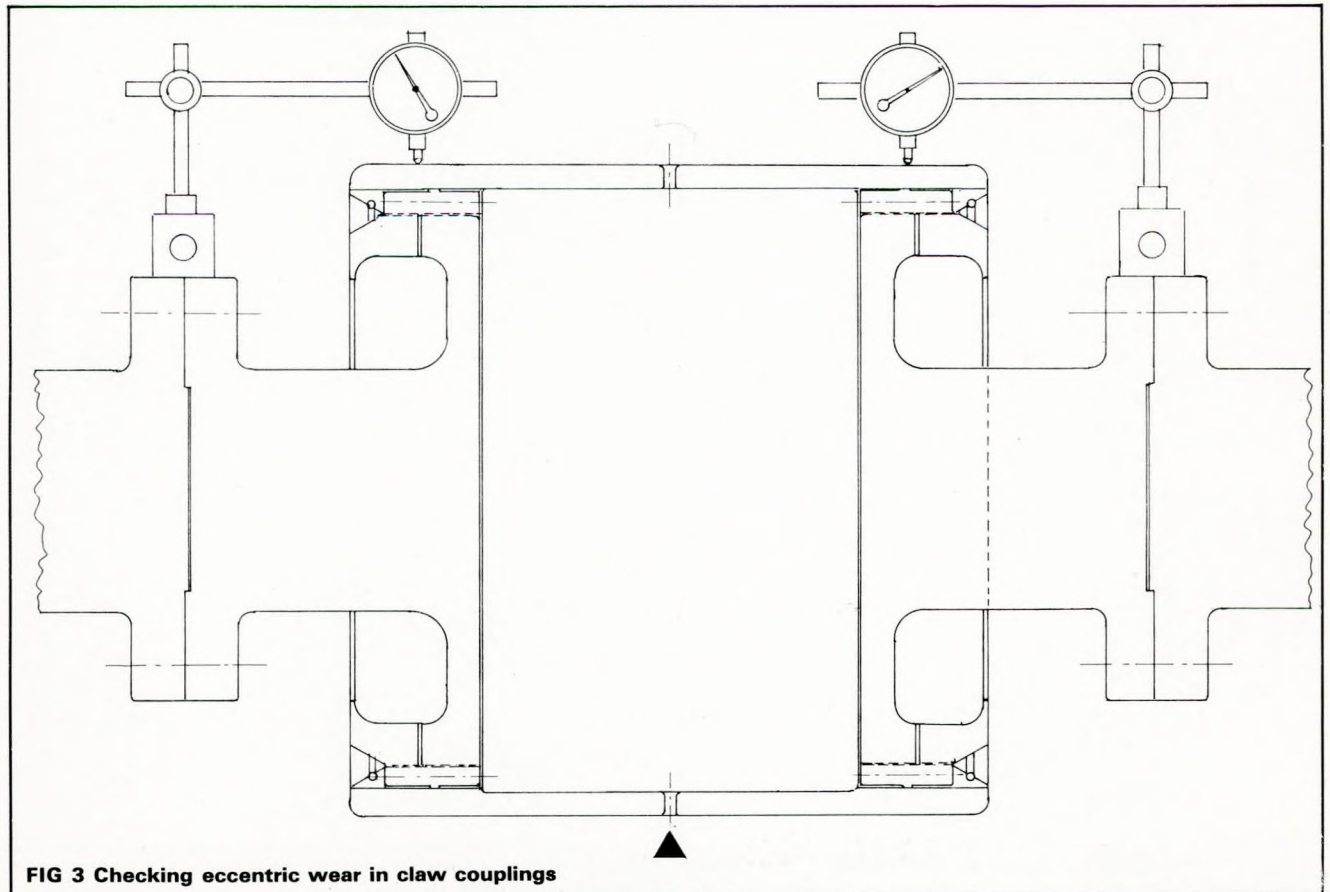
A high degree of running alignment is called for if long service life is to be had from these couplings. Indifferent alignment — usually based on the incorrect allowance for "hot alignment" — produces wear which is always cumulative and eccentric. Depending on the extent of initial alignment the rate of wear can therefore increase with unbalanced centrifugal force until a critical situation is reached in which

the rotor journal reaction is exceeded by this centrifugal force. At that point in time the journal precesses around the bore of the bearing, reducing effective lubrication and causing edge loading. Complete failure of the bearing is then not far away.

Fig 3 shows how the wear can be measured, using a pair of dial gauges. The central sleeve assembly is levered upwards with a wooden batten (making sure there is no jamming) and the movement of the dial gauges is recorded at three angular positions 120° apart. From the maximum throw the centrifugal force at the maximum speed is calculated. If this approaches within 30 per cent of the turbine journal's design load, problems may be developing.

FIG 3 Checking eccentric wear in claw couplings

The cold alignment should be checked and corrected for the "hot alignment" or running condition, using the turbine makers "hot" allowances. A simple yet precise method of checking cold alignment from which declivity and parallel errors are obtainable, was developed by Mr Bryan Hildrew, Managing Director of Lloyd's Register of Shipping, when he was a member of their research team. It is known in the trade as the Lloyd's Two Clock method.

In the case of a P & O tanker it was found to be more convenient — because of tight turn-round times, etc — to have the HP fine tooth or "dental" couplings replaced by flexible metallic couplings which were fitted during a normal drydocking.

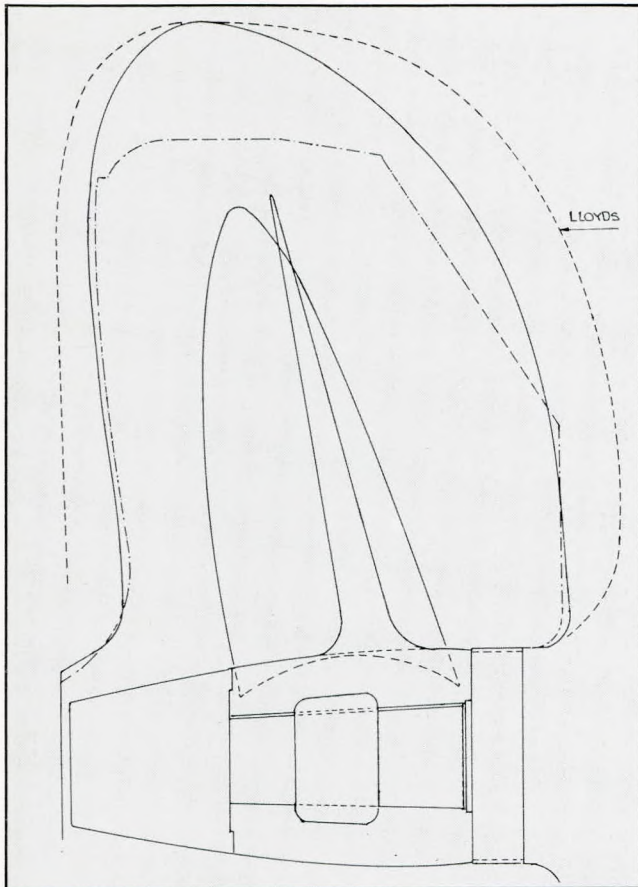
FIG 4 Propeller aperture clearances compared with those required by LRS

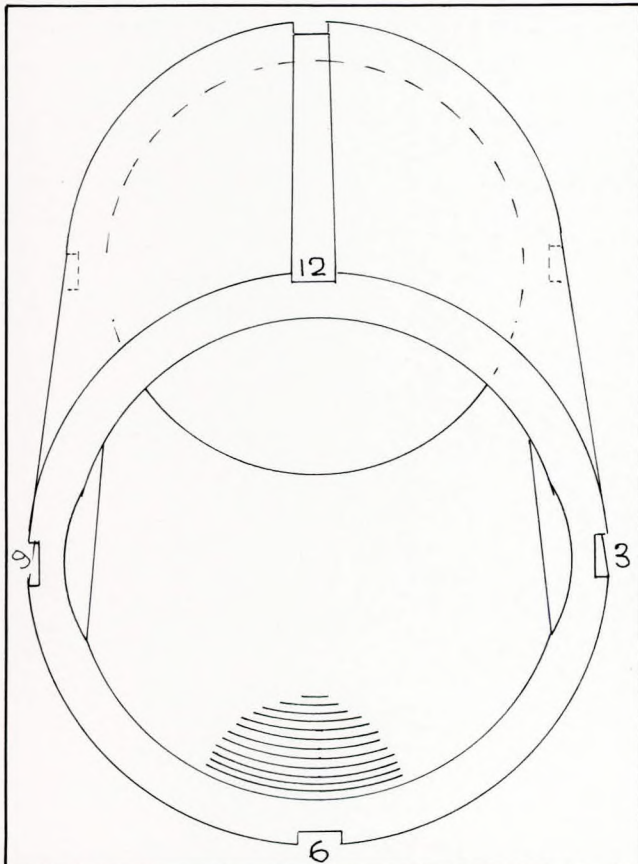
FIG 5 Stern bearing: wear at "6 o'clock" (boundary lubrication)

The abrasive wear, which marks every white metal lined stern bearing at the bottom is due entirely to boundary lubrication conditions which occur at very slow speeds. It is not caused by running under normal conditions. Fig 5, derived from a colour photograph, shows this "6 o'clock" wear pattern in the stern bearing of *Arctaraig*, a P & O VLCC.

However, new problems have occurred, such as those indicated by the author's Fig 5, due to wear at 6 o'clock (boundary conditions)<sup>5</sup>. Such problems could be solved by introducing double- or multi-slope boring of white metal in the aft part, with the so-called elastic calculations, taking into account not only elasticity of line shafting but also white metal. Surprisingly Fig 5 indicates wear at 12 o'clock. In this respect we agree fully with the author that it is due to the influence of the six components of propeller forces and moments, and it occurs not only on full-body VLCC sterns but has also been encountered on smaller ships and even multi-purpose dry cargo ships.

**3.3.3** A good "6 o'clock" bedding contact with the tailshaft is important as this ensures minimum edge loading and limits the abrasive wear pattern under boundary lubrication.

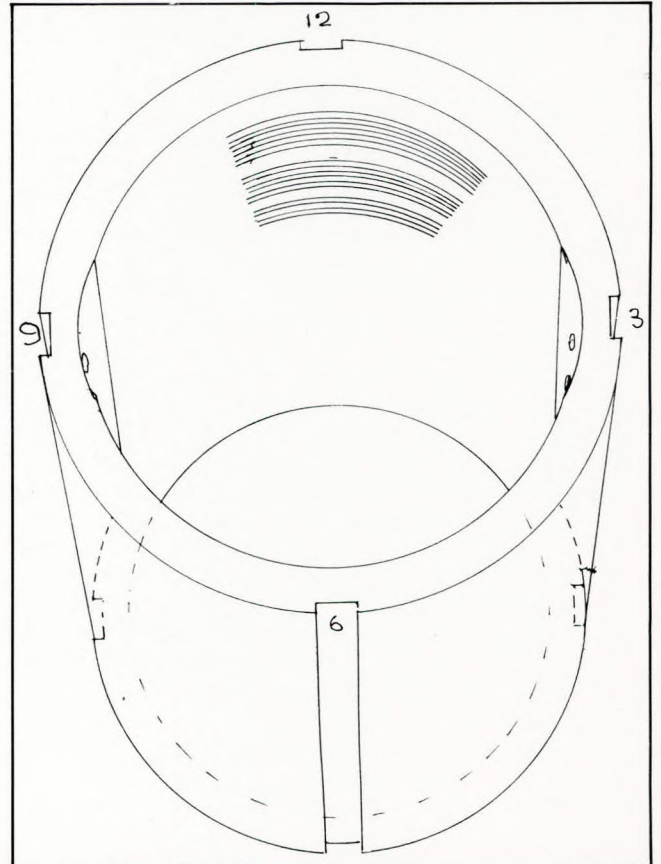
The Author is of the opinion that in single-screw ships with a block co-efficient exceeding about 0.7, the tailshaft runs in the top of the bearing at least until some most ingenious hydrodynamicist can achieve

FIG 6 Stern bearing: wear shown at "12 o'clock" in full-bodied sterns ( $C_b=0.7+$ )

Fig 6 which is also based on a photograph of *Ardaraig's* stern bearing, shows the marking at 12 o'clock for the running condition. Experience will show that this is typical for full bodied ships with conventional wake contours. Notice the changes of shaft attitude resulting from the differences between ballast and loaded draughts.

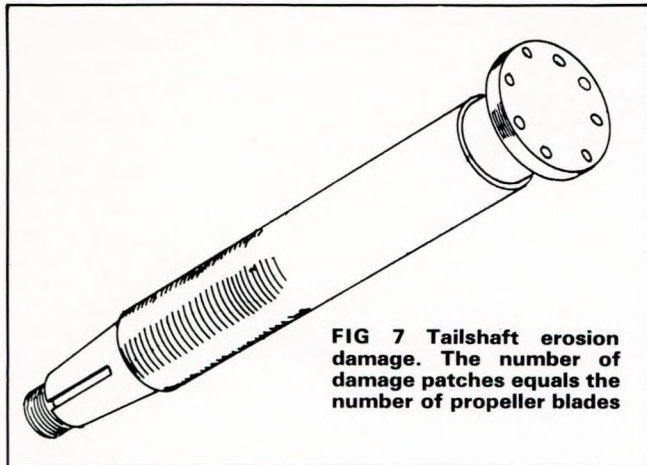
**FIG 7 Tailshaft erosion damage. The number of damage patches equals the number of propeller blades**

of patches equal to the number of propeller blades. The progressive bell mouthed wear-down of the stern bearing produces a very wide spectrum of whirling tailshaft vibrations at a frequency depending on the number of propeller blades.

So it was not uncommon that, in time, the critical frequency would occur in the service speed range with the result shown in the picture. The damage to the stern bearing would then be rapid and in a matter of days all the stock of gland packing on board used up. This is not serious in the Mediterranean, but quite another matter in the middle of the Indian Ocean. Serious damage to the support structure of the aftermost plummer block often adds to the avoidable trauma.

With the enhanced wear resistance of polymeric materials it is unlikely that the younger generation of engineers would see the tailshaft damage shown in Fig 7. As the author has pointed out, this erosion has been caused by the effect of bearing wear upon the point of support of the tailshaft within the bearing and the corresponding change in critical speed of the shaft system. Critical speed is now relatively simple to evaluate in the as-new condition and the wear resistant properties of the new generation of plastic materials will ensure that the critical speed does not approach running speed as time passes. Surely the author will agree that, with new materials already available and in the course of development, it would be folly for engineers to neglect their application to stern bearings with all the technical and cost advantages that would ensue.

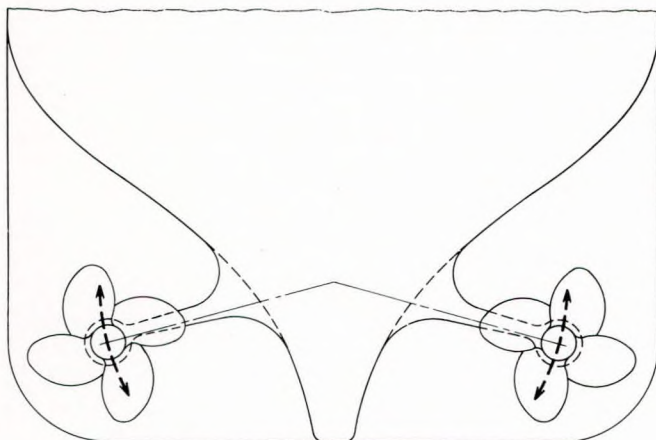
**FIG 8 Arrows show mode of vibration of propeller bosses on a passenger liner**

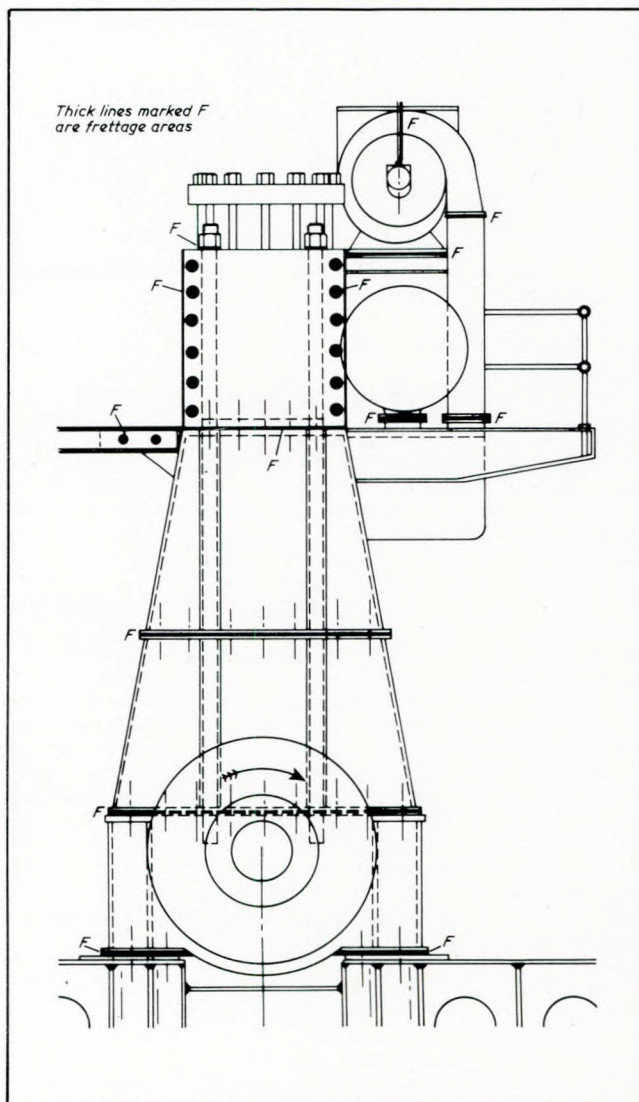
Large, direct-coupled diesel engines usually have long tie rods to take the firing loads down to the main bearing girders. To restrain "violin string" vibration of these rods, pinching screws are provided. The engine makers' instructions on the tightening of the tie rods, (usually by hydraulic means) and on the follow-up of the pinching screws must be taken literally. Otherwise, it is highly probable that a neglected engine will quickly and seriously damage itself by cumulative fretting at the bolted connections, which gets worse at an increasing rate.

Fig 9 Fretting damage in large diesel engines is marked in thick black lines

I also remember an analogous case of fretting damages to large diesel engines, as shown on Fig 9. It was on a passenger liner equipped with two 12-cylinder main engines where very heavy fretting occurred between cylinder block and transverses of the old-fashioned engine. The primary cause of this fretting was vibrations between cylinder block and transverses, which then decreased the pre-stress of tie rods. All this had been aggravated by deformations coming from double-bottom steel-work.

These days there is no excuse for this sort of damage as the manual effort has been removed from tensioning tie rods. Hydraulic nuts are now common practice, supplied from a small pneumatically or electrically driven pump which delivers the required pressure. However, in spite of this, broken tie rods are still found at surveys and the resulting expensive damage is the basis for costly charter party disputes.

The fretting was avoided by putting steel shocks in a convenient place between cylinder block and transverses, and connecting newly-machined surfaces by means of 'Lacit otaphom'. This gave good results.

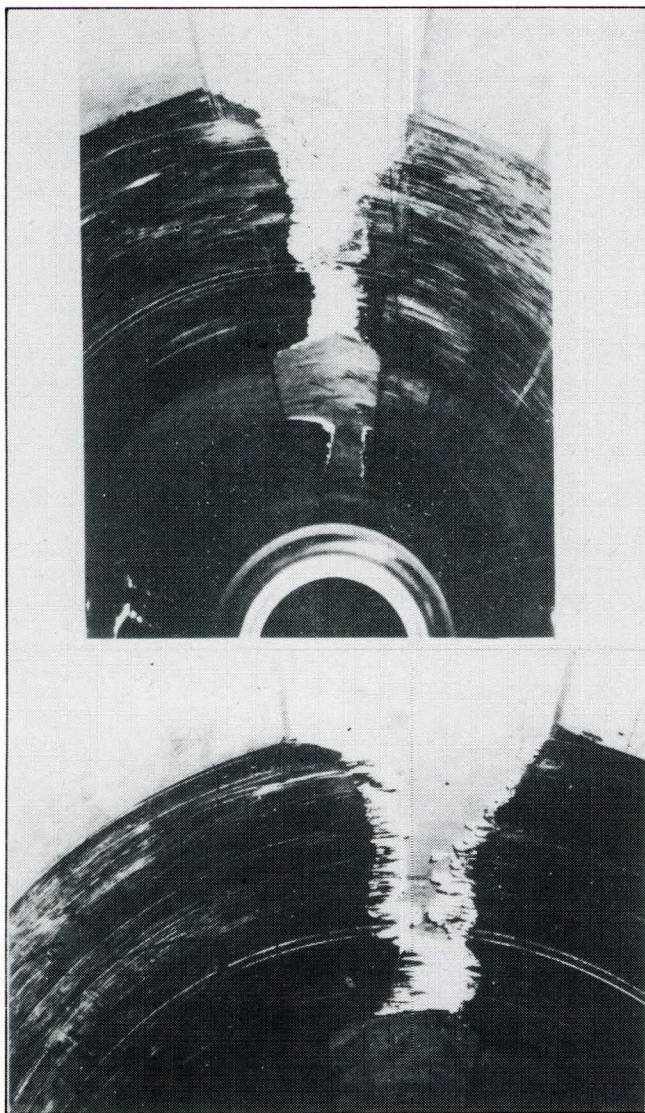
**FIG D1 Upper part of the aft (white metal) bush found seized after sea trials**

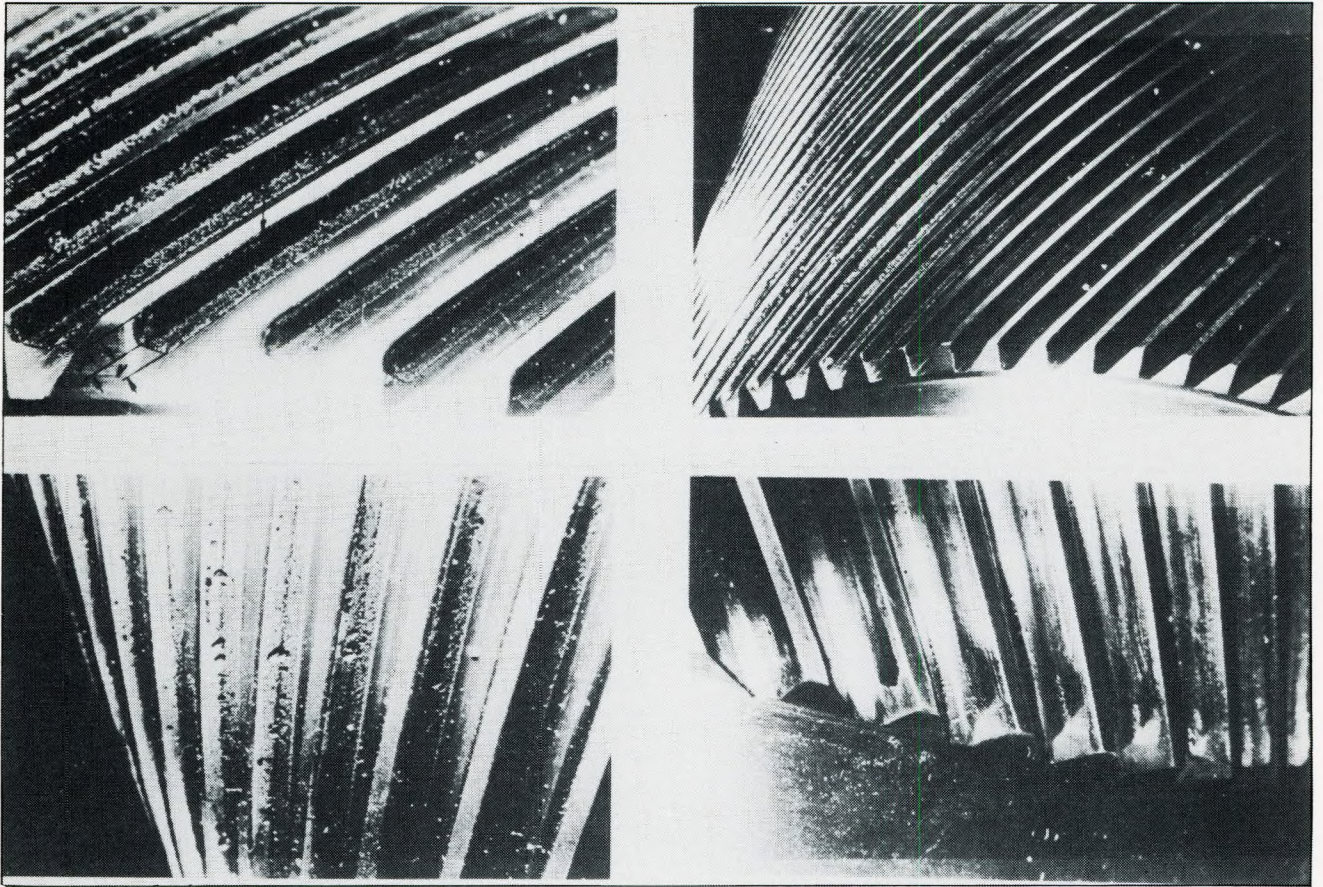
In order to avoid pitting on the forward part of forward helices of the secondary meshing, as shown in Fig D2, it is necessary to proceed with a rational alignment not only of line shafting but of the bull gear wheel shaft journal; the forward bearing always being more loaded during the alignment operation<sup>1,2,3</sup>. Figs 5-7 remind me of the *lignum vitae*-fitted aft bushes of the past. The erosion patches, as indicated on Fig 7, were often accompanied by lateral vibrations of line shafting as the basis of leakage of aft stern and heavy ship vibrations. Fortunately, *lignum vitae* could withstand such whipping of the journal but, for white metal bushes, such cases have shown much more rapid distortion. Fig D3 shows the forward upper part of the forward bush of stern tube which was distorted after only six hours' voyage, without full power, from the outfitting quay to the drydock for cleaning and painting for trials. I experienced such phenomena 18 years ago; these had been predicted by the calculations of the so-called rational alignment which we were trying to introduce into the shipbuilding industry. Neither the shipyard nor the owner wanted to believe the results indicating negative reactions appearing in way of the forward bush; but once they had paid a heavy bill for repairs they were convinced<sup>4</sup>. Since then rational alignment has been universally adopted.

**FIG D2 Pitting, spalling and heavy wear of after helix caused by tilting of thrust block and a non-rational alignment of the shafting supports (17,600 shp,  $n = 108$  rev/min)**

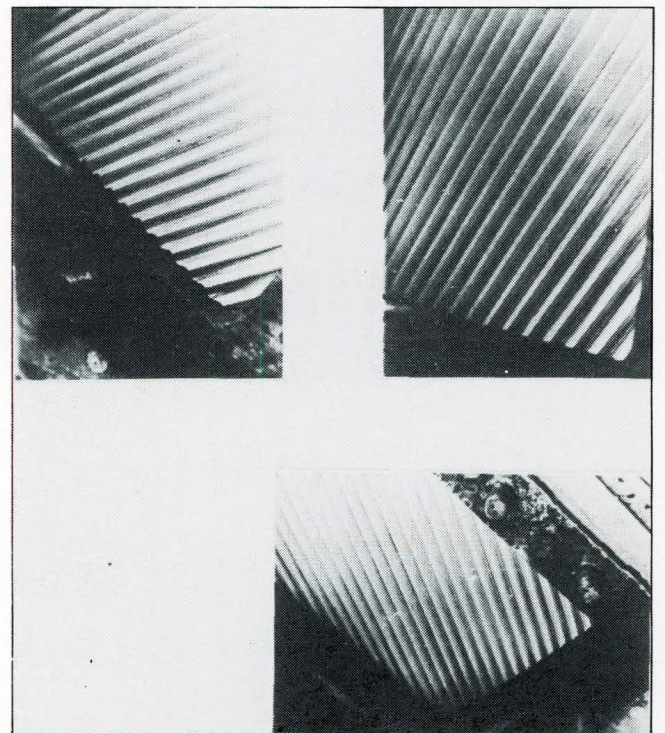
**FIG D3 Pitting, spalling and heavy wear of forward helix caused by flexing of double-bottom, tilting of thrust block and non-rational alignment of the shafting supports (17,000 shp,  $n = 105$  rev/min)**

I thank Mr Volcy for Fig D3 where the forward bush was destroyed during a 6-hour light ship voyage—it can only be described as holding the 'malalignment record'. It must have been difficult to get the tailshaft coupling bolts fitted. Another point of interest is that there appears to be no adhesion between the white metal lining and the wall of the sleeve.
