25 YEARS EXPERIENCE WITH SEA-WATER-COOLED HEAT-TRANSFER EQUIPMENT IN THE SHELL FLEETS

E. B. Shone and G. C. Grim

ISSN 0309-3948
Trans IMarE(TM)
Vol. 98, Paper 11 (1986)

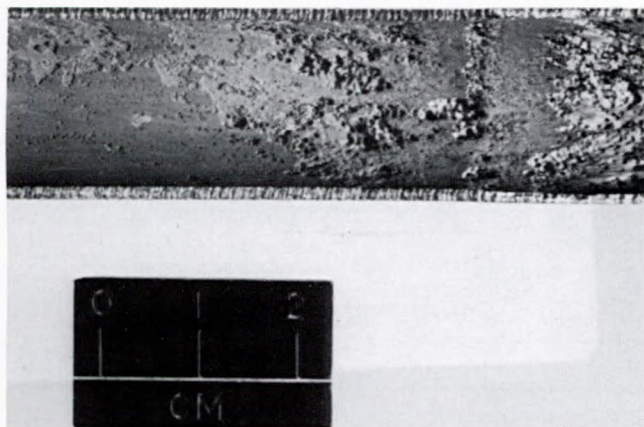
When the *Mitra* was docked during June 1970 an examination was made of the condenser and it was concluded that the majority of the tubes had suffered inlet attack extending beyond the first 6 in of the tubes. The inserts that had been

FIG. 1: View of the inlet end of an aluminium brass tube pitted by impingement attack

fitted were of insufficient length to protect the tubes from all damage. Additionally the soft iron anodes fitted into the waterbox had corroded away, but neither the cathodic protection this would have afforded nor the liberated iron salts had prevented the impingement attack. Urgent remedial action was now required to ensure that further similar failures did not occur.

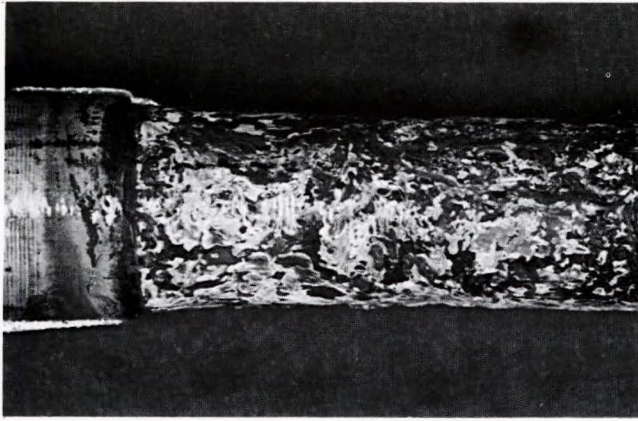
FIG. 3: Section of a condenser tube taken from near a support plate showing the tube to be severely corroded by ammonia

One type of damage was associated with the use of an excess of hydrazine, an oxygen scavenger which decomposes to produce ammonia. The damage was particularly severe on tubes either in or adjacent to the air-extraction section and adjacent to support plates. Figure 3 shows an example of this type of damage on a tube taken from the *Latona*. On this vessel over 2000 tubes had to be replaced. A report by a condenser manufacturer⁶ outlines methods of alleviating the damage and concludes that the primary remedy is to control closely the excess of hydrazine in the feed water. Shipboard efforts to reduce the hydrazine reserve within the boilers have been successful in reducing the incidence of failures but have not entirely prevented them.

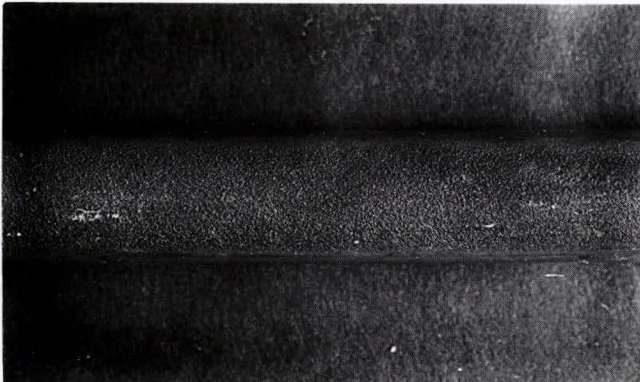
FIG. 4: Section of a tube damaged by steam impingement

Another type of damage that occurred was associated with steam impingement. The tubes affected by this form of attack were usually those in the way of the steam inlet ducts. Figure 4 shows a tube taken from the top row near the entry from the LP turbine on the *Medora* and typifies this form of attack. It can be seen that the aluminium brass tube surface has been roughened where the steam has impinged. Damage of this type did not present a major operational problem for the fleets.

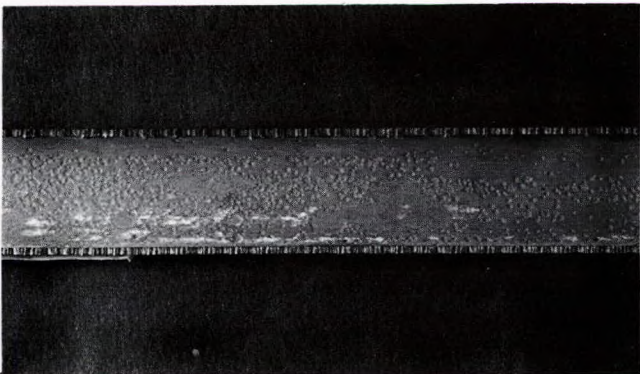
FIG. 5: Pitting corrosion associated with the presence of harmful cathodic films on the tube surface

One of the first vessels to be fitted with the CN 108 tubes was the *Latia*, which entered service in 1974. During its maiden voyage 69 tubes were perforated and had to be plugged. It was later established⁷ that these failures were attributable to the presence of carbon and manganous oxide films on the tubes' surfaces. These films were highly cathodic, and at defects in them the exposed underlying anodic tube material corroded in the flowing sea water.

An example of the pitting corrosion that occurred is shown in Fig. 5. These harmful films had formed during the manufacturing process and it seemed probable that tubes in other

Using this test procedure it was shown that the tubes fitted into the next vessel to be commissioned were also coated with harmful films. It was agreed that these films must be removed. Acid foam cleaning was used and continued until the tubes were found to be clean using our test criteria of 70 mV. The presence of harmful films on tubes had highlighted a serious problem and we were interested in establishing how many suppliers were providing tubes in this condition.

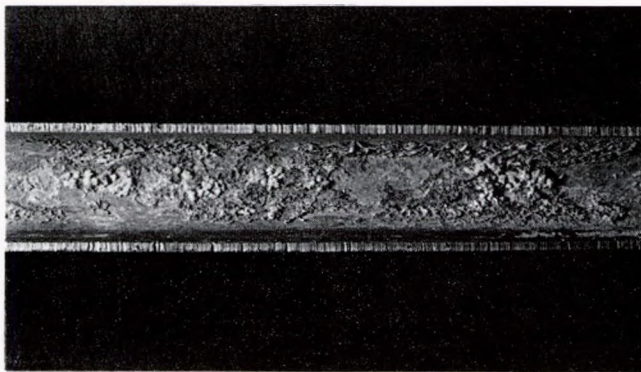
FIG. 6: Corrosion damage in the top of a tube taken from a main condenser

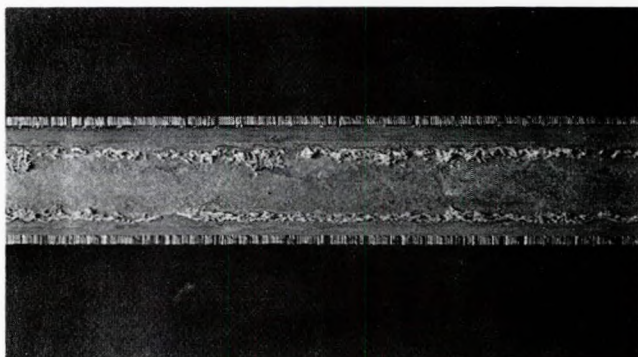
It was found that the sea-water velocity and tube-wall temperature were critical factors in determining the mechanism and rate of corrosion. The in-service failures could readily be reproduced in the test rig when the sea-water velocity fell to below 0.14 m/s. We believe that at these low water speeds pockets of air formed in the tops of the tubes and shielded them from the cooling water. Under these conditions localized high temperatures could occur in the moist chloride-containing air pockets and rapid corrosion would then take place. An example of the damage produced in the condenser test rig under low flow conditions is shown in Fig. 7. Further testing showed that the 90:10 copper nickel alloy and aluminium brass were also prone to this form of corrosion under similar conditions.

FIG. 7: Example of the corrosion that occurred in the top of a condenser tube when the cooling-water flow rate was low

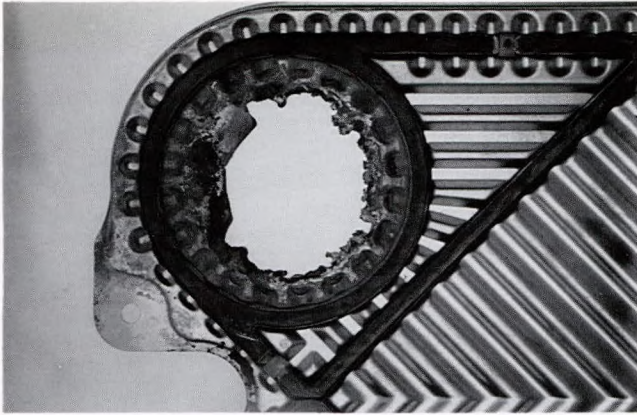
One such failure did occur on a plate from a fresh-water cooler on the *Lepeta*. This failure occurred on a plate with four blind corner discs that was positioned next to the steel end plate remote from the water inlet and outlet. The failed plate, which is shown in Fig. 8, had a roughly circular hole about 90 mm in diameter in it and the area around this hole was covered with rust.

At first glance it was not easy to account for the hole since titanium is not prone to corrosion in sea water under the prevailing operating conditions. However, a close examination showed the damage to have been caused by fretting of the

titanium which had been in contact with the steel end plate. This could only have occurred if the titanium had been distorted and tests were carried out to establish at what water pressure we could expect this distortion to occur. This was done by taking an undamaged corner, clamping it between steel flanges and applying a hydrostatic pressure to the water side.

By progressively increasing and releasing this pressure in small steps of about 0.3 bar (5 psig) a stress/strain curve for the corner was determined. This showed that at a pressure of about 3 bar the blind corner disc had a permanent deflection sufficient to allow the titanium to have contact with the steel backing plate. The vibration on the vessel would then be sufficient to initiate fretting corrosion of the titanium in a roughly circular manner. Once fretting had occurred thinning soon followed and when a hole was worn through sea water would penetrate to the steel backing plate causing it to rust.

FIG. 8: Failed titanium plate from the *Lepeta*

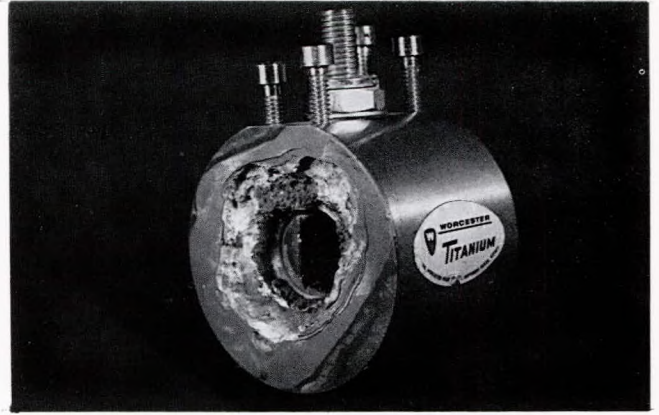
FIG. 9: Corroded titanium valve

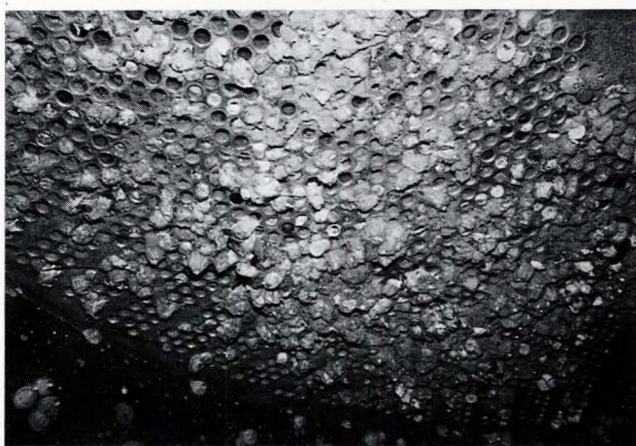
FIG. 11: Main-condenser inlet of the *Latia* heavily fouled following failure of the electrochlorination cells

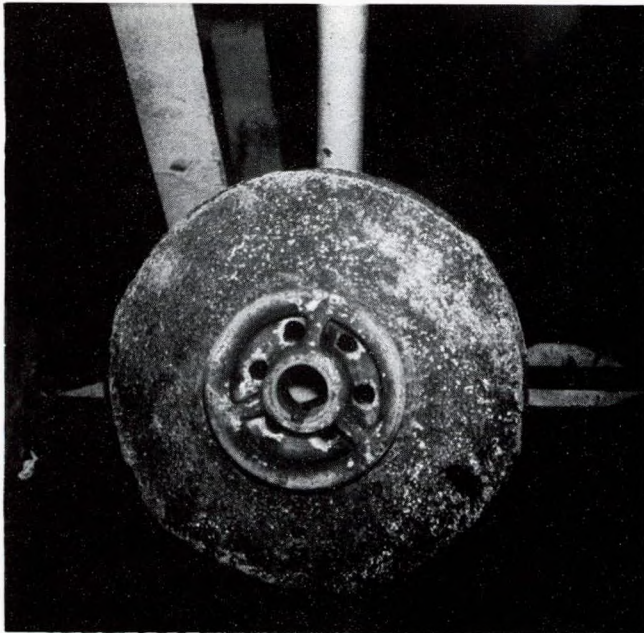
Figure D1 shows an aluminium bronze impeller from a sea-water pump after 15 months service in a new ship (the first of a long series). The heat-exchanger tubes were in holes as

FIG. D1: Aluminium bronze impeller from a sea-water pump after 15 months service

were other bits and pieces of the system. I do not intend to go into details of what was done, but for the cost of a few dollars, mostly on steelwork, and attention to detail normal experience was re-established.
