# Practical Examples of Vibration Analysis Onboard Ships and on Offshore Structures

**B. H. Thomas MSc, PhD**

Vibration Consultants and Instrumentation Ltd

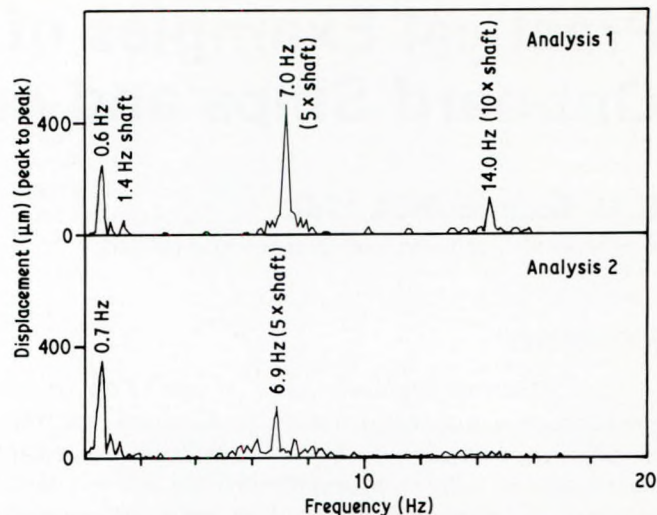
FIG. 1: Frequency spectra for main engine forward end at bottom grating level in axial direction. Upper: analysis no. 1 before inspection. Lower: analysis no. 2 after inspection and adjustment

The major problem identified was associated with vibration at 7 Hz, occurring mainly at the forward end. Consequently, the owner asked for a mechanical inspection of the forward drive mechanism. It was found that the chain driving the second moment balance shaft was slack and that the weights were out of adjustment. The chain and weights were adjusted and, in addition, the main holding-down bolts were tightened.

The adjustments made at the forward end of the main engine and the tightening of the holding-down bolts resulted in a significant reduction in vibration. The final levels in the fully loaded condition were within the manufacturer's specifications but were still on the high side. The remaining vibration was mainly at 7 Hz (main engine firing order) and 1.4 Hz (shaft speed). The propeller-induced vibration also remained low.

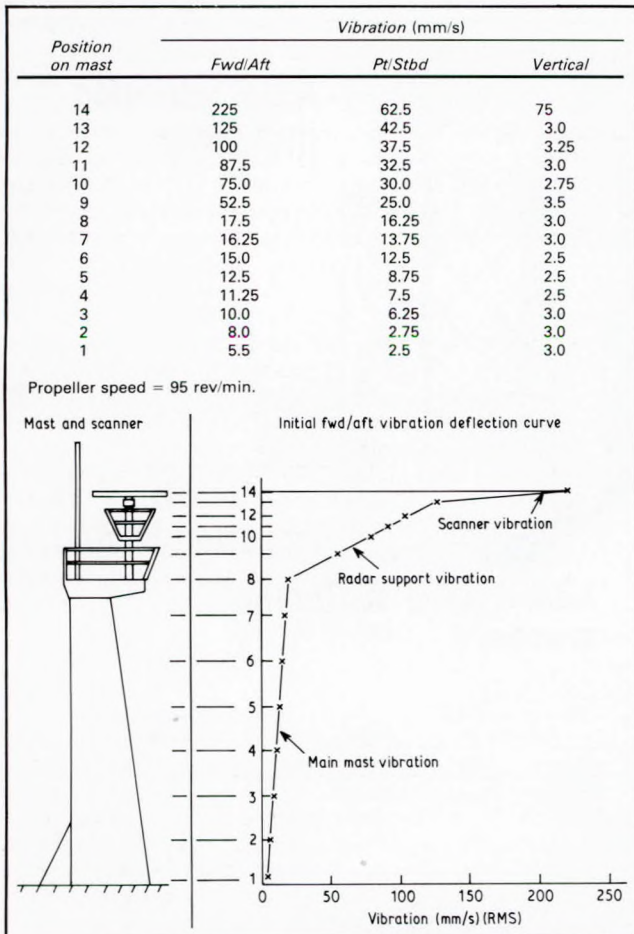
From the results and graph in Fig. 2 it was found that the vibration was excessive on the radar. Usually the vibration level at the top of the radar would not exceed about 60 mm/s but in this case the level is above this figure.

The problem became more readily understood by examining the graph in Fig. 2. It will be seen that the vibration in the forward to aft direction on the port radar scanner was about four times higher than it should be, so this was the reason for the constant failures. It can also be seen that the vibration in the port to starboard direction was less than in the forward to aft direction and in the vertical direction the levels were negligible.

From the graph Fig. 2 it can be seen that in the vicinity of the radar support the rate of change of vibration was very rapid and, in fact, the rate of increase was even larger for the scanner vibration. This led to the conclusion that the radar support frame required substantial stiffening, mainly forward to aft but also partially in the port to starboard direction. Therefore, the radar support was fitted with two extra substantial stiffening tubes in the forward to aft direction, inclined at about 45° to one another, as shown in Fig. 3.

FIG. 2: Initial vibration measurements for mast and radar scanner

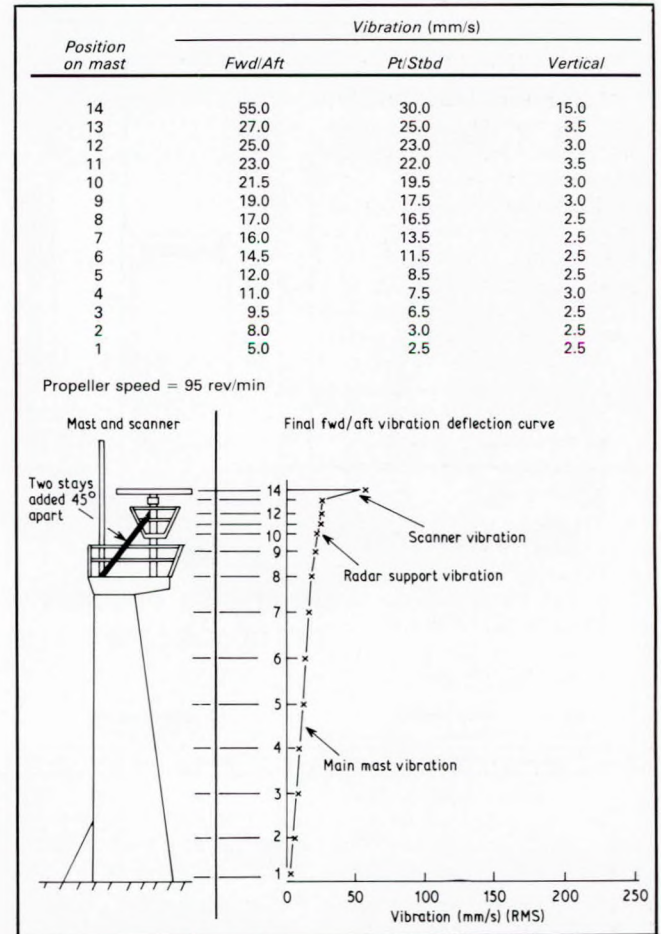
FIG. 3: Final vibration measurements for mast and radar scanner

It will be seen that when the measurements were repeated, the effect of the supports was to reduce considerably the vibration on the radar frame and scanner. In fact, the overall picture can be best appreciated by comparing the deflection curves in Figs 2 and 3.

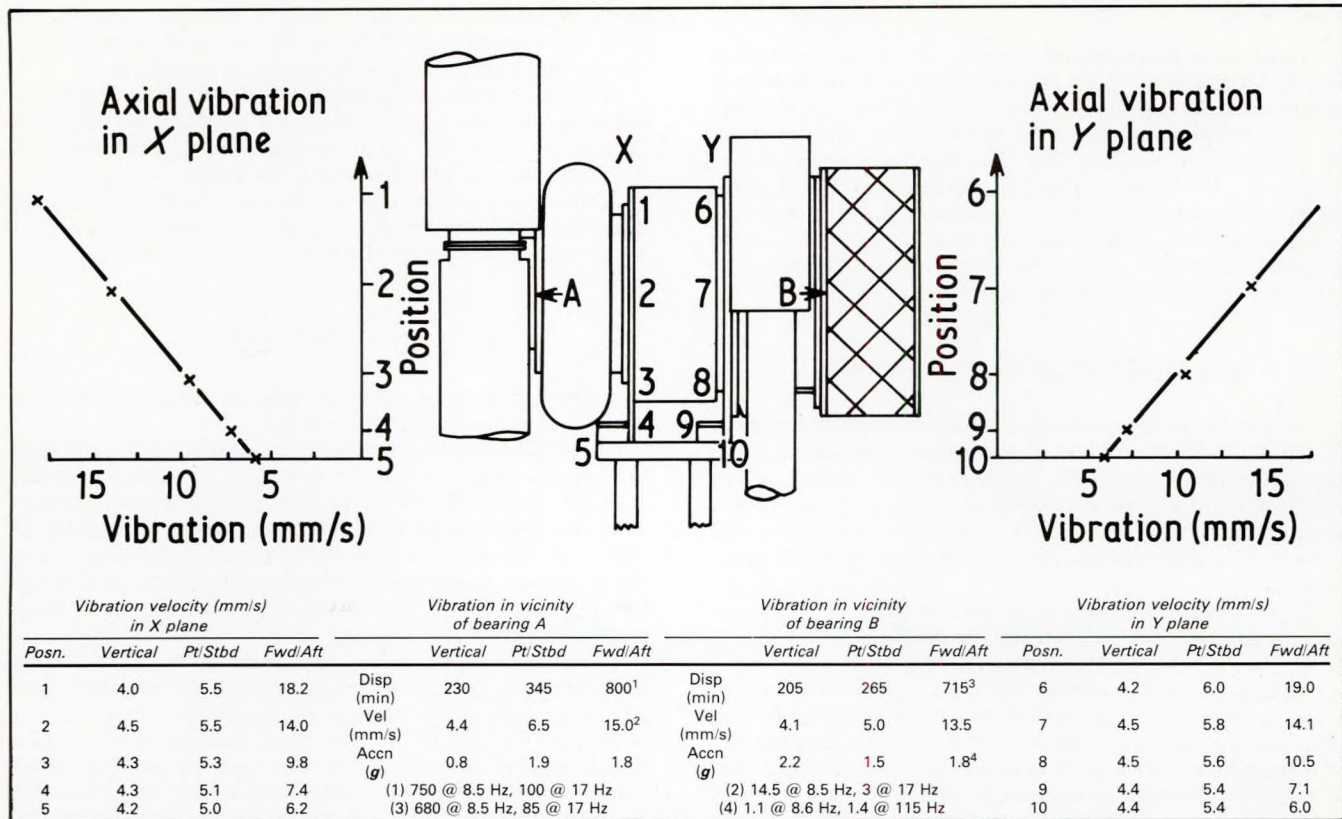
FIG. 4: First vibration measurement on turbocharger during sea trials

One typical example concerned the turboblenders for a main engine. This engine had six cylinders with a maximum speed of about 85 rev/min. Tests were carried out during the initial commissioning stages and it was found that the vibration on the turboblenders increased rapidly with an increase of the main engine speed. At 85 rev/min the initial vibration levels on both blowers was unacceptable. The measurements were taken at a main engine speed of 85 rev/min in the vicinity of the turbocharger bearings at positions A and B for one unit, as shown in Fig. 4. From the measurements of vibration, displacement, velocity and acceleration it will be seen that in the vertical and port to starboard directions the vibration levels were satisfactory. However, in the forward to aft direction (ie in line with the blower shaft) the vibrations were excessive.

It was deduced that additional axial stiffening was required and this was installed by adding two substantial RSJs from brackets on the main engine to the underframe of the turboblower, as shown in Fig. 5. These supports resulted in the vibration levels in the axial direction being reduced to less than half their initial levels. The overall reduction can be seen by comparing the vibration measurements and graphs in Figs 4 and 5.

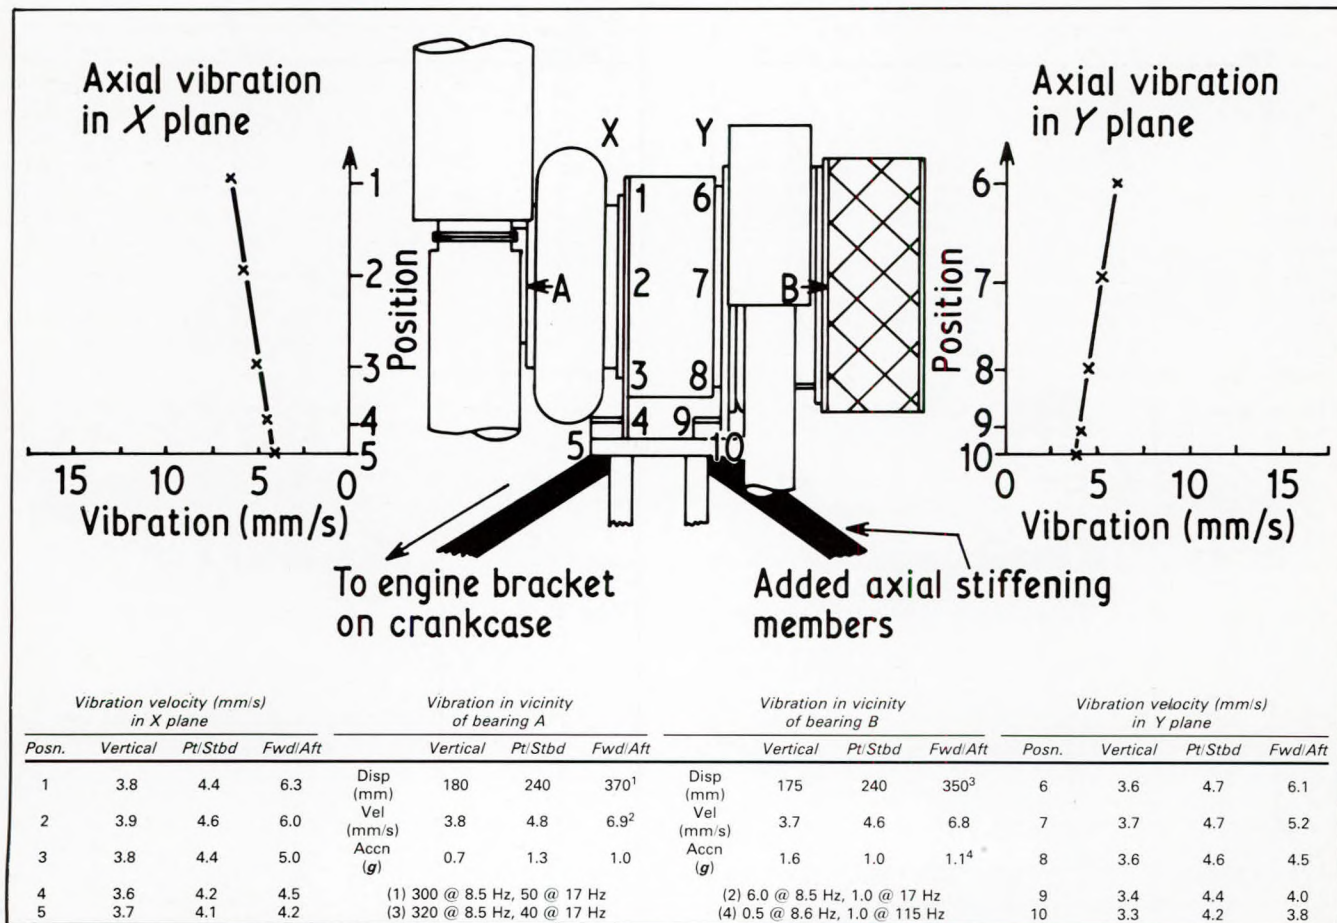
FIG. 5: Vibration measurements on turbocharger at sea after modifications to base

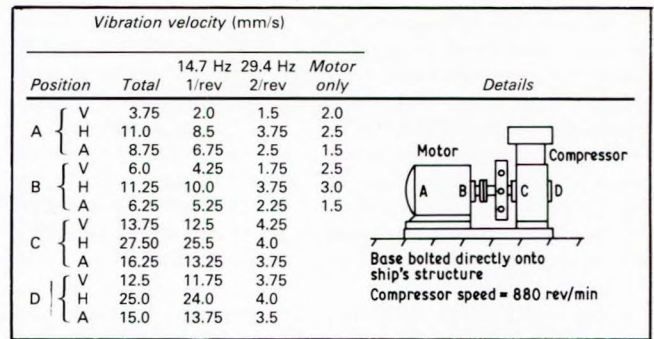
FIG. 6: Initial vibrations on instrument air compressor

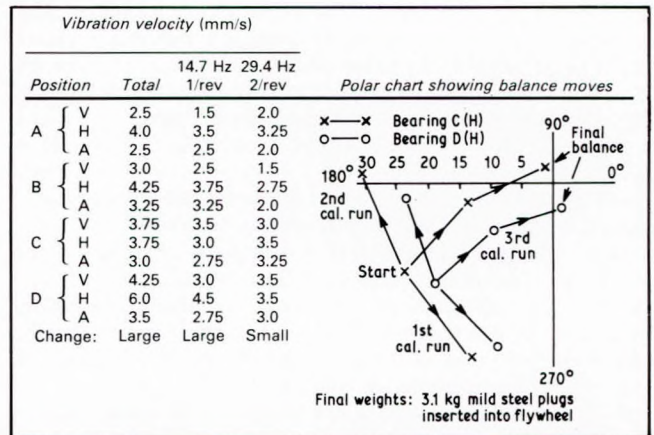
FIG. 7: Vibrations on instrument air compressor after balancing

Note that the twice per revolution component at 29.4 Hz as shown in the tables of Figs 6 and 7 did not alter very much as a result of balancing. This is to be expected as this component is caused by the reciprocal action of the compressor.

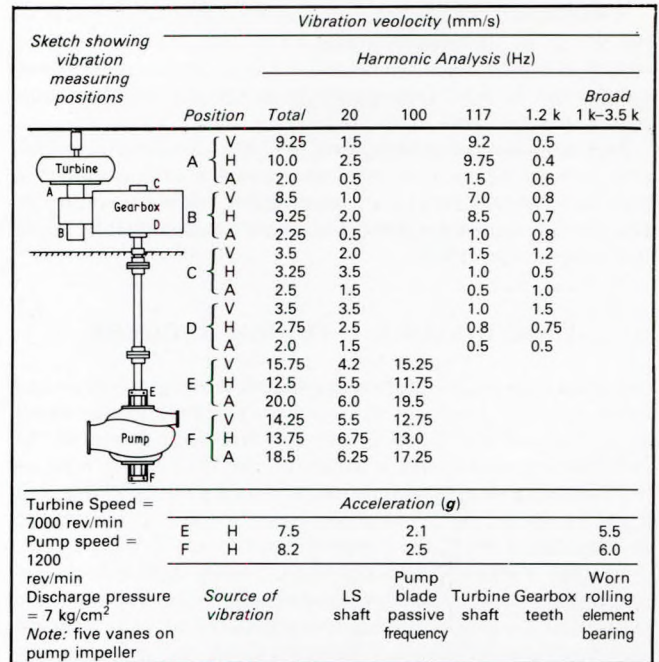
FIG. 8: Cargo pump vibration levels prior to drydocking

For the turbine, which was operating at 7000 rev/min, an acceptable level of vibration may be taken as 3 mm/s (RMS) but it will be seen that this level is exceeded on both bearings A and B in the vertical (V = port to starboard) and horizontal (H = forward to aft) directions. From the harmonic analysis it is concluded that most vibration occurs at 117 Hz, which corresponds to the rotational speed of the turbine. This indicates that there is unbalance and possibly some bearing wear.

The gearbox vibrations for bearing C and D are generally satisfactory. The harmonic analysis shows that the gear teeth vibration at 1.2 kHz is small, indicating that there is little wear and that the mesh is good.

During these tests, a relatively large leak was occurring past the seals on the lower pump bearing. It was therefore recommended that the turbine spindle and bearings should be examined and rectified and that the cargo pump should be given a major overhaul.

During the drydocking, the turbine was balanced and the cargo pump fitted with a new impeller, wear rings, seals and bearings. At the completion of the work, the vibration tests were repeated under similar conditions to the previous tests. It will be seen from Table I that a considerable reduction in vibration was achieved throughout the set, resulting in a satisfactory conclusion to this investigation.

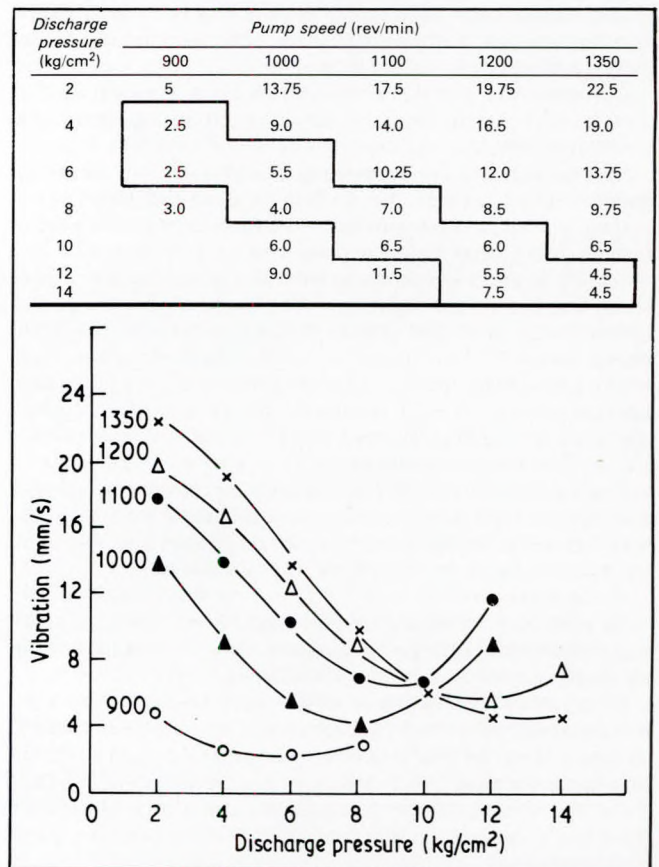
FIG. 9: Typical variation of cargo pump vibrations with change of speed and discharge pressure

Typical vibration levels when pumping water are shown and plotted against varying discharge pressures in Fig. 9, where each curve is drawn with the machine at constant speed. From these graphs it will be seen that there is an optimum discharge pressure at each speed. This optimum range is indicated by the values within the lines in the table. In general terms, as the pump speed is increased, so does the most suitable discharge pressure. Unfortunately, in practice, there is a tendency to operate the pumps outside the optimum ranges with the result that large vibrations occur and then cause failure.

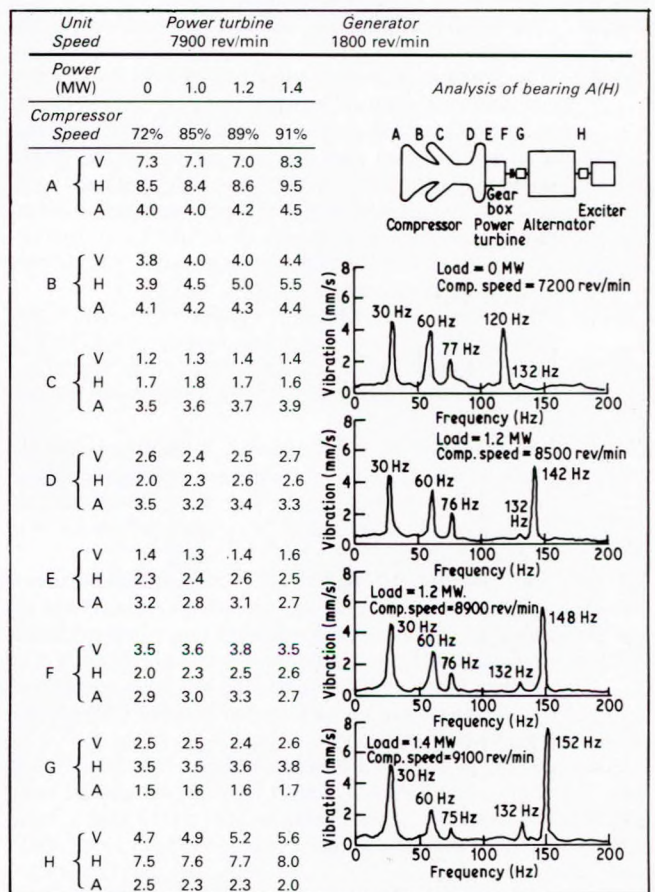
**FIG. 10: Vibrations on gas turbine generator and real-time analysis of bearing A(H) before repair**

The project was commenced by taking a range of measurements at different loads in the vicinity of the bearings, as shown in Fig. 10. It was found that the vibrations were particularly large in the area surrounding bearings A and H. First, an analysis of the bearing H measurement showed that a large 30 Hz component was present, which indicated that the generator was out of balance.

The pattern of vibrations on bearing A were much more complex so a real-time analysis trace was taken in the horizontal direction for each load condition, as can be seen from Fig. 10. This analysis reveals that the components of vibration and their most likely causes were as follows:

- 30 Hz This is very large and is due to the unbalance of the generator rotor.
- 60 Hz This is a twice per revolution vibration of the generator shaft and is caused by some misalignment between the generator and gearbox. It will be seen that as the load is increased and the unit heats up, the 60 Hz component reduces, most probably because as a result of the growth of the set, the alignment between the generator and gearbox tends to improve. Although this 60 Hz vibration is present, the overall level is relatively small.

- 76 Hz This is an unusual vibration which corresponds to the first critical speed of the power turbine rotor. In this case it is most likely caused by slight whirling of the power turbine rotor, but because it is so small it is not serious.

- 120 Hz The vibrations at these frequencies, which occurred at different loads, are from the compressor. It will be observed that both the frequency and vibration levels increased with load. This component of vibration is of concern because the magnitude was so large. It was deduced that the non-drive-end bearing of the compressor had worn.

After the analysis, the compressor non-drive-end bearing was physically examined and found to be worn, as had been predicted. Therefore, a new bearing was fitted and a high-speed in-position dynamic balance was carried out (see Figs 11 and 12).

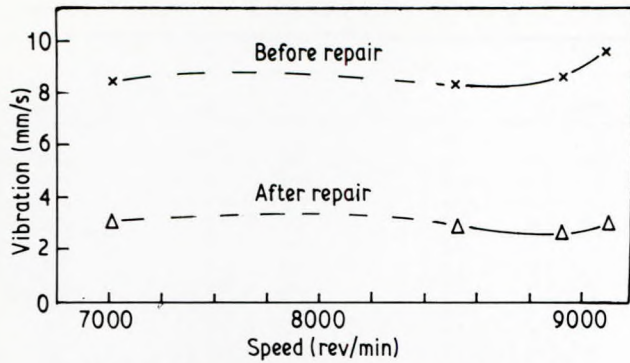
FIG. 11: Compressor non-drive-end vibrations

The vector diagram (Fig. 12) shows the individual stages of balance and the plot of vibration against speed before and after repair are compared in Fig. 11. Once these improvements had been completed, another set of vibration measurements and real-time analysis traces were taken (see Fig. 13).

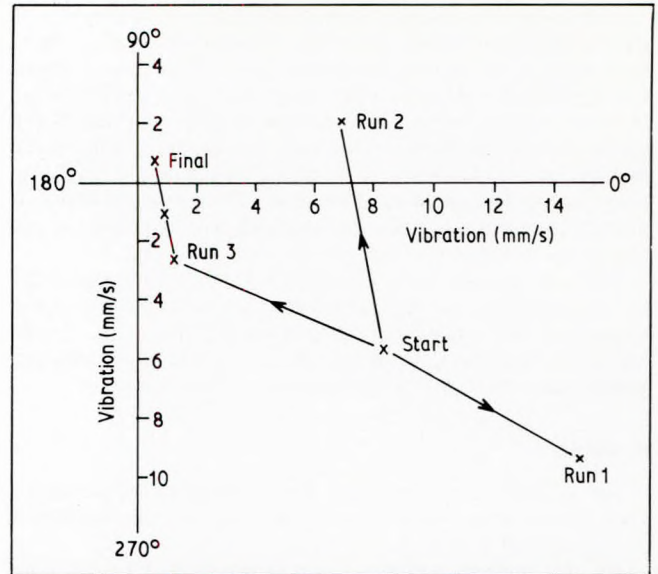
FIG. 12: Alternator non-drive-end vibrations showing progression of vector changes with improvement of balance

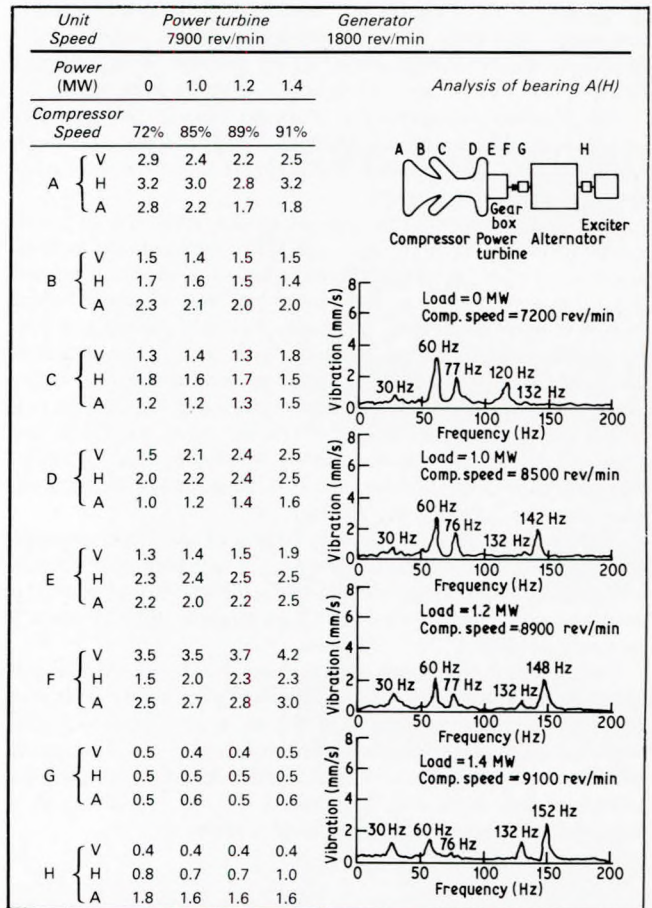
It can be seen that the overall vibration has reduced to a satisfactory level. The 30 Hz component from the generator was down to about 1 mm/s and the vibrations from the compressor were within International Standards.

FIG. 13: Vibrations on gas turbine generator after balance and real-time analysis of new bearing A(H)

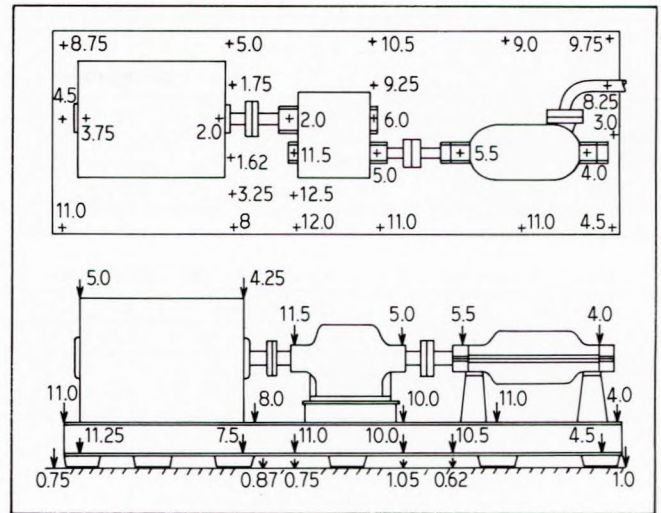
A further test was carried out by taking measurements in a vertical direction down the side of the machine and base frame (Fig. 15). On a normally supported machine one would expect the vibration levels to decrease going down towards the base, but it was noticed in this case that the vibrations tended to increase in the vicinity of the base. Also, the level of vibration

FIG. 15: Vertical vibrations (in mm/s) on water injection pump. Upper: plan view. Lower: side view

on the floor structure under the isolation mounts were acceptable in that the levels varied between about 0.5 and 1.0 mm/s.

Clearly there was a very large difference in vibration between the floor and base frame, which indicated that the isolation mounts were far too flexible, with the result that they most probably amplified the overall vibration, rather than attenuating it! This is a common problem with isolation mounts which either have been incorrectly selected in the first place, or have deteriorated through wear.

To prove that the isolation mounts were too flexible, temporary wedges were placed between the base frame and floor to short-circuit the isolation mounts. This resulted in the vibrations being reduced to about a third of their original value. Therefore, the solution in this instance was to balance the low-speed drive and to install much stiffer isolation pads between the frame and floor.

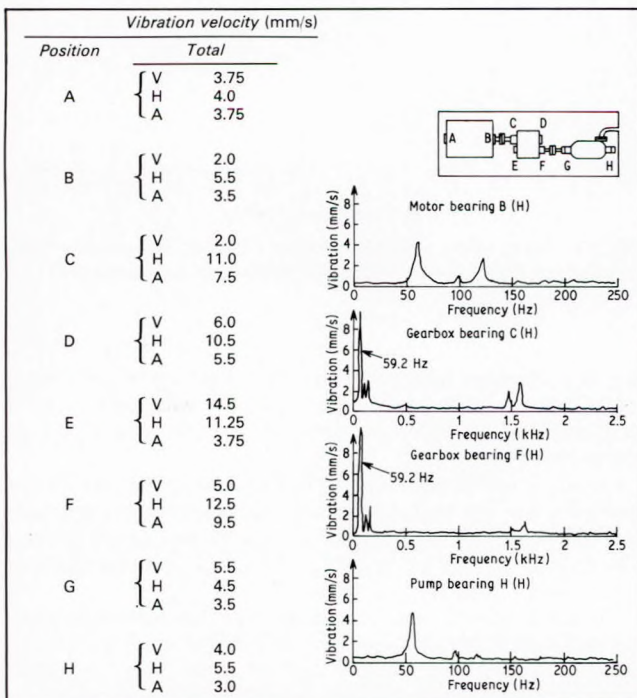
It was found that the vibration levels were high, as can be seen from Fig. 14. Therefore, selected positions were tape recorded and these were later processed through a real-time analyser and a hard copy of the vibration trace taken using an X-Y plotter. Copies of the real-time analysis trace are shown in Fig. 14.

FIG. 14: Vibration levels and real-time analysis for water injection pump

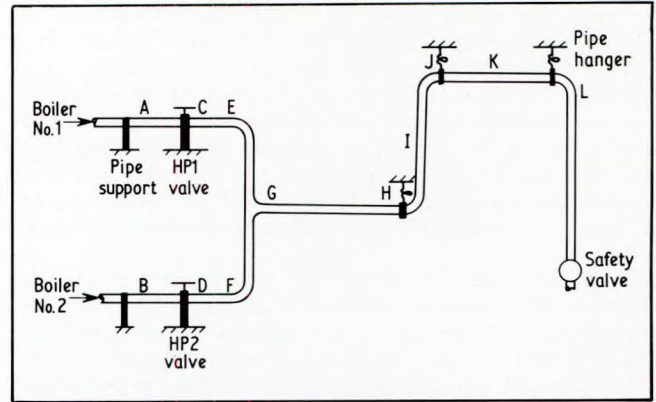
To illustrate this point, a problem which was encountered on a section of ten year old high-pressure steam pipe which ran from twin boilers has been selected. The arrangement of the pipework is shown in Fig. 16 and measurements of vibration were taken at each of the positions denoted by letters. The test was repeated for the following conditions:

It can be seen from Table II that the vibrations in the vertical direction are almost twice those measured horizontally and that the main component of vibration was at 29 Hz. Clearly, the region between positions H and K was experiencing excessive levels, so much so that the pipe joints were continually leaking and cracks were appearing at the flanges.

**FIG. 16: High-pressure steam pipes from twin boilers**

After the test, the pipe hangers at positions H and J were examined. These were found to be badly worn and the springs had wasted away in certain places. Therefore, they were not giving adequate restraint to the pipework. It was decided to take two courses of action:

After the work had been completed, another set of vibration measurements was taken with the pipework carrying high pressure steam and the two valves open. The measurements are shown in Table III from which it will be noted that the vibration levels with the new and refurbished hangers had been reduced considerably.

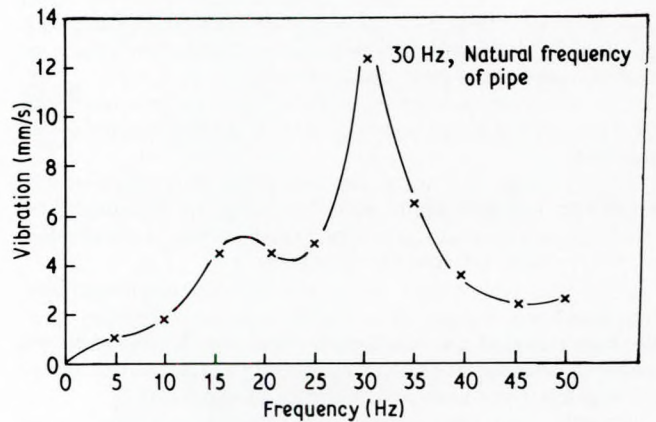
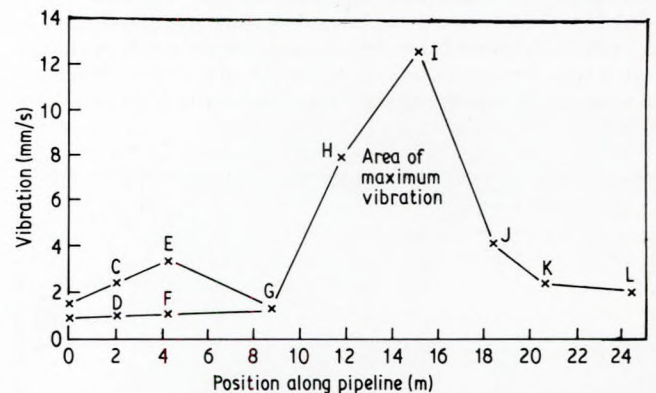
This test, therefore, proved that the 'on-line' forces were exciting the pipework natural frequency and thus causing the various failures previously encountered.

**FIG. 17: Tests using vibration exciter. Upper: Resonance test, position I(V). Lower: Vibration deflection along pipe(V)**
